Information request – CLM/2016/026078 - 4 Woodbank Road, Hanmer Springs 7334

Claim: CLM/2016/026078

4 Woodbank Road, Hanmer has suffered damage from the Kaikoura Earthquake sequence late in 2016. This Scope Report has been completed for insurance assessment and estimating only.

APPENDIX A | Architectural Damage and Remedial Plans

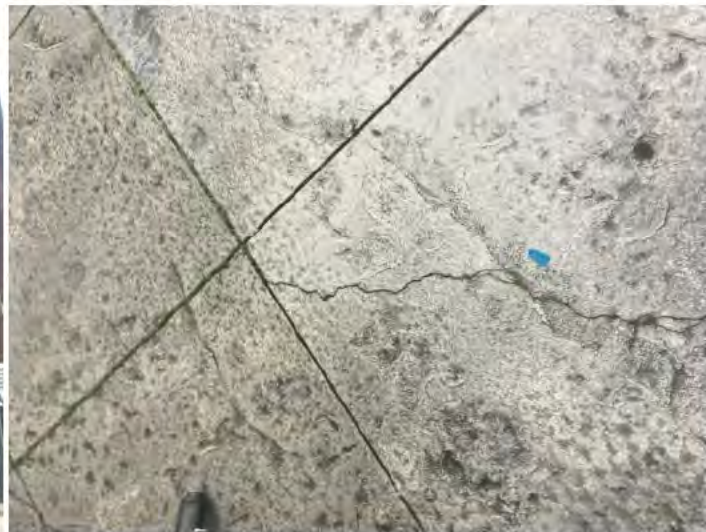
11. Typical cracking of cut concrete patios

- The bamboo timber strip flooring should be replaced.
- The kitchen splashbacks should be removed and replaced.
- Concrete patios should be replaced as required.

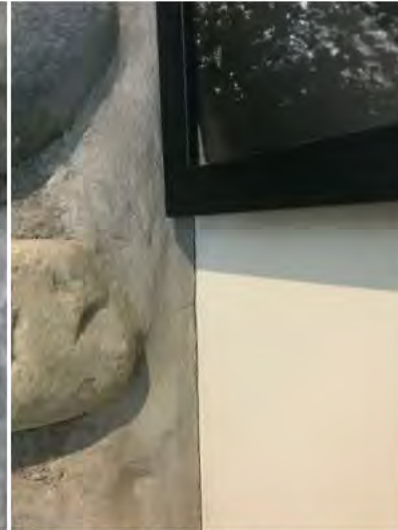
5. Entry (1.00) movement between stone and wall, minor cracking to mortar

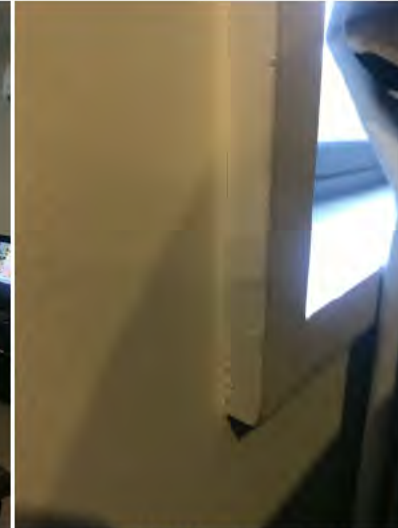
8. Family (1.01) movement to window and wall cracking

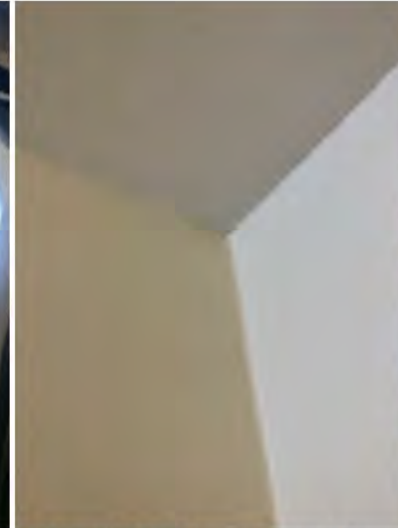
9. Family (1.01) movement to ceiling wall junction

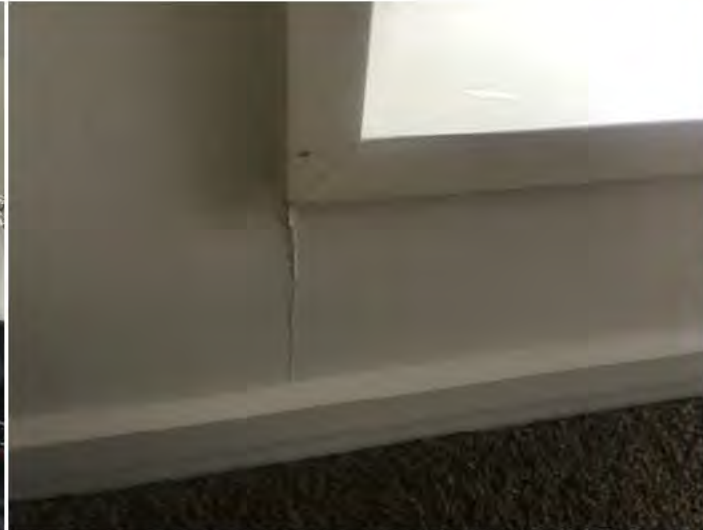
2. Lounge (1.05) cracking under window

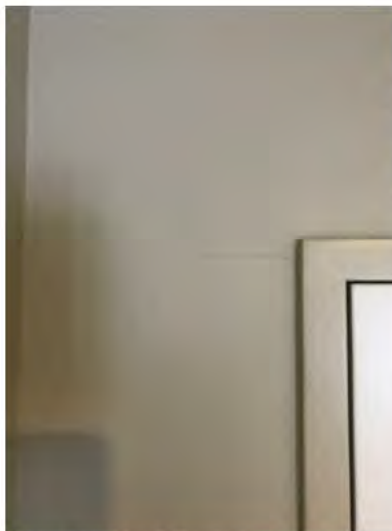
10. Hall (1.12) wall cracking

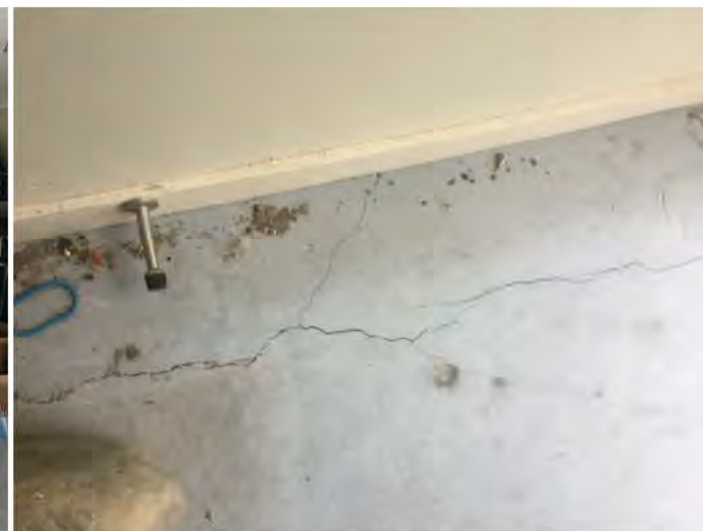
14. Garage (1.17) cracking to slab

It is recommended that the cracking to the garage concrete slab-on-grade is repaired in accordance with MBIE guidelines.

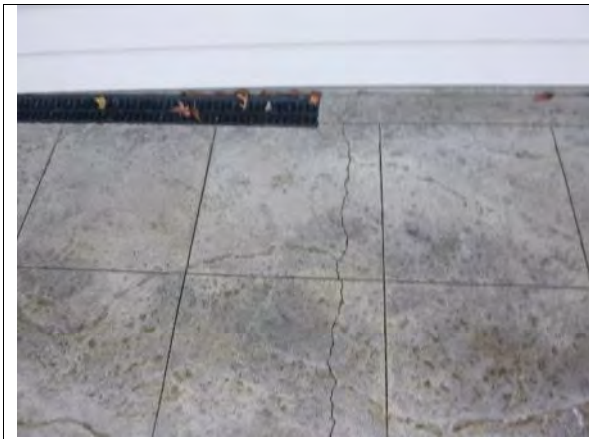
- The stamped concrete patio to the north has cracked in numerous locations and separated from the main dwelling’s concrete slab.
- Asphalt adjacent to the garage door has slumped and separated from the stone veneer cladding.
- The sealed joint between the Rockcote plaster/Linea weatherboard cladding and soffits has cracked in various locations.
- A gully trap located on the north elevation patio has cracked.

Photo 7: Cracking in adjacent external paved surfaces

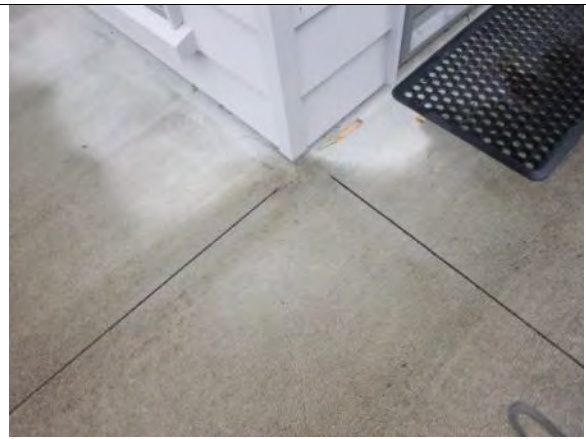
Photo 8: Cracking in adjacent external paved surfaces

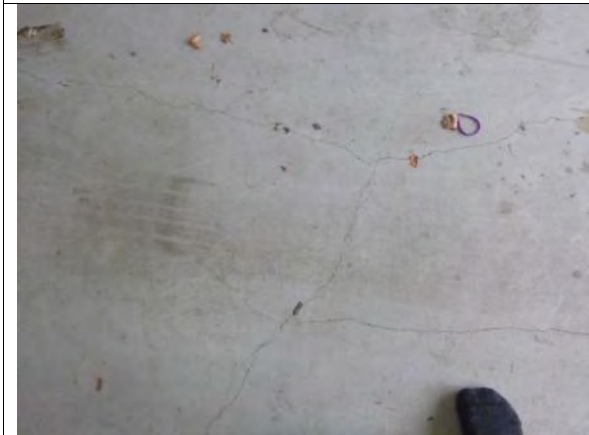
Photo 9: Typical cracking within the garage concrete slab-on-grade

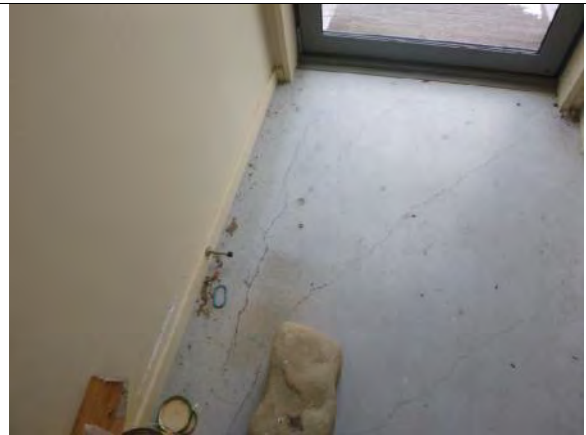
Photo 10: Cracking within the garage concrete slab-on-grade

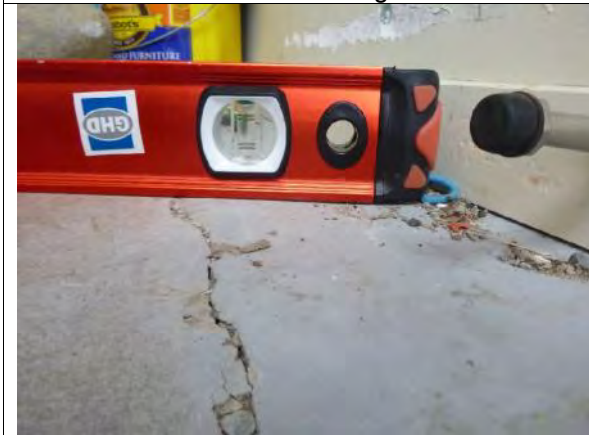
Photo 11: Variation in floor level adjacent to cracking within the garage

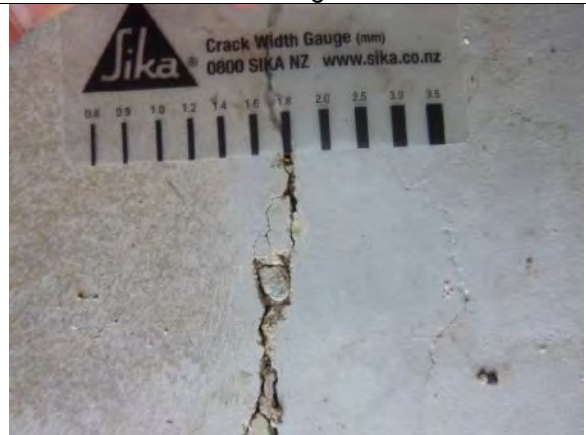
Photo 12: Cracking within the garage approximately 1.8 mm in width

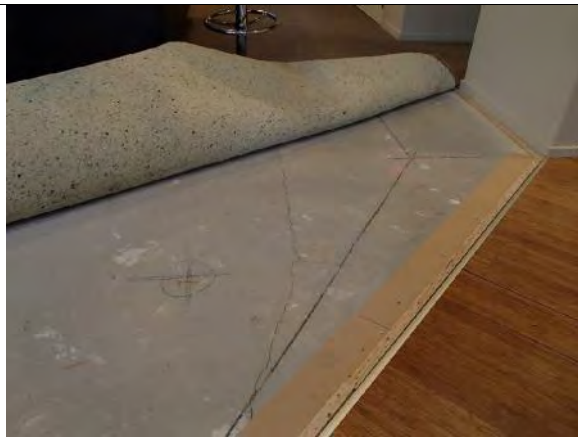
- It is recommended that cracking within the garage concrete slab-on-grade is repaired in accordance with the MBIE guidelines. Minor cracking observed elsewhere within the garage, and those visible in the photographs provided by the homeowner are considered to be the result of shrinkage and not earthquake related damage requiring repair.

Photo 13: Image provided by the homeowner of cracking within the kitchen (room 1.02) concrete slab-on-grade

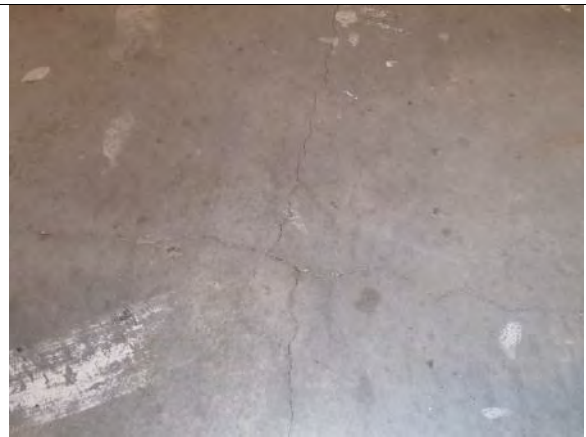
Photo 14: Image provided by the homeowner of cracking within the lounge (room 1.05) concrete slab-on-grade

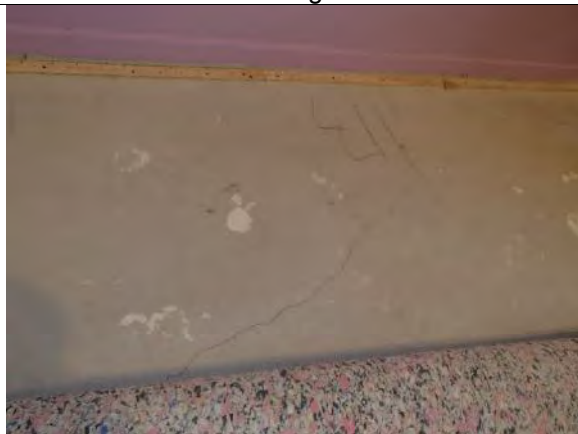
Photo 15: Image provided by the homeowner of cracking within the bedroom 2 (room 1.10) concrete slab-on-grade

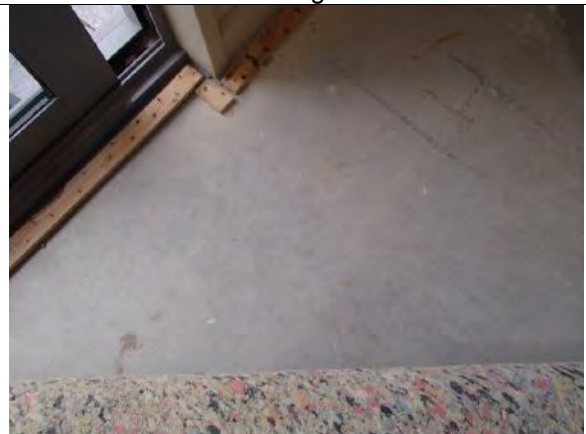
Photo 16: Image provided by the homeowner of cracking within the bedroom 4 (room 1.13) concrete slab-on-grade

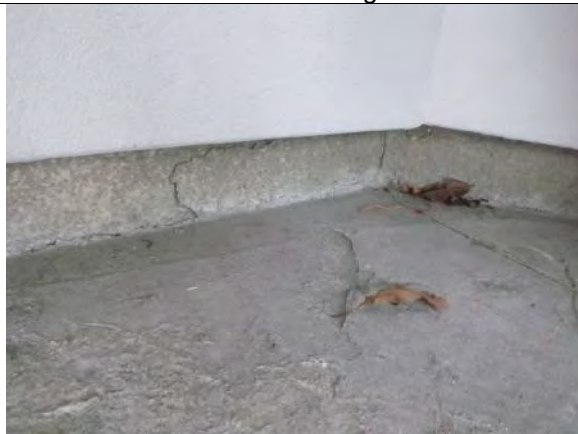
Photo 17: Perceived cracking in the side of the managers' residence slab-on-grade; however, this is likely to be screed remnants from the adjacent external concrete surface

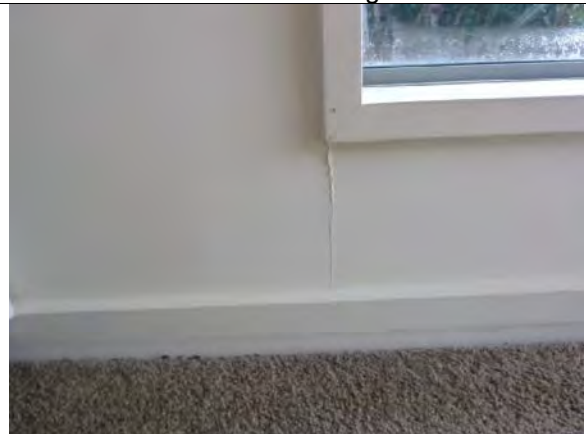
Photo 18: Typical cracking within the managers' residence plasterboard linings

It is recommended that repairs be completed to the plaster and plasterboard wall linings in accordance with MBIE guidelines and relevant GIB publications.

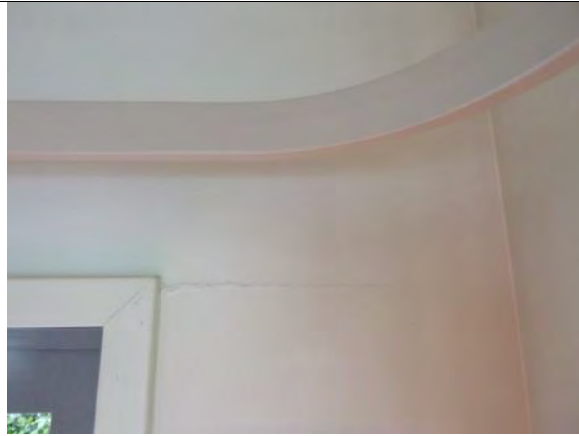
Photo 19: Typical cracking within the managers' residence plasterboard linings

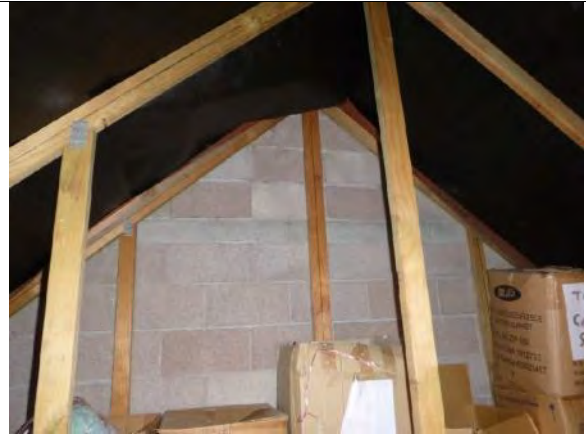
- Minor cracking between, and dislocation of, the concrete blockwork within the firewall separating the manager's residence and the apartment units was observed; however, this isolated damage is minor and considered not to be earthquake related.

Photo 20: View of the masonry firewall located between the managers' residence garage (room 1.17) and the adjacent apartment wing

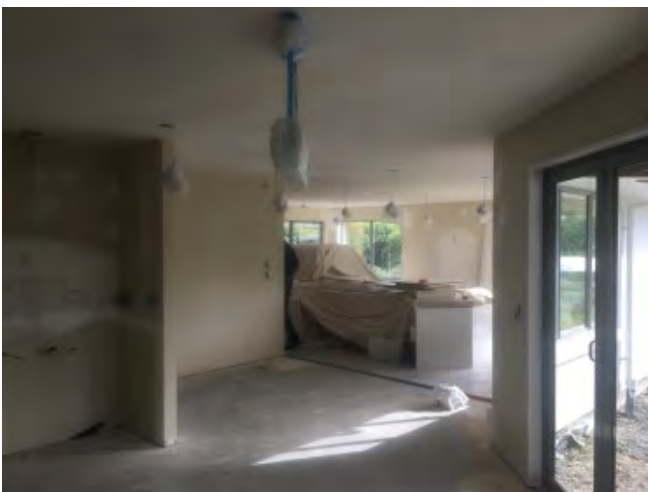
Kitchen - Plasterboard lining repairs complete, painting underway, cabinetry and bamboo flooring removed

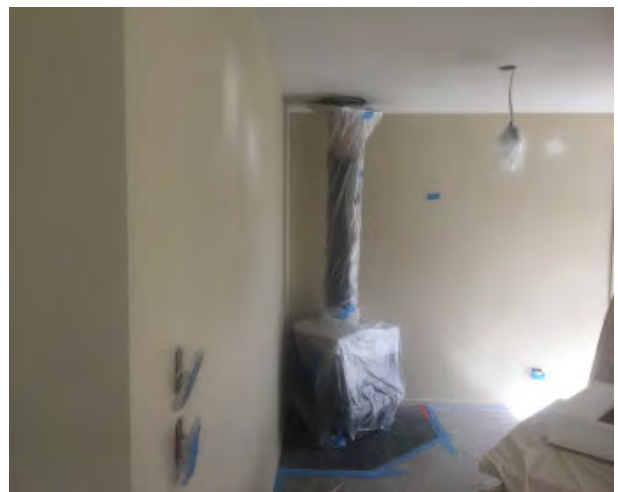
Lounge - Plasterboard lining repairs complete, painting underway

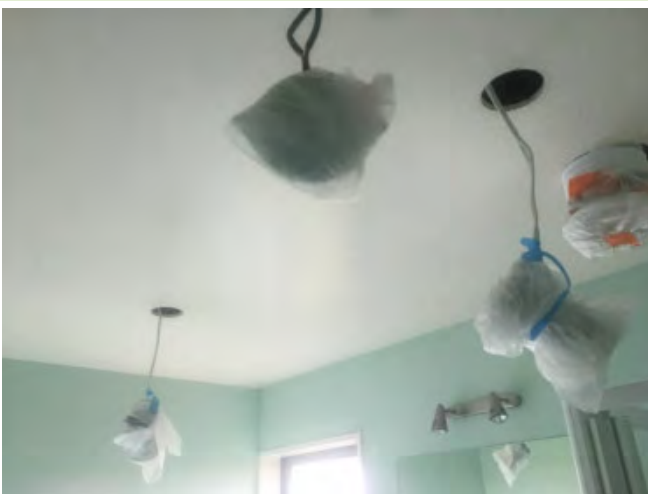
Bathroom - Painting underway, electrical fittings protected

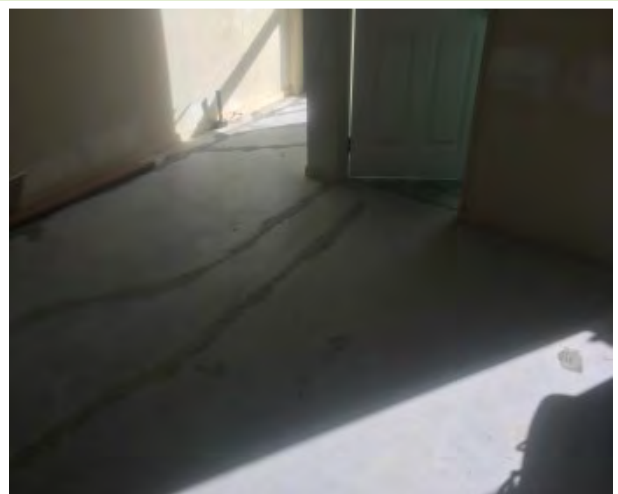
Garage - Epoxy repairs to the concrete slab underway
