Standard Property Report

Report number:	7830807
Inspection date:	05th Nov, 2021
Property address:	4C Old Wairoa Road 2110 Auckland New Zealand

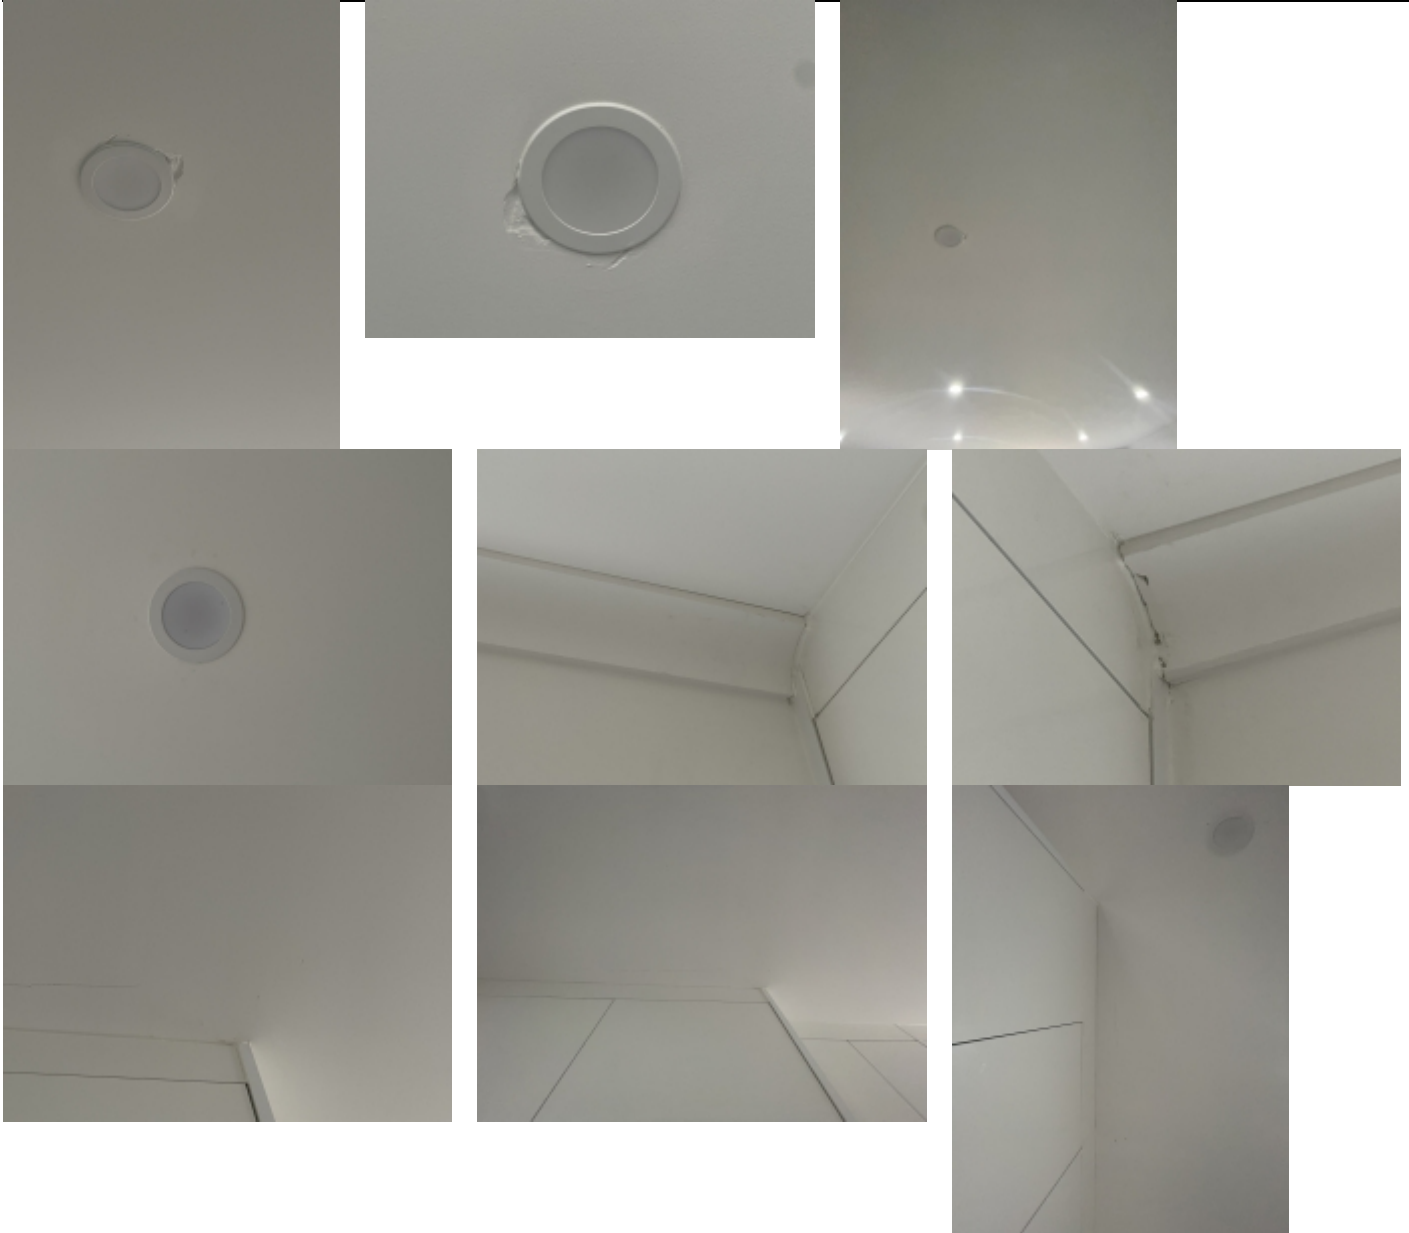
Room / Area Name	Living/Kitchen
Details	There are finishing defects in the ceilings in the living space around one of the light fixtures and in the centre of the plasterboard in the living space. The finishing around the coving in the kitchen and in front of cabinetry has not been completed to a tradesman like standard.

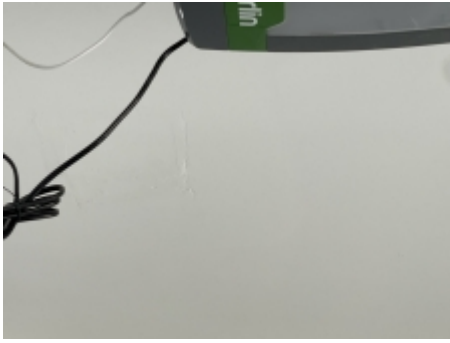
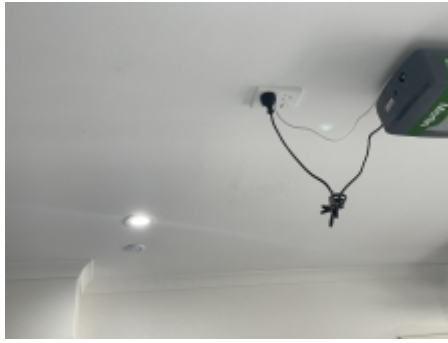
Room / Area Name	Garage
Details	There is an area in the garage ceiling that has not been finished to a tradesman like standard.

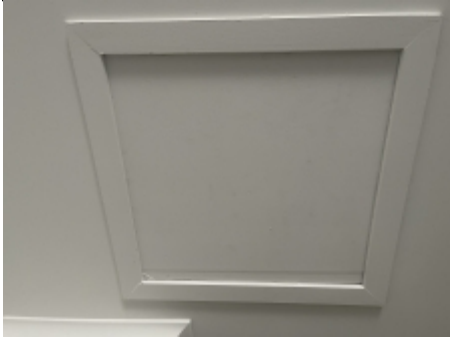
Room / Area Name	Access Hatch
Details	The interior roof space access hatch panel has been constructed from a plasterboard remnant with the tapered edge exposed and has a broken corner.

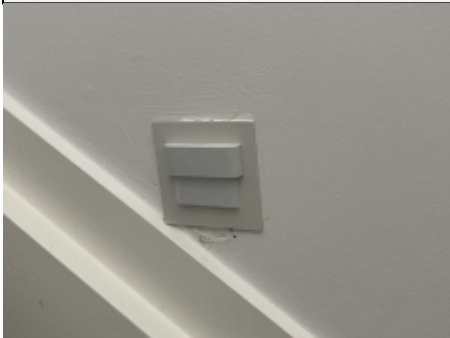
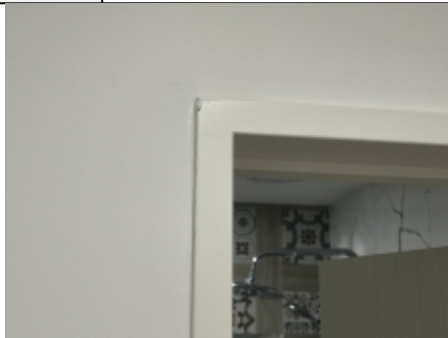
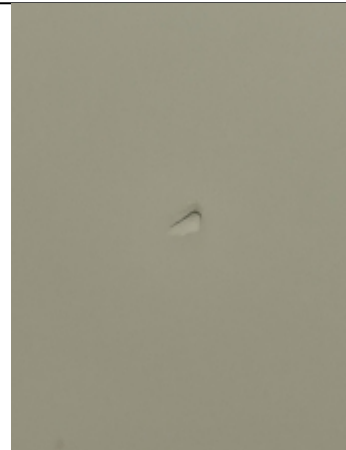
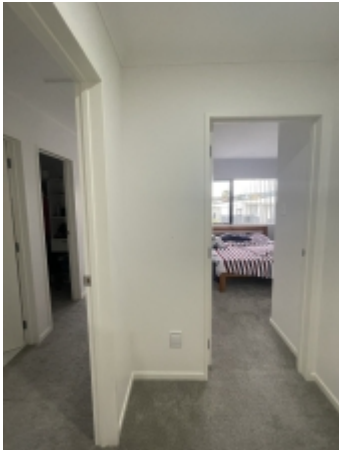
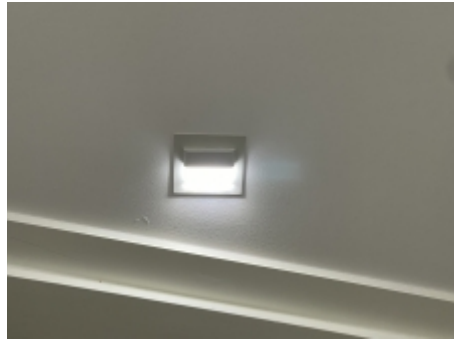
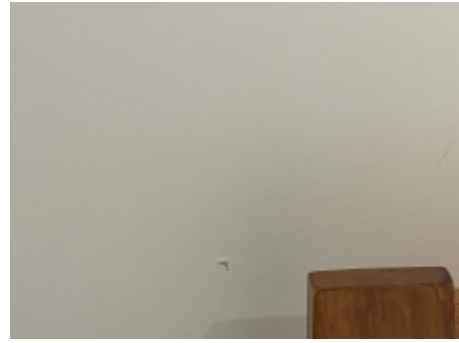
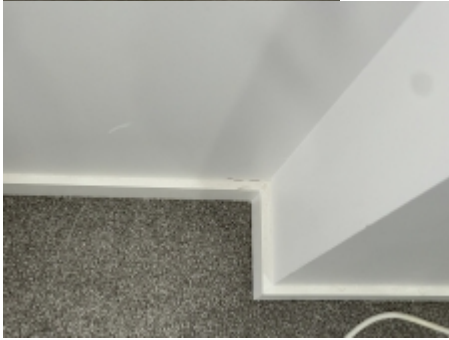
Room / Area Name	Various
Details	There are areas throughout the dwelling, particularly in the hallway around tread lights, and around architraves and skirting that have not been finished to a tradesman like standard.

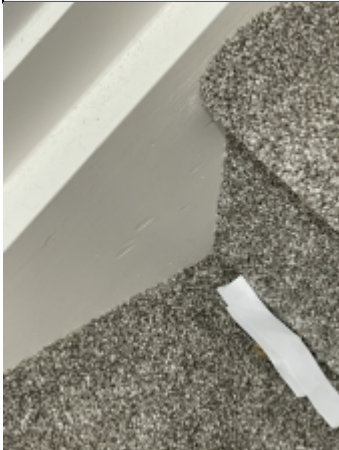
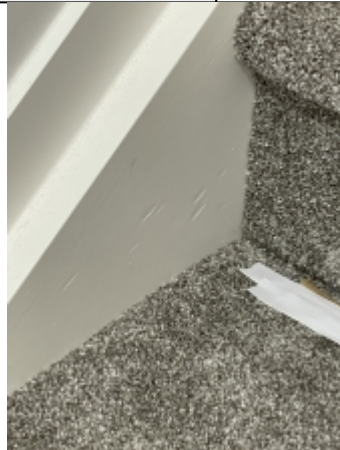
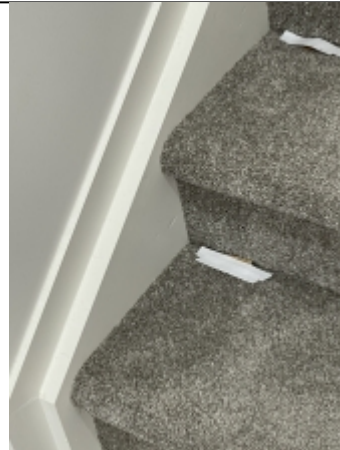
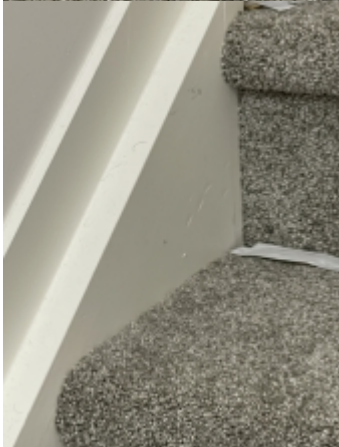
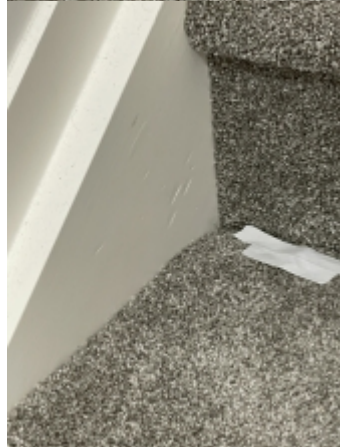
Room / Area Name	Stairs
Details	The carpet smooth edge at the side and rear of the stair treads is piercing through the carpet.

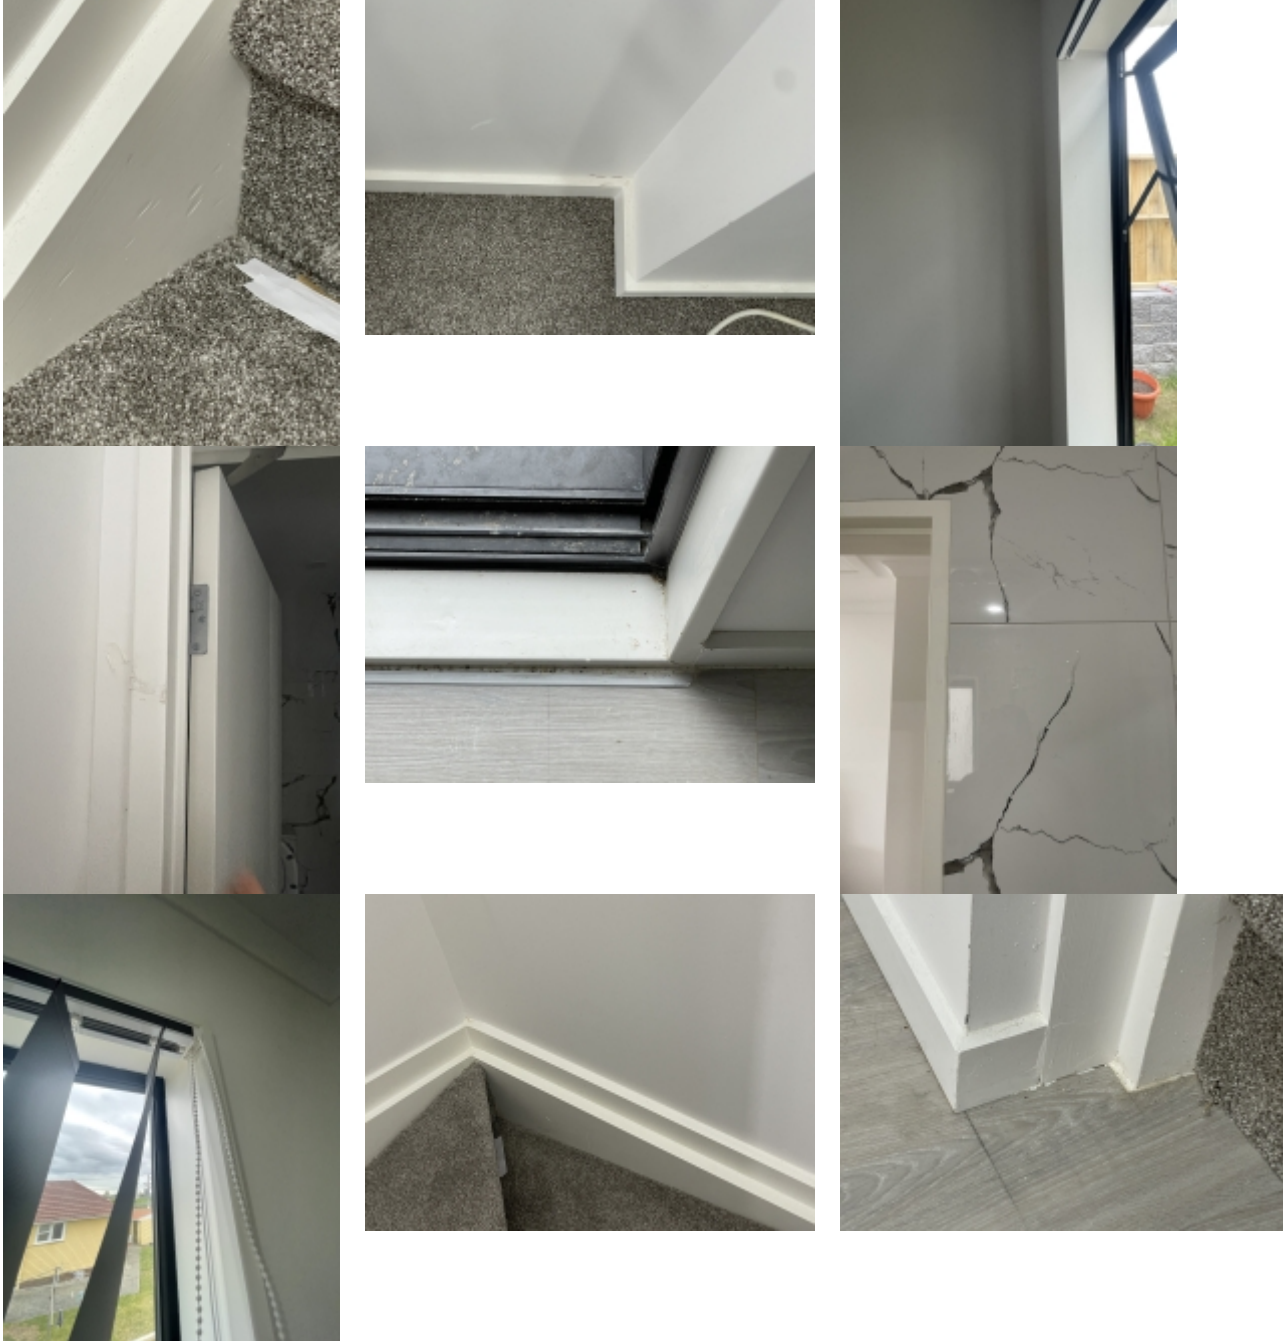
Room / Area Name	Various
Details	The architraves around the bathrooms have silicon another materials on them, the junctions between the plasterboard and the architraves and skirtings has not been completed to a tradesman like standard, the stair rises have defects in the finishing that has not been completed to a tradesman like standard.

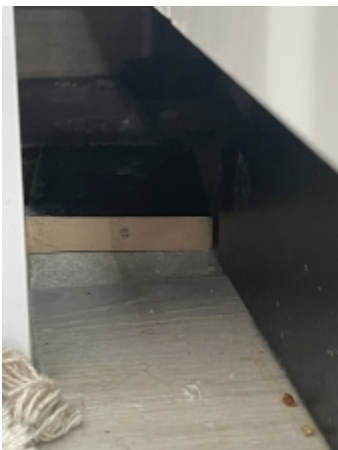
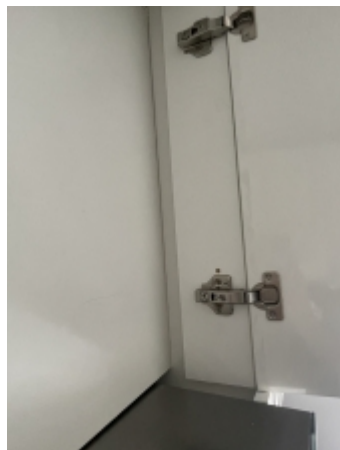
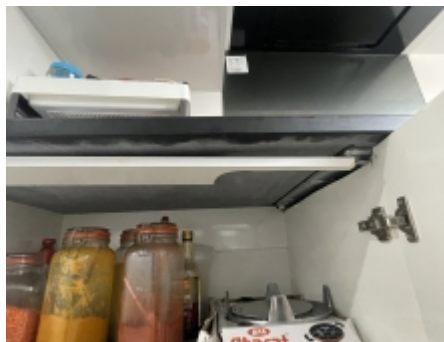
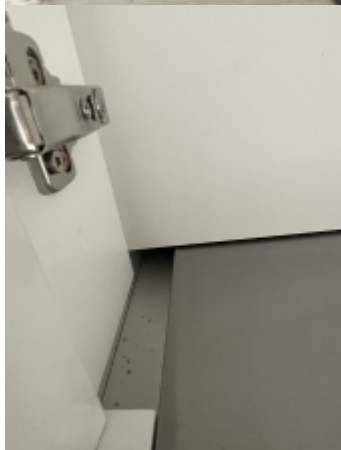
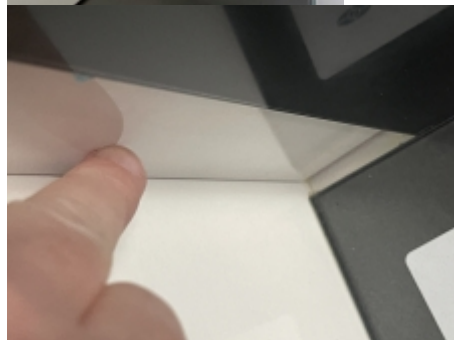
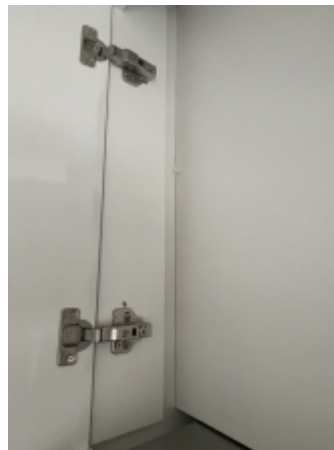
Room / Area Name	Kitchen
Details	One of the toe kicks and some of the filler panels around the rangehood are loose and require repairs.

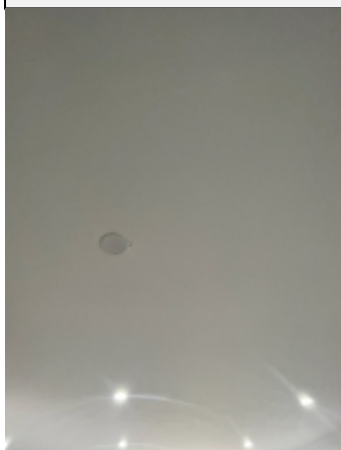
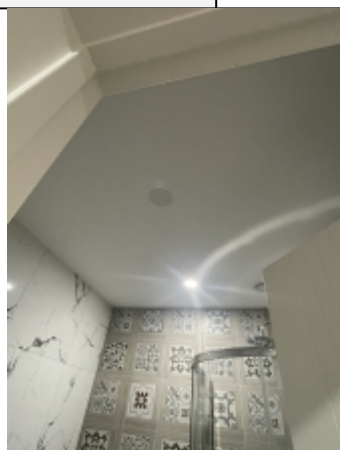
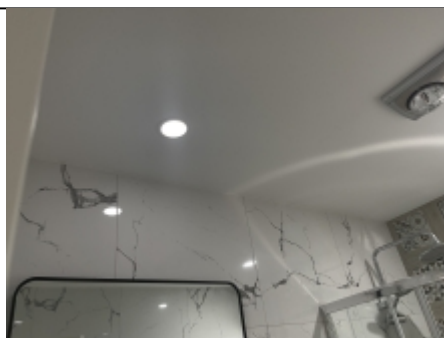
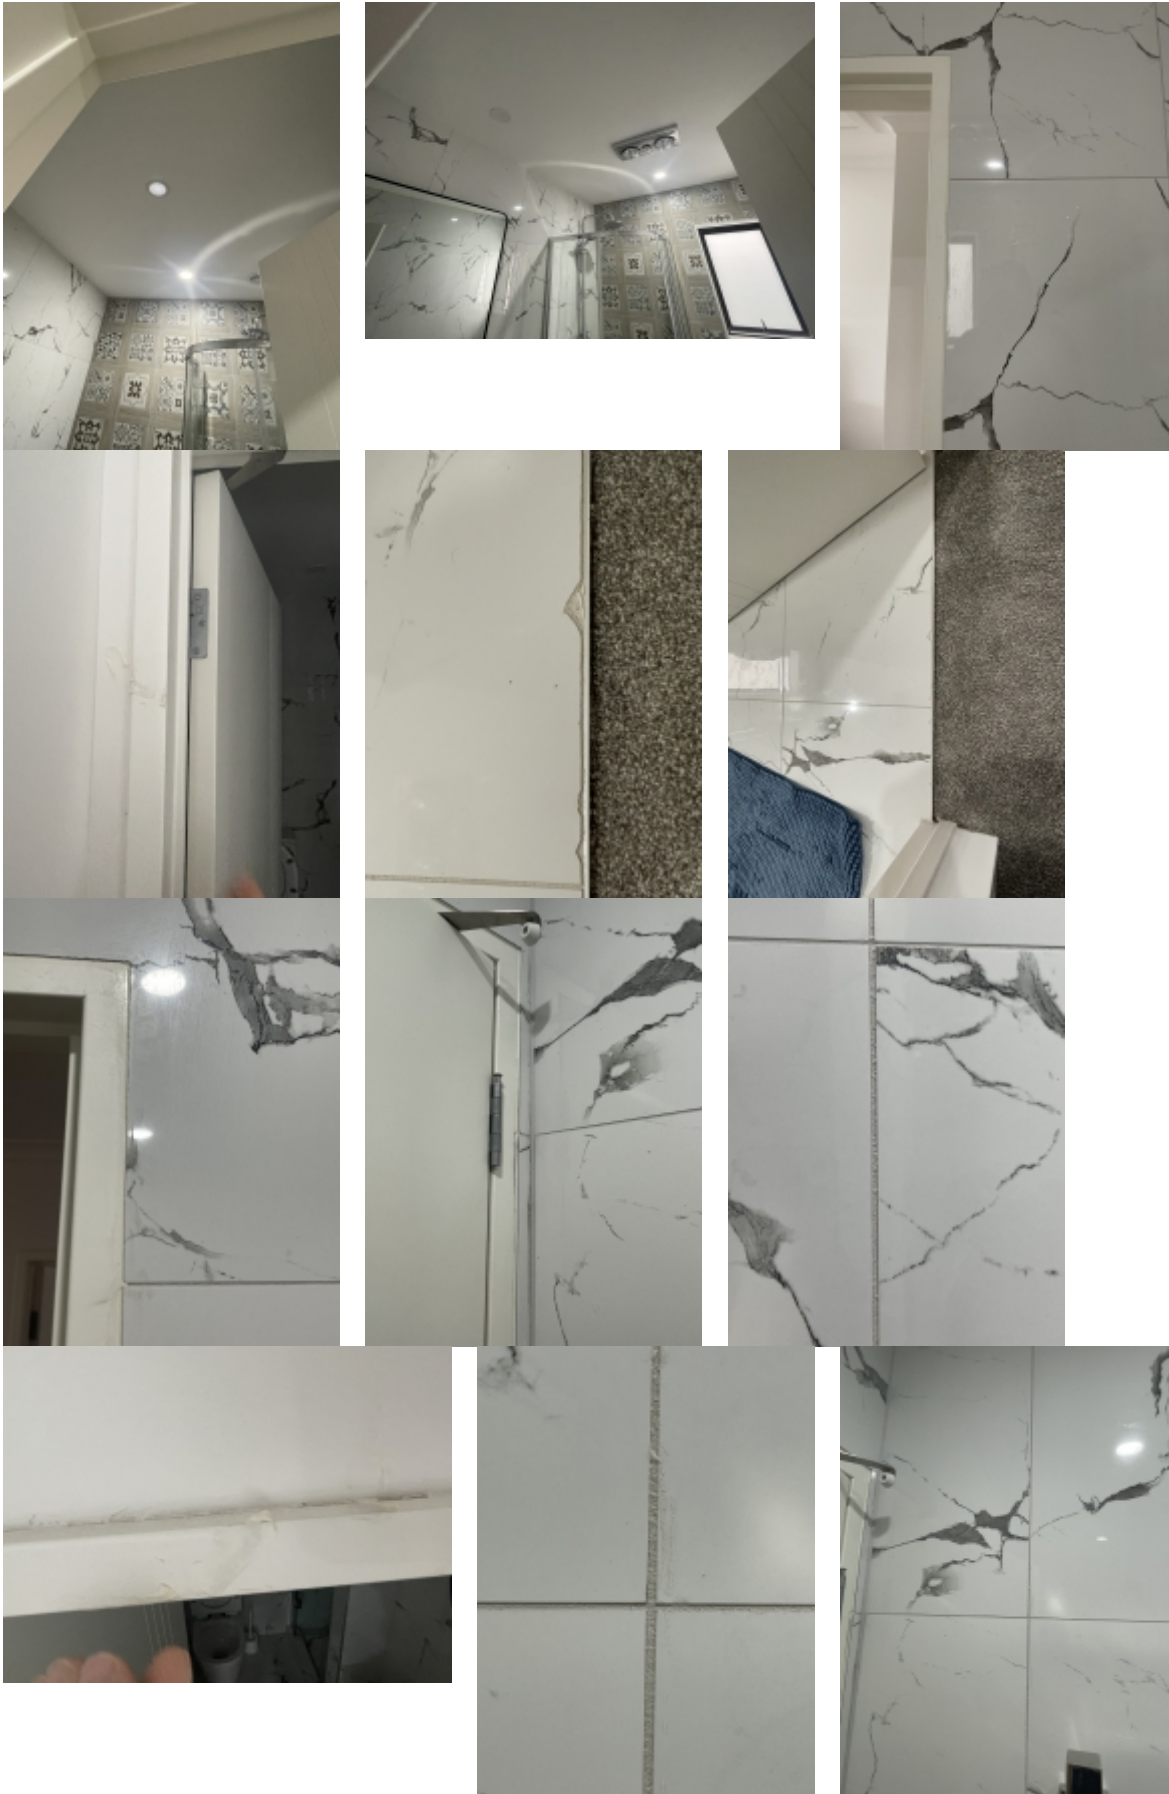
Room / Area Name	Bathrooms
Details	<p>Various light fixtures in the bathrooms were not functioning and were flickering at the time of inspection.</p> <p>The tiling and grouting in the bathrooms in areas has not been completed to a tradesman like standard with rough patch of grout, sealant and silicon visible over woodwork and trim, tile cuts in the master ensuite that are not smooth.</p>

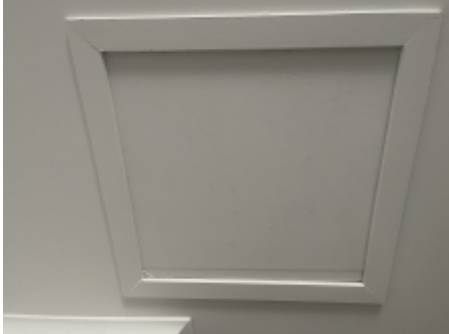
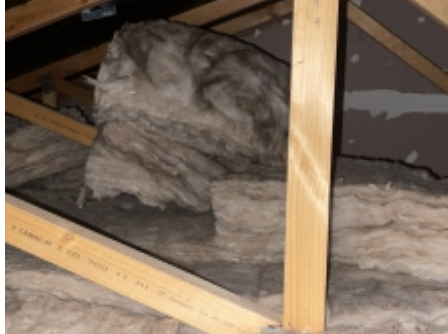
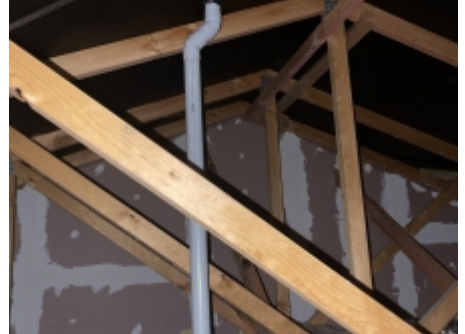
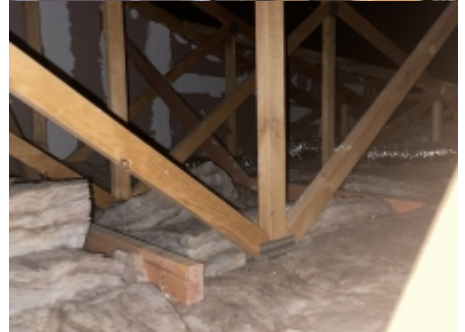
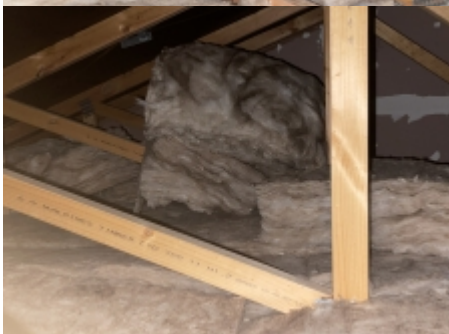
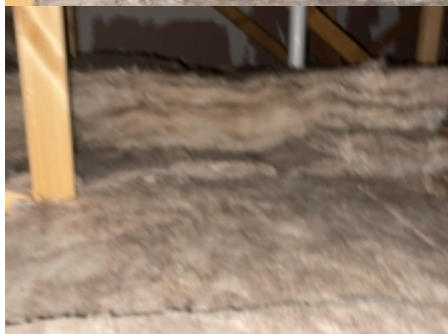
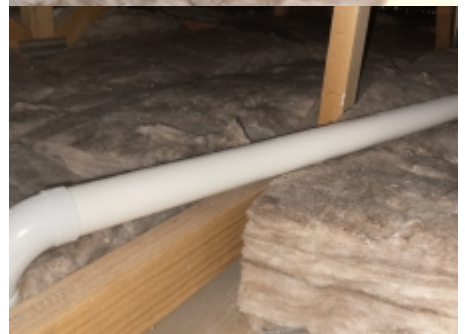
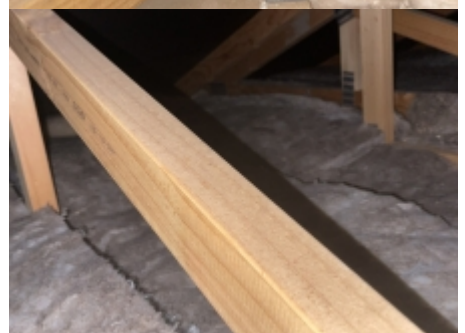
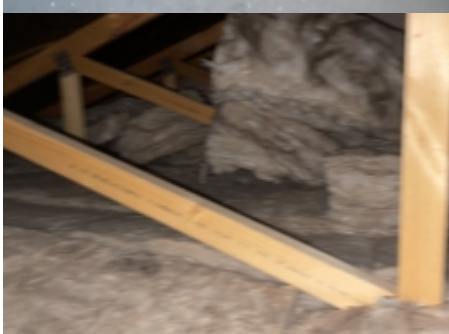
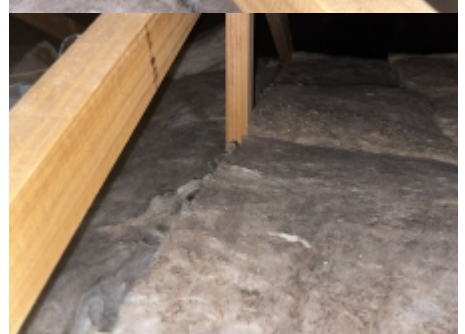
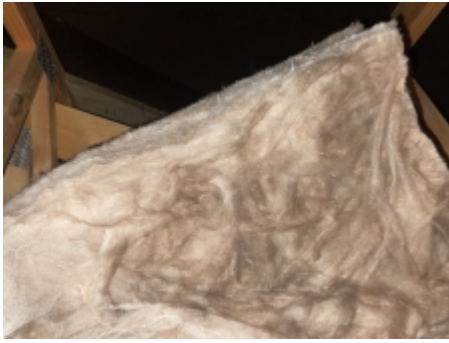
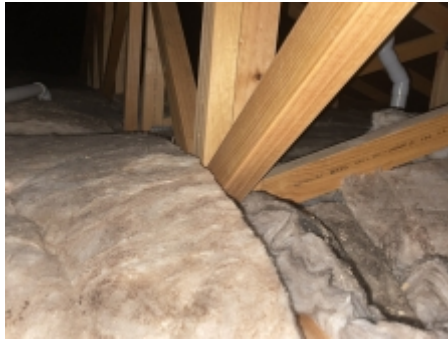
Room / Area Name	Interior Roof Space
Details	The interior roof space was inspected via the access hatch. The plumbing and electrical as well supported, there is thermal fibreglass insulation installed. There is a firewall. The Writer has not seen plans or documents so is unable to comment on construction specification. The interior roof framing has been completed to an acceptable standard.

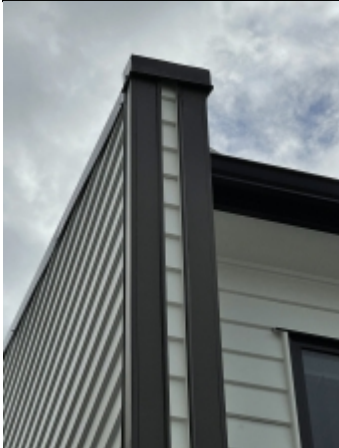
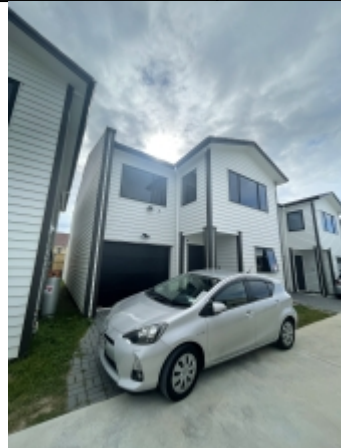
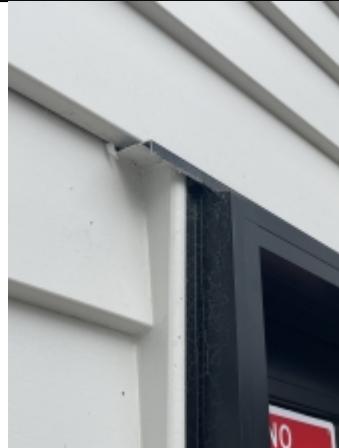
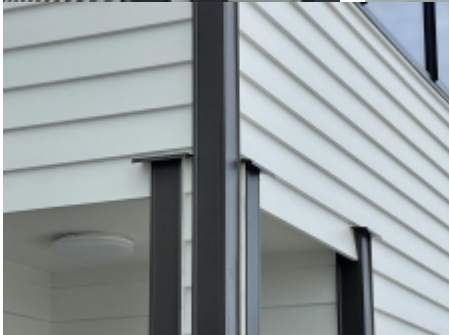
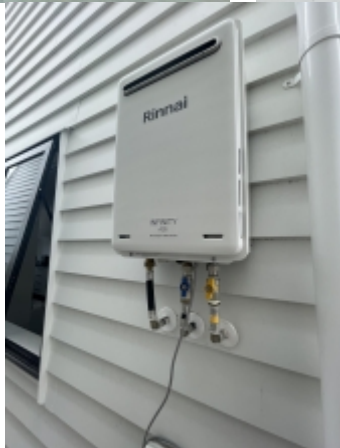
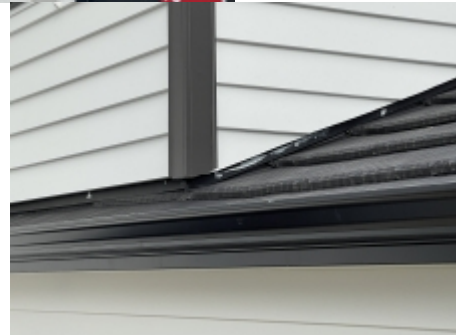
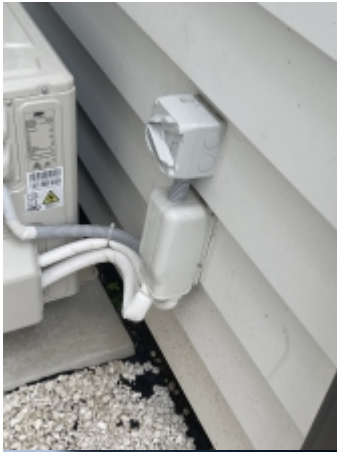
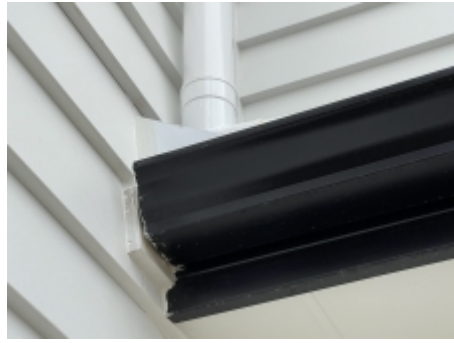
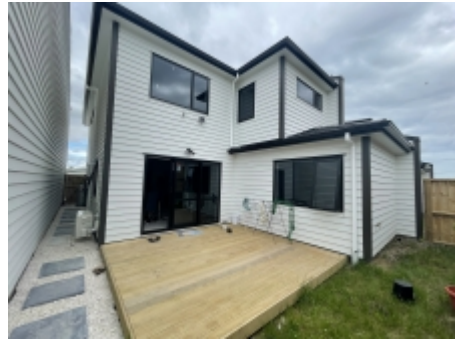
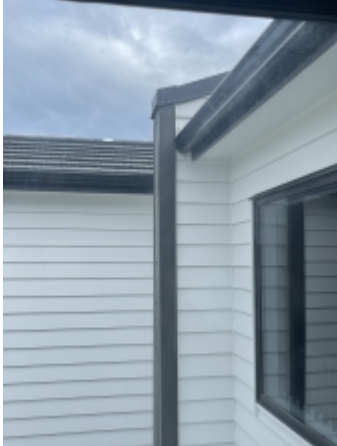
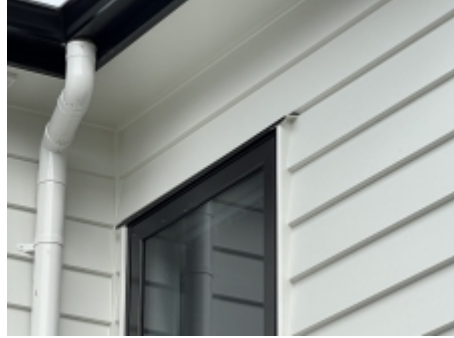
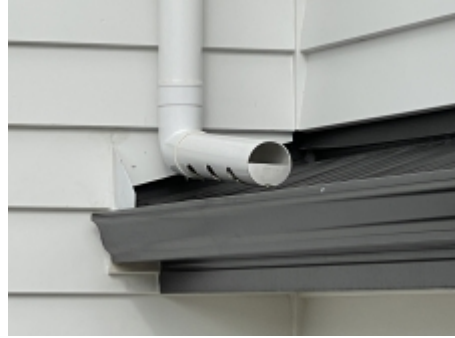
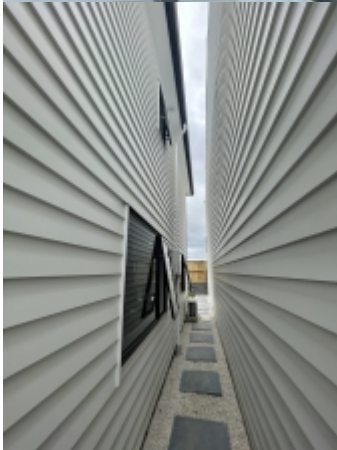
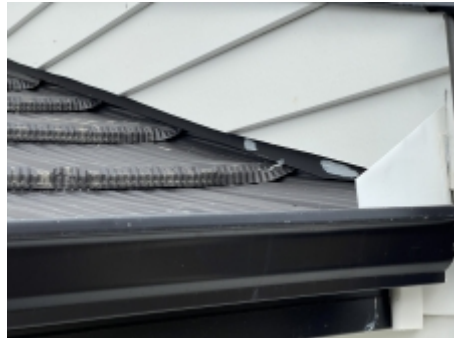
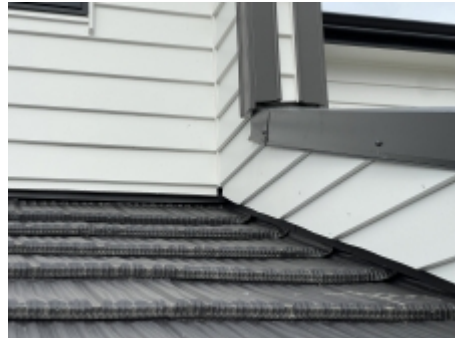
Specific Area	Exterior Cladding
Details	The exterior fibre cement weatherboard cladding has been completed to an acceptable standard. The double glazed aluminium joinery has mechanical head flashings installed. The roof to wall junctions are appropriately flashed and diverter flashings installed to the upper level where appropriate. There are a number of penetrations for services, we recommend these are regularly monitored and maintained to ensure no water ingress occurs.

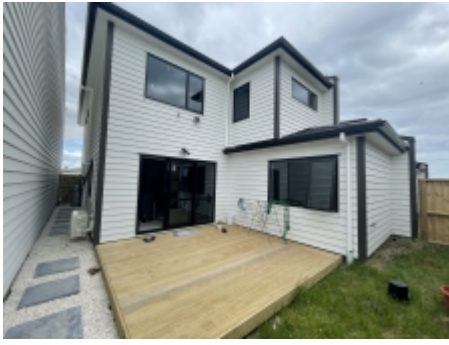
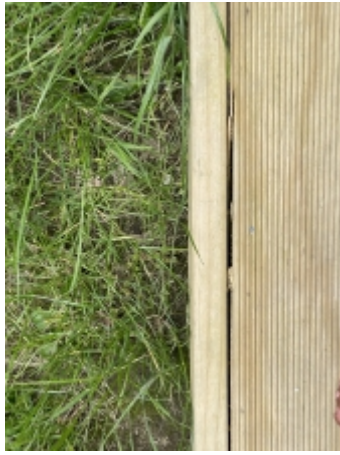
Specific Area	Deck
Details	The deck has been constructed to an acceptable standard, there is a decking board at the perimeter that is broken.

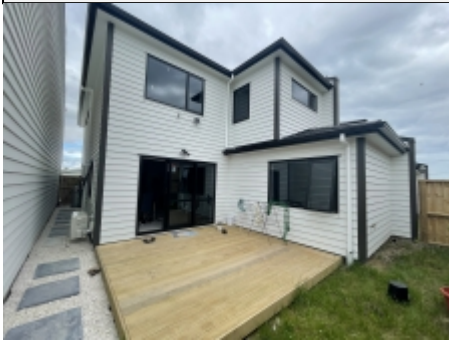
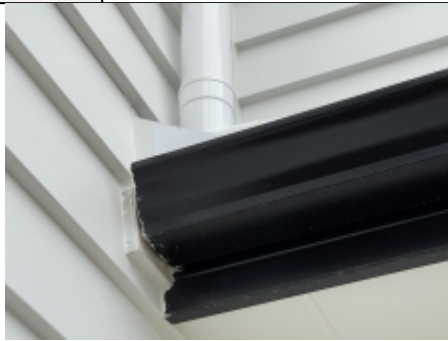
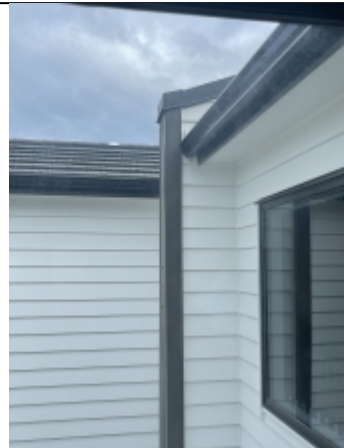
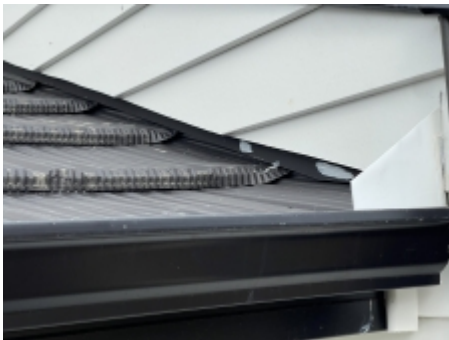
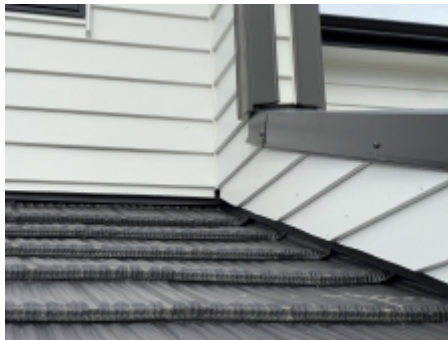
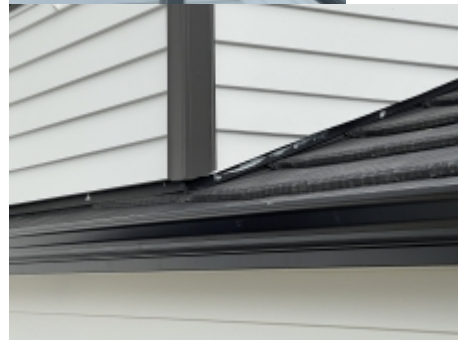
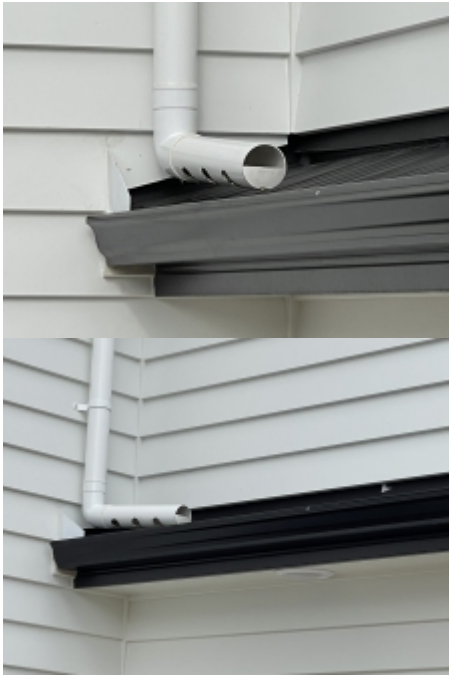
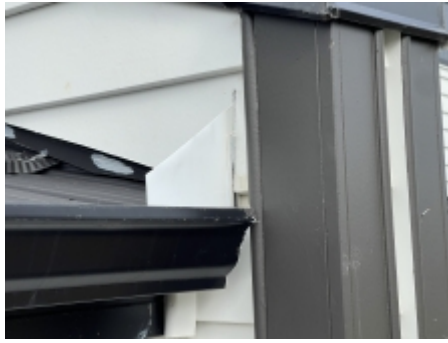
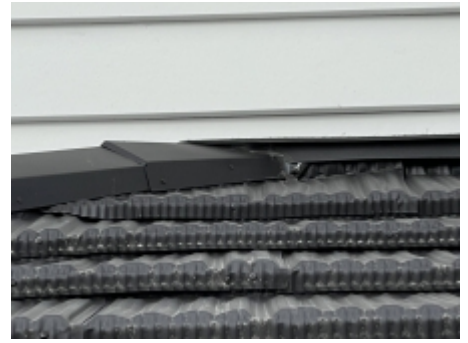
Specific Area	Roof
Details	The roof has higher than 3.6 m so was inspected visually from various locations around the site. The roof has been constructed to an acceptable standard, there are appropriate diverter flashings and guttering and spreaders installed at correct locations. There are a number of penetrations for services, regular roofing and guttering maintenance is essential as part of a long-term maintenance plan.

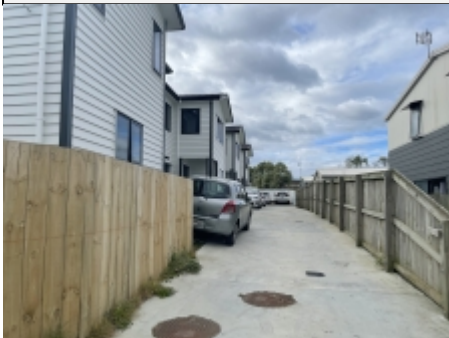
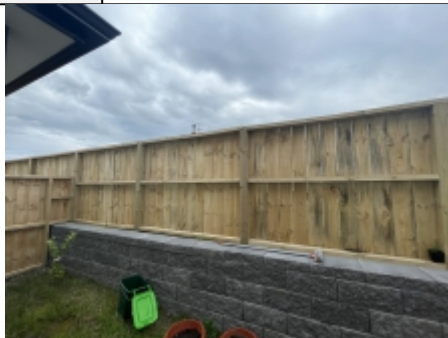
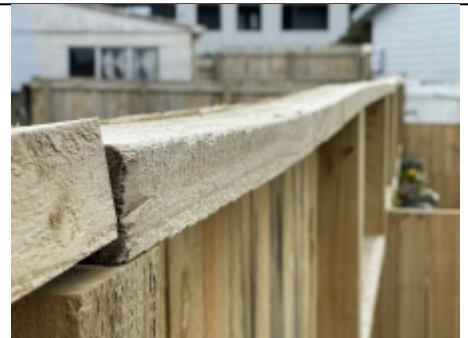
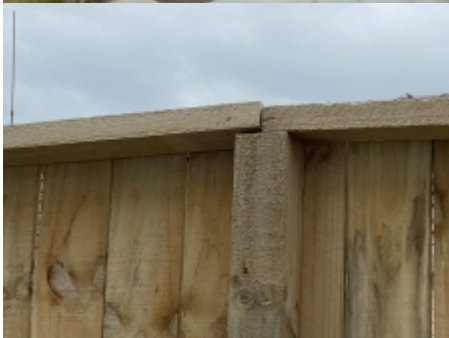
Specific Area	Fences
Details	The fences have been constructed to acceptable standard. The rails at the rear of the dwelling require additional fixings.
