Sketch of site including all retaining walls

Retaining wall layout sketch

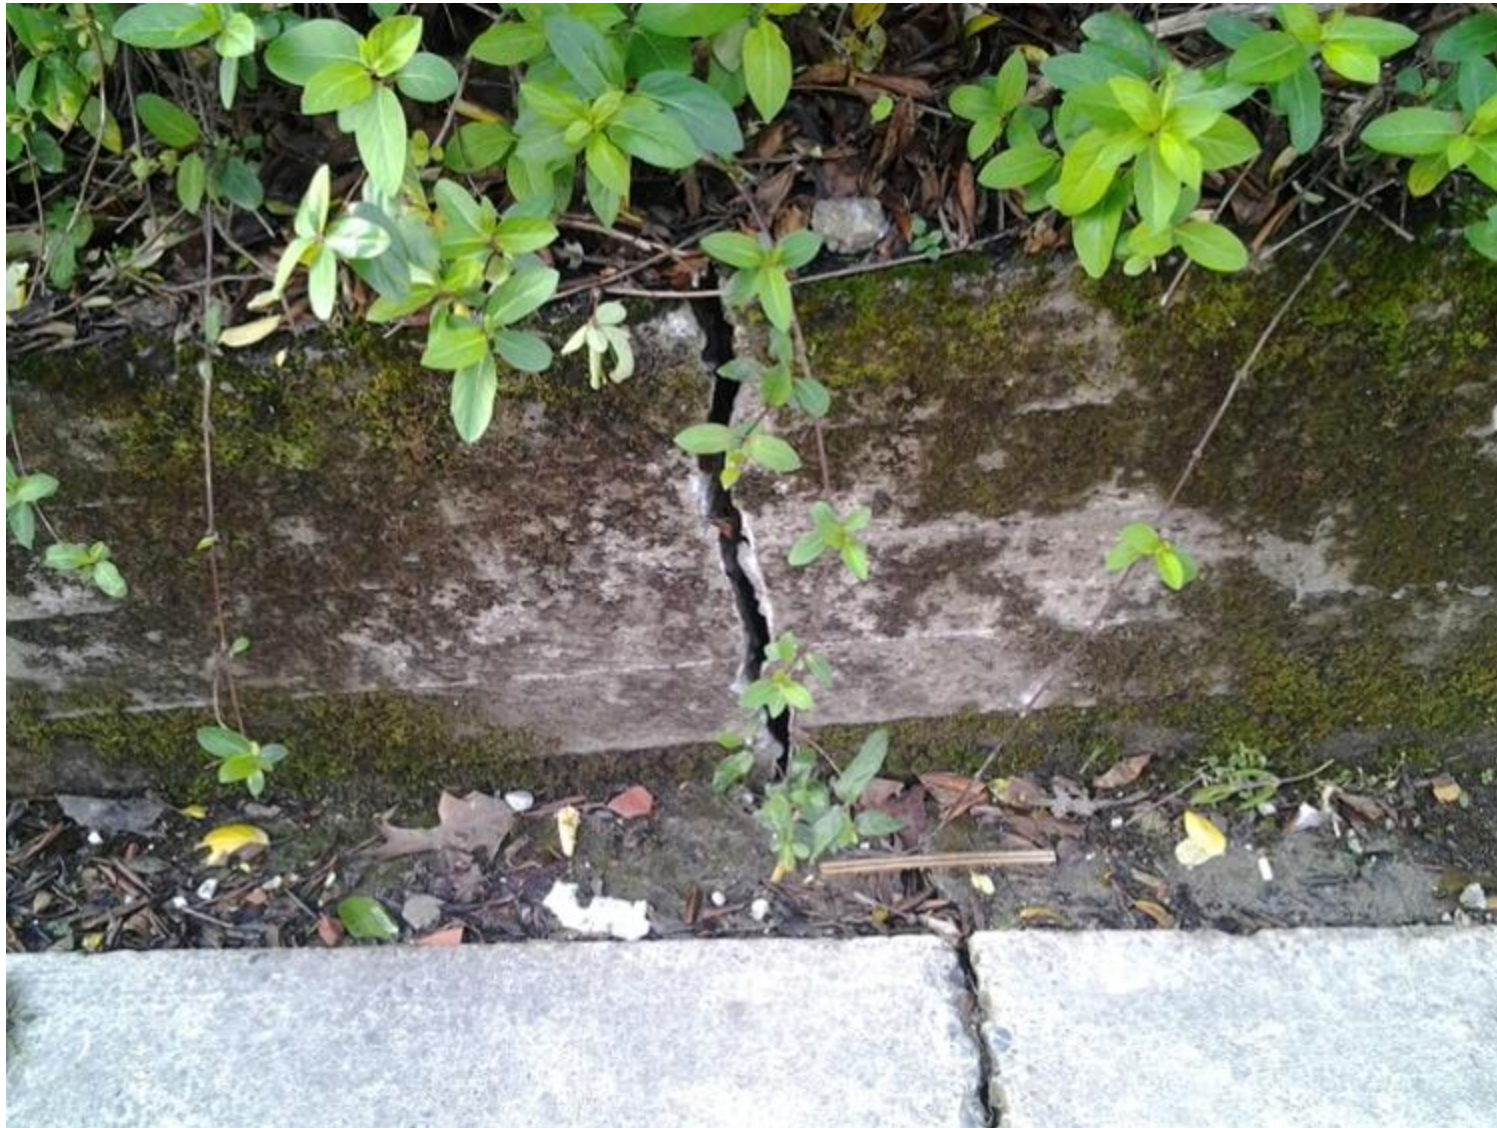
The wall is displaying vertical cracks and separation to a joint along its length

Vertical cracking to wall 4

Partial / sectional replacement

Moderate crack repairs

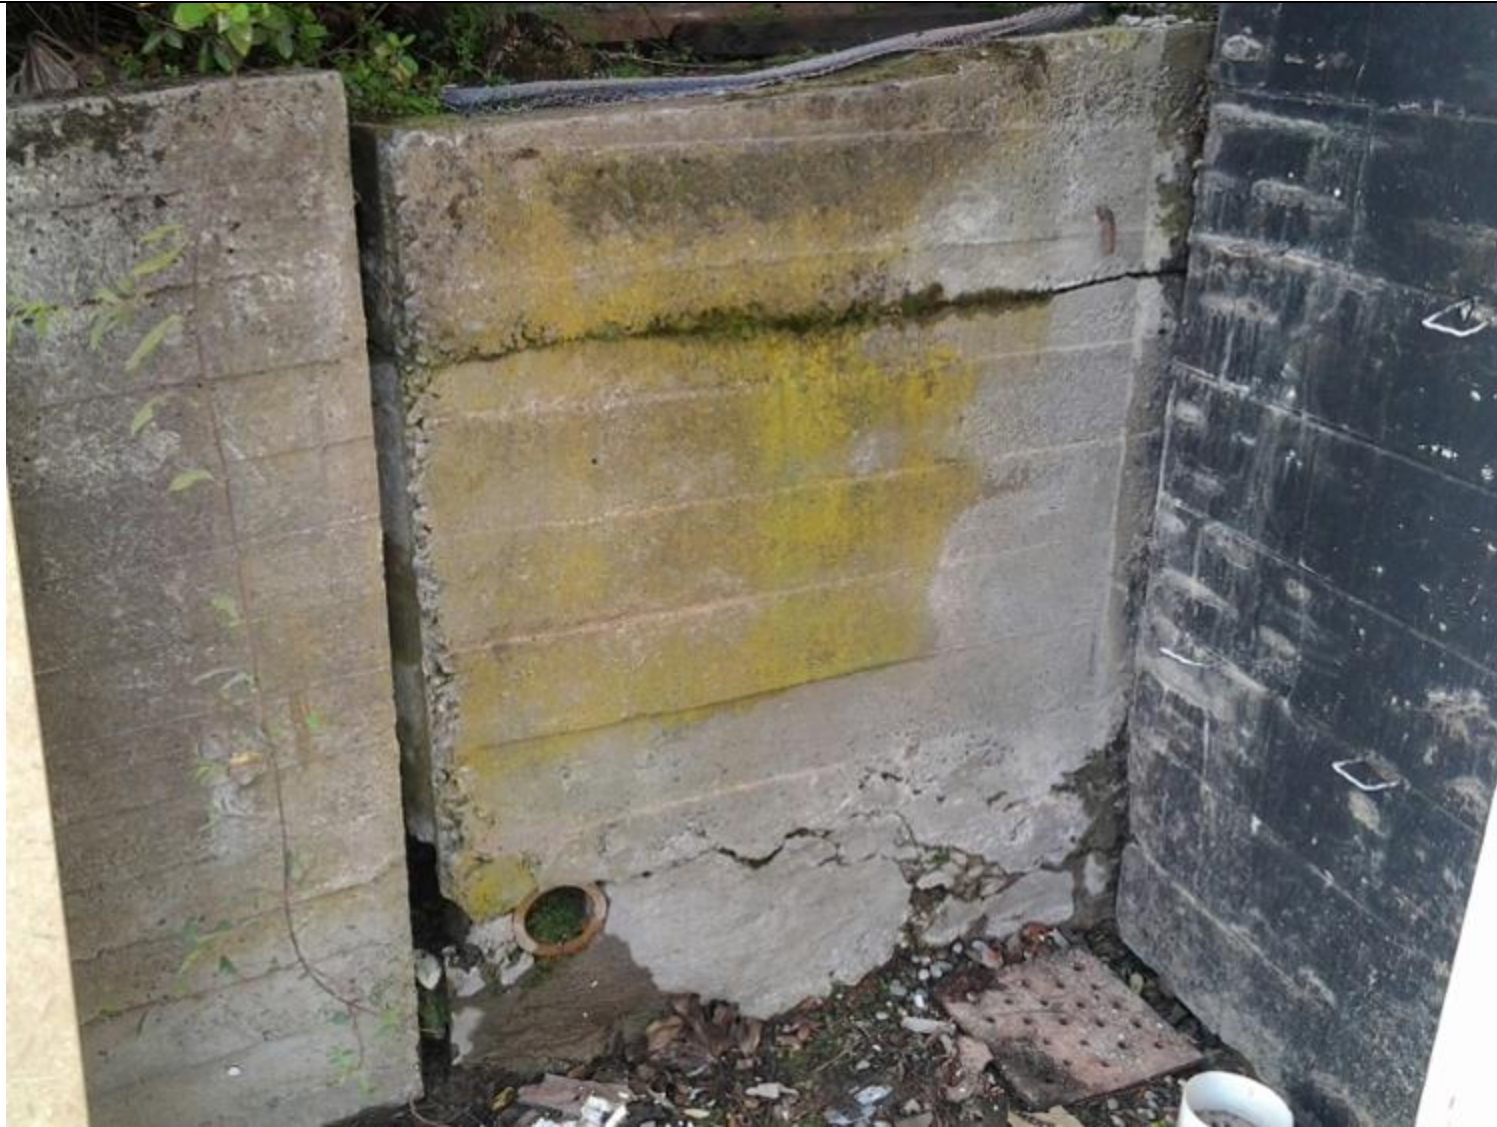
Seperation and horizontal cracking to wall 4 in front of the garage

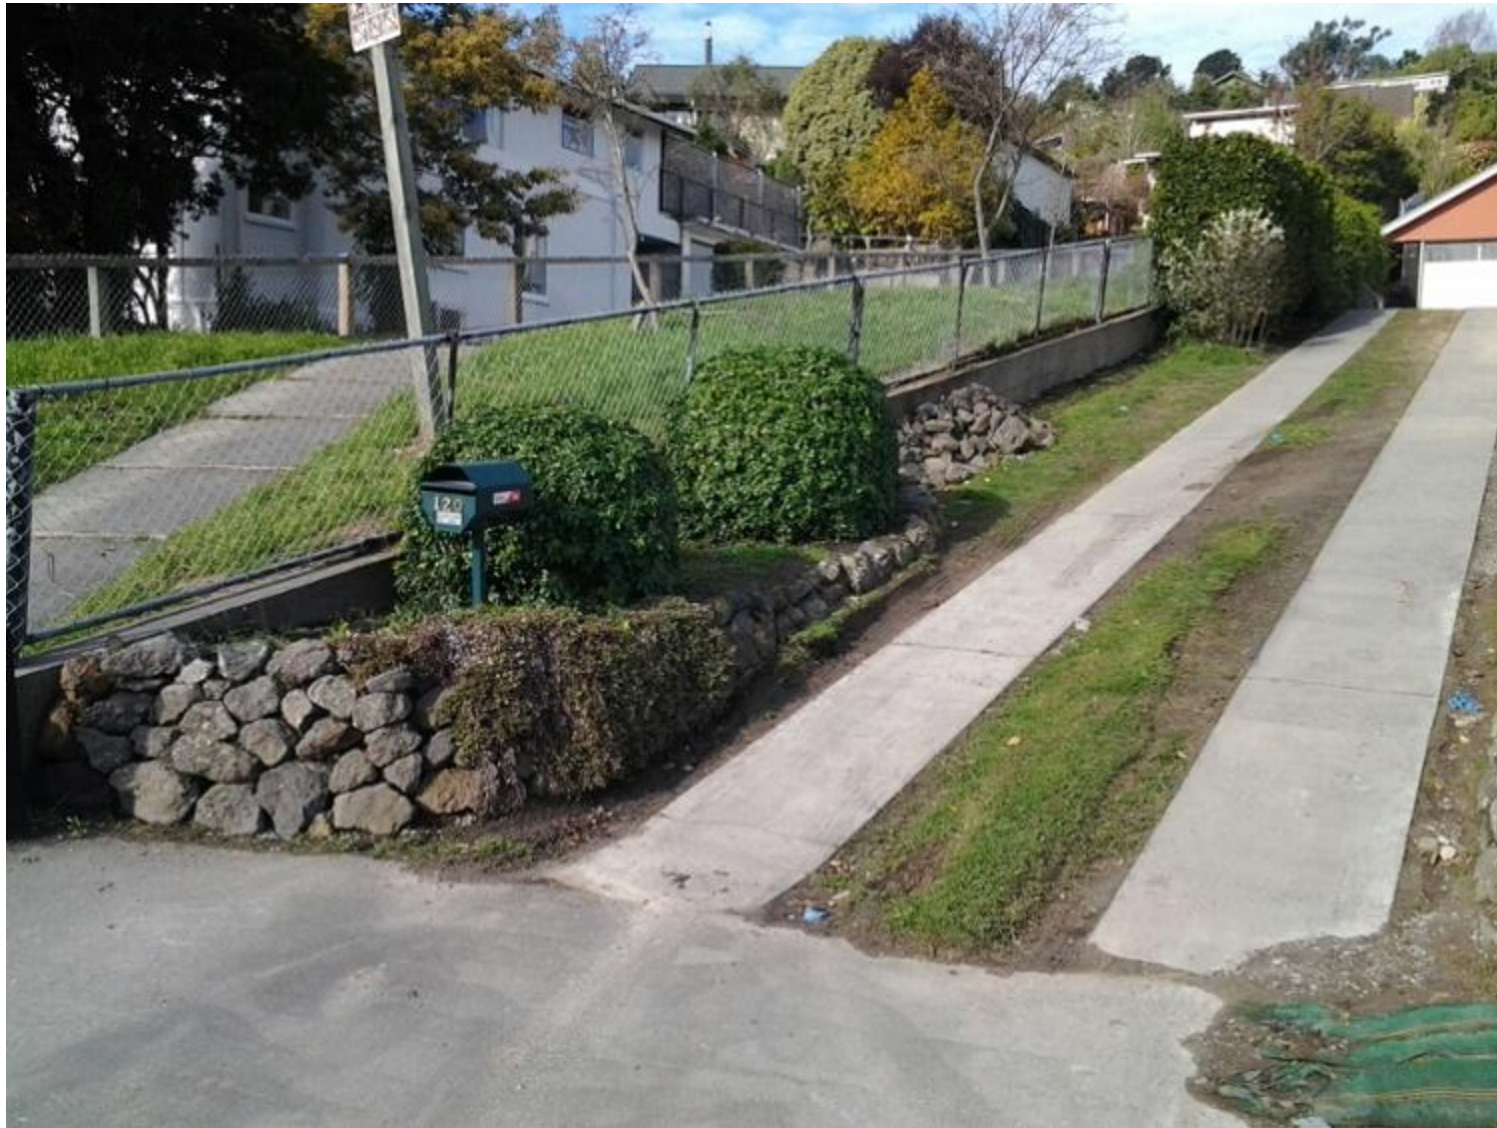
Elevation of wall 5 on the LHS boundary from the road

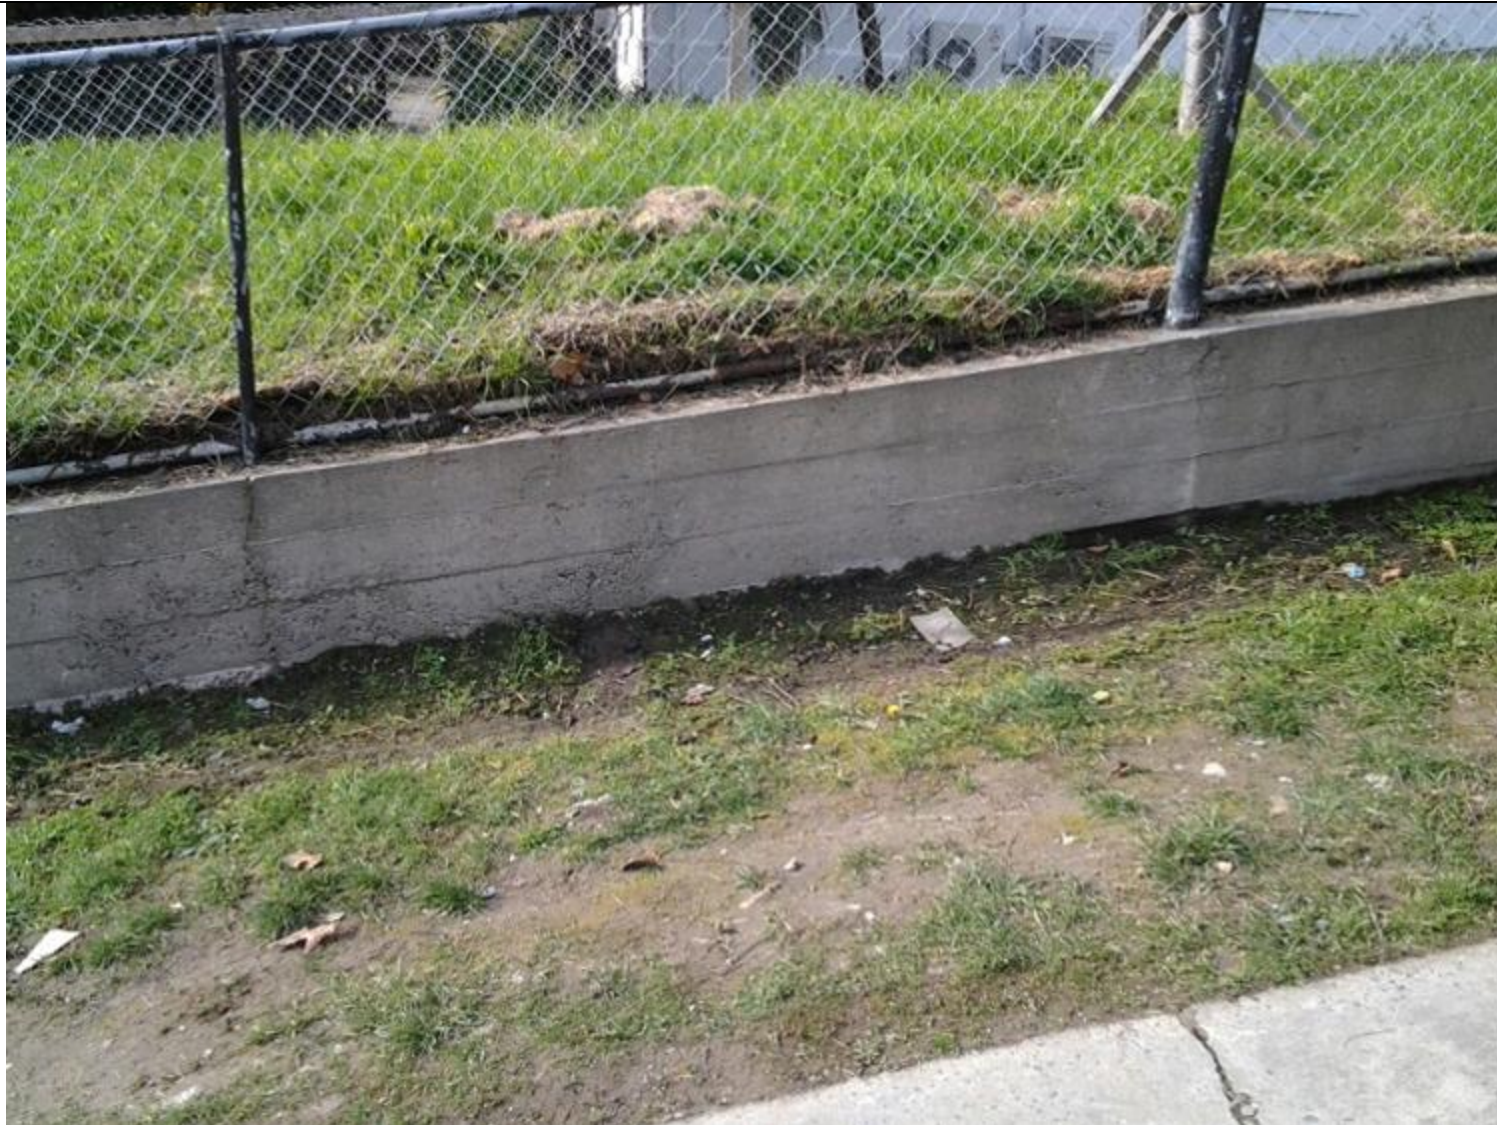
The wall is displaying vertical and horizontal cracking along its entire length

Vertical cracking to LHS of wall 5

Partial / sectional replacement
Moderate crack repairs

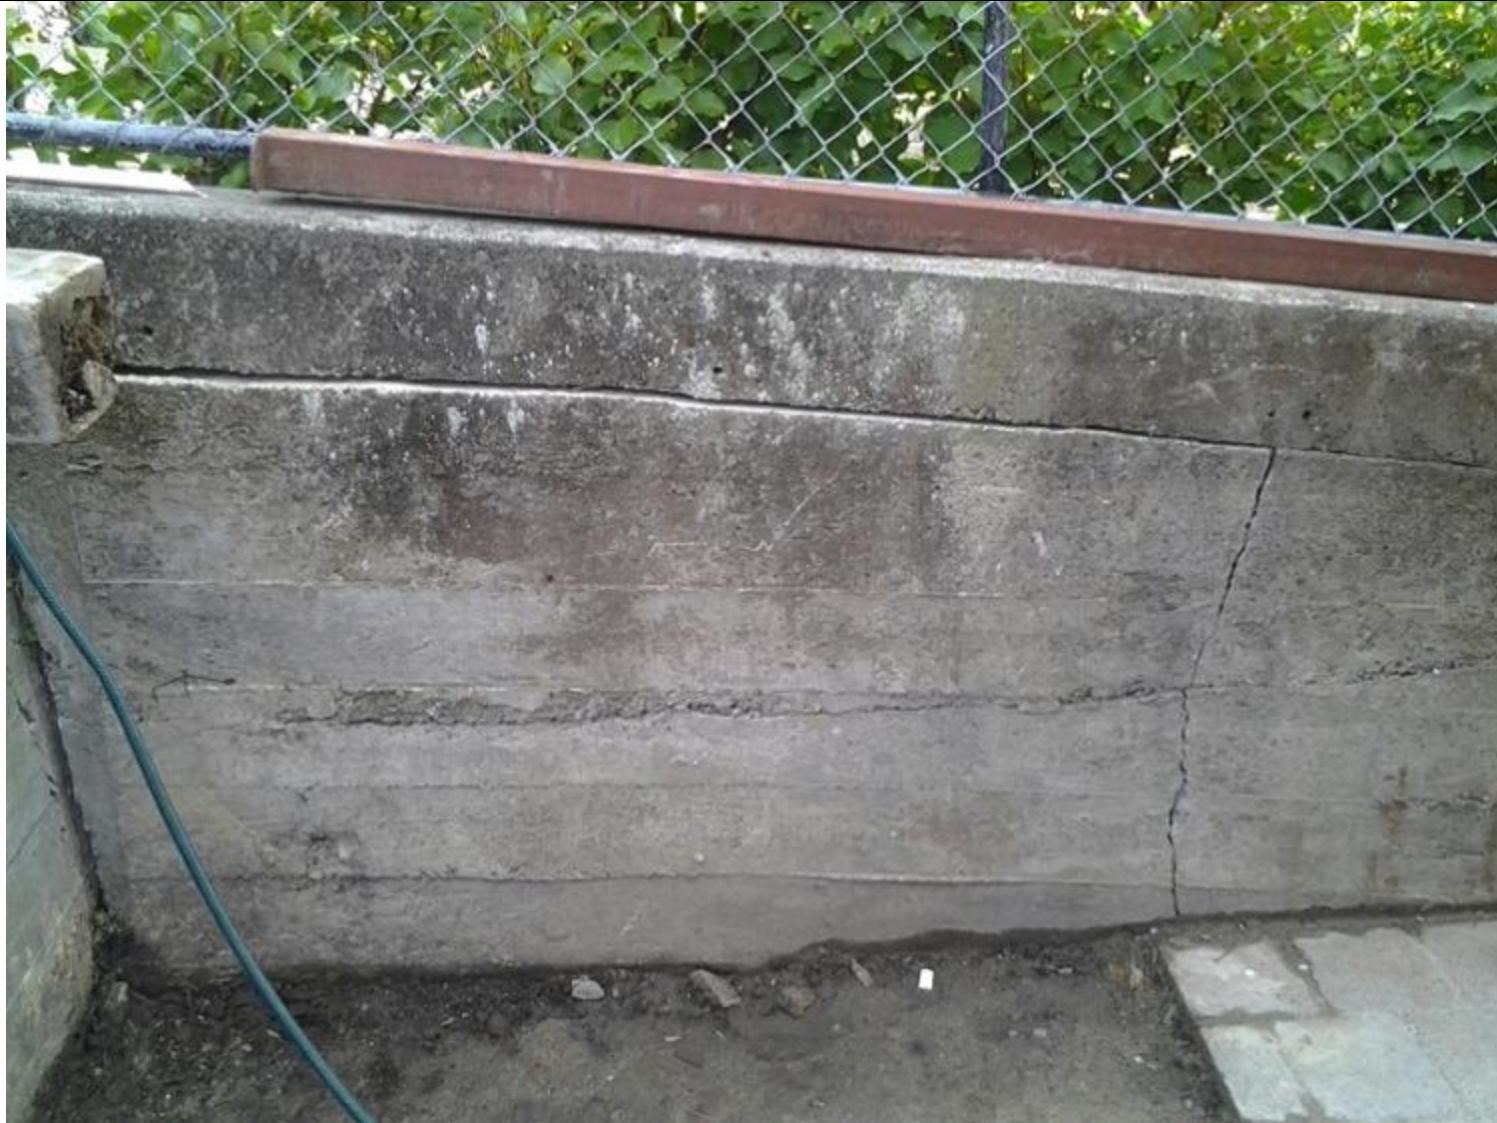
Vertical and horizontal cracking to the RHS of wall 5 behind the house

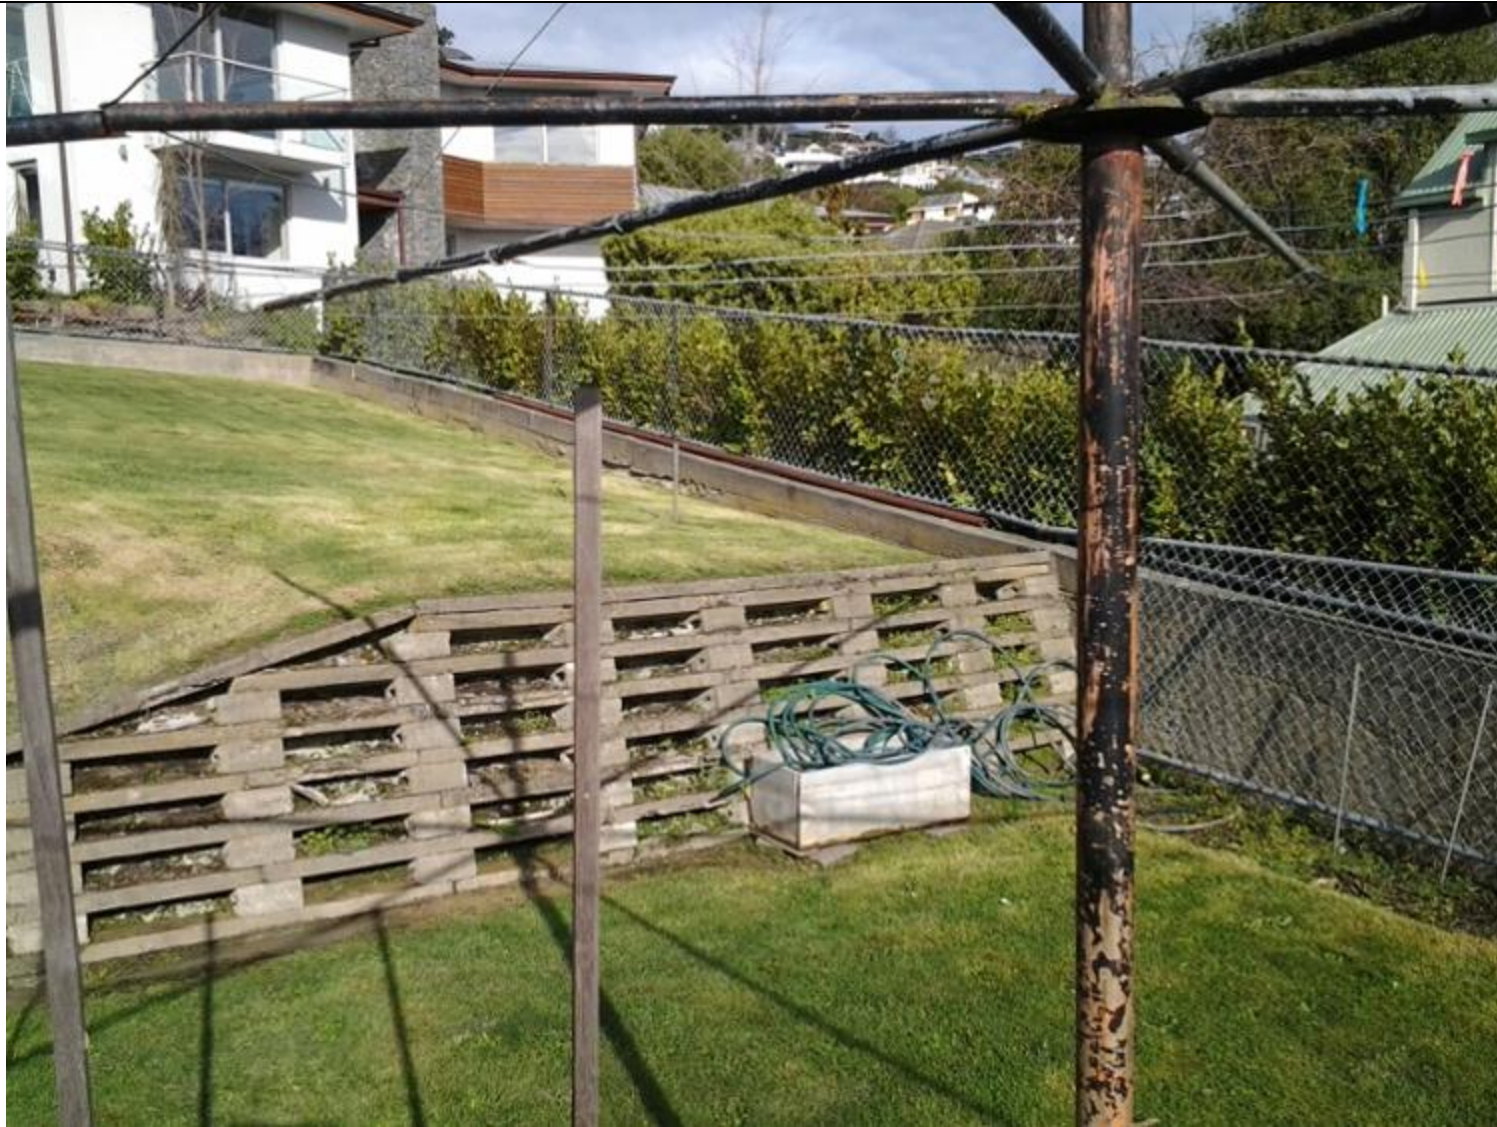
Elevation of RHS of wall 5 from the upper garage

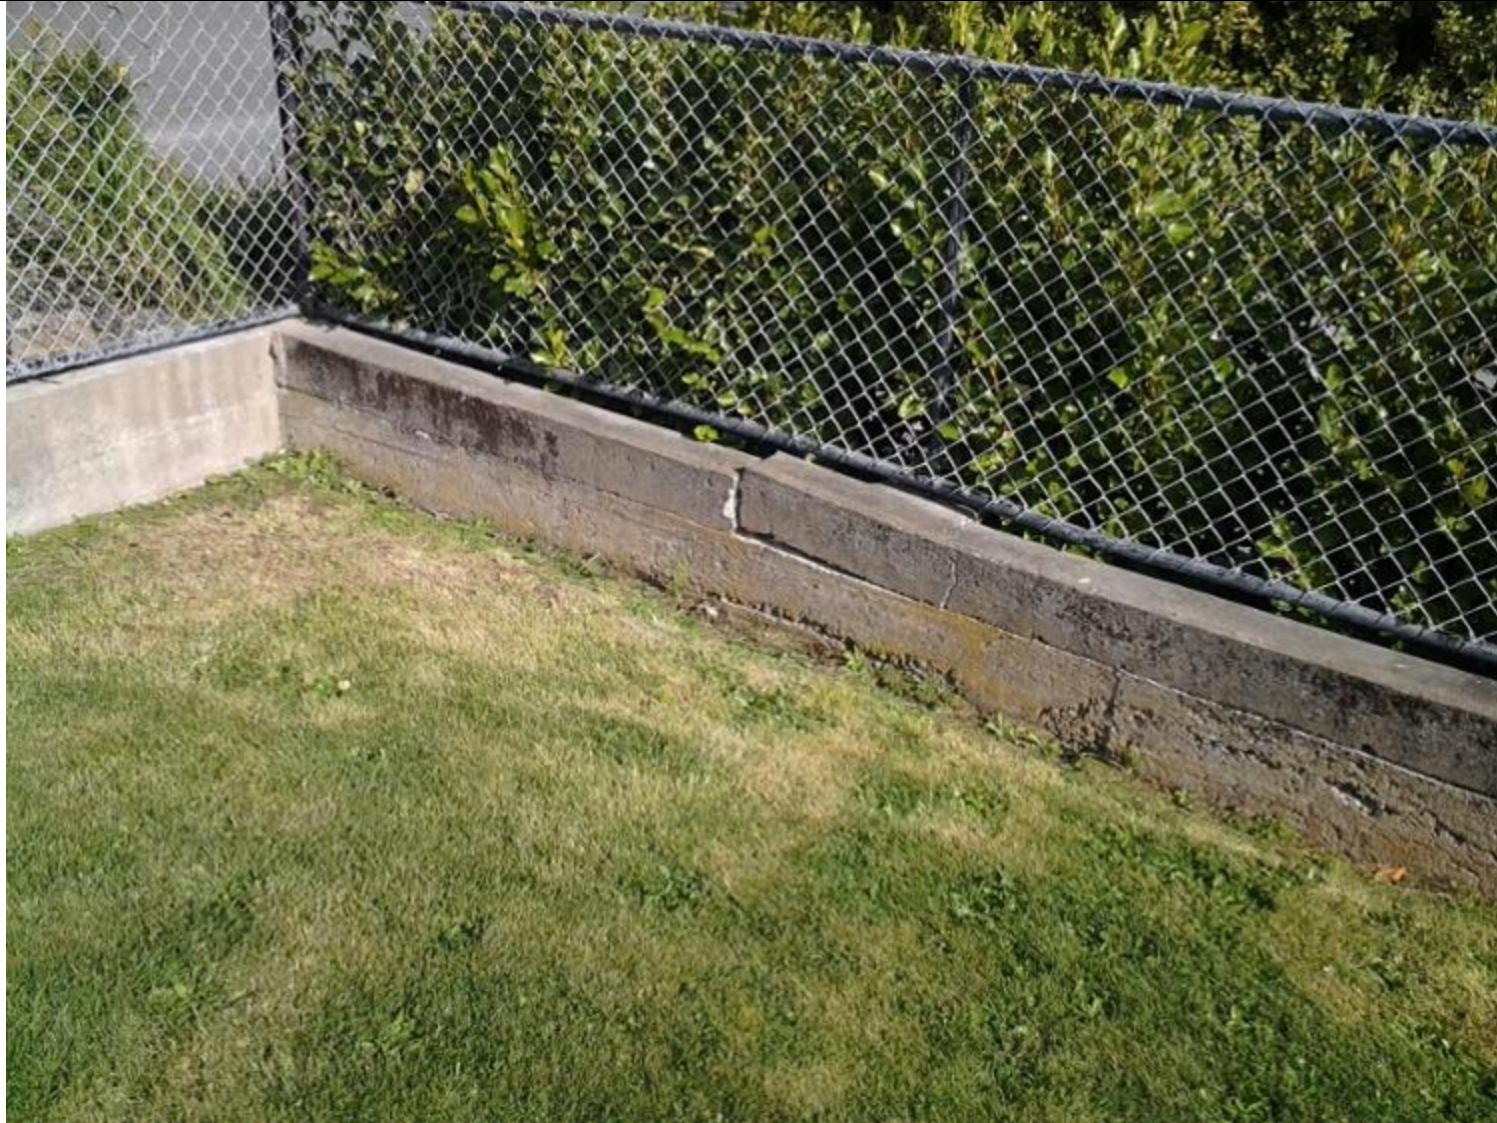
Cracking to wall 5 in the top RHS corner of the section

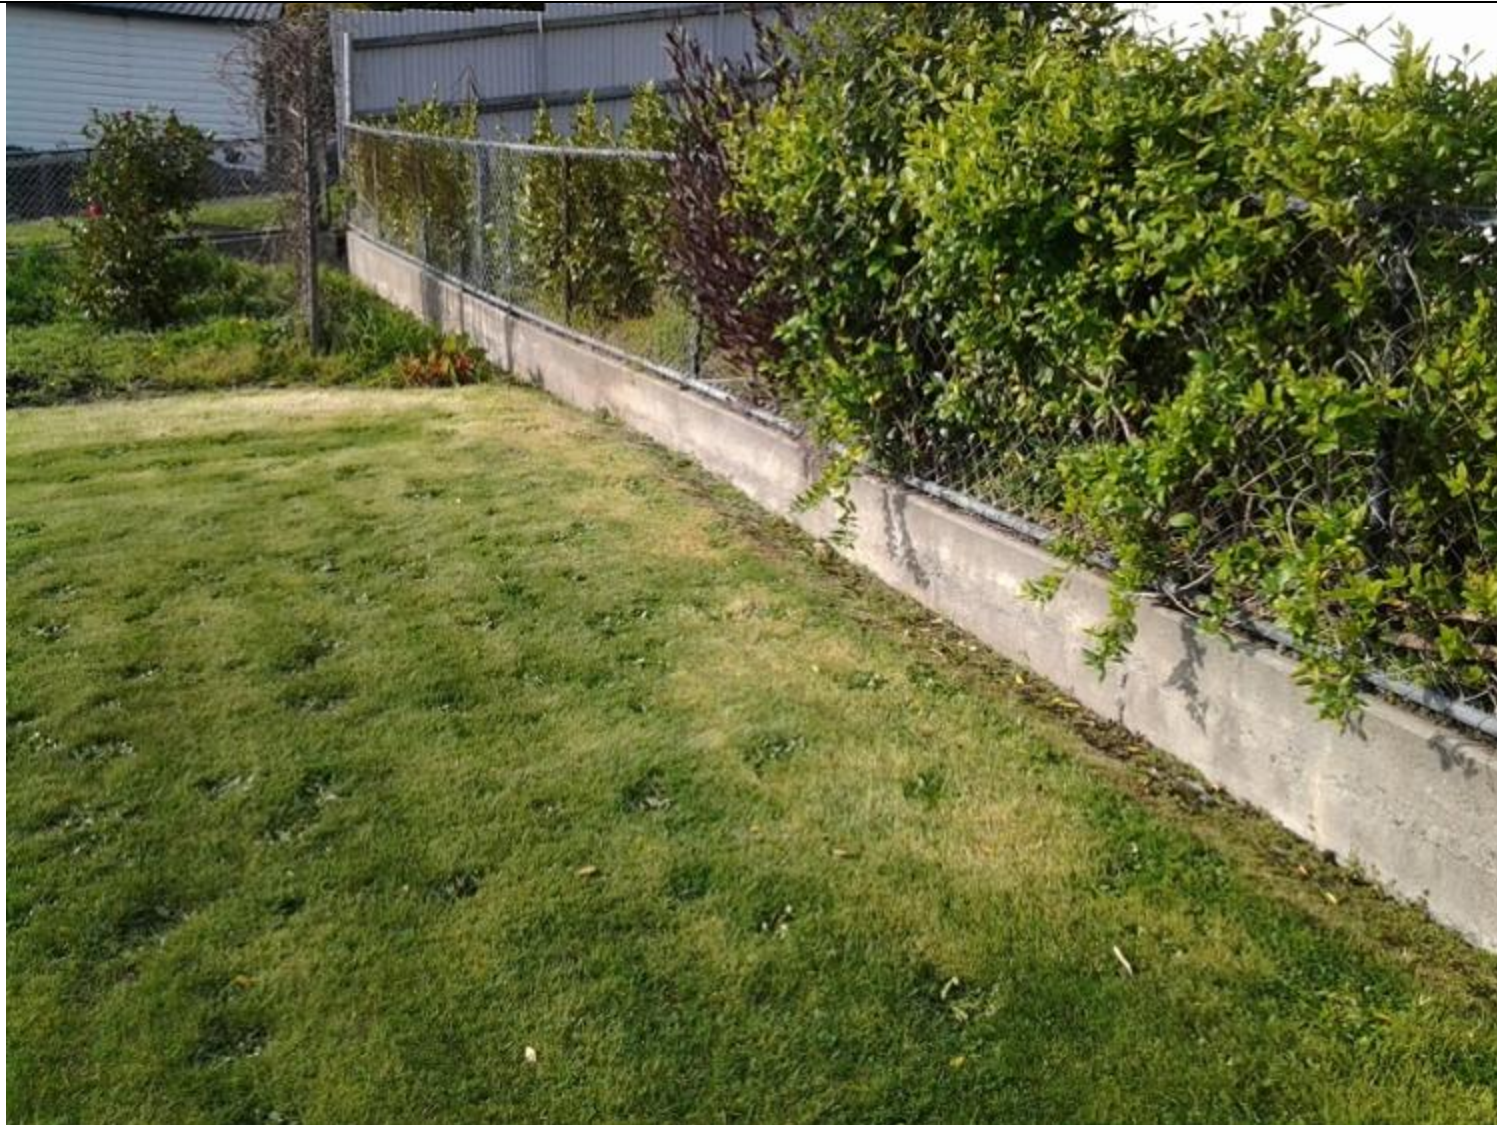
Elevation of wall 5 across the rear of the section from the RHS

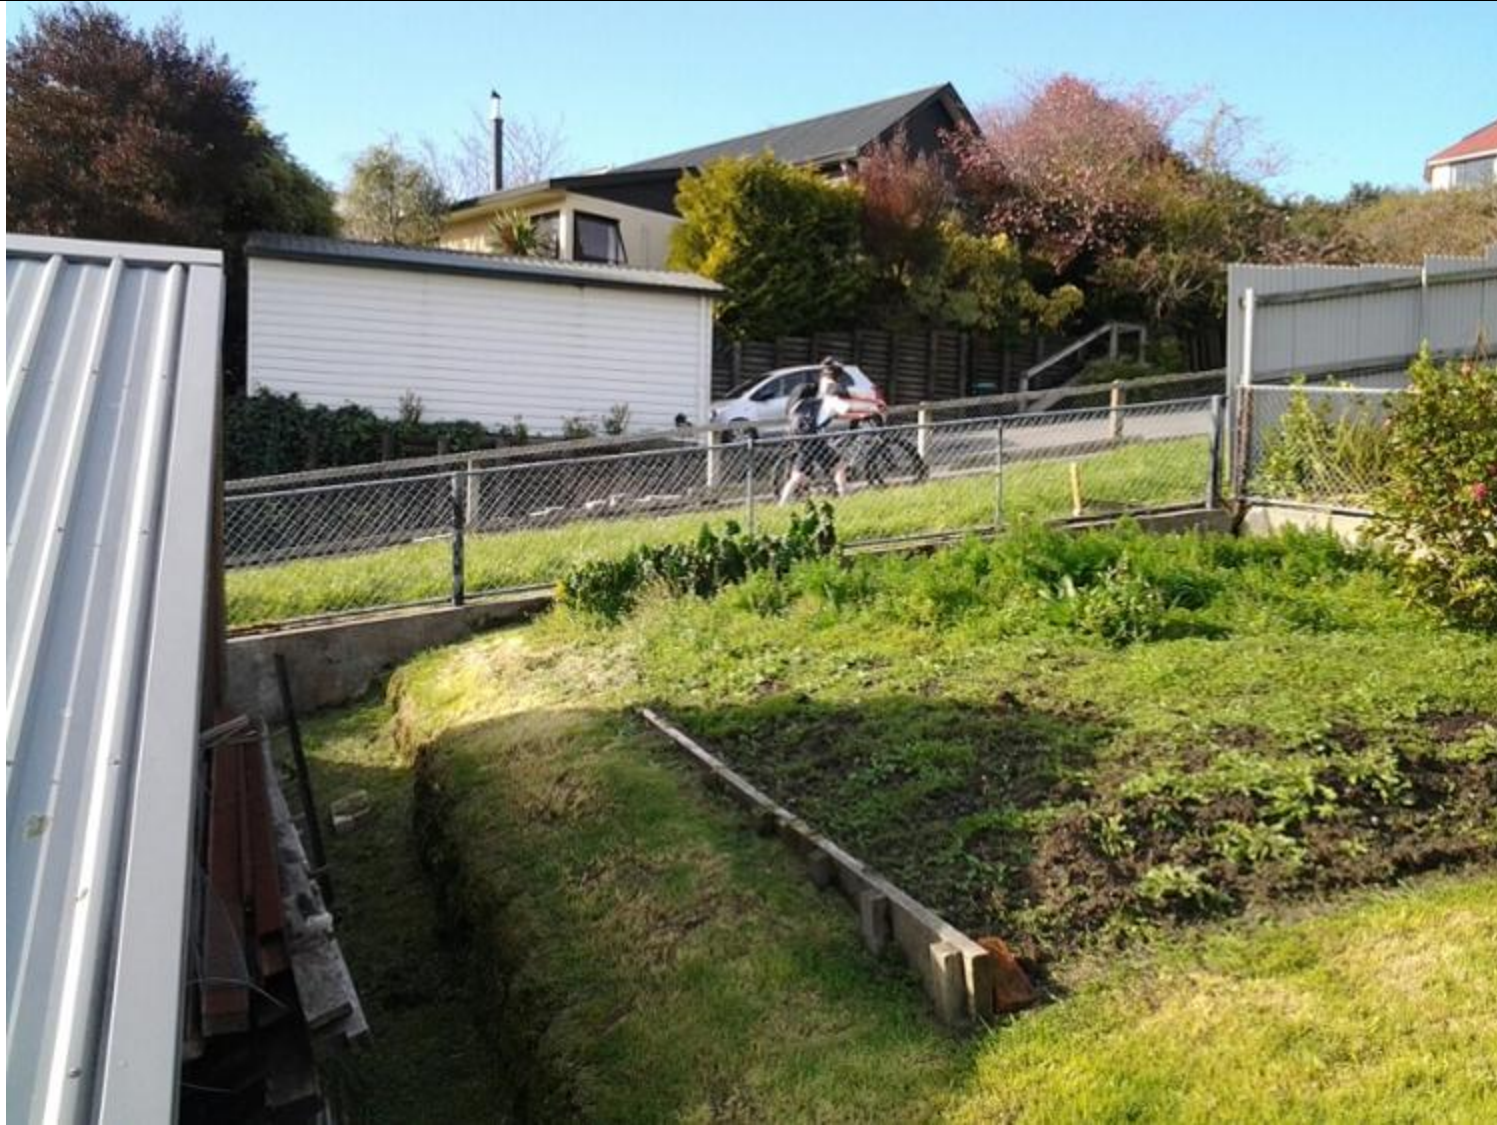
Elevation of wall 5 on the LHS behind the upper garage

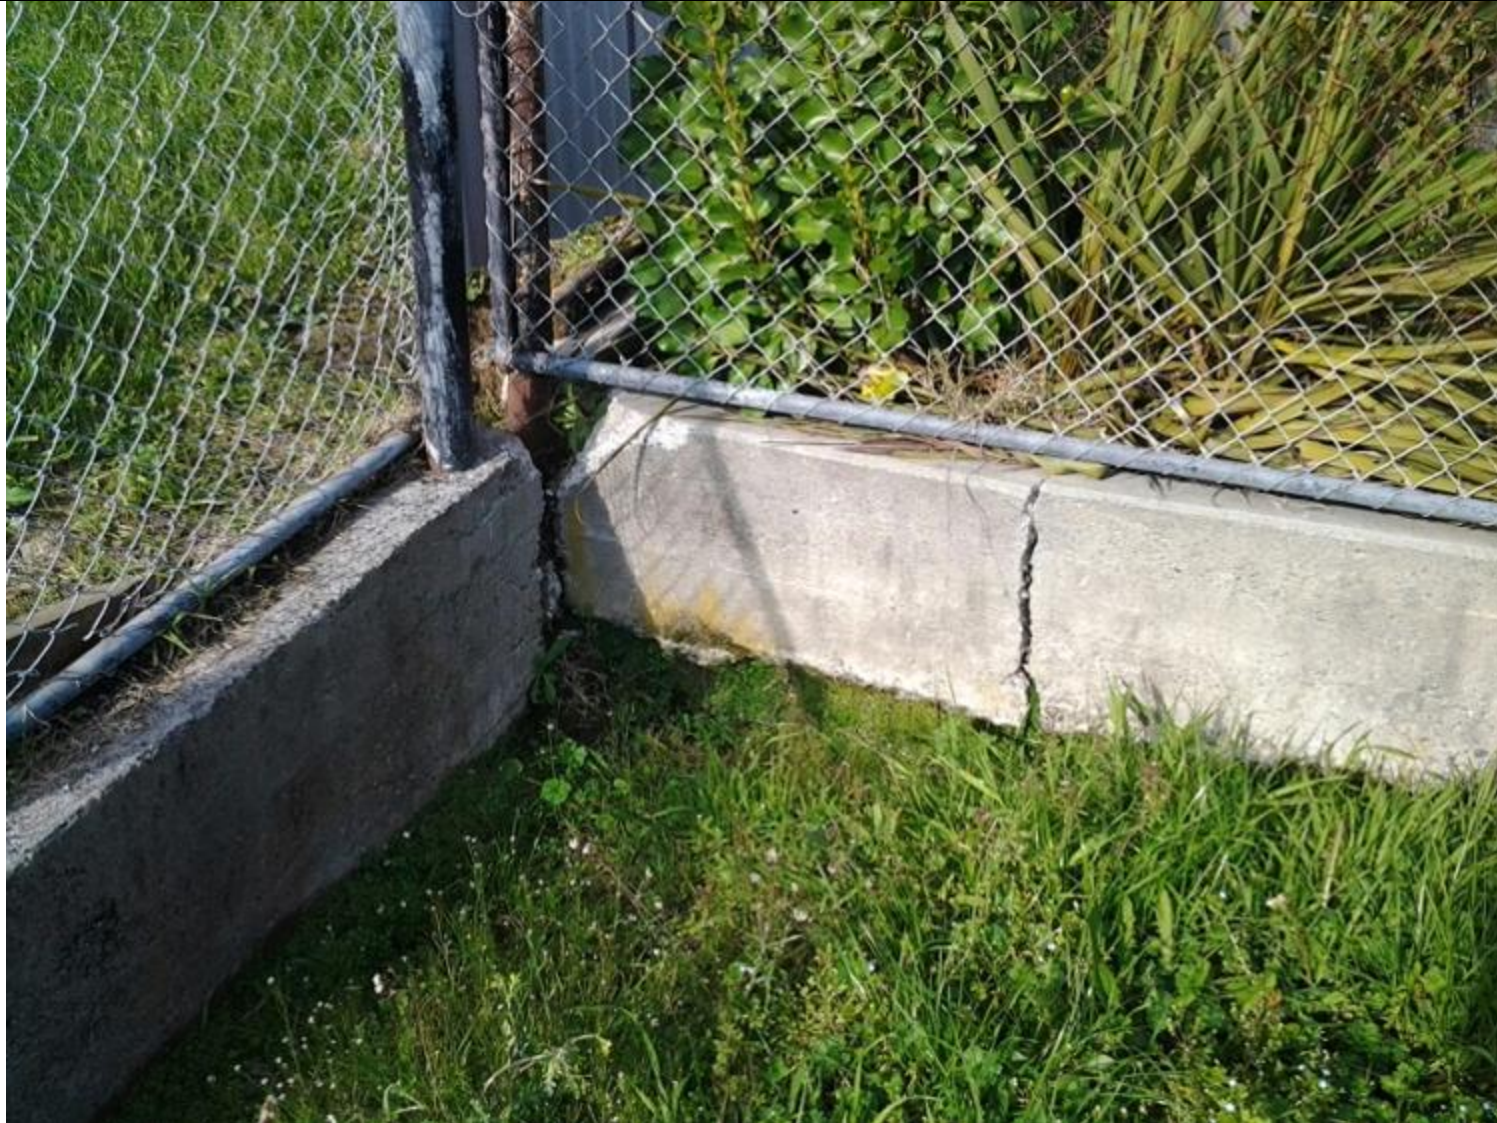
Cracking to wall 5 in the top LHS corner of the section

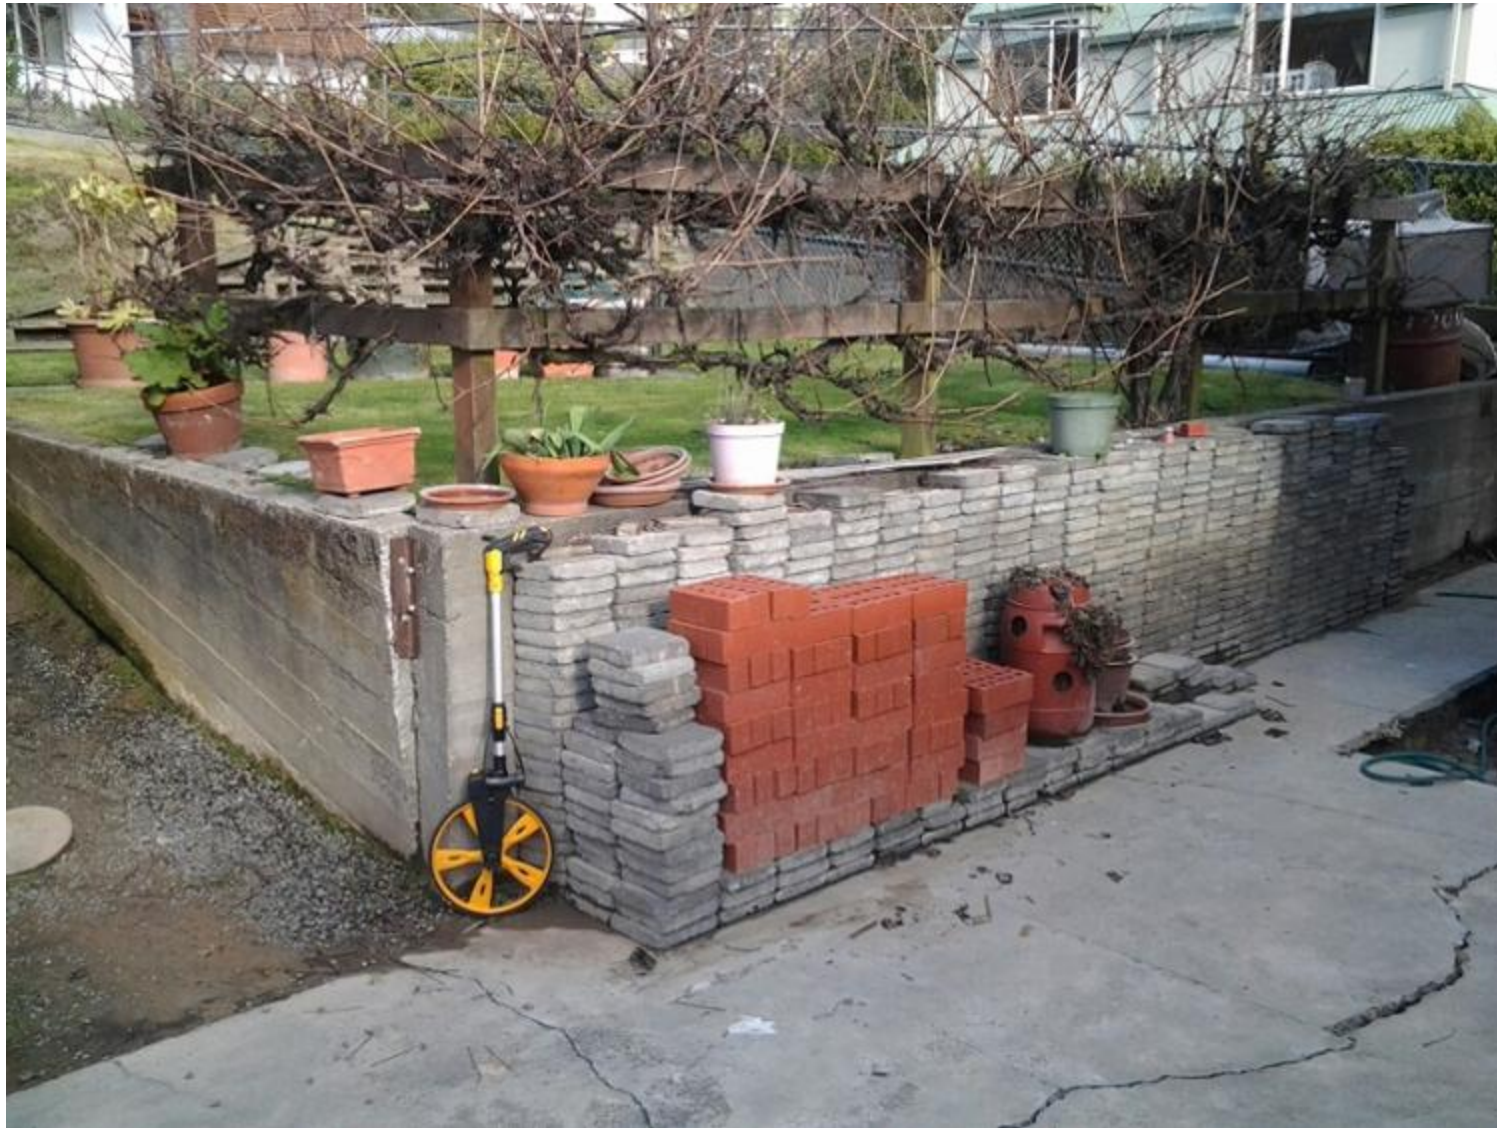
Elevation of wall 6 behind the house

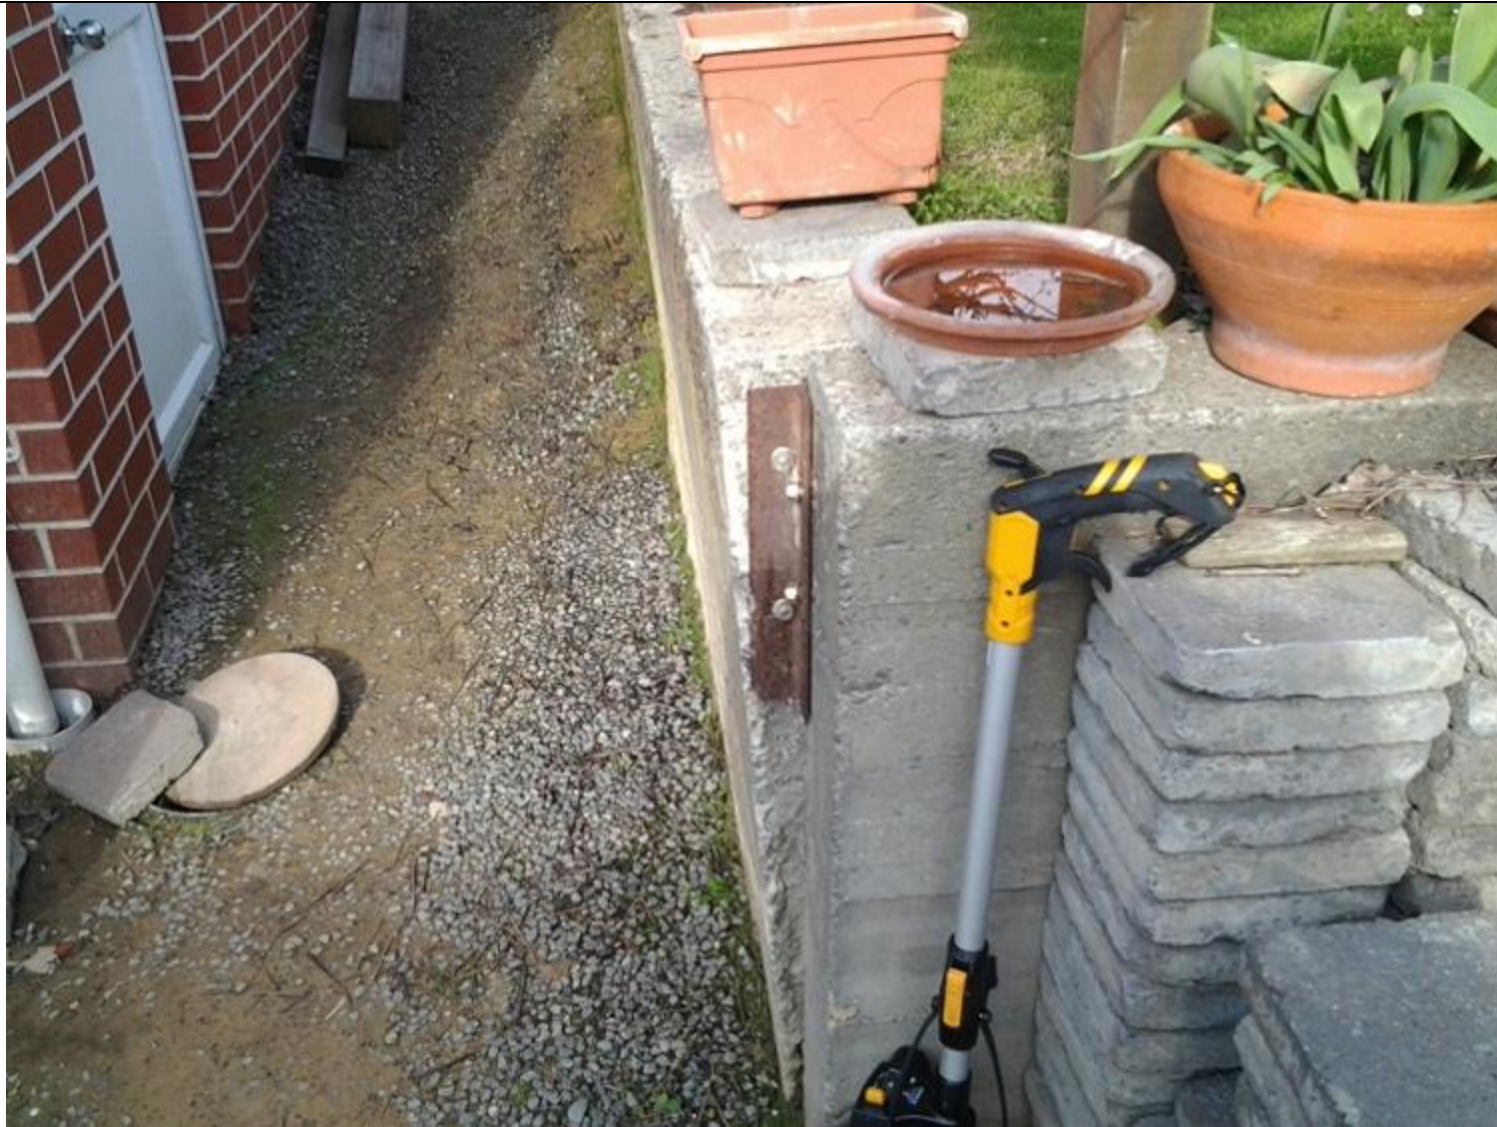
The return wall along the RHS of the upper garage is leaning. There are vertical cracks to the far RHS

Return wall leaning toward the upper garage wall

Partial / sectional replacement
Moderate crack repairs

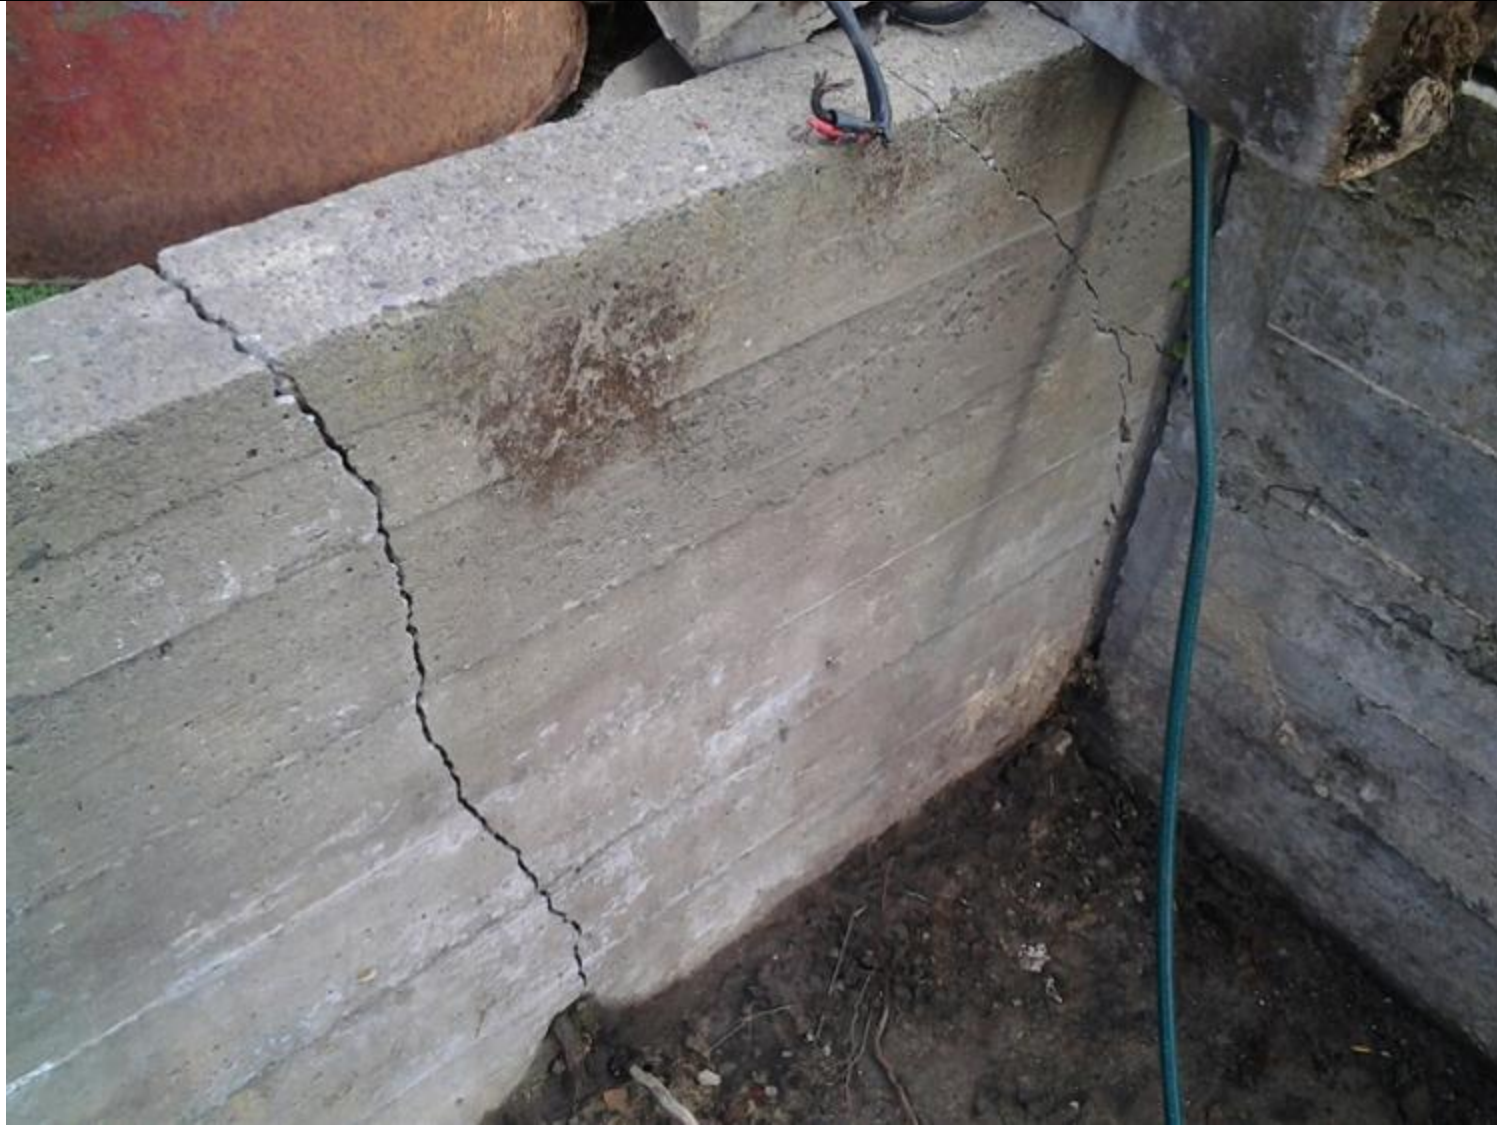
Vertical cracking to the far RHS of wall 6
