Sketch of site including all retaining walls

Retaining wall layout sketch

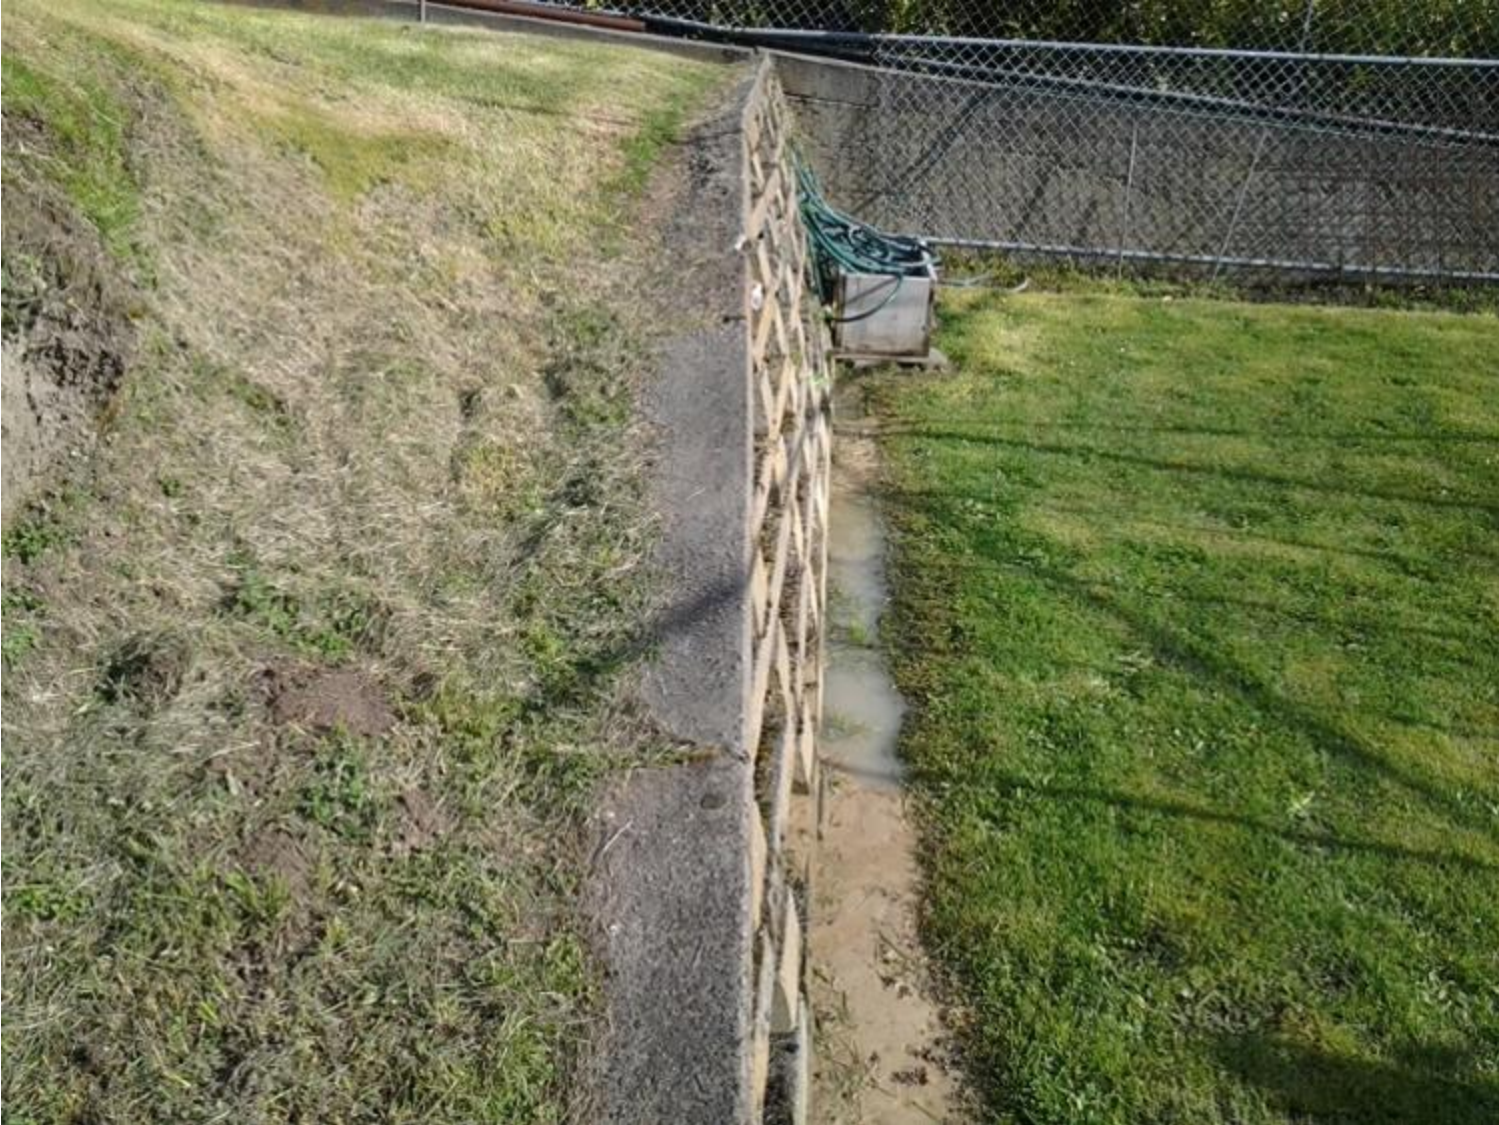
The cribs within the wall are slightly misaligned

Misalignment to the cribs within the wall

Repair
