KIWI INSPECTIONS LTD

RESIDENTIAL HOUSE INSPECTION

46 Murphys Rd
Christchurch, Canterbury 8025

Tallia
27/11/2024

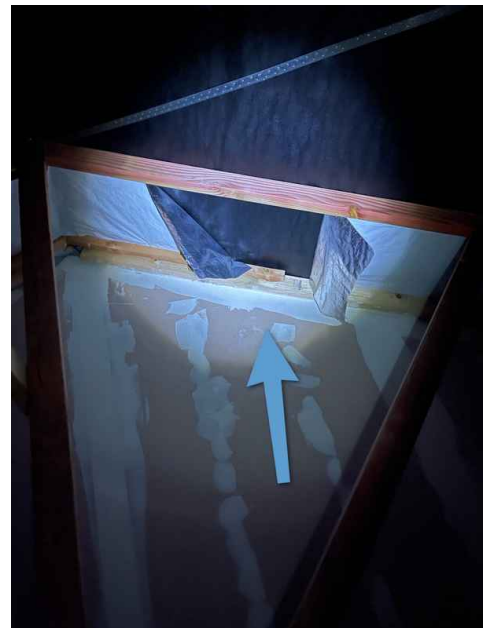
6.4.1 Roof Space Images:

RIPS/TEARS WERE NOTED TO THE ROOFING UNDERLAY

Regular checks of the roof cavity are recommended, these checks should be a visual inspection looking for vermin and any water ingress or staining, if any issues are noted remediation is recommended. [More information can be found by clicking here.](#)

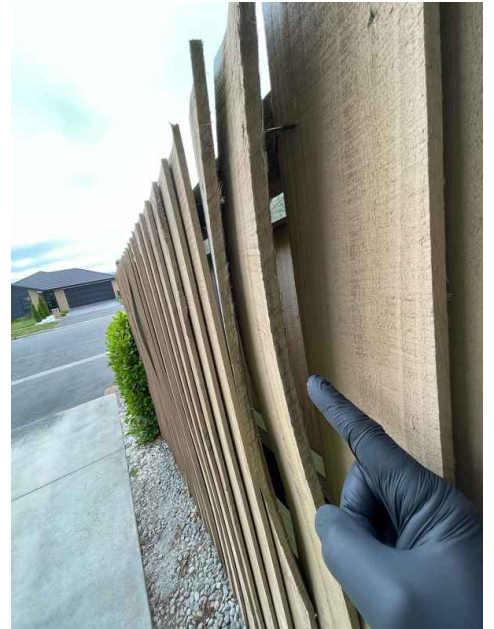
9.1.1 Fences

The fencing is in an average condition that consistent with its age, general maintenance to loose/damaged timber is recommended.

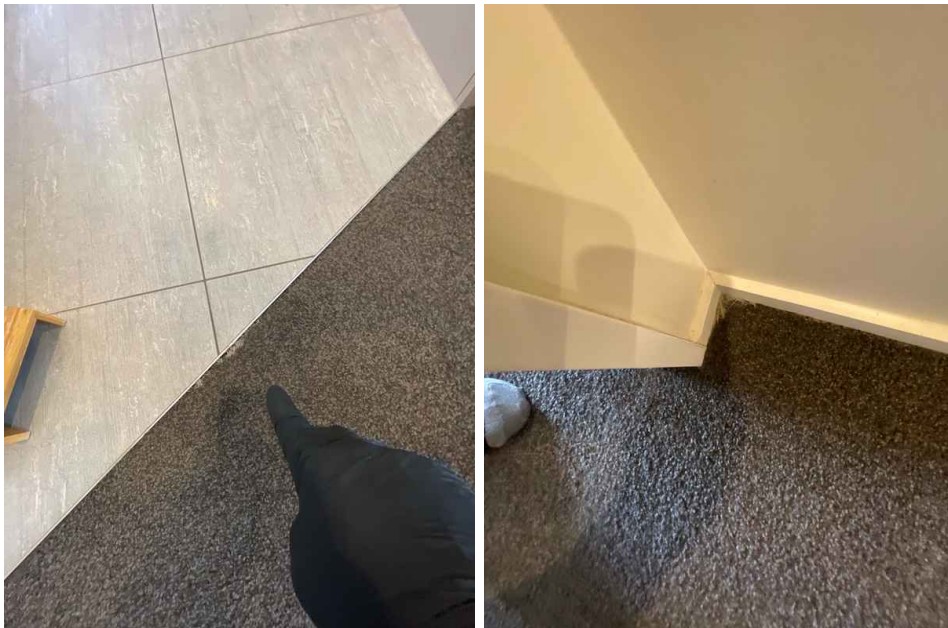
14.4.1 Flooring

MINOR WEAR ON THRESHOLD

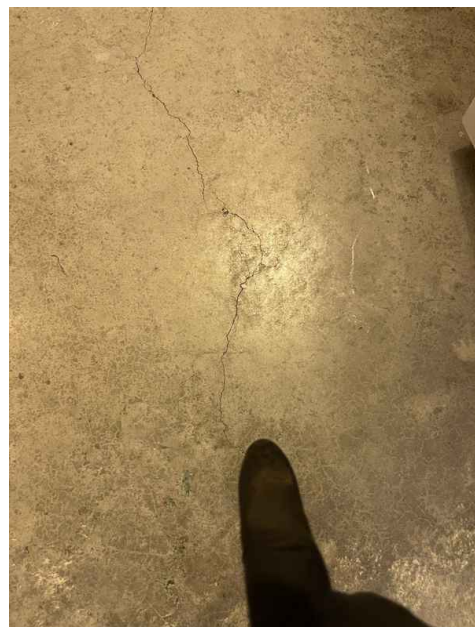
CRACKING TO FLOORS NOTED
