SUMMARY

46 Murphys Rd, Christchurch,
Canterbury 8025

Tallia
27/11/2024

Aaron Krahaugen
Kiwi House Inspections
Kiwi Inspections LTD
+64275522004
aaron@kiwiinspections.nz

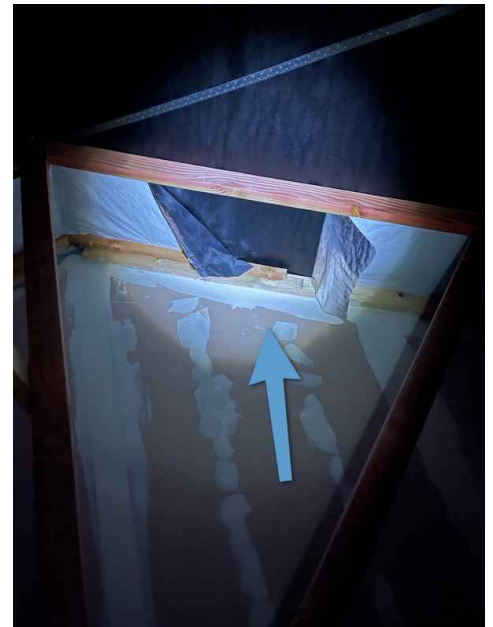
6.3.1 Roof Underlay

RIPS/TEARS WERE NOTED TO THE ROOFING UNDERLAY

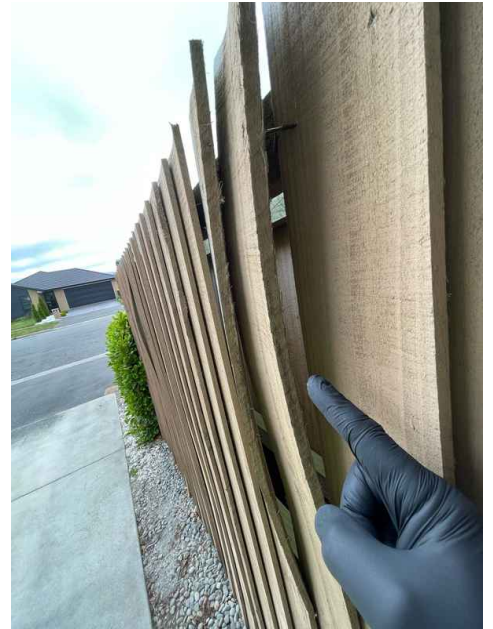
9.1.1 Fences

The fencing is in an average condition that consistent with its age, general maintenance to loose/damaged timber is recommended.

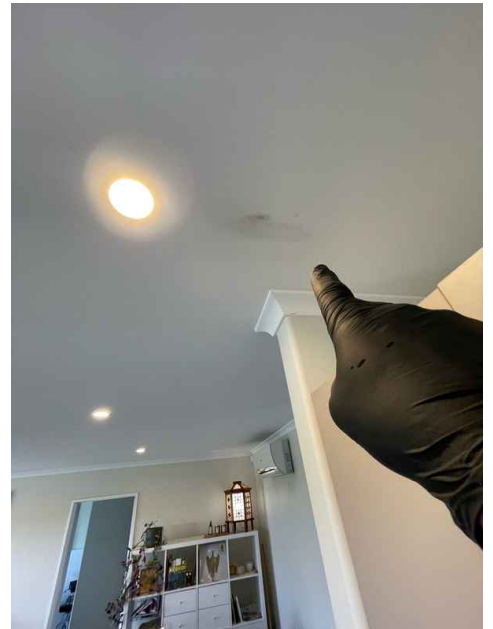
14.1.1 Walls and Ceiling

MARK ON CEILING- OWNER ADVISES THIS IS FROM AN AEROSOL PEST DISPENSER

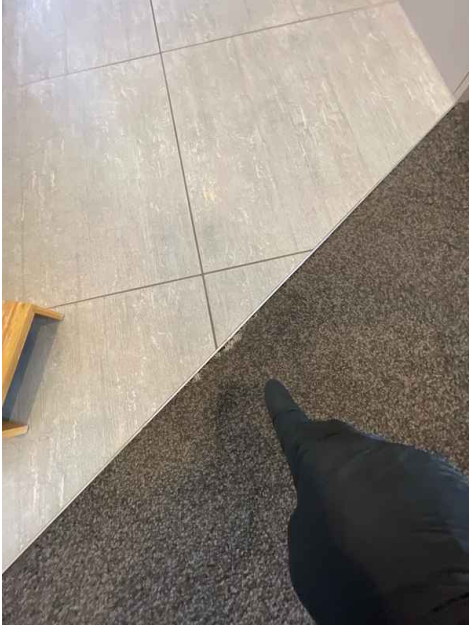
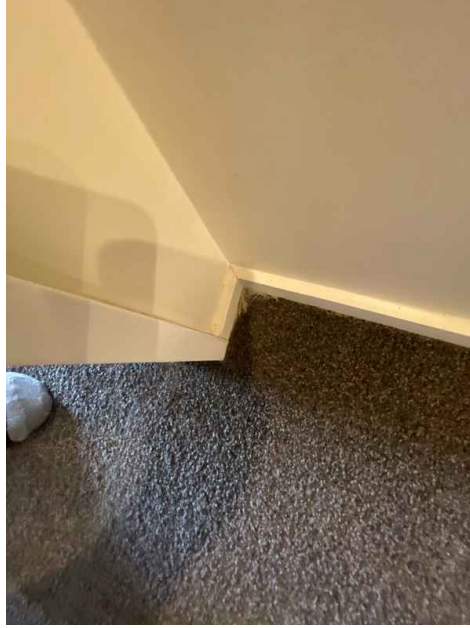
14.4.1 Flooring

MINOR WEAR ON THRESHOLD

Maintenance Item

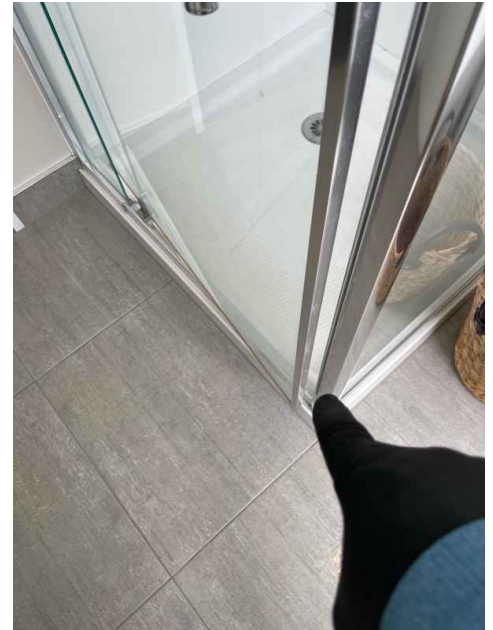
18.5.1 Fixtures

SHOWER DOOR REQUIRES ADJUSTMENT

Maintenance Item

Maintenance to the shower door is required to restore smooth operation.

Recommendation
Contact a qualified professional.

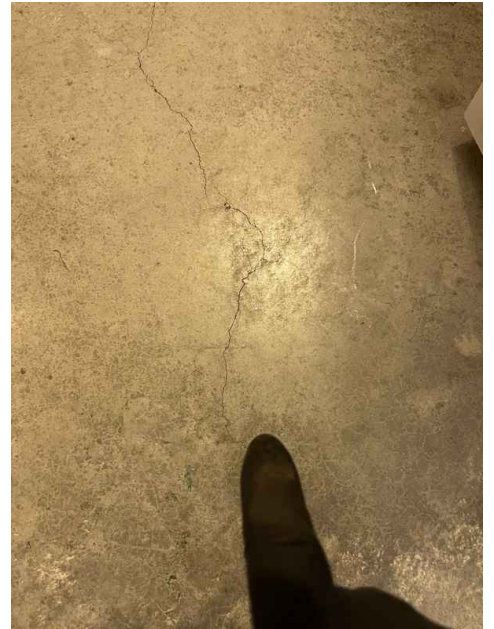
23.1.1 Floor System

CRACKING TO FLOORS NOTED

Maintenance Item

This is deemed consistent with the age and concrete expansion and contraction.
