RDA Consulting

26 August 2022

**52746 REFLEKT BURNBY GEOTECH
SHALLOW SOILS INVESTIGATION AND ASSESSMENT FOR 78 BURNBY DRIVE, TE
ANAU**

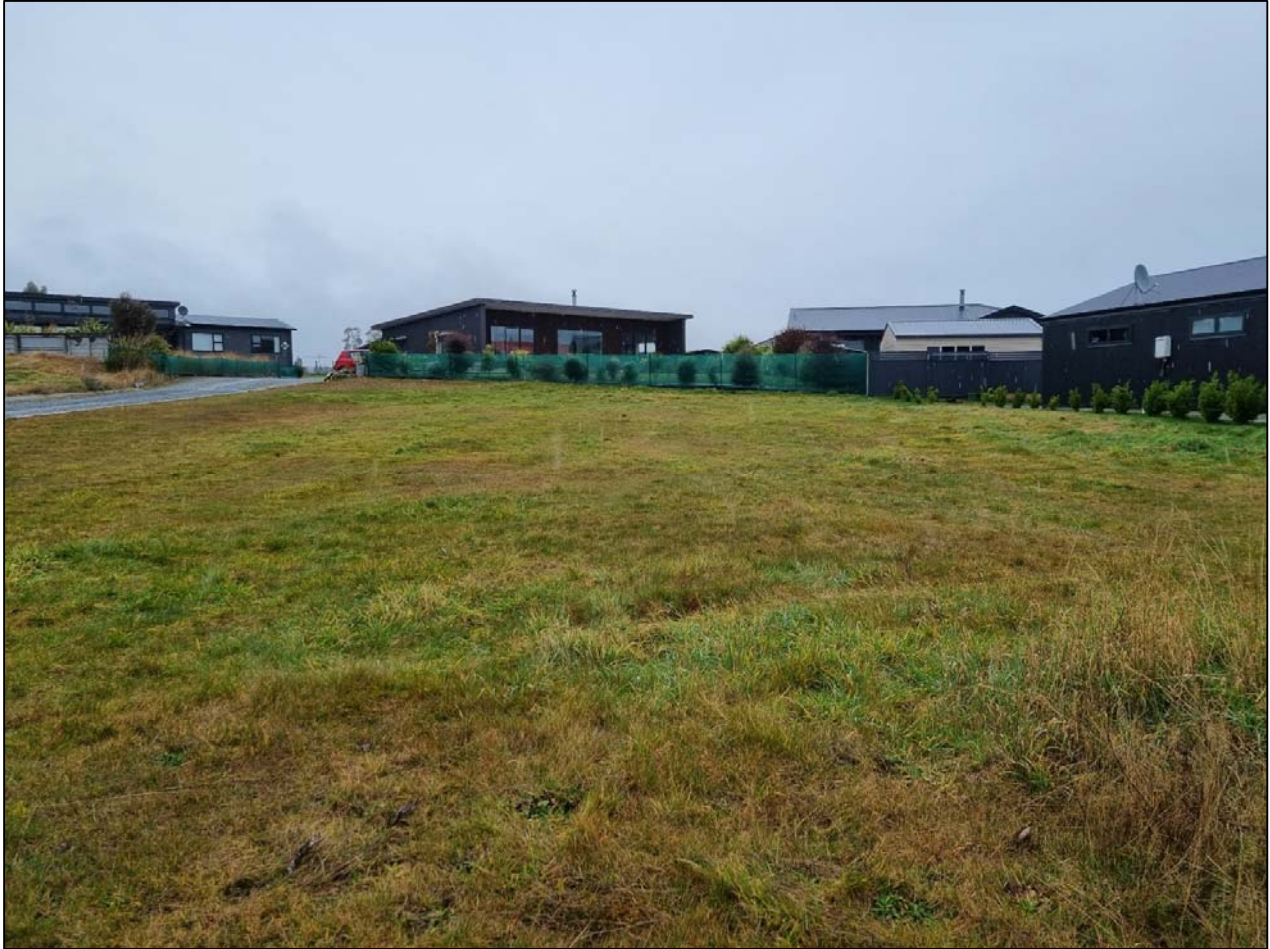
The site was vacant with no apparent earthworks or filling. The boreholes undertaken did not encounter any evidence of filling.

Photo 1: Overview of the site looking North.

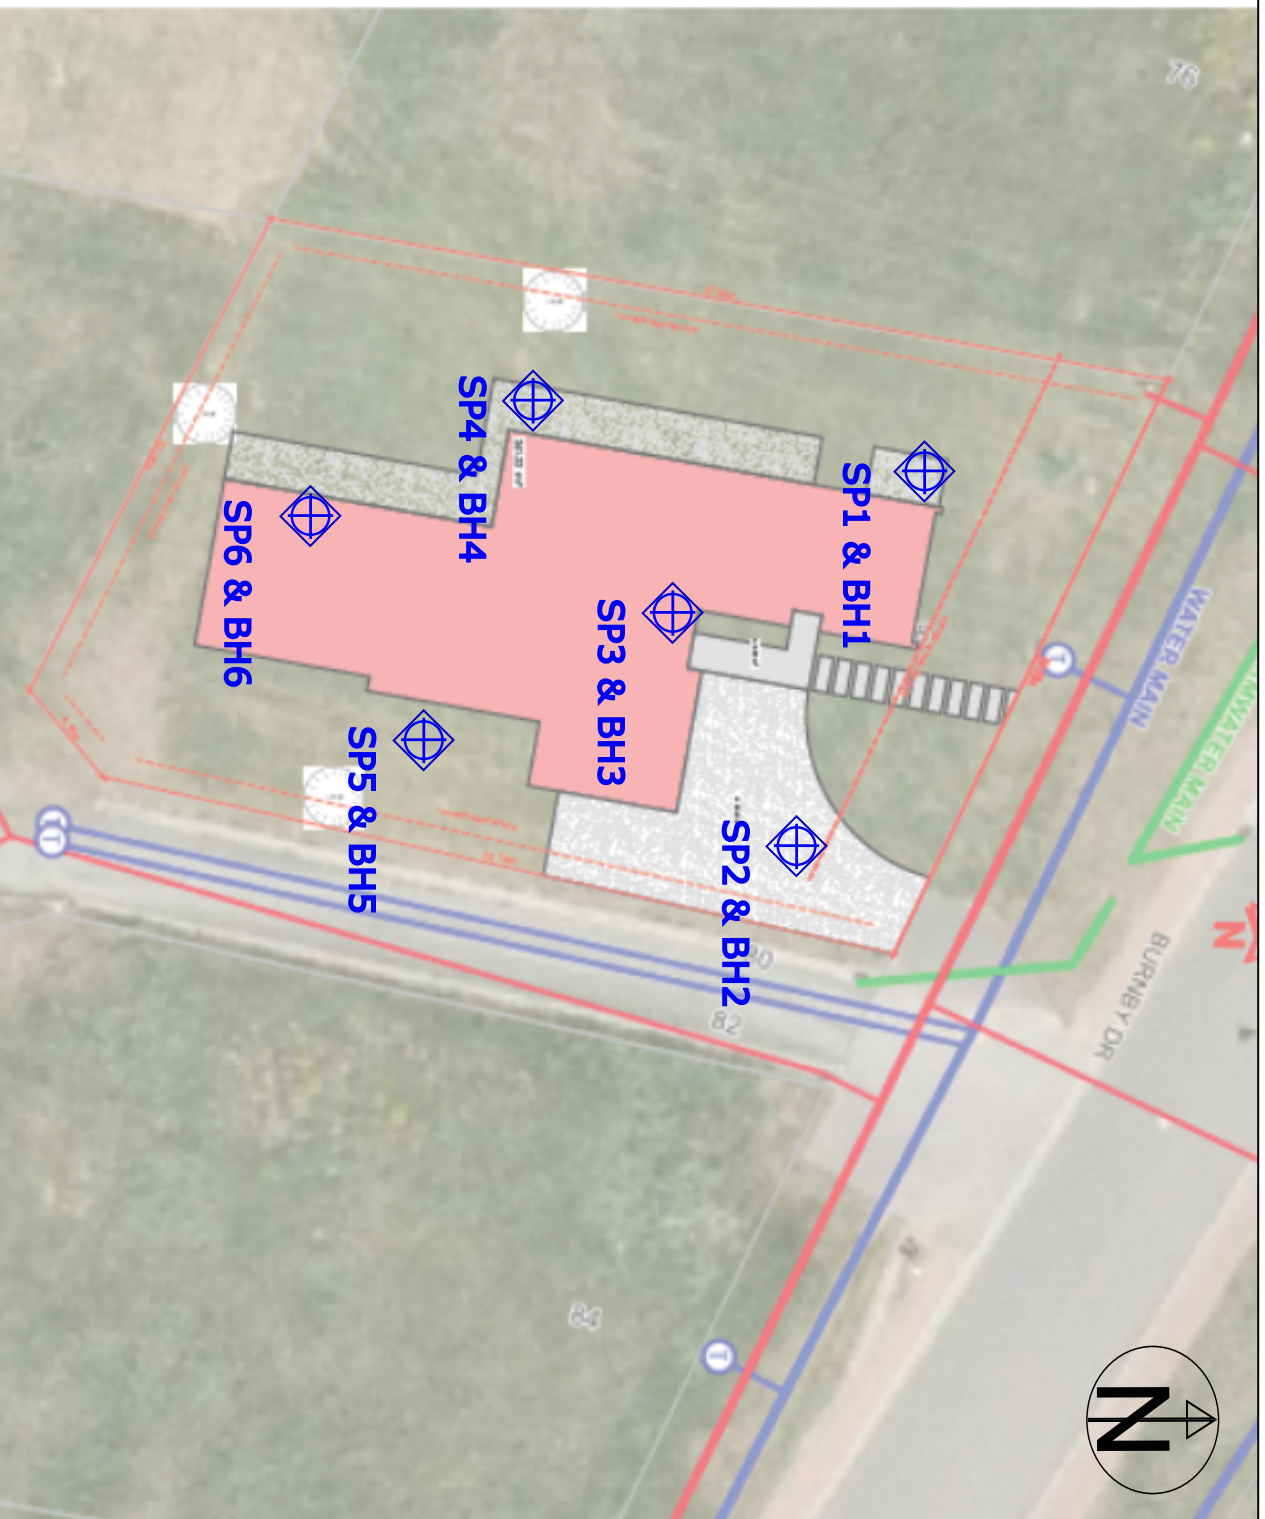
Drawing Title:
Test Location Plan

The Scala results have shown that the soils in each test location have Geotechnical Ultimate Bearing Capacity strengths of greater than 300 kPa, as measured in accordance with NZS3604:2011. The remaining constraints in Section 2 above have also been satisfied and therefore the testing confirms that the area tested meets the definition of “good ground”, generally between 0.15 meters below ground level (mbgl) to 0.35 mbgl. The attached Test Location Plan shows the location where tests were undertaken onsite.

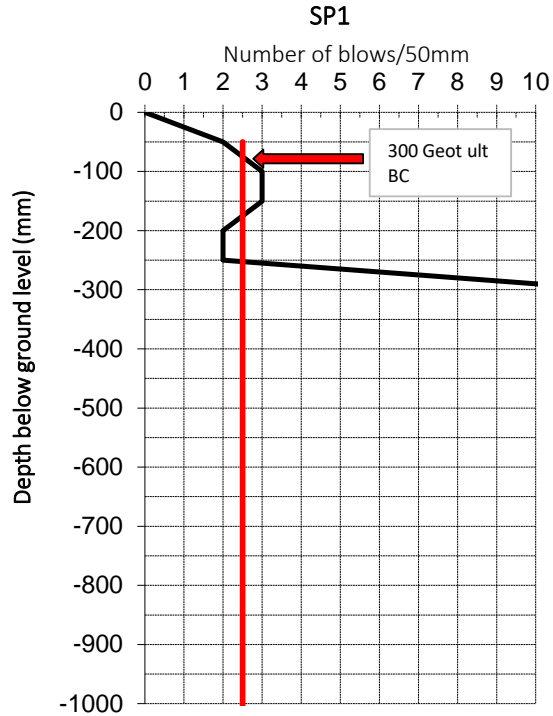
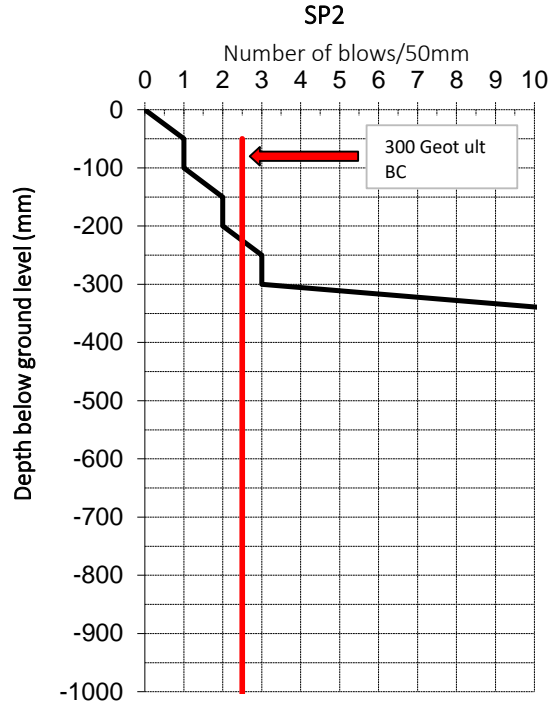
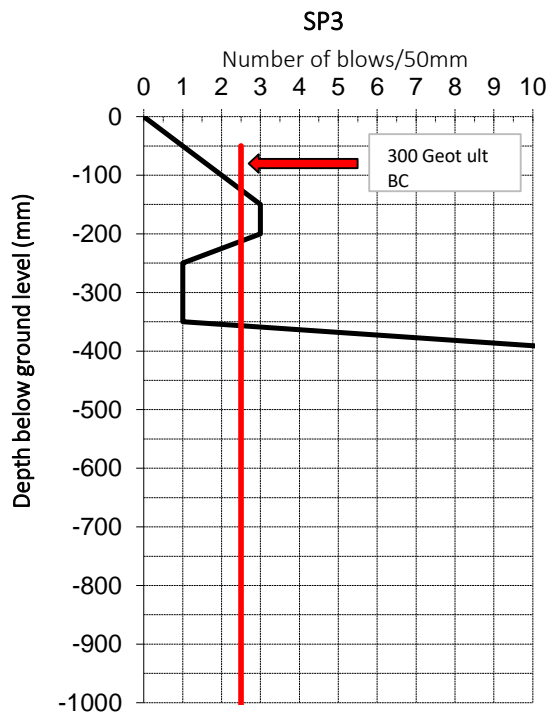
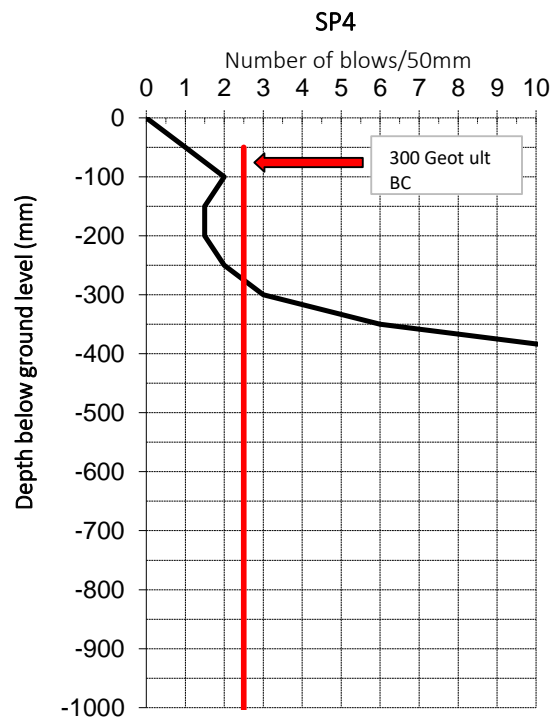
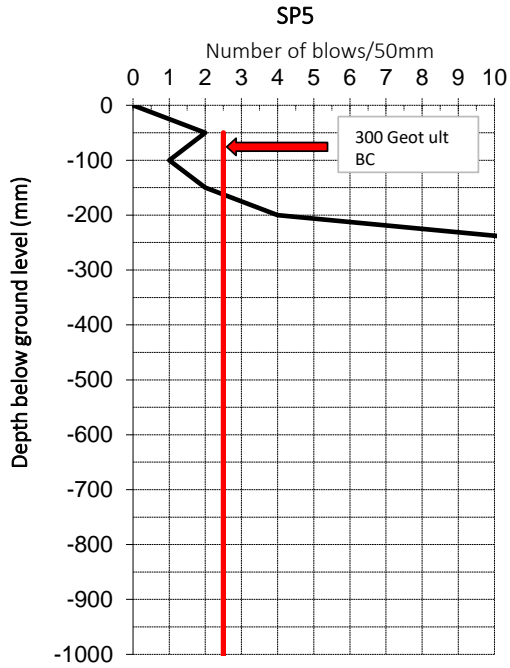
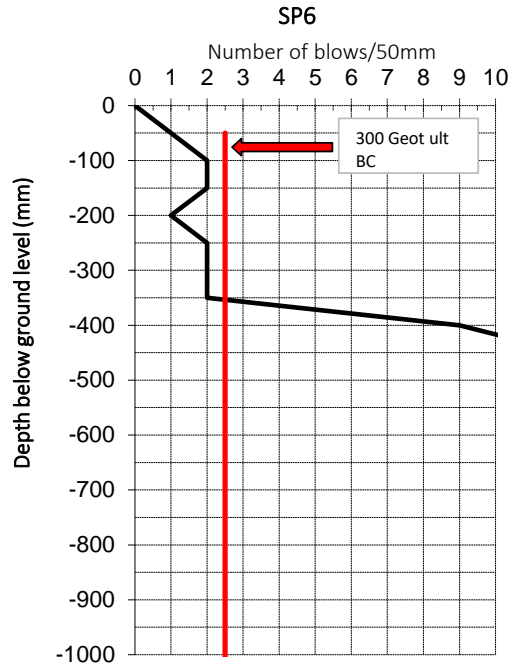
SCALA PENETROMETER RESULTS

SCALA NUMBER	DEPTH TO 300 kPa (mbgl)	DEPTH TO 200 kPa (mbgl)	DEPTH TO TEST COMPLETION (mbgl)	DEPTH TO REFUSAL/BOUNCING (mbgl)
1	0.25	>0.05	0.30	0.30
2	0.25	0.05	0.35	0.35
3	0.35	0.05	0.40	0.40
4	0.25	0.05	0.40	0.40

5	0.15	>0.05	0.25	0.25
6	0.35	0.05	0.45	0.45

The Scala results have shown that the soils in each test location have meet the Geotechnical Ultimate Bearing Capacity strength of 300 kPa required, in accordance with NZS3604:2011 at the depths as shown in Table 1.

Note: No Friction correction has been applied to the field results. 5 Blows per 100mm is considered compliance with NZS3604 3.3.7

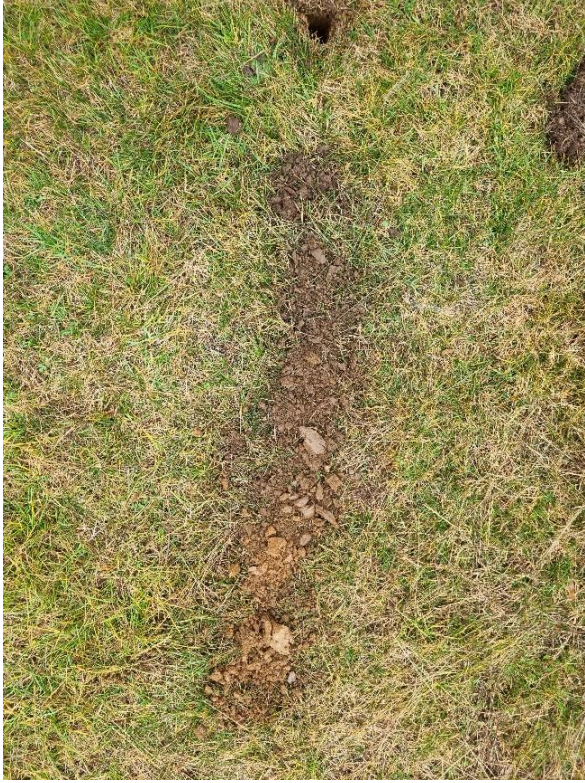
HA-1		Hand Auger Borehole Log

0.1	ψψψψψψ ψψψψψψ ψψψψψψ ψψψψψψ	organic sandy clayey SILT with trace gravel; dark brown; dry; sand, fine; gravel, fine to coarse, subrounded to rounded; rootlets		Dry	TOPSOIL

0.2	ψψψψψψ ψψψψψψ						
0.3	οxxοxxοxx οxxοxxοxx οxxοxxοxx οxxοxxοxx	gravelly clayey SILT; yellow/brown; very stiff; moist; gravel, fine to coarse, sub rounded to rounded; sand, fine		Moist	ALLUVIAL	>206

0.4	οxxοxxοxx οxxοxxοxx						
0.5		Unable to penetrate further - gravel					
0.6

1.4							
1.5							
Comments: No Groundwater encountered							
						Reviewed by:	SMA

All topsoil and organic matter beneath the proposed building footprint will need to be removed and replaced with compacted certified fill as per NZS4431 to achieve the foundation levels required. If excavations are undertaken and the removed soils are transported using a public roadway, ensure that a stabilised entrance way is constructed at the entrance and exit of the site to enable erosion and sediment control.

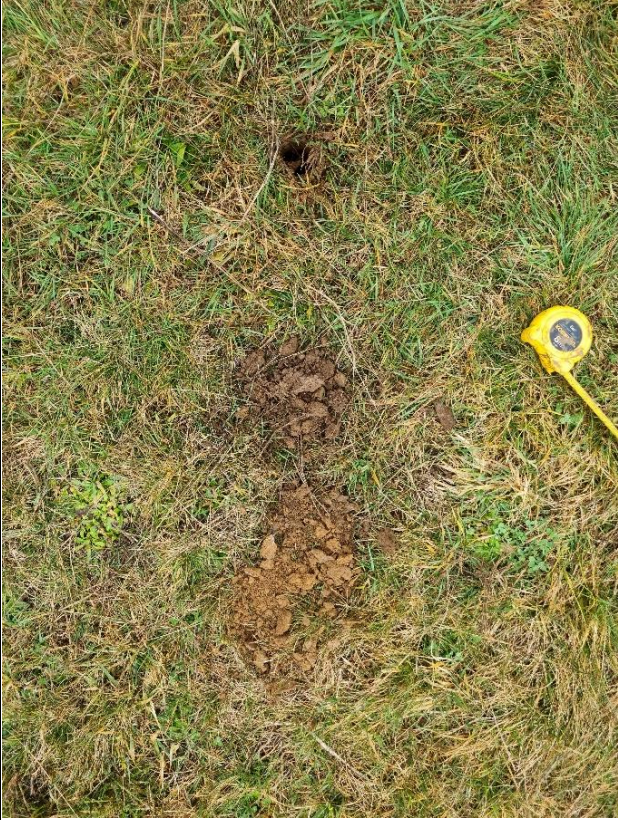
HA-2		Hand Auger Borehole Log

0.1	ψψψψψψ	organic sandy clayey SILT with trace gravel; dark brown; dry; sand, fine; gravel, fine to coarse, subrounded to rounded; rootlets			Dry	TOPSOIL

0.2	ψψψψψψ							
0.3	οxxοxxοxx οxxοxxοxx	gravelly clayey SILT; yellow/brown; very stiff; moist; gravel, fine to coarse, sub rounded to rounded; sand, fine			Moist	ALLUVIAL	147/28

0.4		Unable to penetrate further - gravel						
0.5

1.5								
Comments: No Groundwater encountered								
							Reviewed by:	SMA

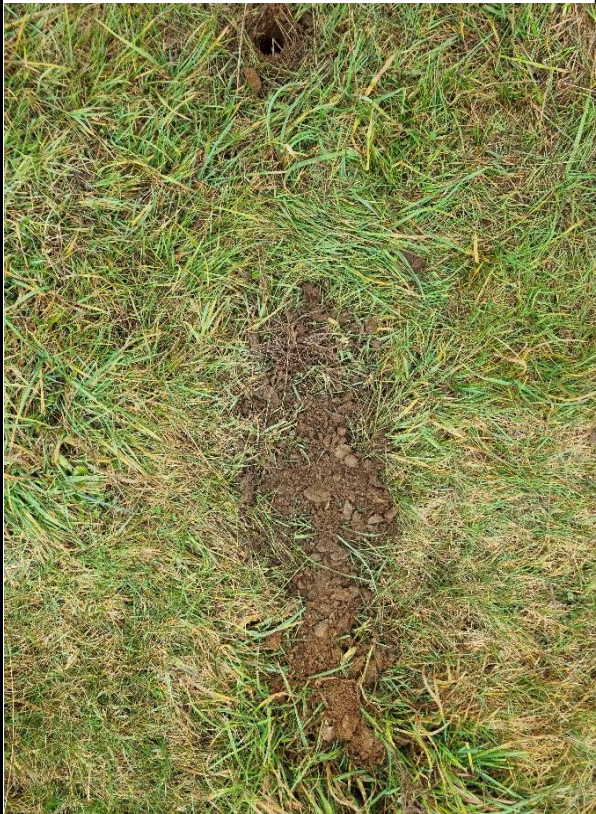
HA-3		Hand Auger Borehole Log

0.1	ψψψψψ	organic sandy clayey SILT with trace gravel; dark brown; dry; sand, fine; gravel, fine to coarse, subrounded to rounded; rootlets	Dry	TOPSOIL

0.2	ψψψψψ					
0.3	ψψψψψ					
0.4	οxxοxxοxx οxxοxxοxx οxxοxxοxx	gravelly clayey SILT; yellow/brown; very stiff; moist; gravel, fine to coarse, sub rounded to rounded; sand, fine	Moist	ALLUVIAL	105/28	3.7

0.5		Unable to penetrate further - gravel				
0.6

0.7						
0.8						
0.9						
1.0						
1.1						
1.2						
1.3						
1.4						
1.5						
Comments: No Groundwater encountered						
					Reviewed by:	SMA

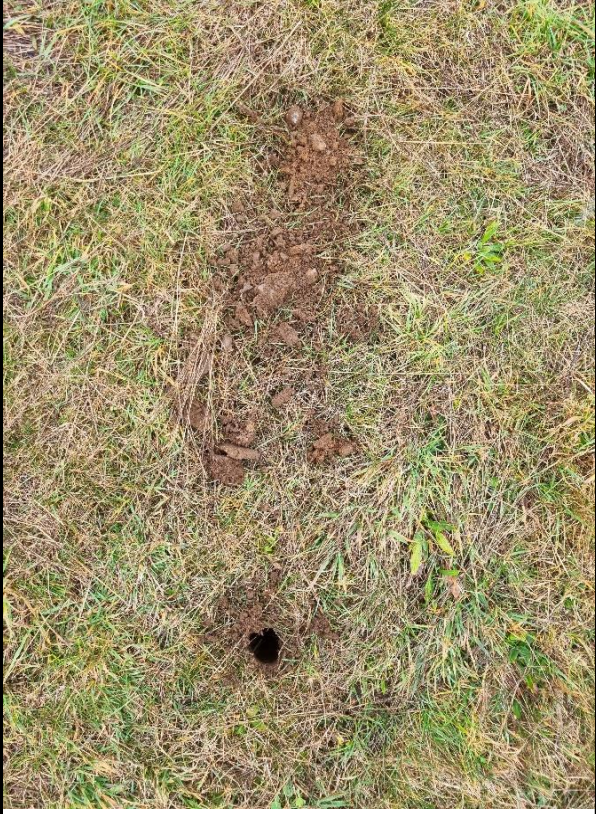
HA-4		Hand Auger Borehole Log

0.1	ψψψψψψ ψψψψψψ ψψψψψψ ψψψψψψ	organic sandy clayey SILT with trace gravel; dark brown; dry; sand, fine; gravel, fine to coarse, subrounded to rounded; rootlets		Moist	TOPSOIL

0.2	ψψψψψψ ψψψψψψ						
0.3	οχχοχχοχχ οχχοχχοχχ	gravelly clayey SILT; yellow/brown; very stiff; moist; gravel, fine to coarse, sub rounded to rounded; sand, fine			ALLUVIAL

0.4		Unable to penetrate further - gravel					
0.5

0.6							
0.7							
0.8							
0.9							
1.0							
1.1							
1.2							
1.3							
1.4							
1.5							
Comments: No Groundwater encountered							
						Reviewed by:	SMA

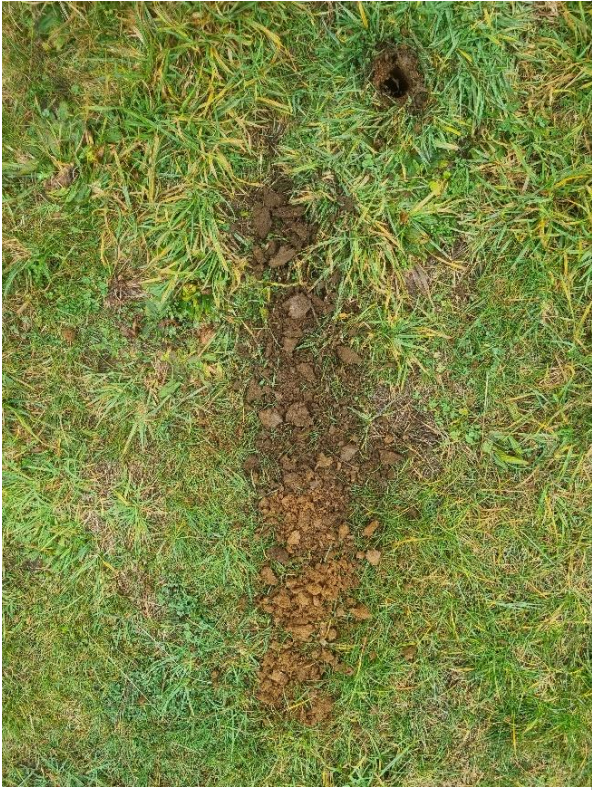
HA-5		Hand Auger Borehole Log

0.1	ψψψψψψ ψψψψψψ ψψψψψψ ψψψψψψ	organic sandy clayey SILT with trace gravel; dark brown; dry; sand, fine; gravel, fine to coarse, subrounded to rounded; rootlets			Dry	TOPSOIL		7.3

0.2	ψψψψψψ ψψψψψψ							
0.3	οχχοχχοχχ οχχοχχοχχ	gravelly clayey SILT; yellow/brown; very stiff; moist; gravel, fine to coarse, sub rounded to rounded; sand, fine			Moist	ALLUVIAL	118/17

0.4		Unable to penetrate further - gravel						
0.5

1.5								
Comments: No Groundwater encountered								
							Reviewed by:	SMA

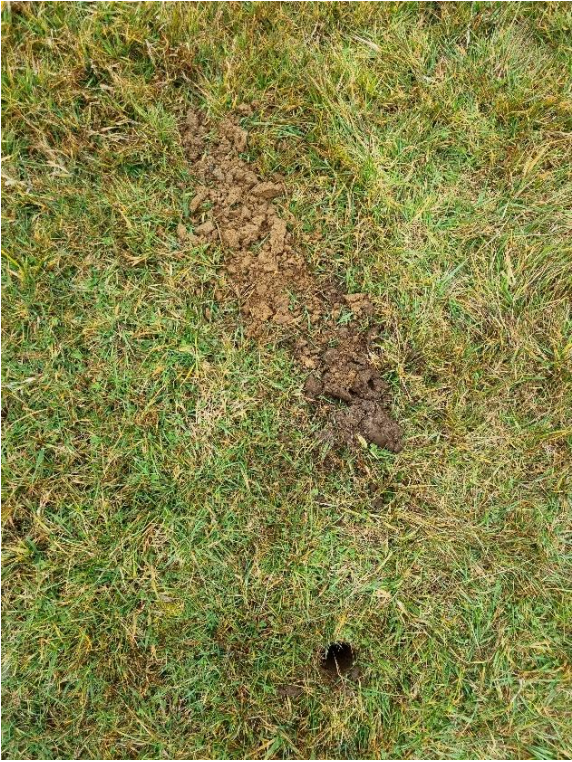
HA-6		Hand Auger Borehole Log

0.1	ψψψψψψ	organic sandy clayey SILT with trace gravel; dark brown; dry; sand, fine; gravel, fine to coarse, subrounded to rounded; rootlets			Dry	TOPSOIL		4.1

0.2	ψψψψψψ							
0.3	ψψψψψψ							
0.4	ψψψψψψ							
0.5	οxxοxxοxx οxxοxxοxx	gravelly clayey SILT; yellow/brown; very stiff; moist; gravel, fine to coarse, sub rounded to rounded; sand, fine			Moist	ALLUVIAL	91/22

0.6		Unable to penetrate further - gravel						
0.7

0.8								
0.9								
1.0								
1.1								
1.2								
1.3								
1.4								
1.5								
Comments: No Groundwater encountered								
							Reviewed by:	SMA
