STRAIGHT UP
INSPECTIONS

CERTIFICATE OF INSPECTION

Client	Cari Hill
Address of Property	109 Shakespeare St, Cambridge
Inspector	Alistair Simpson
Company	Straight Up Inspections
Position	Director
Qualifications	Builder
Date of Inspection	20 Jul 2021

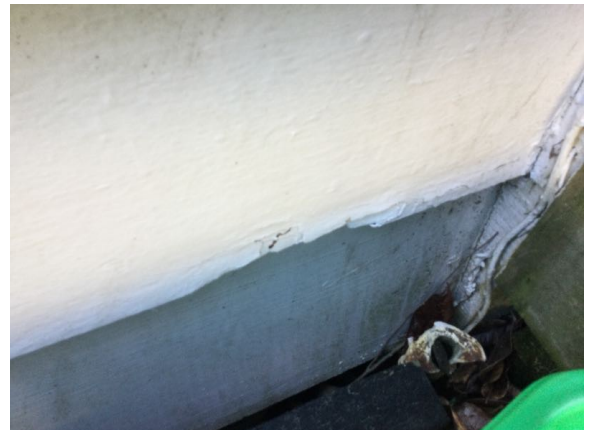
- ⚠️ There are some areas of rot developing in the bottom weatherboards on the southern side of the building. These need to be repaired as soon as possible to prevent further damage. Further investigation is required by a licensed building practitioner.

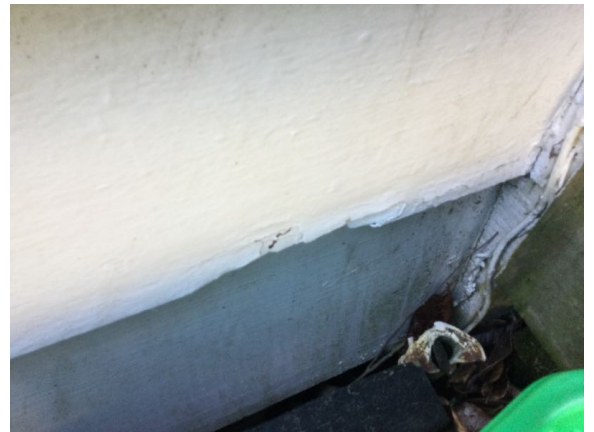
There are some areas of rot developing in the bottom weatherboards on the southern side of the building. These need to be repaired as soon as possible to prevent further damage. Further investigation is required by a licensed building practitioner.

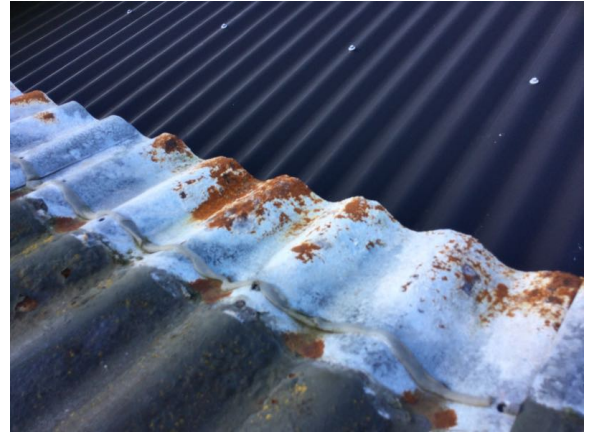
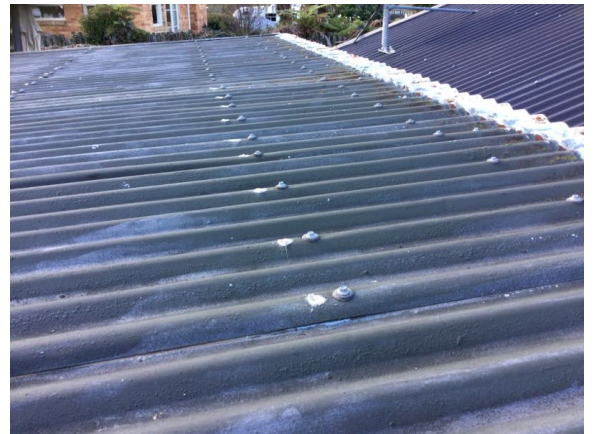
The carport roof has areas of rust developing. These should be cleaned back and repainted to prevent further damage. There are also a number of holes that have been repaired with silicone which is a temporary solution and will fail in time.

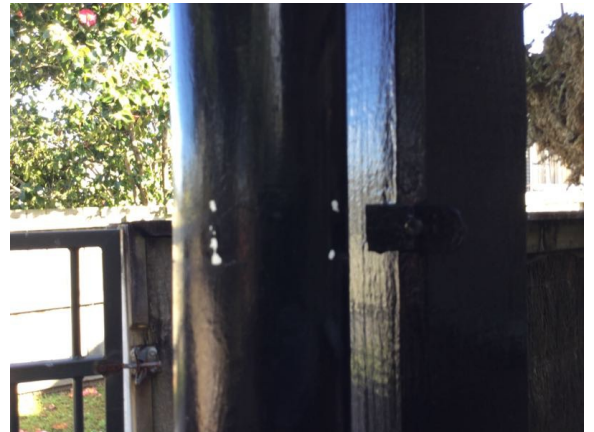
The clips on the down pipe on the south eastern corner are broken and should be replaced.

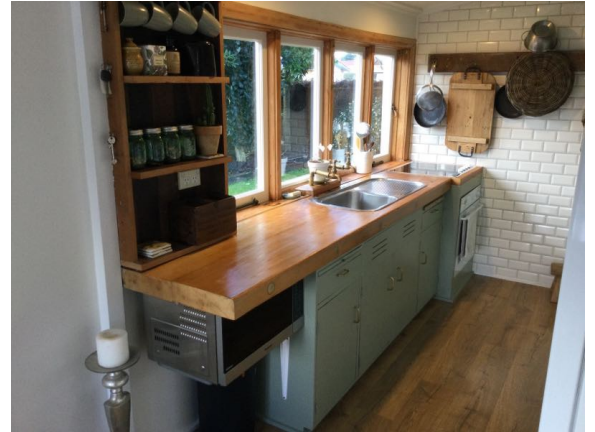
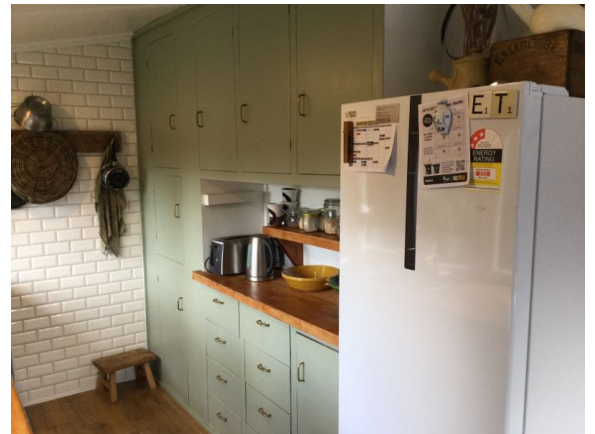
- timber benchtop
- stainless steel sink and drainer
- the sink is surface mounted
- stainless steel taps
- an electric underbench oven (not tested)
- bench mounted ceramic hob (not tested)
- there is no extractor fan (we recommend one is installed to remove steam and odours from the kitchen, this should be vented outside)
- solid timber cabinets
- solid timber doors
- solid timber drawer fronts

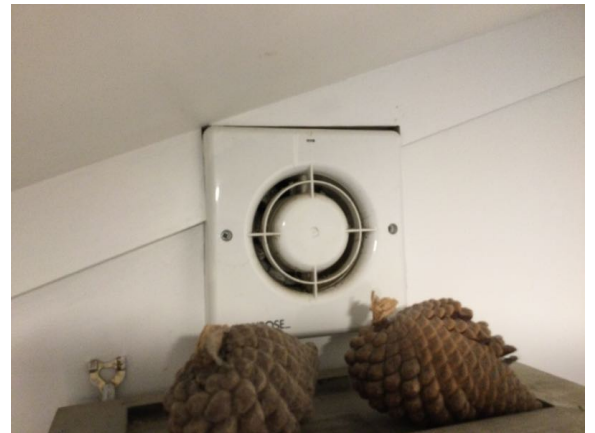
- wall mounted extractor fan
- The extractor fan was not working at the time of inspection.
