## Independent building inspection report on 10 Goodland Place, Rolleston

## **INDEPENDENT BUILDING INSPECTION**

**10 Goodland Place, Rolleston**

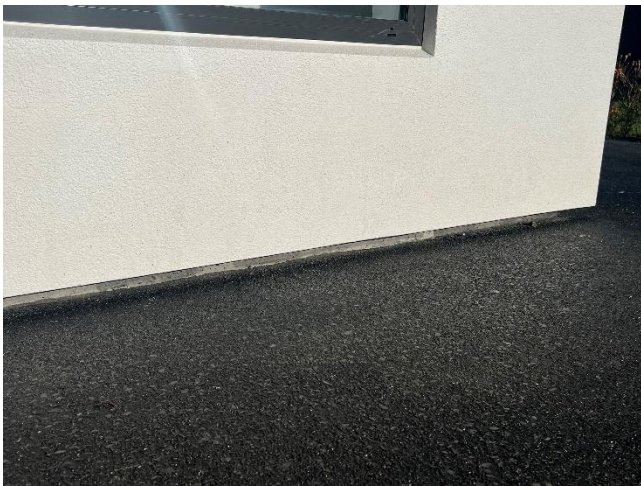
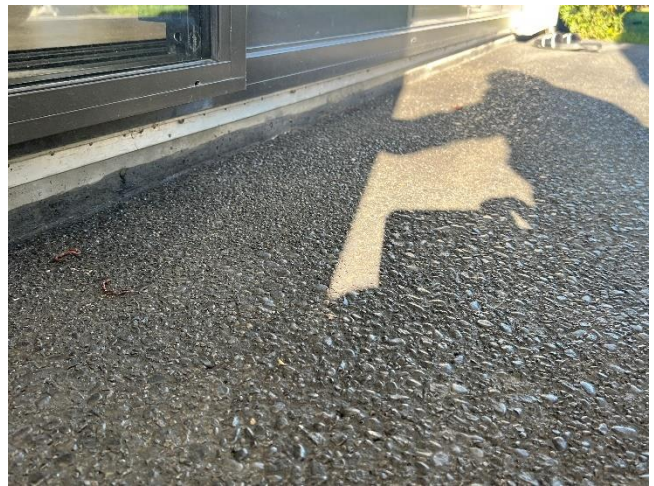
The dwelling is constructed on the following foundation system, Concrete slab on ground, it is presumed that this is placed over a granular base with a damp-proof membrane and complies with NZ3604 SECTION 7.

Generally, the foundation construction appears to be well constructed and is currently in good foundation condition for their type and age showing no obvious signs of stress movement either vertically or horizontally.

Viewing of the foundations was limited due to the current ground heights obstructing the foundation.

Floor levels were randomly checked with a zip level in various locations throughout the dwelling, the dwelling appears to be within the Ministry of Business, Innovation and employment guidelines, variation in level over the floor plan is <50 mm, please note this is not a floor level survey, tolerances in measuring devices and benchmarks may occur.

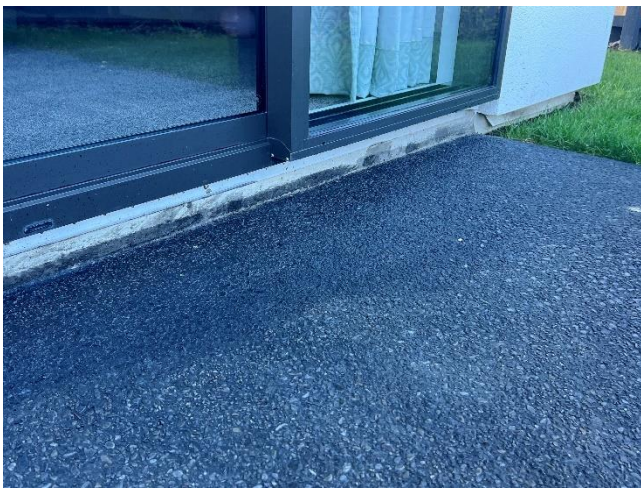
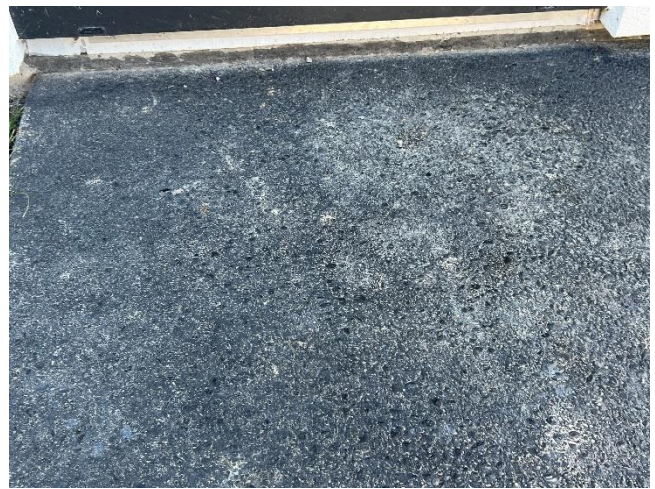
The current finished ground levels are satisfactory to prevent any moisture ingress by means of capillary action, with concreted and paved areas having the correct falls away from the dwelling and channelled into the appropriate cesspits.

It is recommended that vegetation is kept clear of the foundation and that ground clearances are maintained.

**Recommendations:** Ground and garden levels should be kept below and clear of the cladding and finished floor heights to minimise water ingress, unless specialised drainage is installed the current standards taken off the floor are A min of 150mm to permanent paving and 225mm to unprotected ground

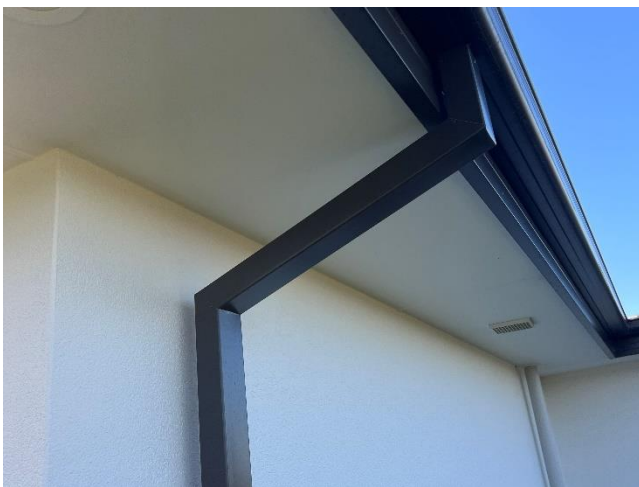
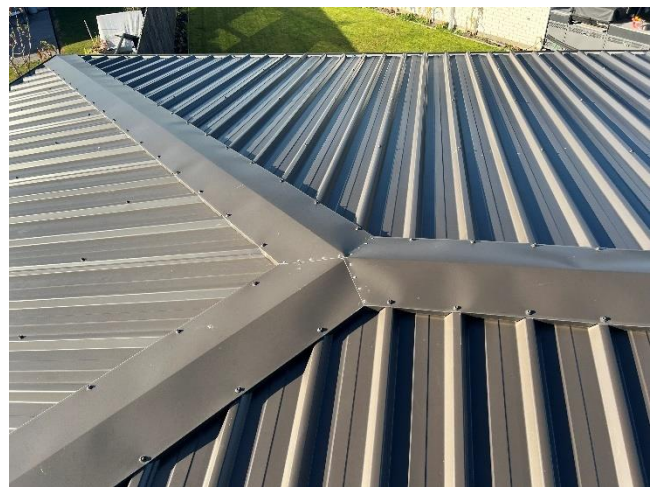
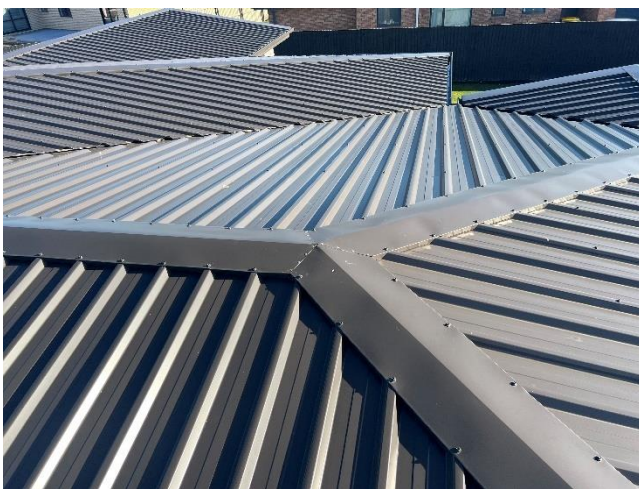
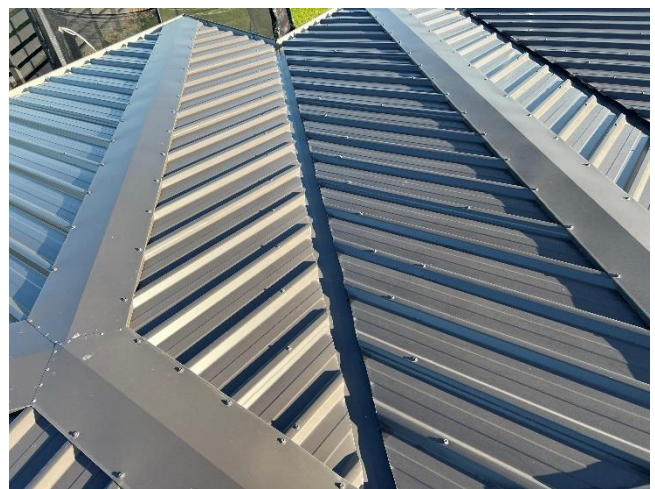
The roof is a profiled metal roof generally in good condition, showing no signs of foot/traffic damage with all flashings suitably fixed.

Metal external spouting and downpipes are well fixed in accordance with good trade practice.

Soffits are painted fibre cement sheets with a paint finish.

**Recommendations:** Regular checks of the roof cavity are recommended, these checks should be a visual inspection looking for vermin and any water ingress or staining, if any issues are noted remediation is recommended. More information can be found @ <http://www.maintainingmyhome.org.nz/maintenance-guides/roof-maintenance-guide/>

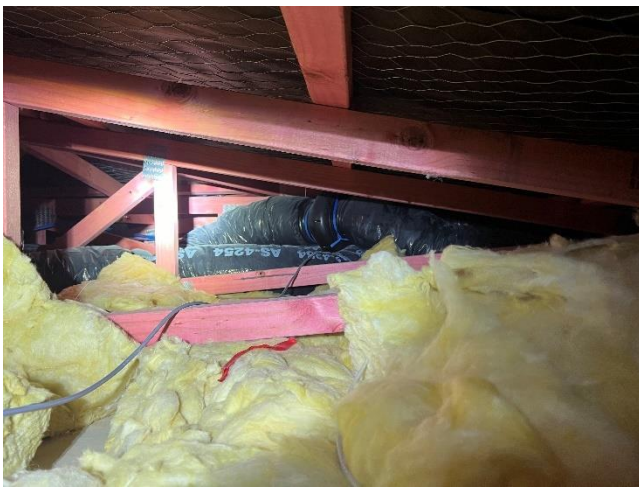
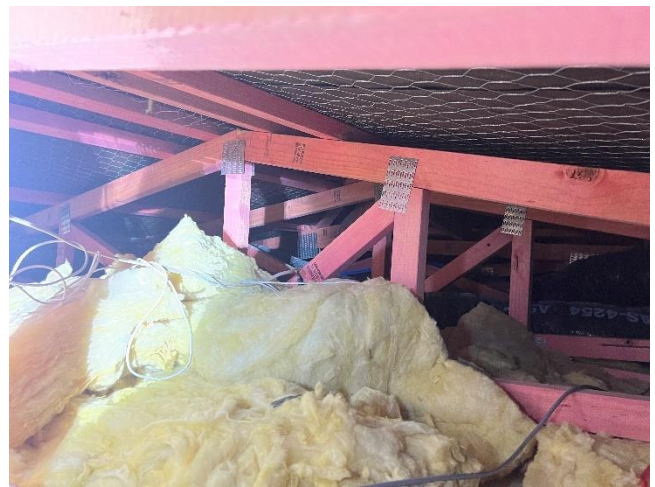
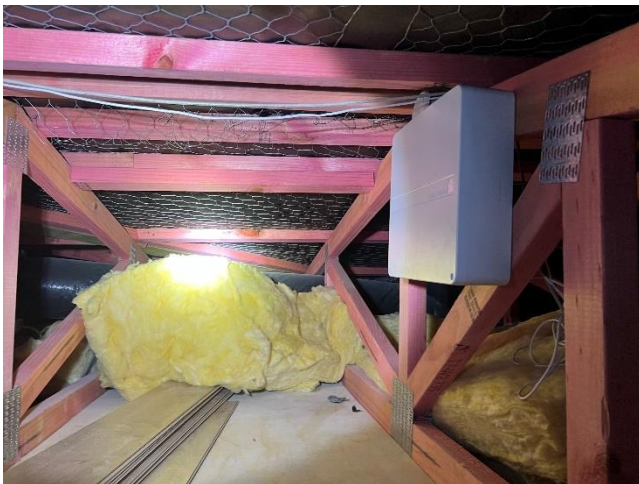
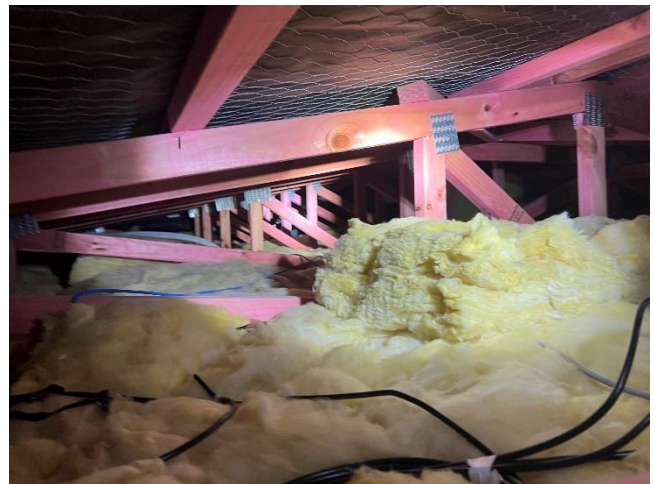
The roof design and construction consist of conventional, specific design manufactured roof trusses in a hip/valley formation are in good condition with purlins well attached. Trusses are skew-nailed, and "z" nailed to comply with NZS3604.

The ceiling is well insulated with glass wool insulation to flat ceiling areas, the insulation is in good condition. Roofing underlay is a bitumen mesh supported paper with no visible issues.

**Recommendations:** Regular checks of the roof cavity are recommended, these checks should be a visual inspection looking for vermin and any water ingress or staining, if any issues are noted remediation is recommended. More information can be found at <http://www.maintainingmyhome.org.nz/maintenance-guides/roof-maintenance-guide/>

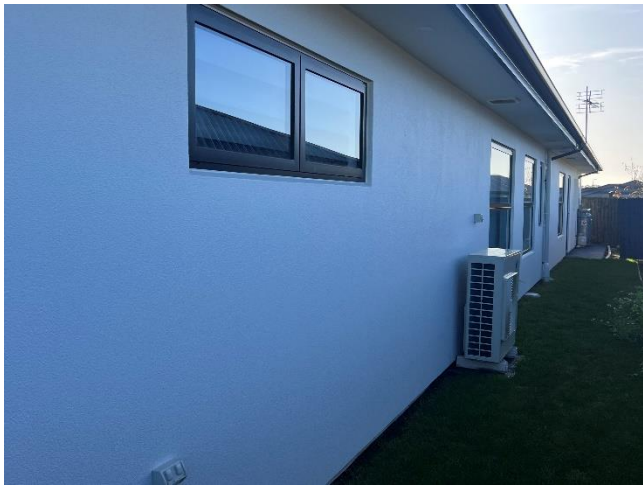
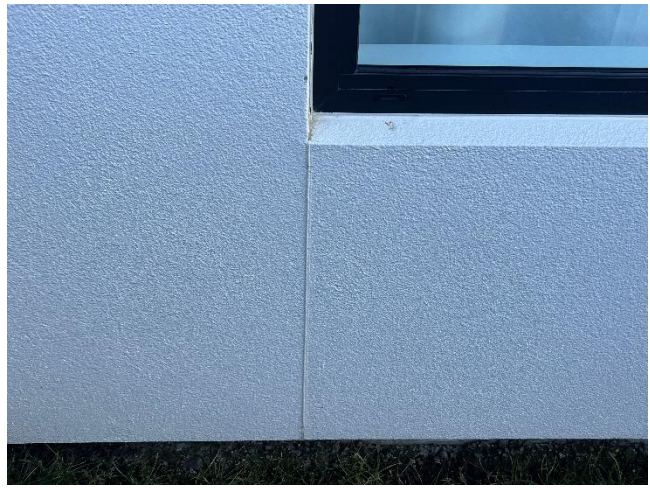
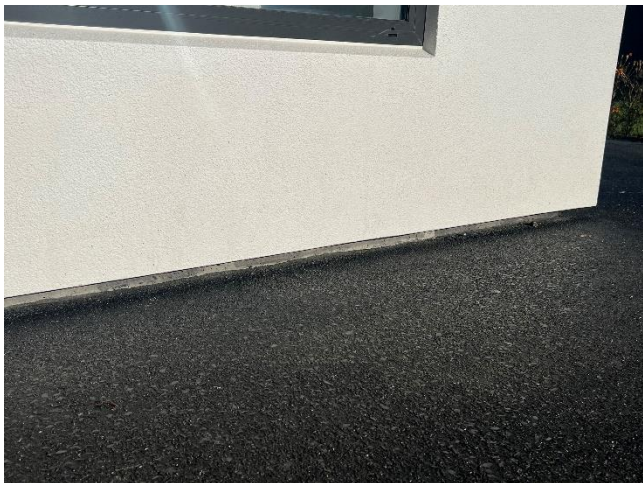
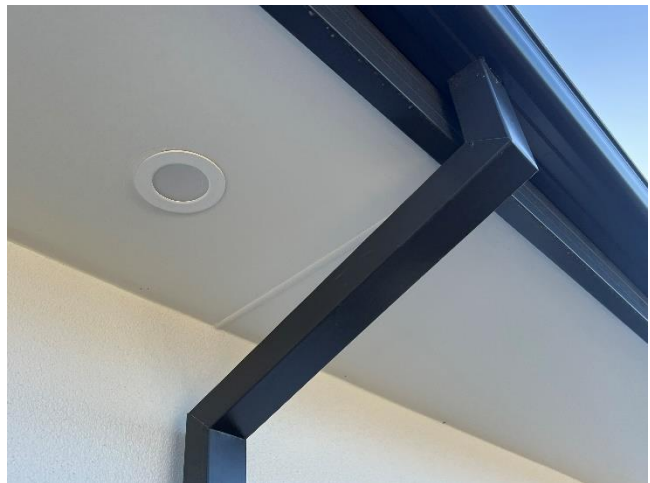
The cladding system is a manufactured plaster system over a vented and drained cavity system.

The plaster system appears to be installed over an AAC panel, a hand applied plaster and paint system has then been applied, the cladding system has been installed to a good trade standard at the time of construction with no current visible issues noted at the time of inspection, it is recommended that council records are checked to verify the cladding substrate used.

**Recommendations:** Regular cleaning is recommended to the cladding system. More information can be found at <http://www.maintainingmyhome.org.nz/maintenance-guides/external-wall-maintenance-guide/> <http://www.maintainingmyhome.org.nz/maintenance-guides/painting-guide/>

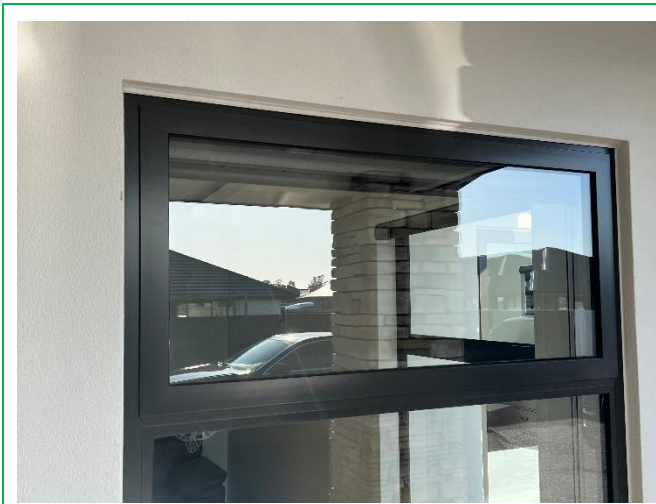
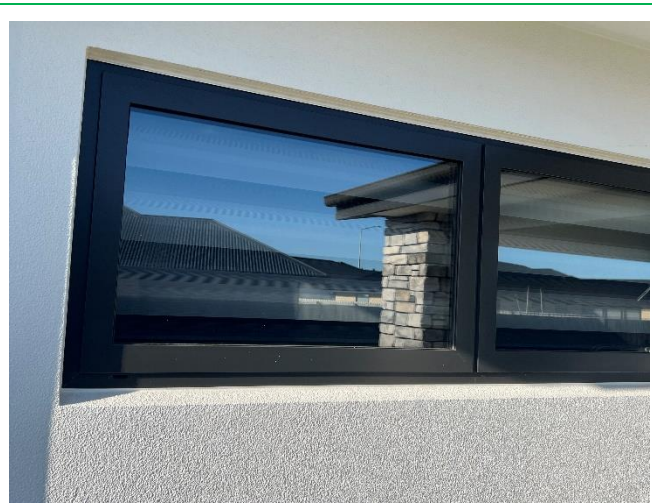
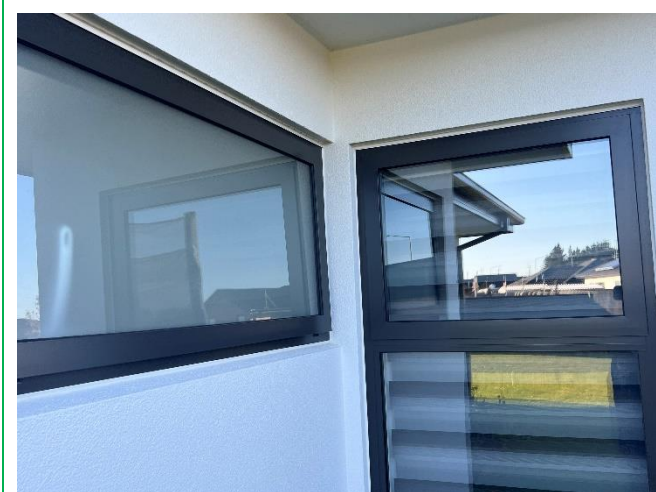
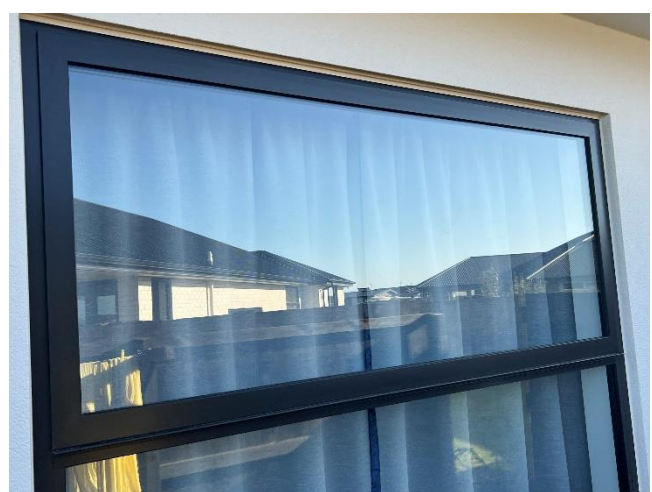
Doors and windows are operating correctly with locks and latches functioning adequately. the joinery has been flashed and sealed as required at the time of construction.

Generally, the exterior joinery is in good condition for its age. It is recommended that the exterior joinery is regularly cleaned and maintained to prolong the life of the system and minimise issues that may occur. Please ensure drainage channels are kept clear of any debris.

**Recommendations:** Regular cleaning and maintenance is recommended to the window system. More information can be found @ <https://www.wganz.org.nz/guides/maintenance/>

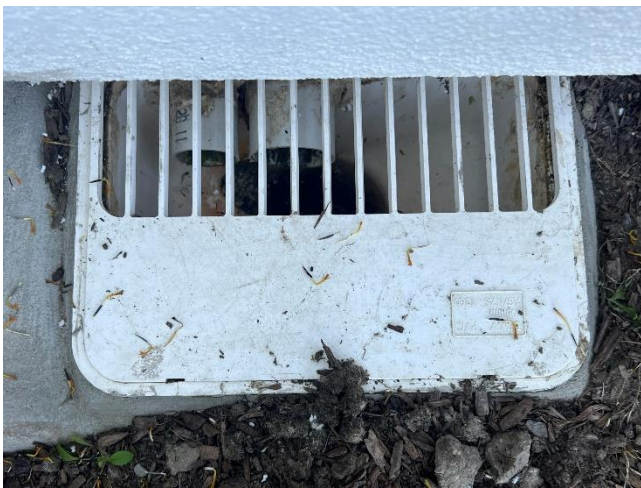
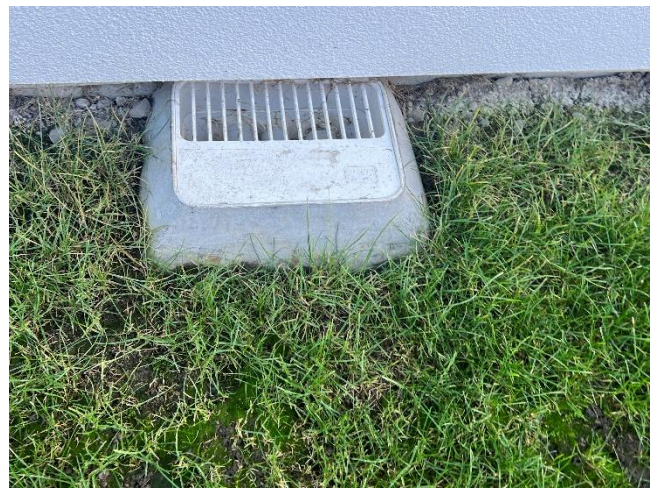
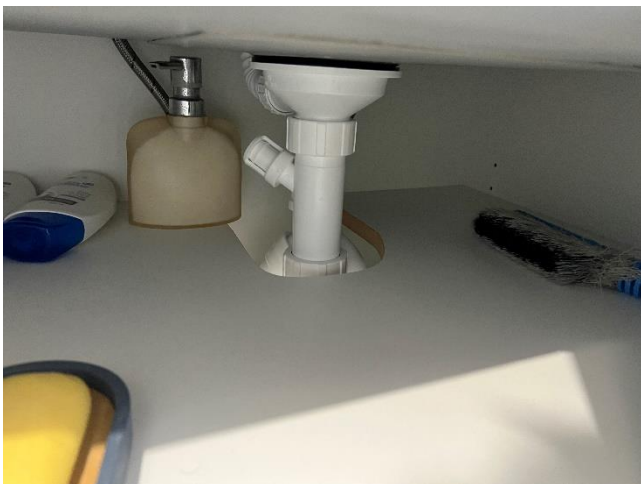
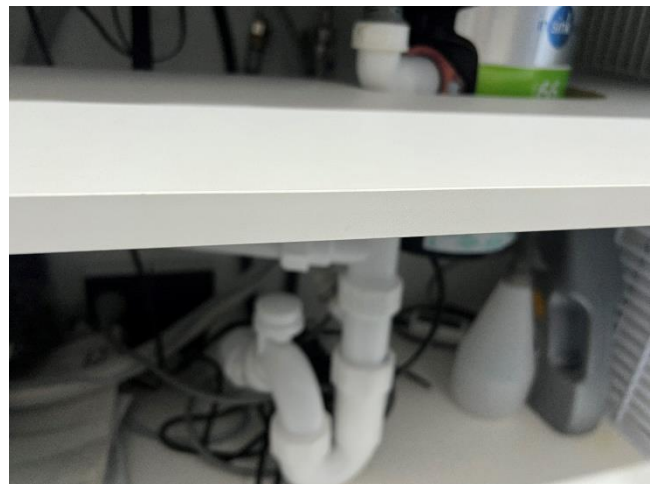
The pressure of the taps is good. Plumbing fittings are in good condition.

Downpipes discharge into downpipe inlets.

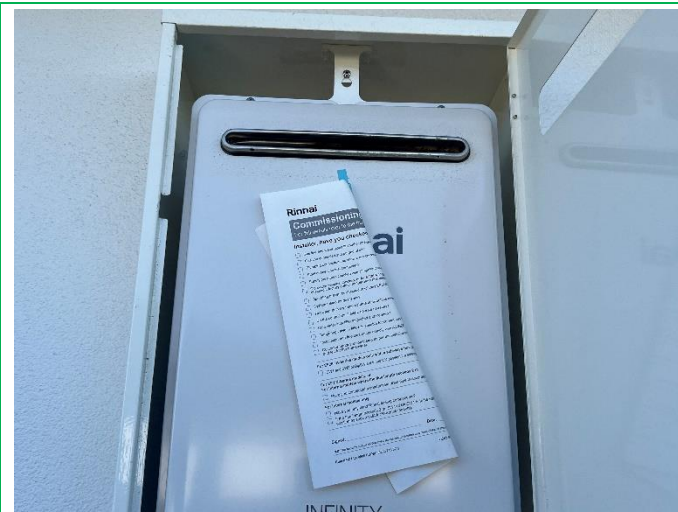
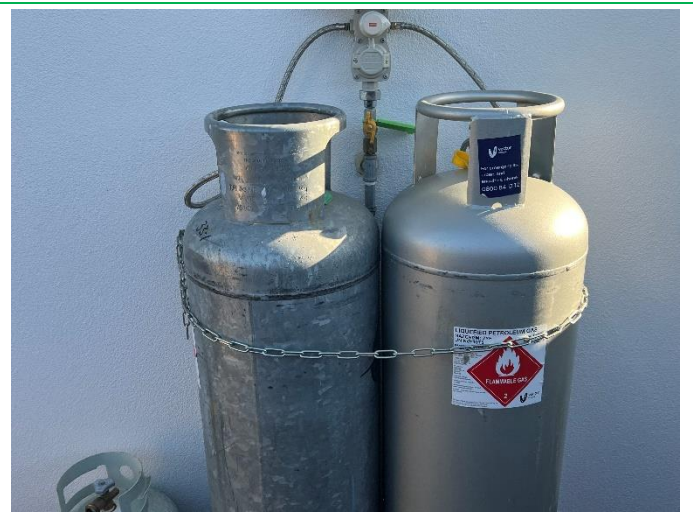
Hot water heating is achieved by a gas califont that has been installed to the exterior. It appears to have been installed to a good standard of finish, with the correct taps and fittings having been installed.

**Recommendations:** Regular checks for leaks and issues is recommended. More information can be found at <http://www.maintainingmyhome.org.nz/issues-and-repairs/term/water-heating/> <https://www.masterplumbers.org.nz/homeowner-info/tips-and-advice/staying-safe-with-gas/>

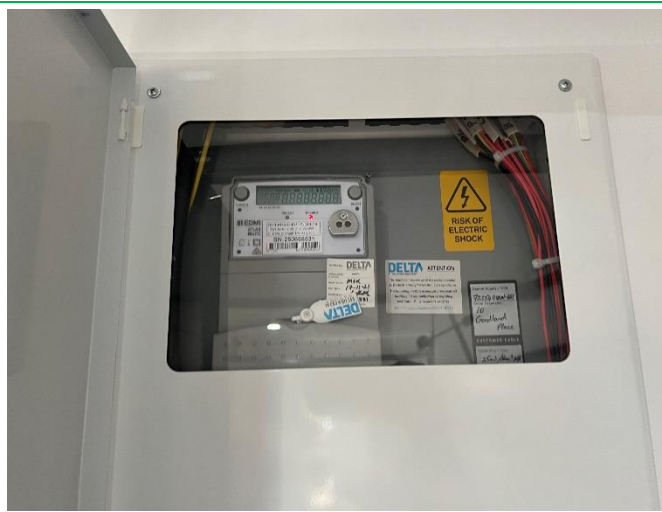
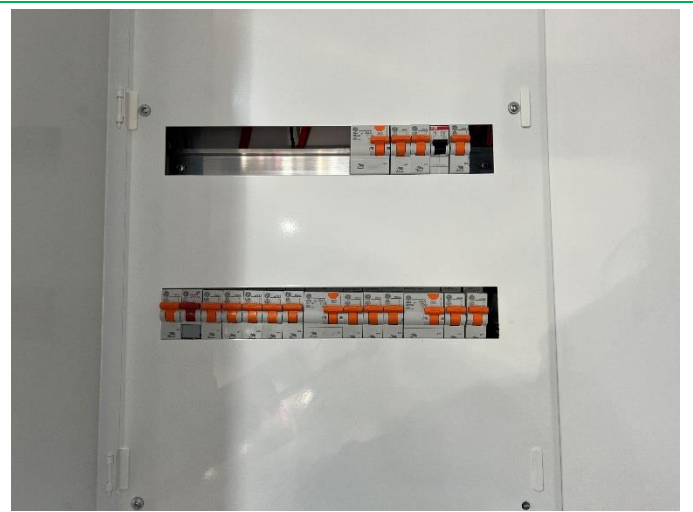
A standard distribution board has been professionally installed to the interior of the dwelling, with no obvious signs of excess heat build-up at either the board or power points.

A home alarm system is installed, this was not tested.

**Recommendations:** electrical work is a restricted trade and should only be completed by a registered electrician. Further information and tips can be found at <http://www.maintainingmyhome.org.nz/issues-and-repairs/term/electrical/>

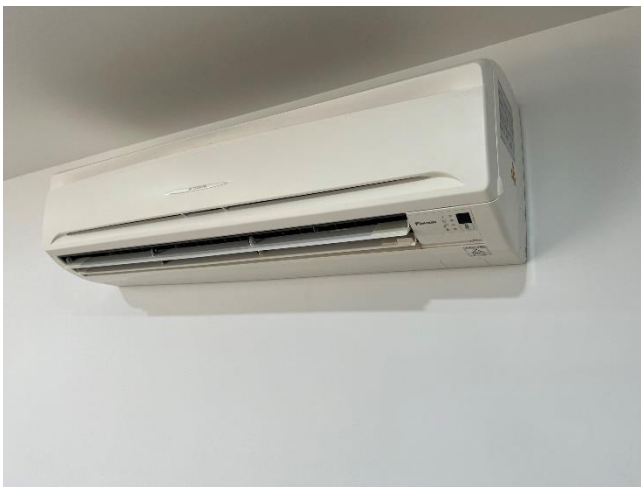
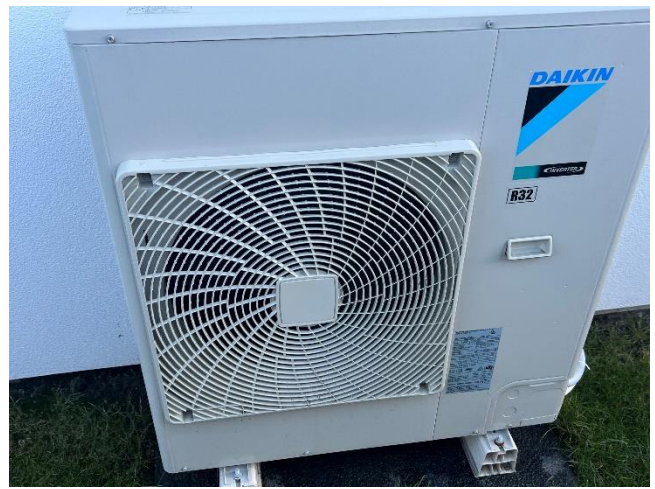
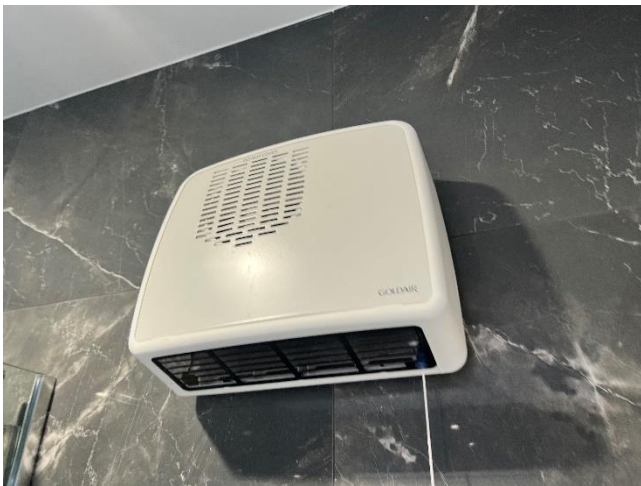
The heat pump was tested and found to be working with no visible issues.

Further heating is supported by wall mounted electric heating.

It is recommended that the heat pump is regularly serviced as per the manufacturer's recommendations.

**Recommendations:** Regular cleaning and servicing of heating is recommended; further information and tips can be found at <http://www.maintainingmyhome.org.nz/issues-and-repairs/term/heating>

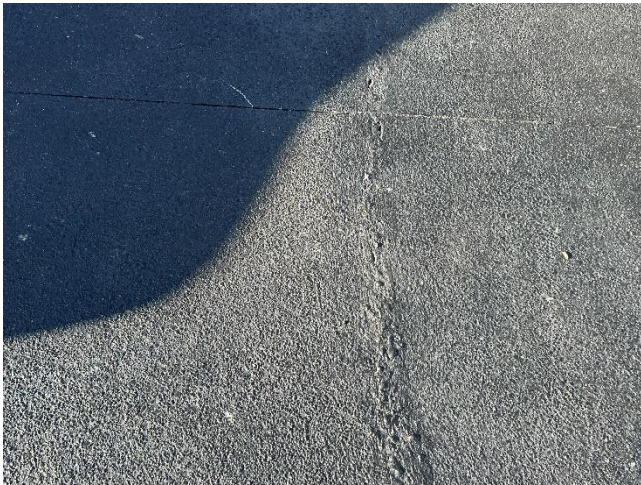
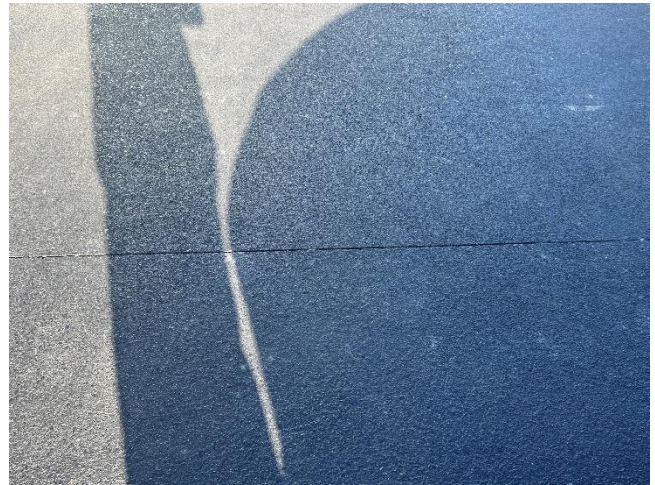
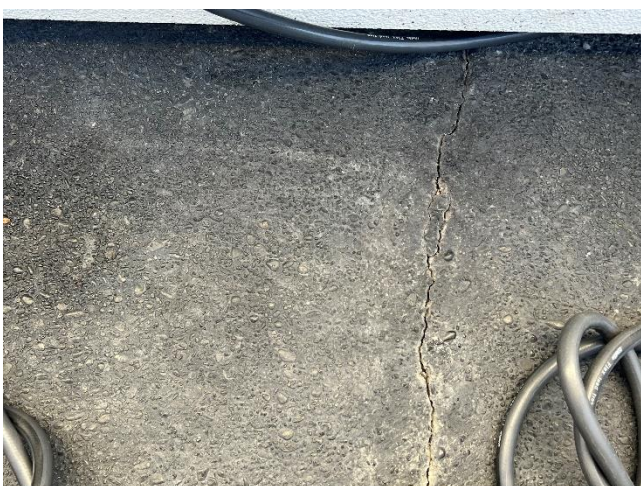
The driveway is exposed aggregate concrete, paths and patio have been constructed of exposed aggregate concrete. These are in generally good condition for their age and intended use.

Cracks are noted to the concreted surfaces, these appear to be consistent with the age, construction techniques and general use of the concreted surfaces.

**Recommendations:** Regular cleaning and maintenance is recommended.

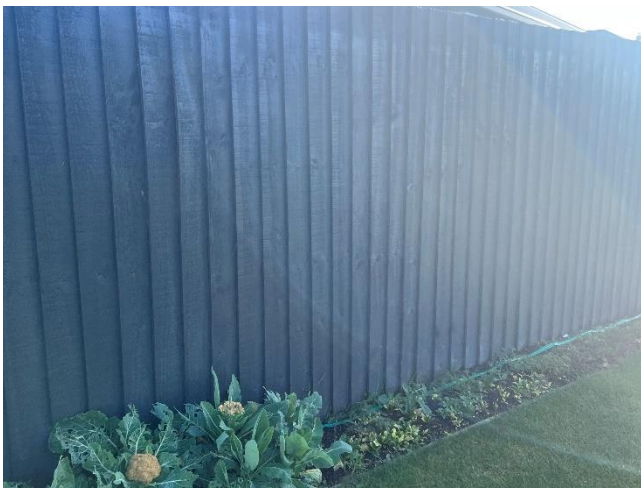
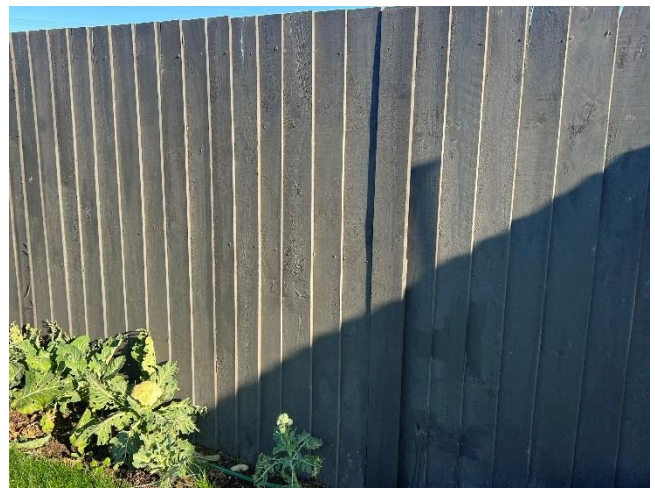
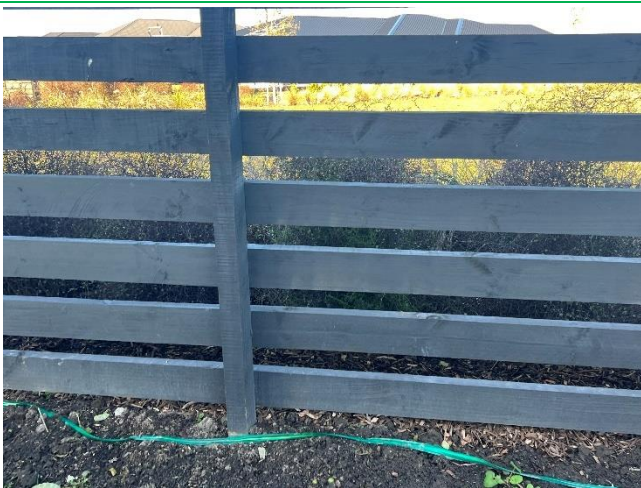
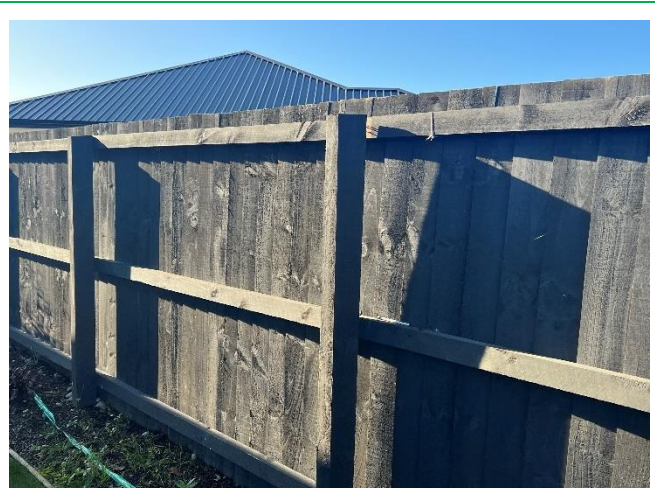
Fencing consists of a timber paling installed on a timber post and rail.

In general fencing is in good condition however some areas are in contact with the ground, this can increase and promote decay to the bottom edges of the timber palings.

**Recommendations:** Regular cleaning and maintenance of damaged palings is recommended.

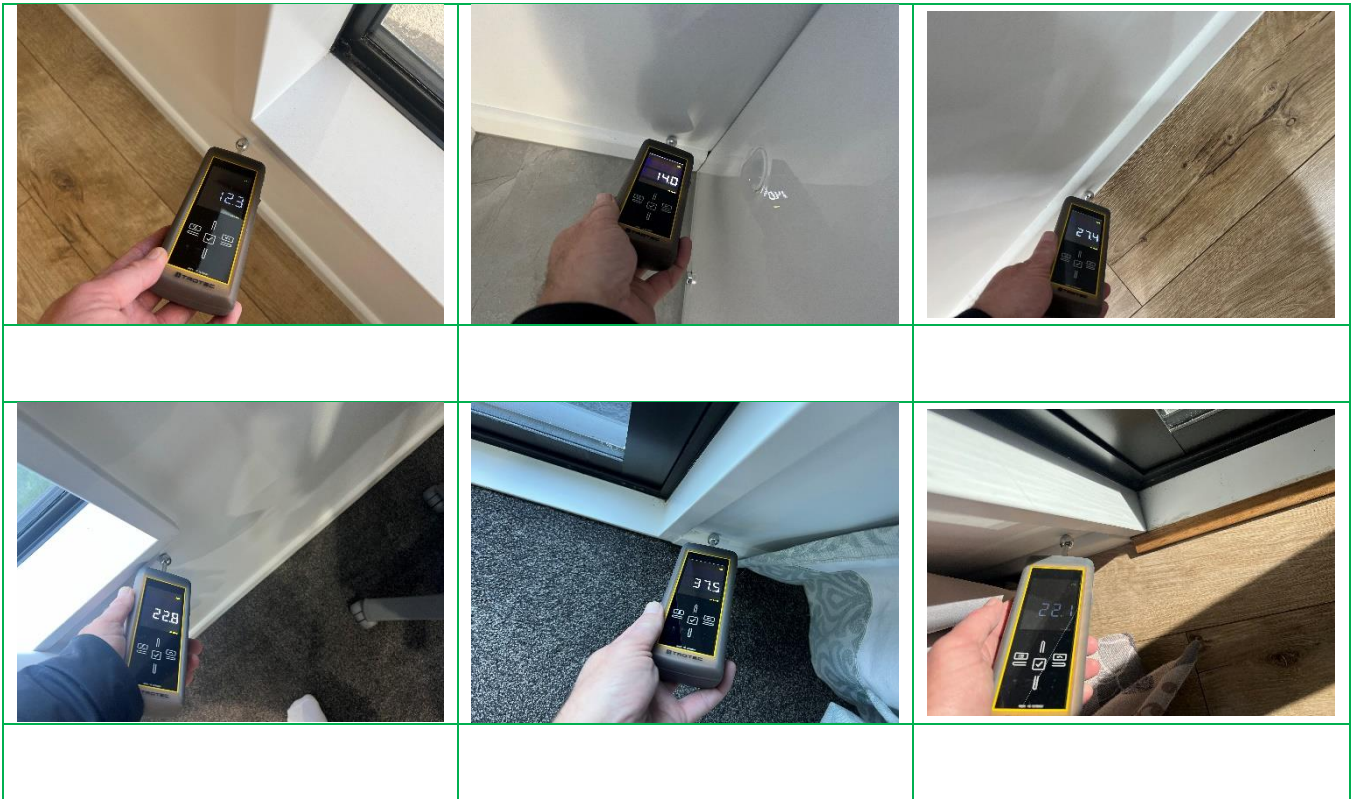
Moisture content readings were taken throughout the dwelling at areas potentially at risk using a Tro Tec T660 capacitive non-invasive moisture meter.

A base reading was taken on an internal wall at the entry which is known to be dry giving a reading of 21 all readings returned figures of between 14 and 40 indicating there was no excess moisture present in the internal framing in the areas tested at the time of inspection. Generally, moisture content readings of framing that read between 20 and 50 are considered to be dry, in that, timber framing will always retain an element of moisture, even after it has been kiln dried and generally it is accepted that internal timber framing may have the linings fixed with a moisture content reading of 50 or less. Further to this, moisture content readings tend to be 2-3% higher than normal during high humidity and colder air temperatures.
