**HOUSE PRE-PURCHASE INSPECTIONS**

## House Inspection

**Client Address** 25B Rehia Rd, Massey

INSPECTION DATE: 24/09/2018

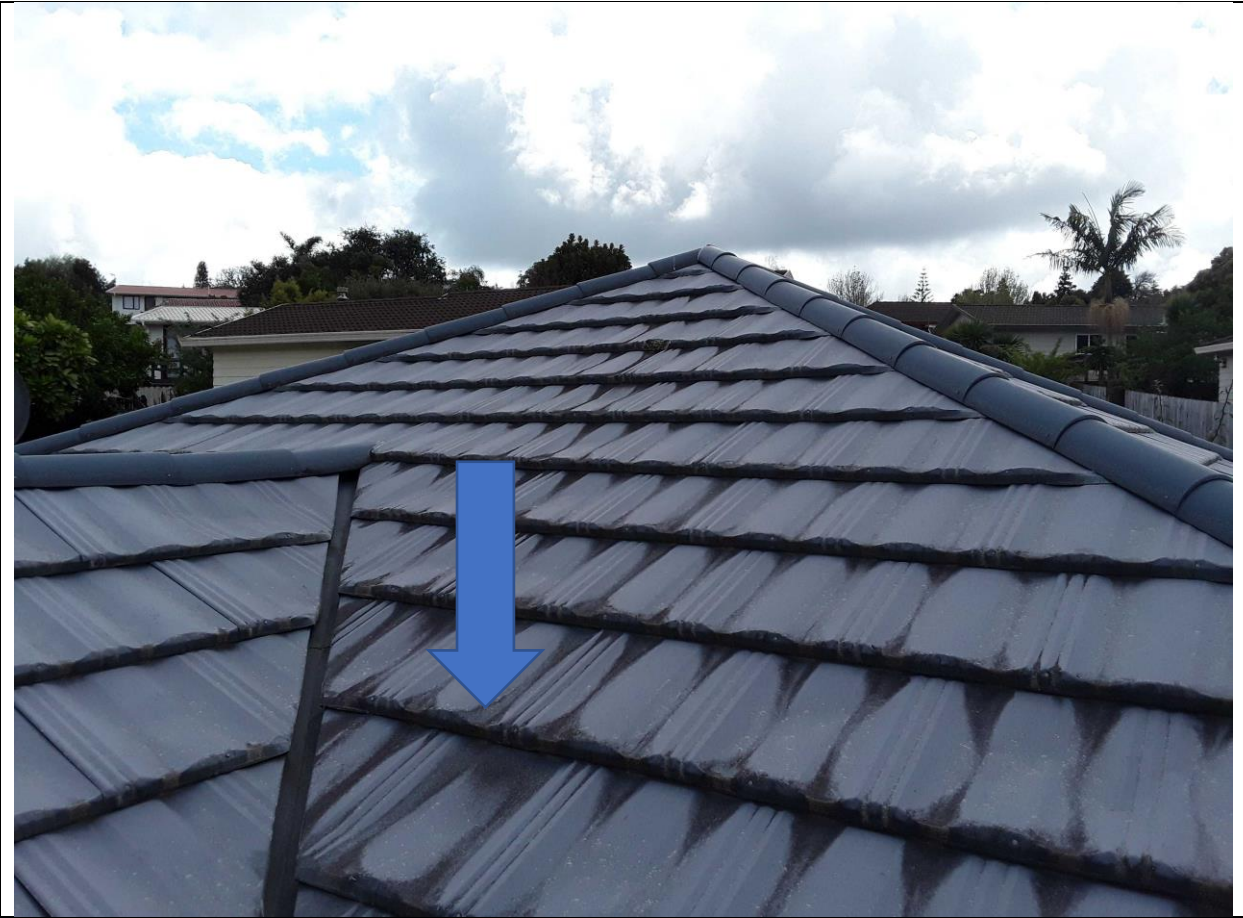
### Roof 1

Roofing Component	Condition	Notes
Roofing Condition	average	Roof was weathered and worn in many places. Moss and mould growing in many areas and there were many dents from people climbing on roof in past
Paint Coverage	poor	Heavy wear
Rust Concerns	No	
Roof Fixings	average	
Roof Flashings	average	
Roof Penetrations	good	
Signs of internal moisture	No

Blue arrow – Dirty with moss and mould growing, needs a clean

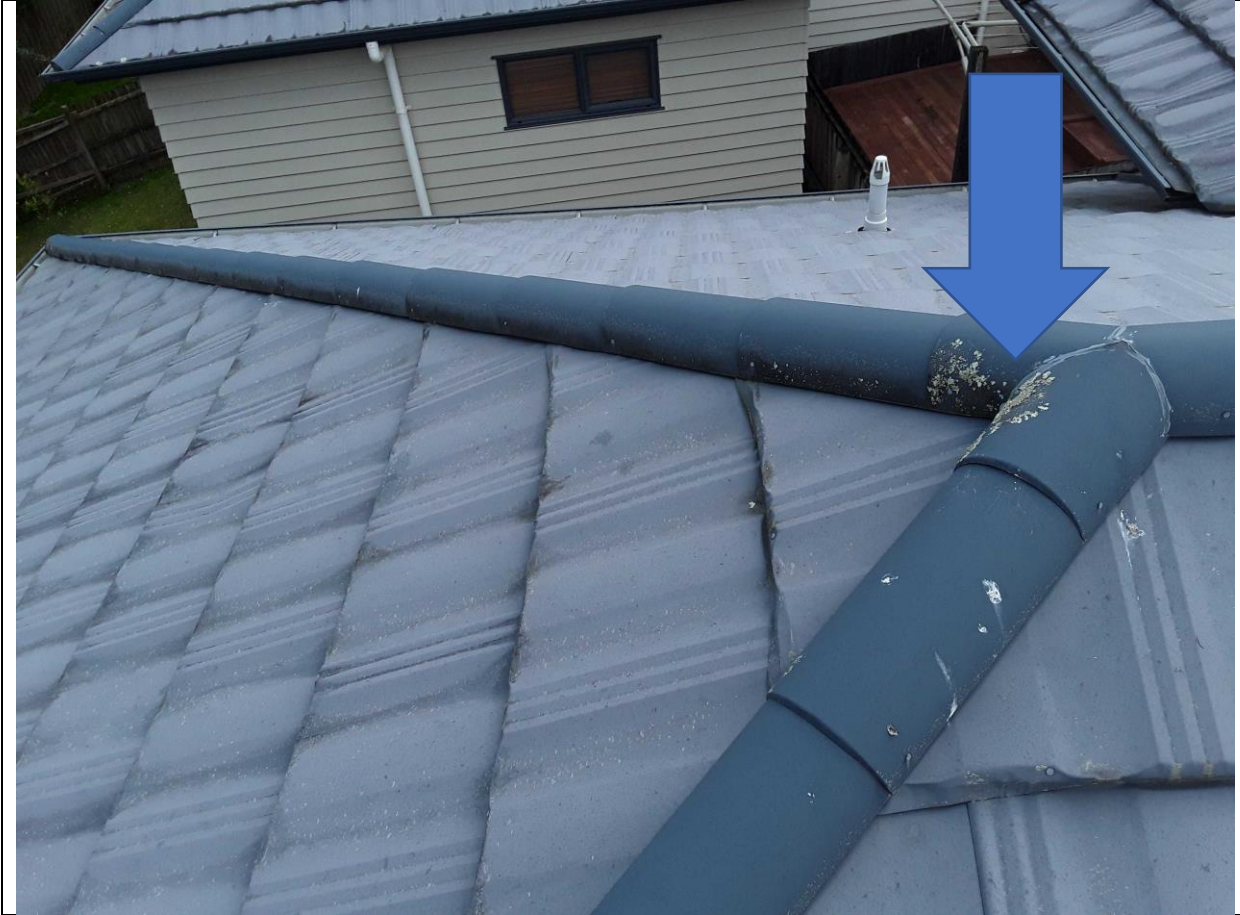
**Roof 2**

Blue arrow – Moss and mould growing

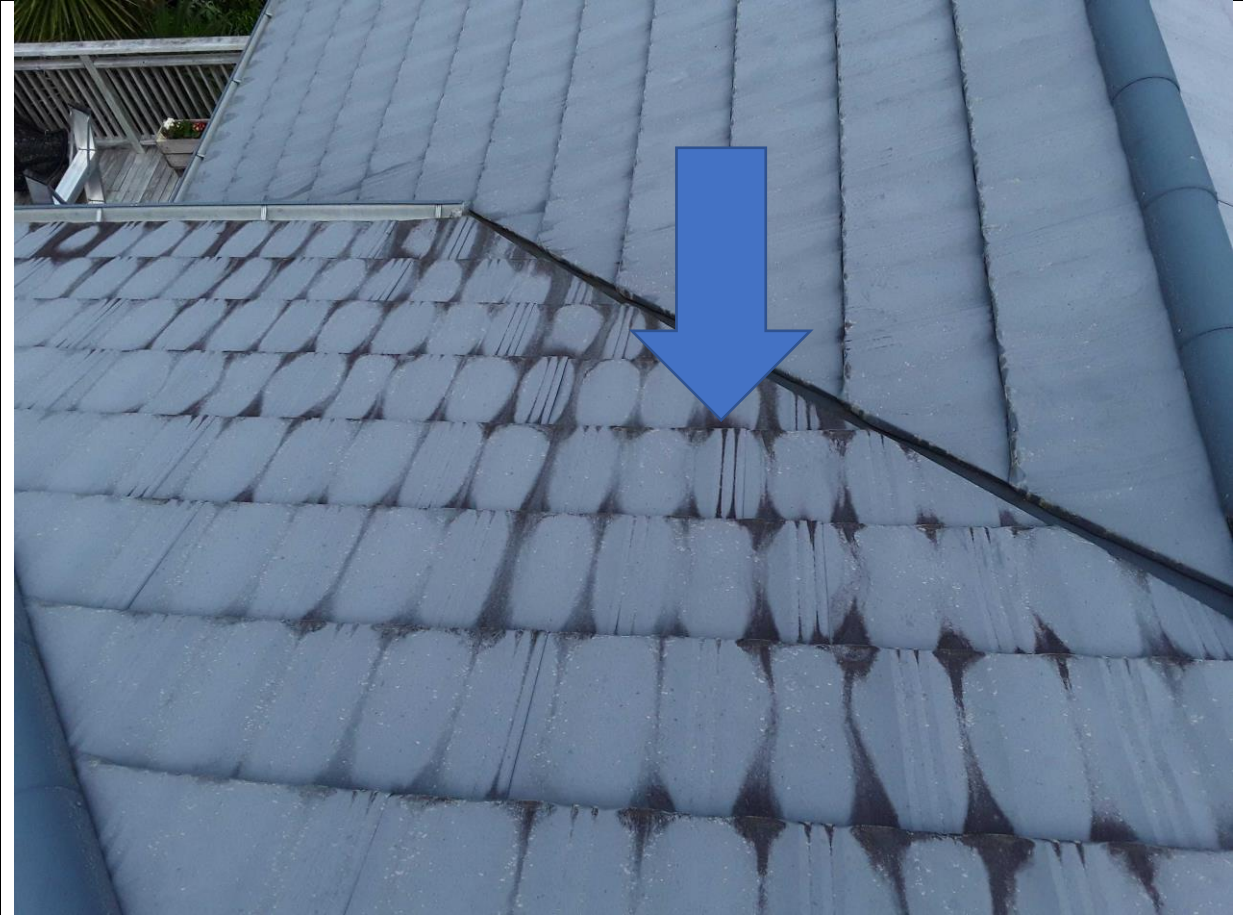
**Roof 3**

Blue arrow – Dirty

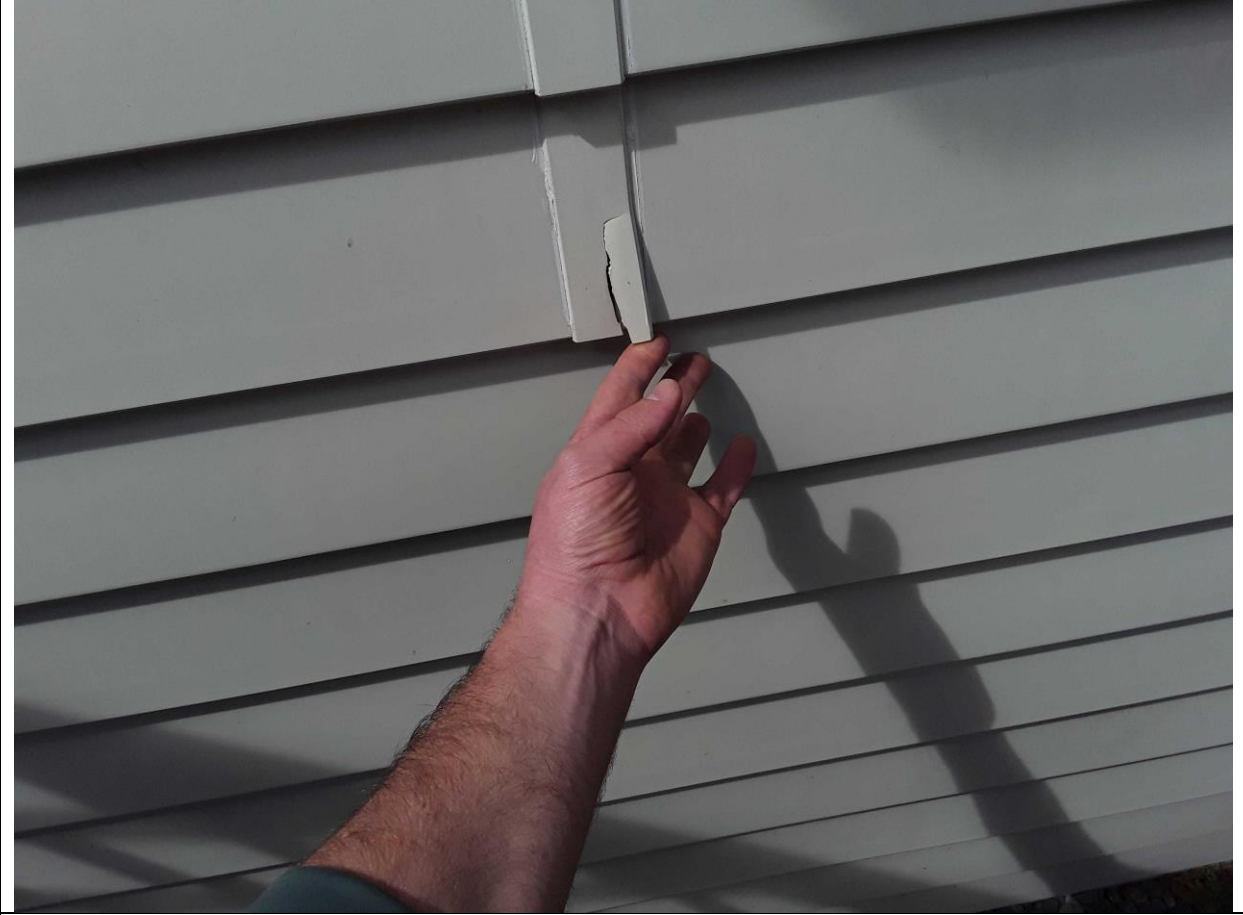
**Side 1**

Cladding Component	Condition	Notes
Cladding Condition	average	Some jointers were missing with some damaged, needed a clean but overall cleaning
Sealing or flashing of penetrations	good	
Trims, scribes and facing condition	good	
Signs of movement / subsidence	no	
Paint or stain coverage	good	
Ground clearance	good	
Fixings	good	
Cavity System	average	none in line with age of structure Top Deck
Rust concerns	no

**Broken Jointer**

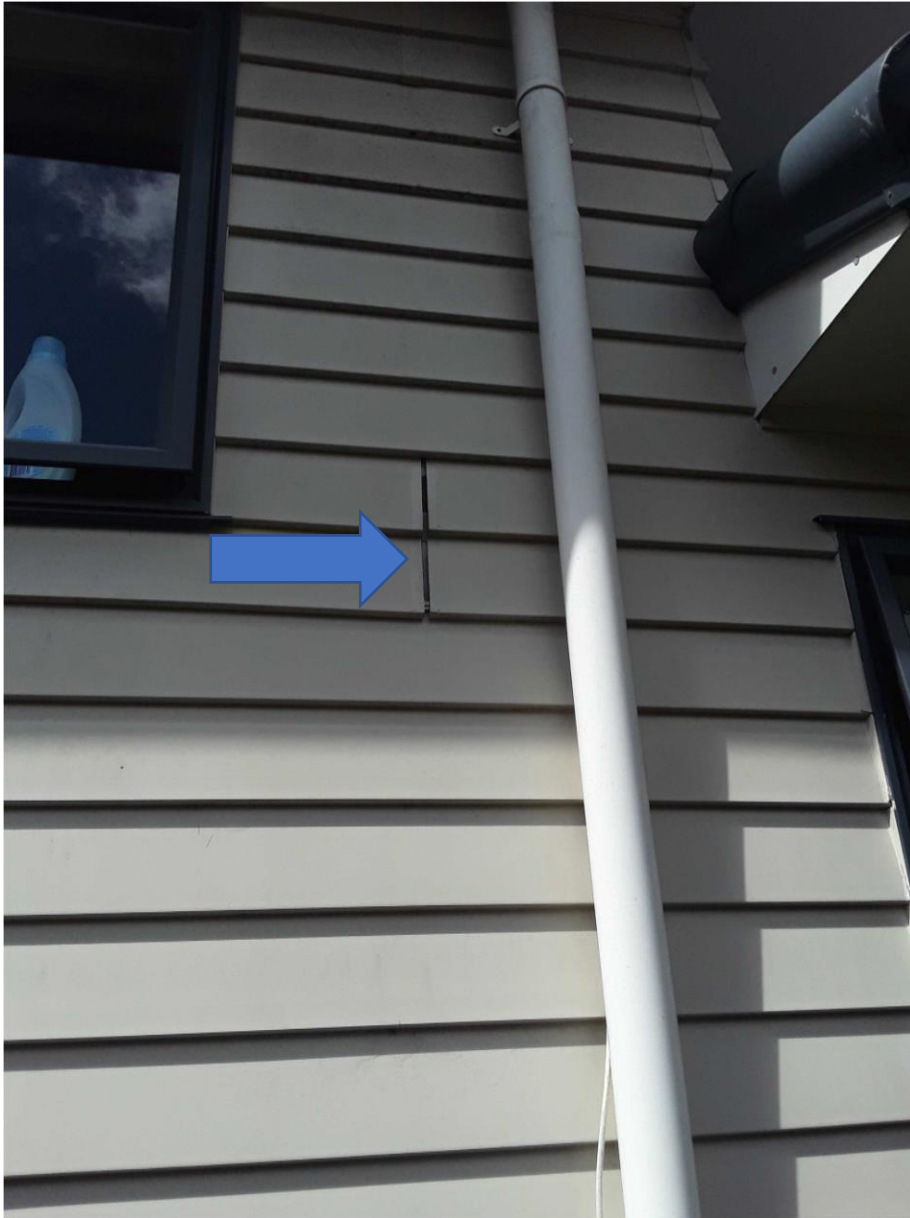
**Side 2**

Blue arrow – Missing jointer

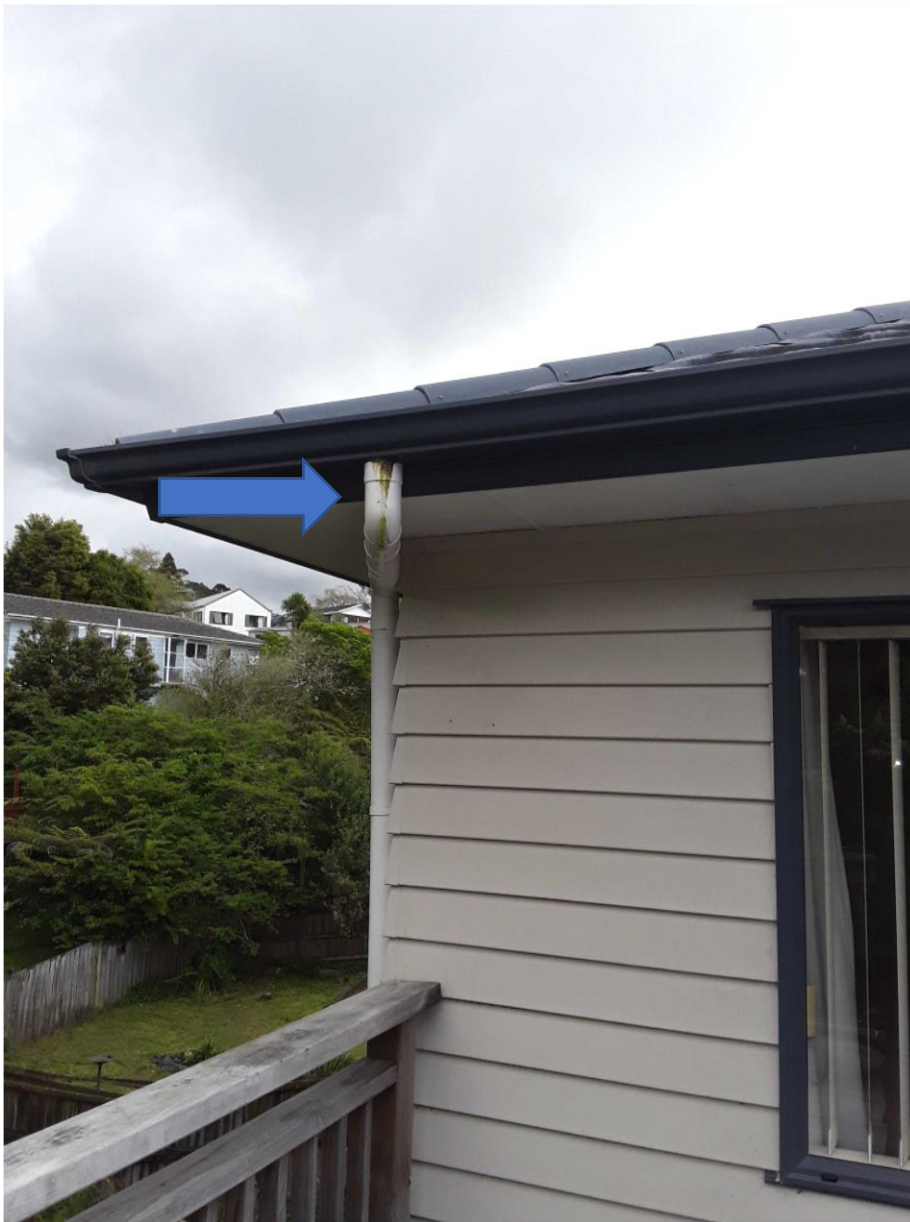
**Deck 1**

Blue arrow – Slimy down pipe

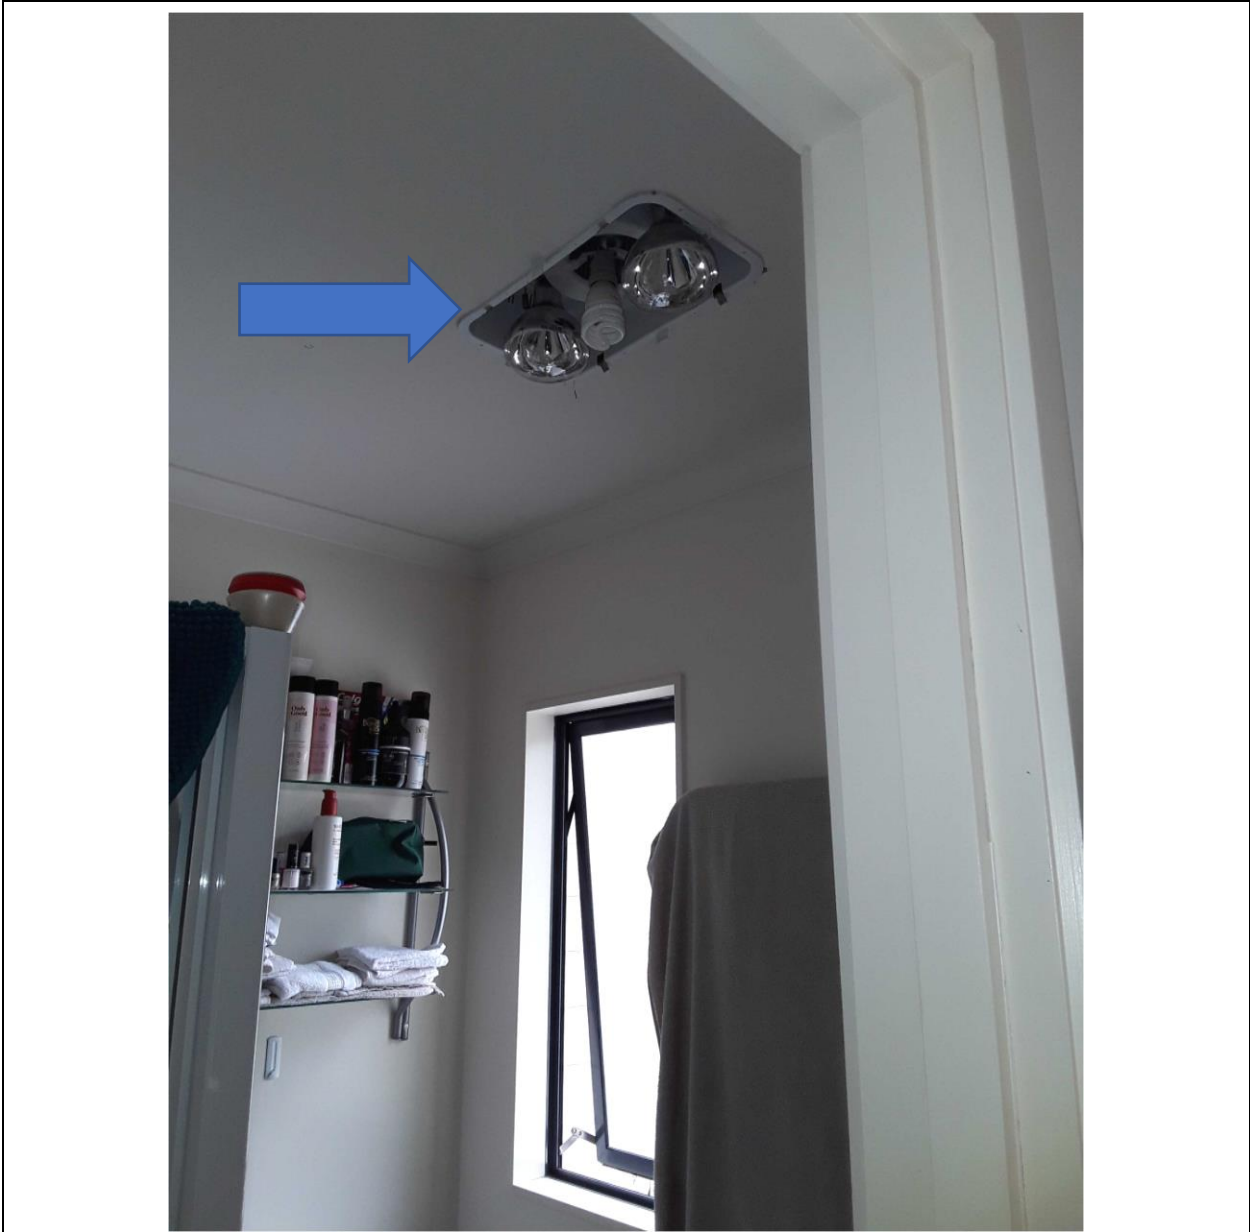
Blue arrow – Broken light mount
