Brian Marsh Property Inspection

9 Weatherdeck Close
Whitby
Wellington

**CERTIFICATE OF INSPECTION
IN ACCORDANCE WITH NZS 4306:2005**

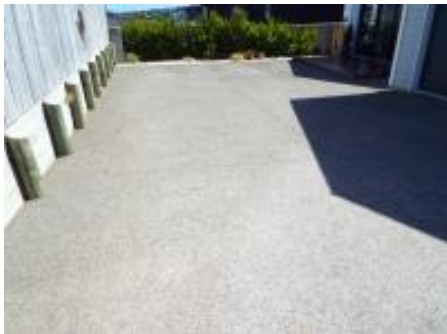
good order

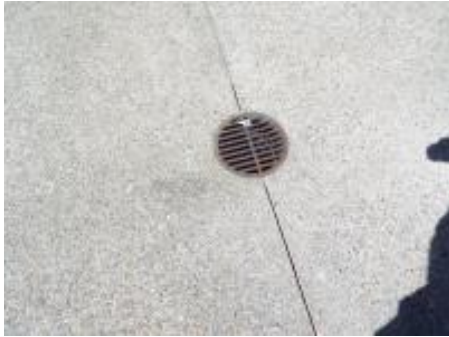
good drainage noted

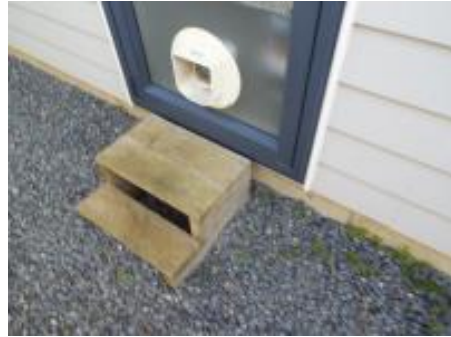
no issues

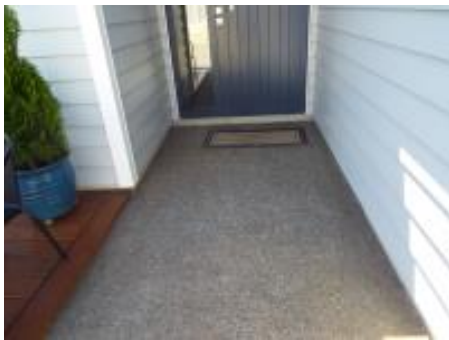
paths fine

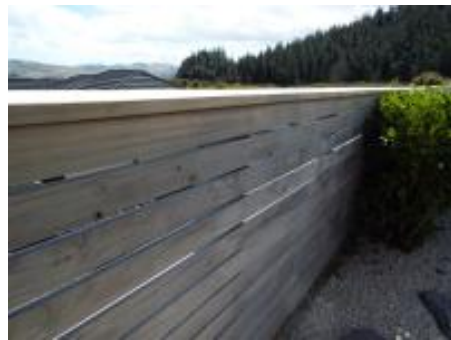
good order

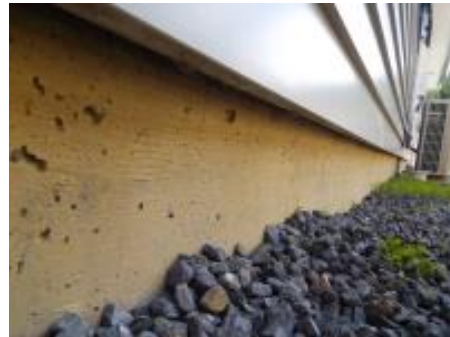
no issues

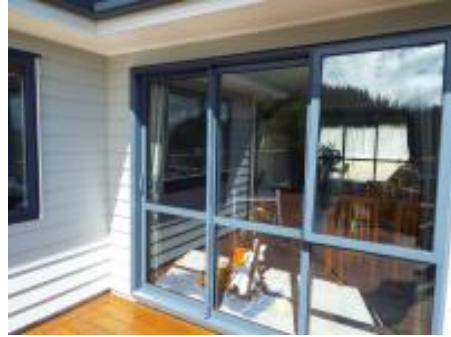
joinery in good working order

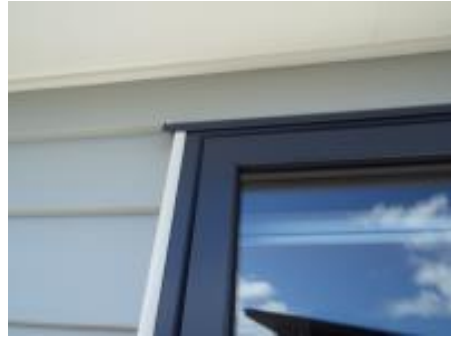
good flashing detail

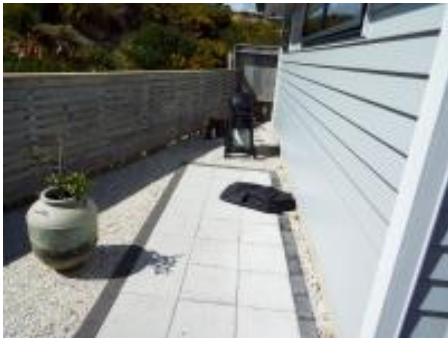
no issues

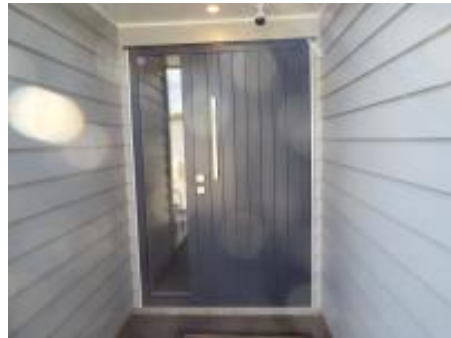
good order

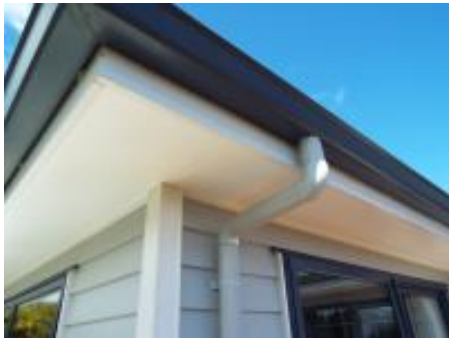
good order

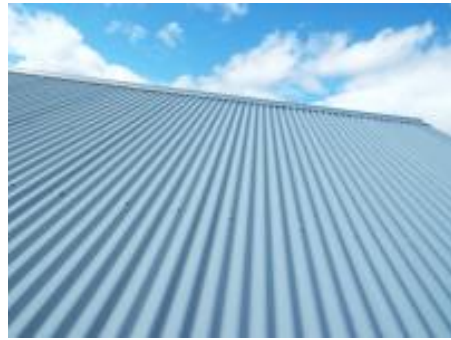
roof clean at the time of inspection

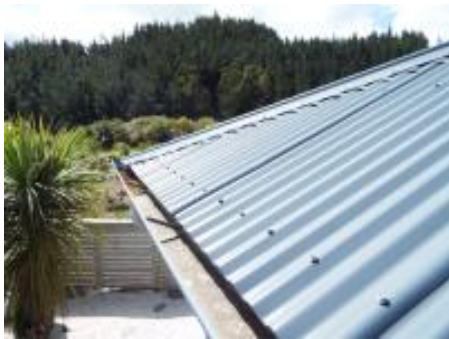
gutters clean at the time of inspection

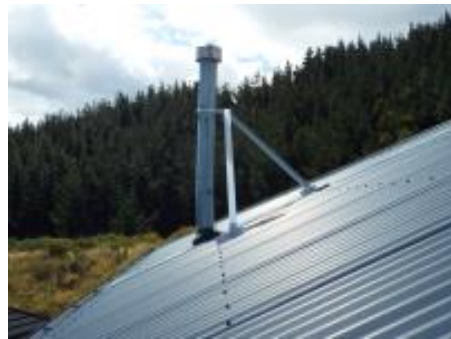
no issues

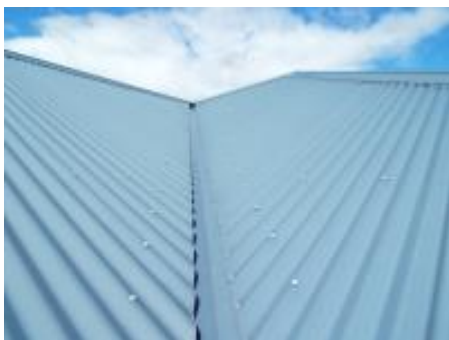
valley flashing in good order

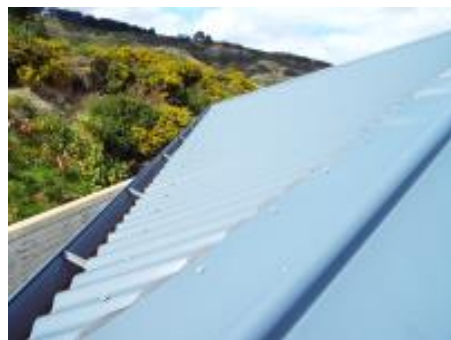
no issues

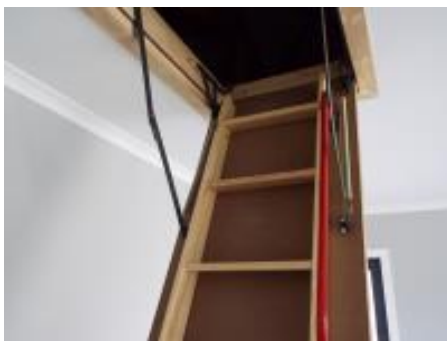
good access

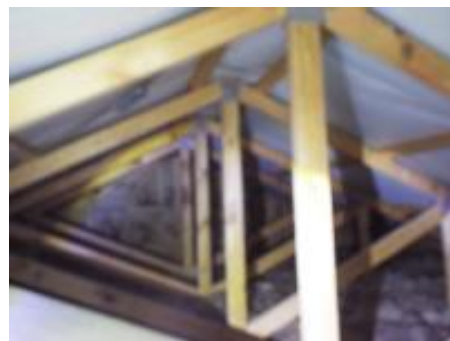
all dry at the time of inspection

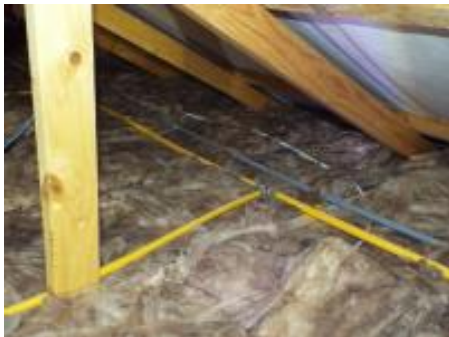
no issues with the plumbing at the time of inspection

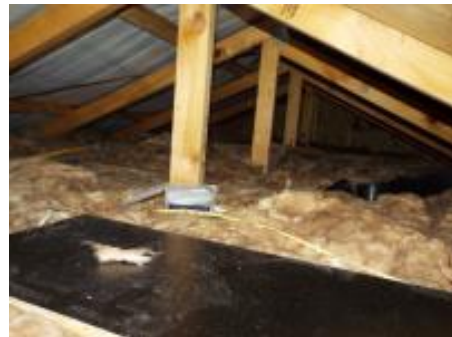
well insulated

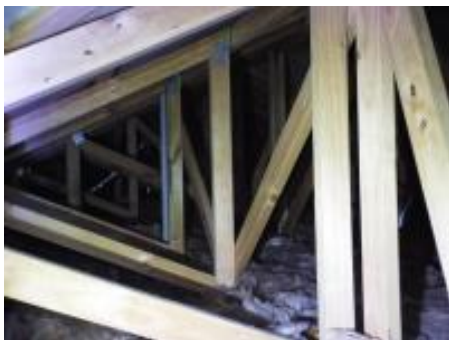
good order

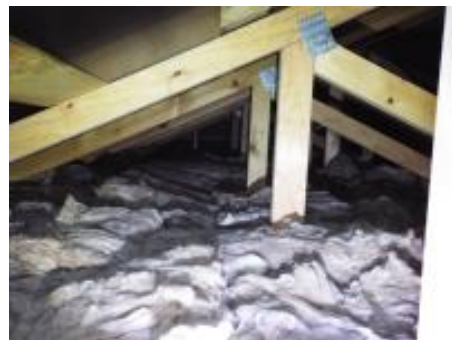
no issues

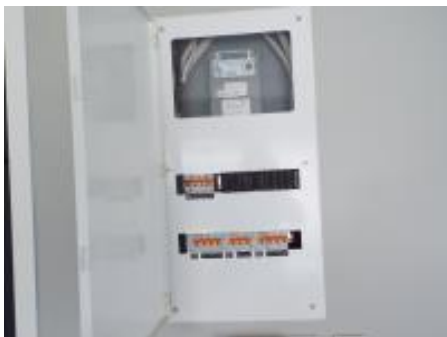
good order

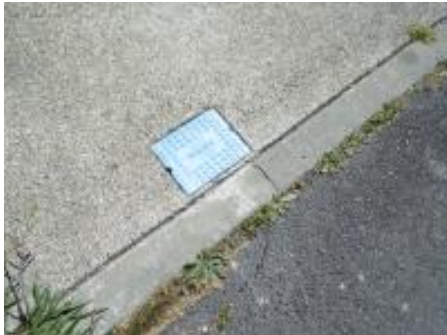
toby in front of the property

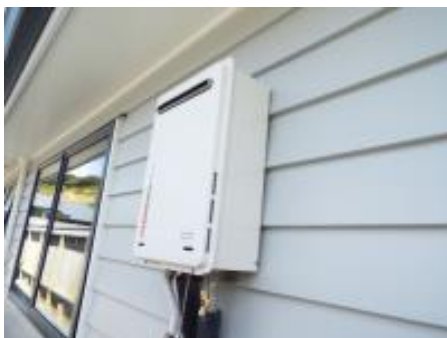
good order

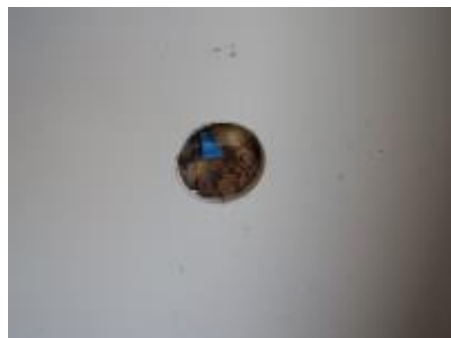
shut off valve in the garage

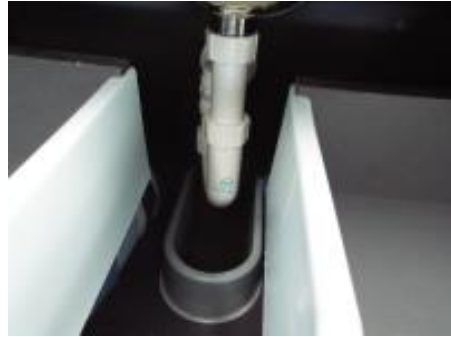
no issues

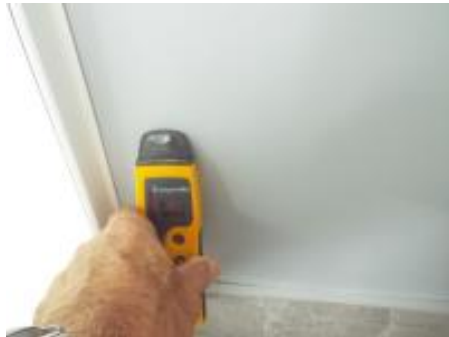
13.8%

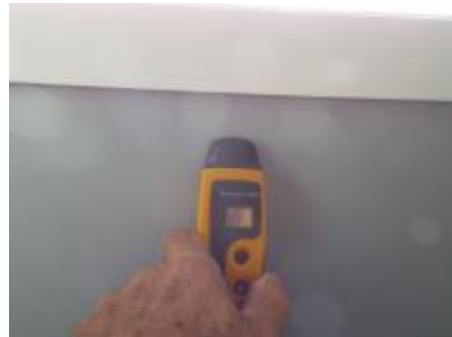
14.2%

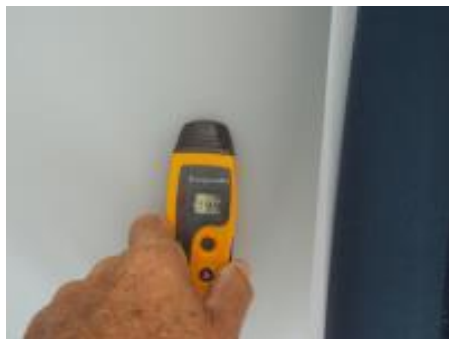
14.4%

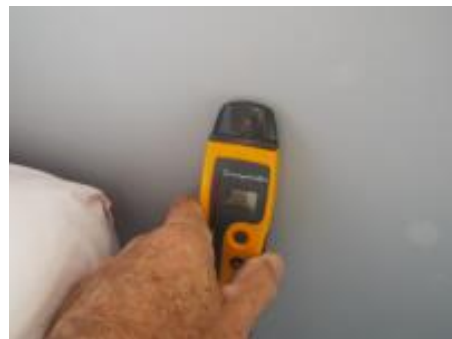
12.7%

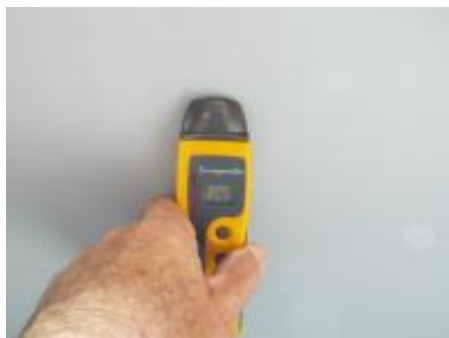
14%

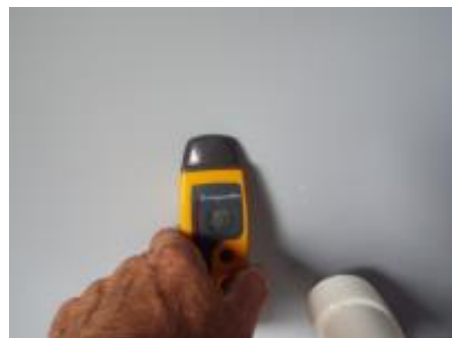
13.8%
