Property Inspection Report

**23B
Burrows Street
Tauranga**

28 May 2024

INSPECTION REPORT: for: 23B Burrows Street, Tauranga

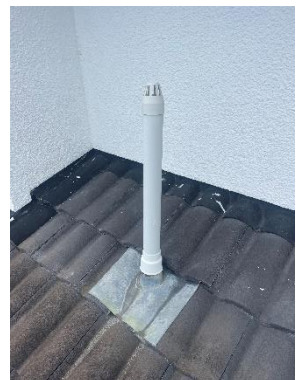
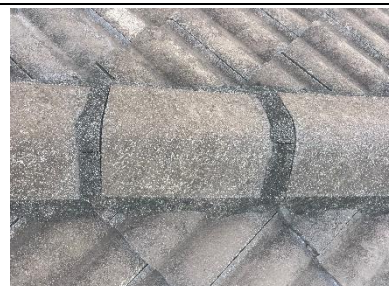
- **Type:** Concrete, Butynol.
- **Condition:** *Average*
- **Ridge & Hip Cap Condition:** *Average Repairs & Maintenance Required.*
- **Noted:** The plaster haunching is starting to crack and fall away.
- **Recommendation:** *Repair as required.*

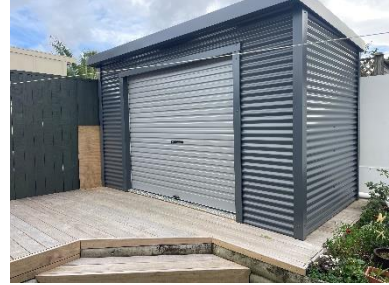
- **Type:** Colour Steel
- **Permit Required:** No
- **Noted:** The garden shed is closer than 1.5 metres to the side boundary. Neighbours consent would have been required to place it closer than 1.5 metres from the boundary.

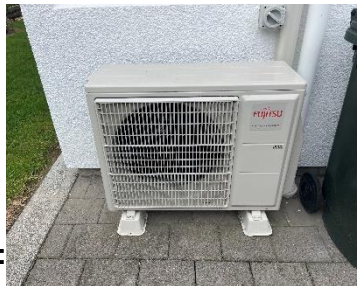
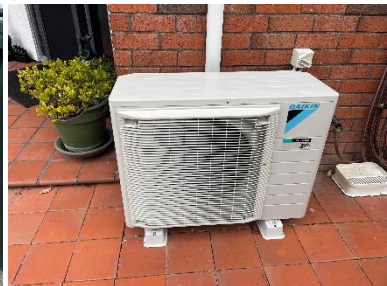
- **Type:** Two Air Conditioning Units.
- **Condition:** *Acceptable*
- **Recommendation:** *Clean and service these units prior to use. Failing to do so can affect insurance cover if heater is found to be the cause of the fire. Heater should be serviced by a qualified technician and client should be supplied with a service certificate.*

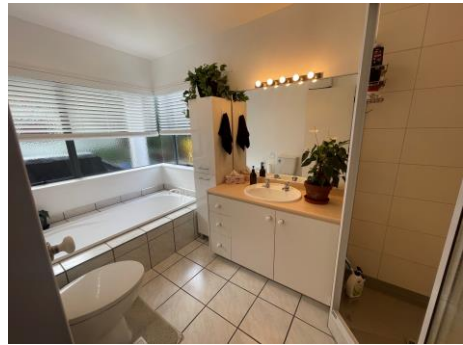
- **Plumbing:** PVC & Flexihose
- **Condition:** *Acceptable*
- **Condition of fixtures & fittings:** *Average Repairs & Maintenance Required.*
- **Shower:** Boxed Cubicle Tiled
- **Bath:** PVC
- **Door & Window Function:** *Average*
- **Noted:** There is no ceiling extractor fan fitted.
- There is a raised moisture reading in the shower tiles.
- **Recommendation:** *Fit ducting kit venting to the exterior to remove excess steam and moisture to the exterior. Although this was not a requirement at the time of construction it is recommended that this should be done.*
- *Dry out with a dehumidifier and re-seal grout lines.*
- **Moisture Reading:** 17.2% ACCEPTABLE
