**Re: Pre-Sale Report on 3 Huia Rd, Titirangi  
Job Ref: 260618**

## PRE-SALE REPORT ON THE DWELLING LOCATED AT 3 HUIA RD, TITIRANGI

**EPG REPORT REF: 260618**

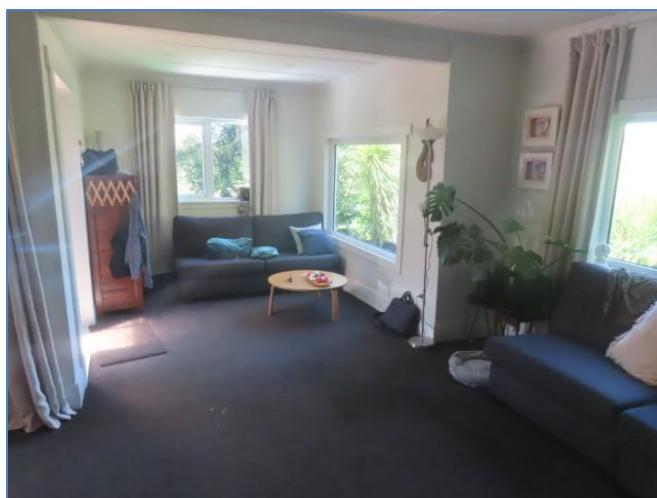
- 5.7 The lounge and dining areas are combined to provide open plan living and are located off the reception area.
- 5.8 The wall and ceiling linings appeared to be in good condition at the time of our inspection.
- 5.9 Capacitance Meter readings obtained from this area ranged from 11.6 – 15.4.

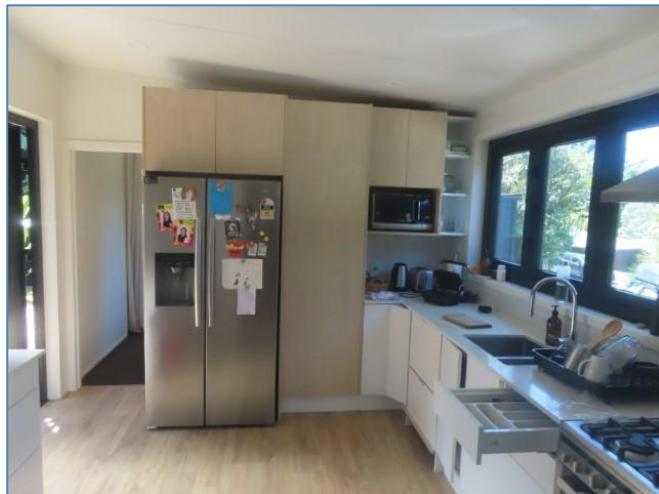
- 5.10 The kitchen consists of a 1.5 bowl, gas hob, electric oven, dishwasher, waste disposal unit, rangehood, pantry and engineered stone benchtops.
- 5.11 The floor covering to the kitchen is tongue and groove overlay which appeared to be in good condition at the time of our inspection.
- 5.12 The water pressure to all outlets is adequate.
- 5.13 The wall and ceiling linings are in good condition.
- 5.14 A set of bifold doors provides access to the deck.
- 5.15 Capacitance Meter readings obtained from this room ranged from 13.0 – 13.3.
- 5.16 *Access to all exterior walls could not be gained due to built-in units.*

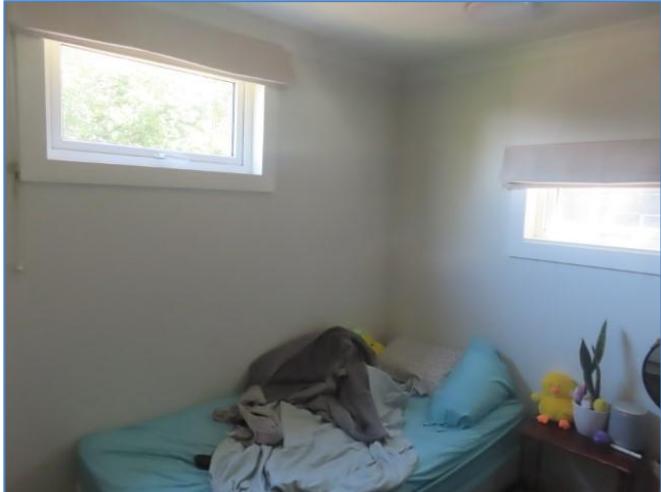
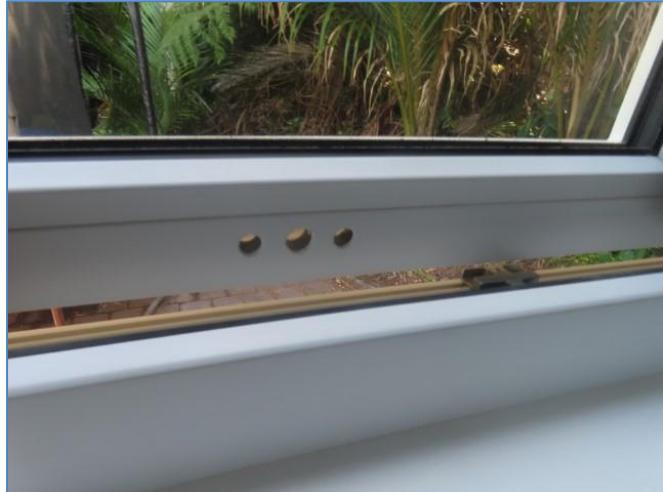
### Bedroom One

- 5.19 This bedroom is a double sized room with a single sized wardrobe installed.
- 5.20 The handle latch to the window is missing.

5.21 The bedroom door binds and need easing.

5.22 Capacitance Meter readings obtained ranged from 13.1 – 19.4.

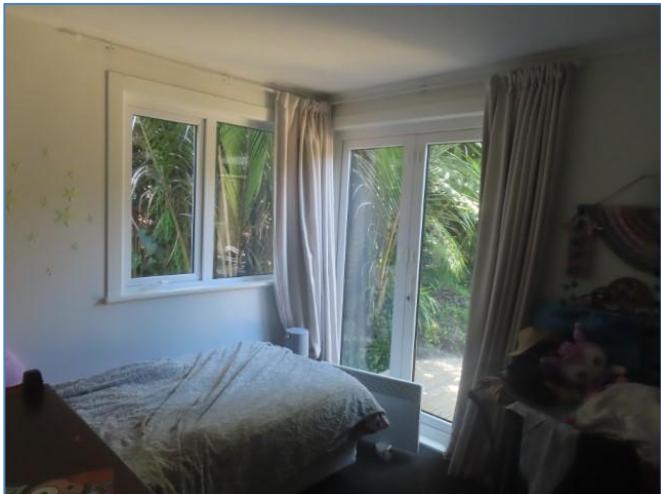
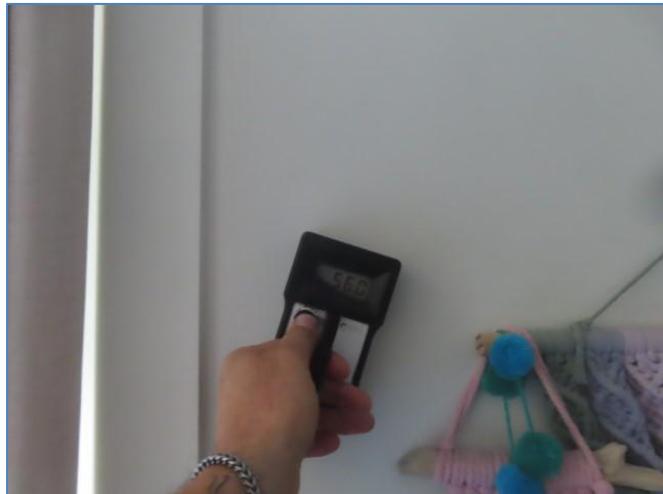
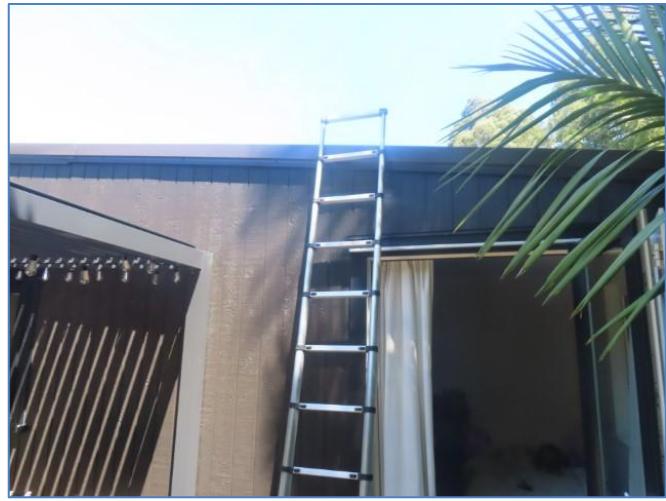
### **Bedroom Two**

5.25 Capacitance Meter readings obtained ranged from 13.9 – 56.0. Elevated reading located off the doors. No obvious point of moisture entry.

- 13.5 Apart from bedroom two, all other capacitance meter readings were of an acceptable level with no elevated readings being returned at the time that this test was undertaken. This could change with varying weather conditions. When reading this we must refer you back to sections **4.0 (Moisture Testing)** inclusive of this report. We again advise that there may be the potential for future issues, and it is very important for you to maintain this building to the highest level and address any issue as they are

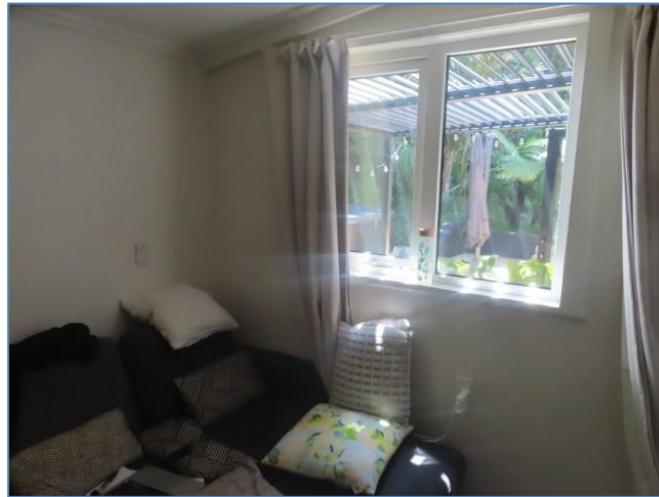
### **Bedroom Three**

5.27 Capacitance Meter readings obtained ranged from 13.4 – 16.0.

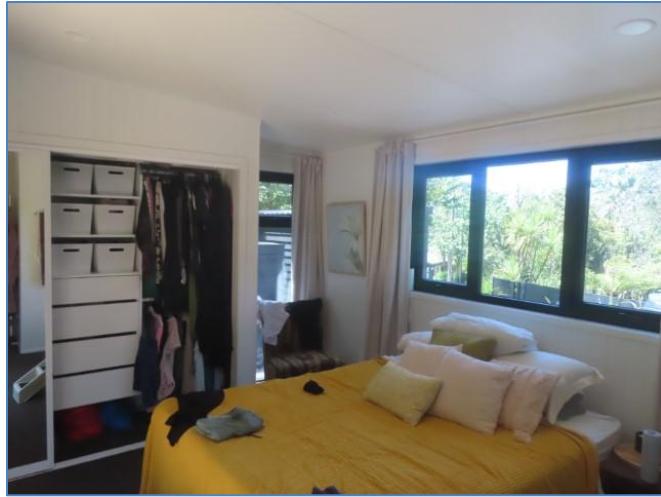
### **Master Bedroom & Ensuite**

5.29 The wall and ceiling linings are in good condition.

5.31 Capacitance Meter readings obtained ranged from 11.5 – 13.0.

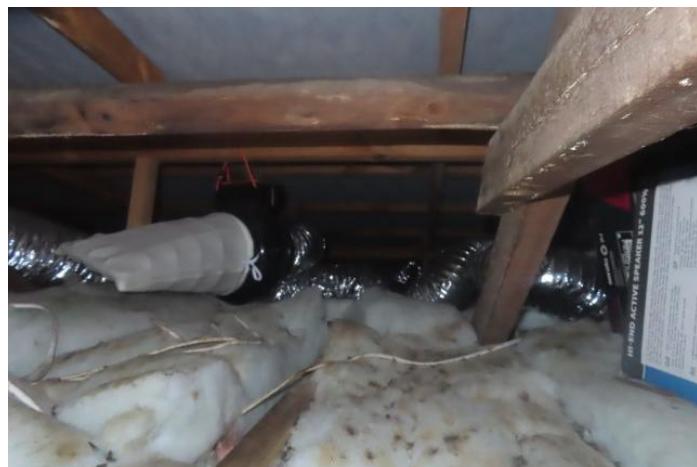
### **Ceiling Space**

5.45 The ceiling space is sound, clean, dry and insulated with polyester and fibreglass. The insulation materials appeared to be in good condition at the time of our inspection.

5.46 A home ventilation system has been installed.

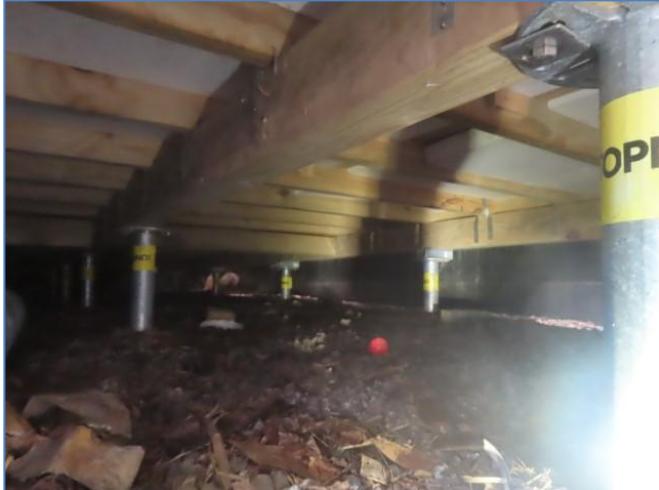
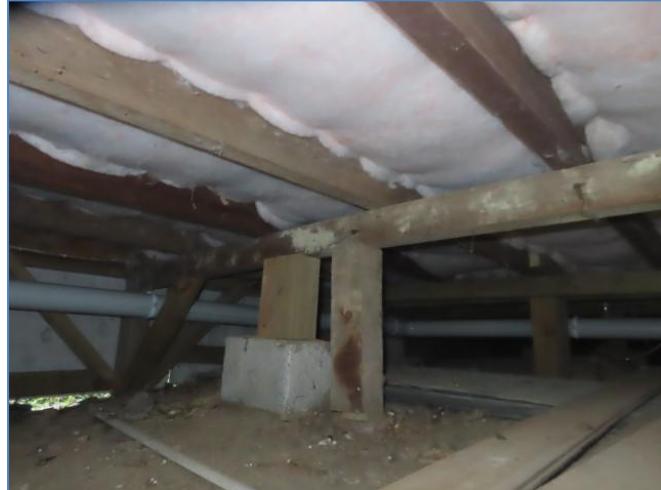
7.1 These foundations are of precast foundation blocks, 125x125 senton piles and screw piles. These foundation blocks support 100x75 jackstuds, 2 x 150x50 and 100x75 bearers and 150x50 floor joists.

7.2 The ground within this area was dry with no evidence of insect infestation was sighted and had adequate ventilation provided at the time of this inspection.

7.3 There is adequate clearance between the subfloor framing and the ground.

7.4 There is under floor insulation provided. This prevents a visual inspection of the flooring.

7.5 With older houses on original foundations it is common for floor levels to undulate. We therefore recommend that if the client looks to renovate etc. in the future that these foundations be assessed further and addressed where necessary if required. **LEAVE IN FOR PROOFER**

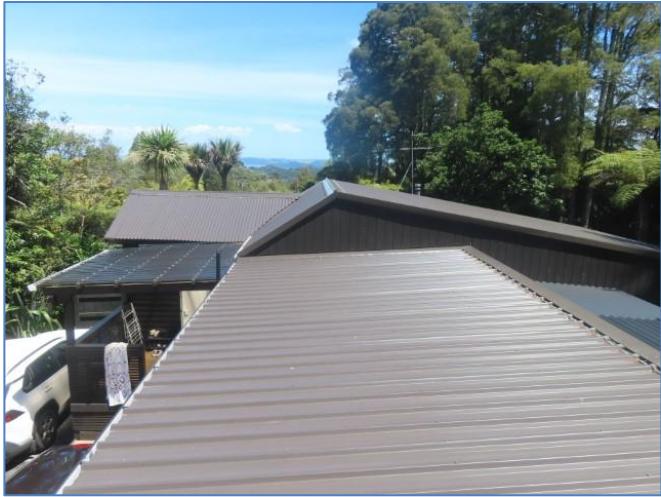
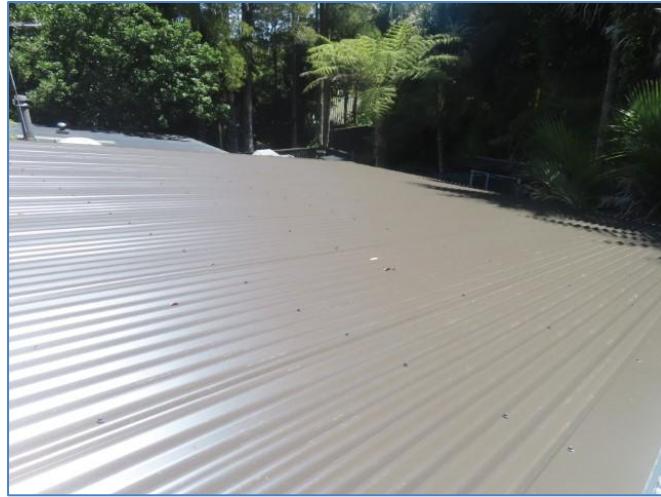
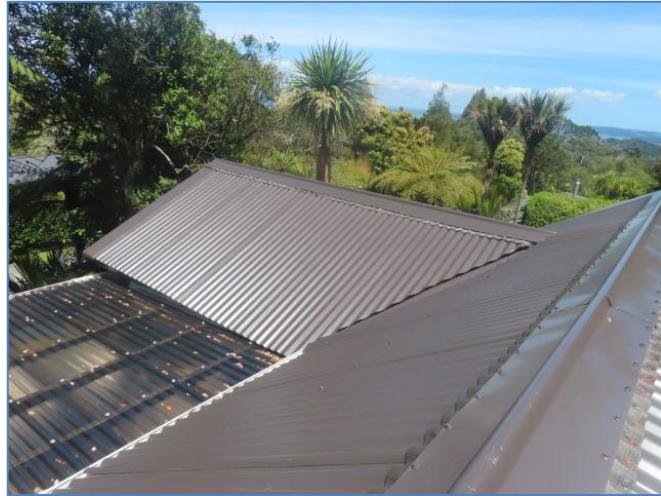
9.1 The roof is a gable and monopitch and valley roof clad with longrun corrugated and trapezoidal coloursteel and appeared to be in good condition at the time of our inspection.

9.2 The spouting is PVC with PVC downpipes all of which appeared to be in good condition at the time of our inspection.

9.4 The valley flashings appeared to be in good condition at the time of our inspection. This opinion only extends to the portion of the flashing that is visible.

9.3 The spouting requires regular cleaning of debris to ensure correct operation.

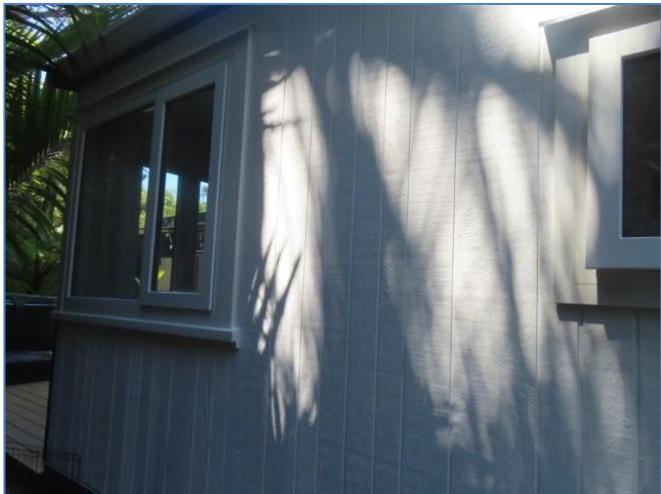
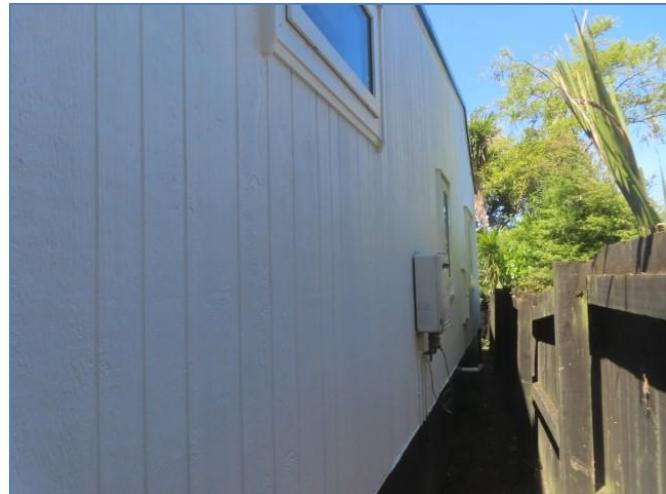
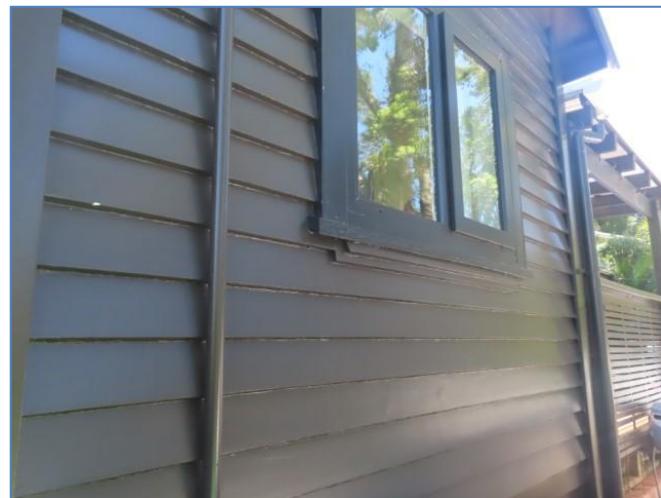
- 10.1 The exterior cladding to this dwelling is bevel backed weatherboards and weathertex sheet cladding direct fixed to the framing and on a drained and ventilated cavity system.
- 10.2 The weatherboards themselves appeared in sound condition at the time of this inspection.
- 10.3 The paint finish is in fair condition; *A good condition to exterior finish will provide the required level of protection provided the finish is kept clean and free of grime.*
- 10.4 The exterior ground levels in relation to floor level and base does comply with the requirements of the NZ Building Code. *The minimum requirements are 150mm from the top of the floor down to the ground for paved surfaces and 225mm for unpaved*

surfaces. Monitoring and maintaining these areas will be required. Insufficient ground clearance presents a risk as the accumulation of ground water and the ability for water splash which can result in moisture ingress through wicking. Wicking is the term used to describe water being drawn up into building elements by capillary action. Some cladding materials are absorbent and this action can result in damage. The other issue is that the cladding must overlap the top of the floor level by 50mm. If the ground levels are too high then the cladding will be too close to the ground and in the case of weatherboards excessive continual moisture can result in timber decay. It is important that these clearances are maintained.

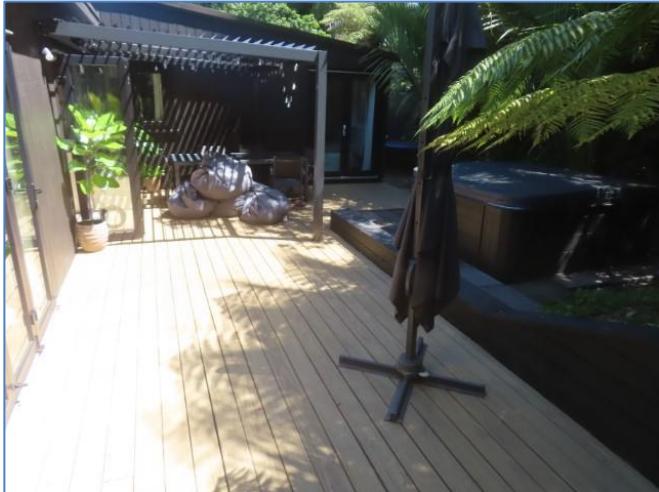
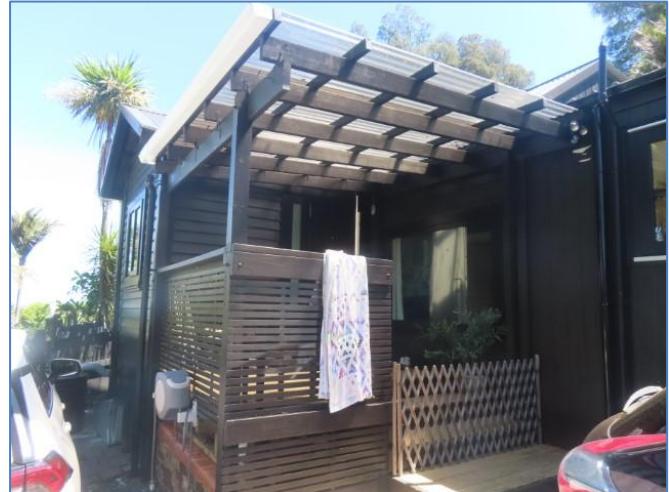
- 11.1 There is a timber deck: This is located off the front and rear of the dwelling and in general appeared to be in good condition at the time of our inspection.
- 11.2 Construction is of timber frame subfloor structure with timber decking.
- 11.3 Hook up spouting to the covered pergola.

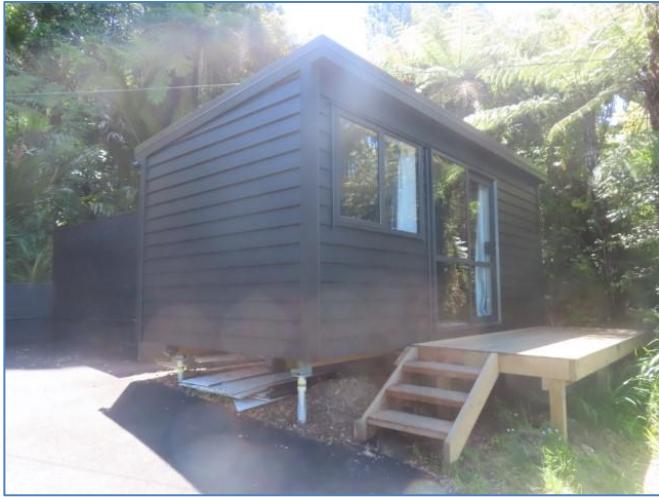
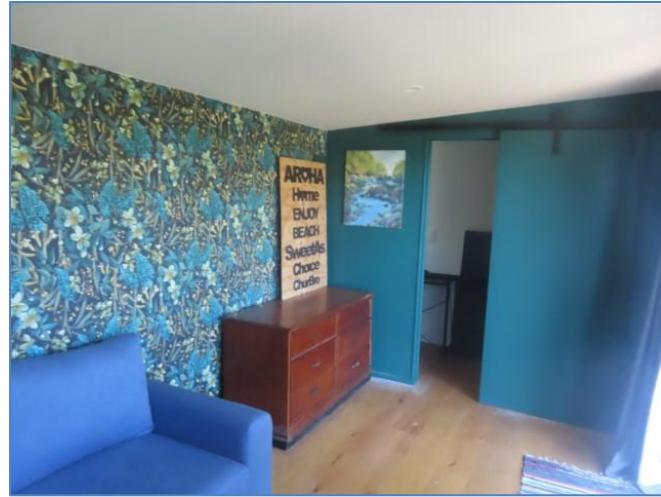
- 12.1 All paved areas that surround the dwelling are in good condition.

- 12.2 These areas appear to be functioning with no signs of ponding evident.

- 12.3 Fences around the dwelling appear in fair condition.

- 12.4 This is a freestanding sleepout and is of timber frame construction and appeared in sound condition at the time of inspection.
