Residential Apartment Inspection Report

41e Tawa Street MT MAUNGANUI

Date of inspection: 22 March 2021

Type of inspection: Pre-purchase Residential Apartment Inspection

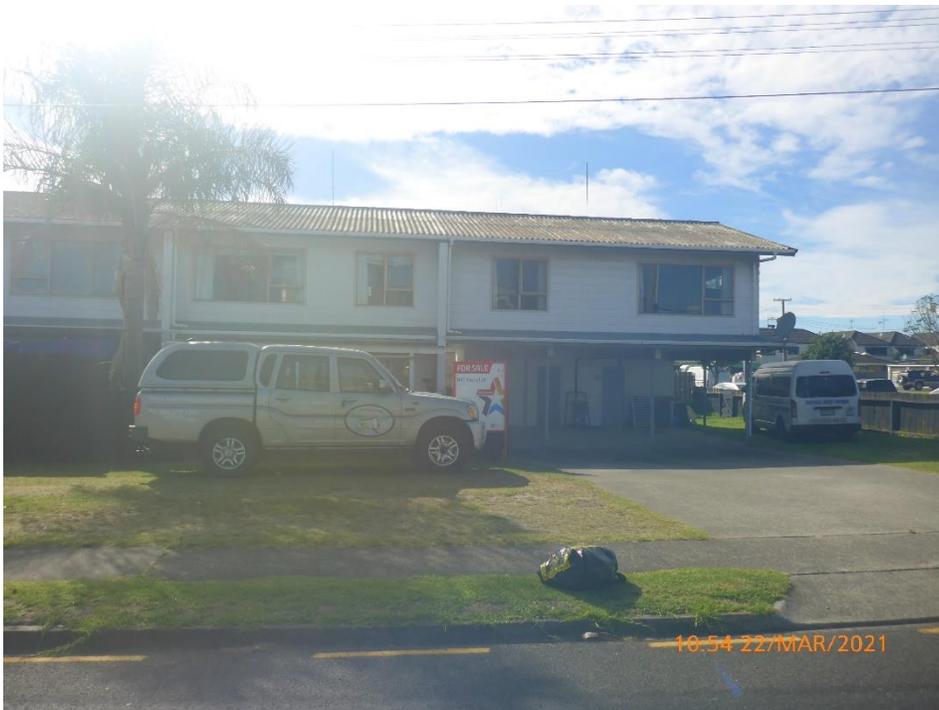
Site	Significant	Minor	No Fault	Not applicable	Comments
			✓		The site is relatively flat with a slight fall towards the road. The fences are in a good condition for their age. Clarification needs to be sought regarding responsibility when fences may need repairs or replacement.

A1. Flat site with slight gradient towards the road.

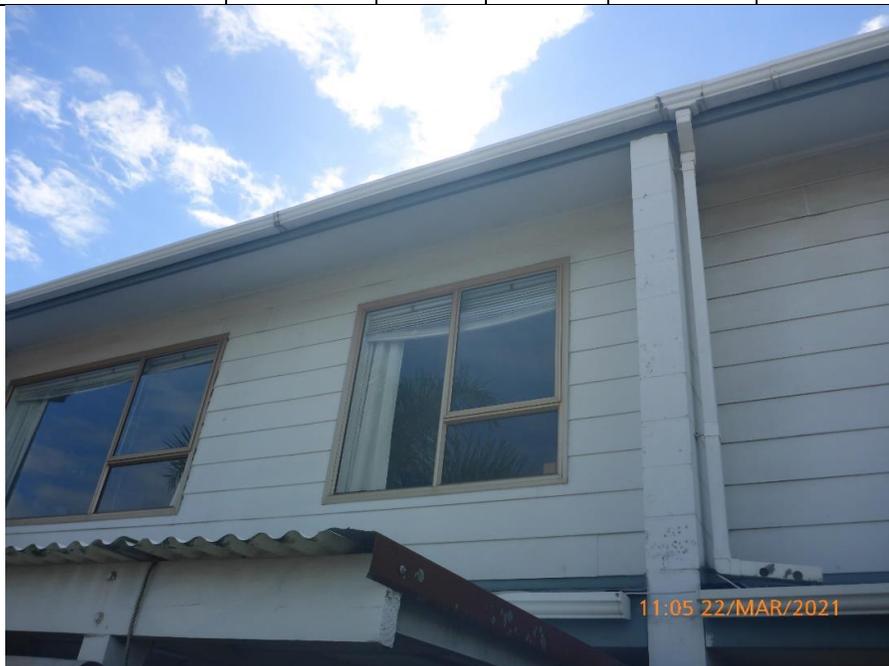
B1. The cladding consists of Hardie weather boards. It is suspected these weather boards may contain asbestos.

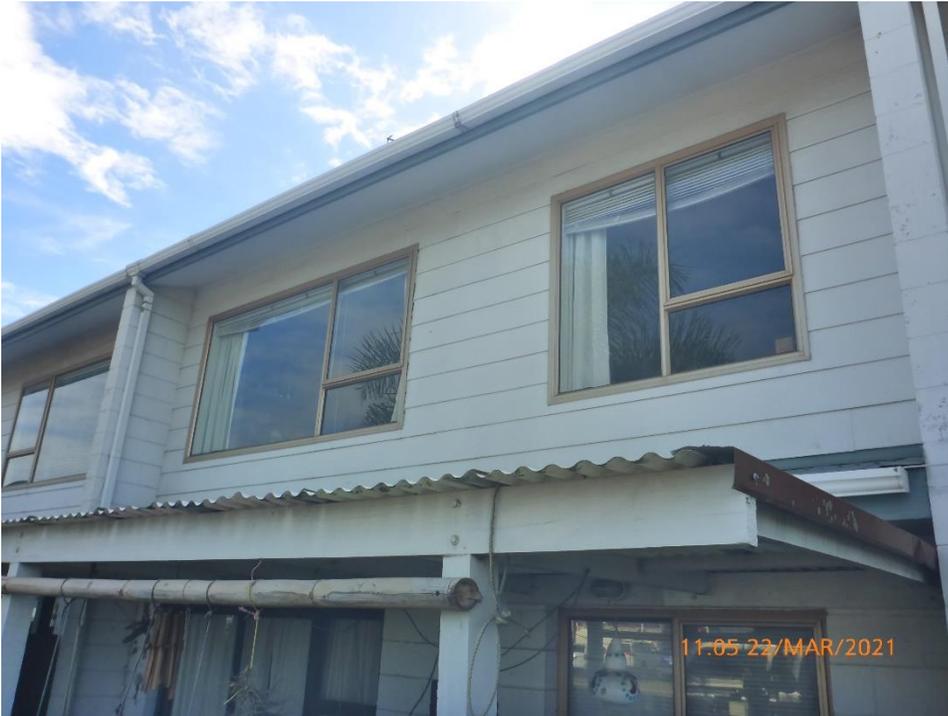
B2. The eaves protect the upper edges of the windows against weather conditions. It is suspected due to the age of the materials, that the eave boards may contain asbestos particles.

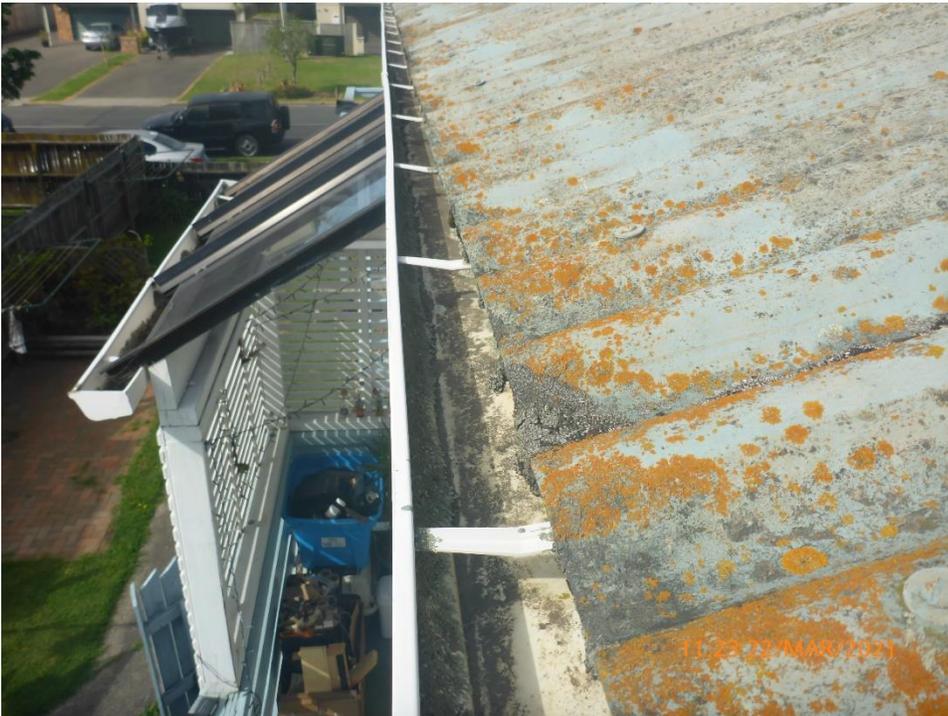
B3. The gutter of the unit was relatively clean on the day of the inspection.

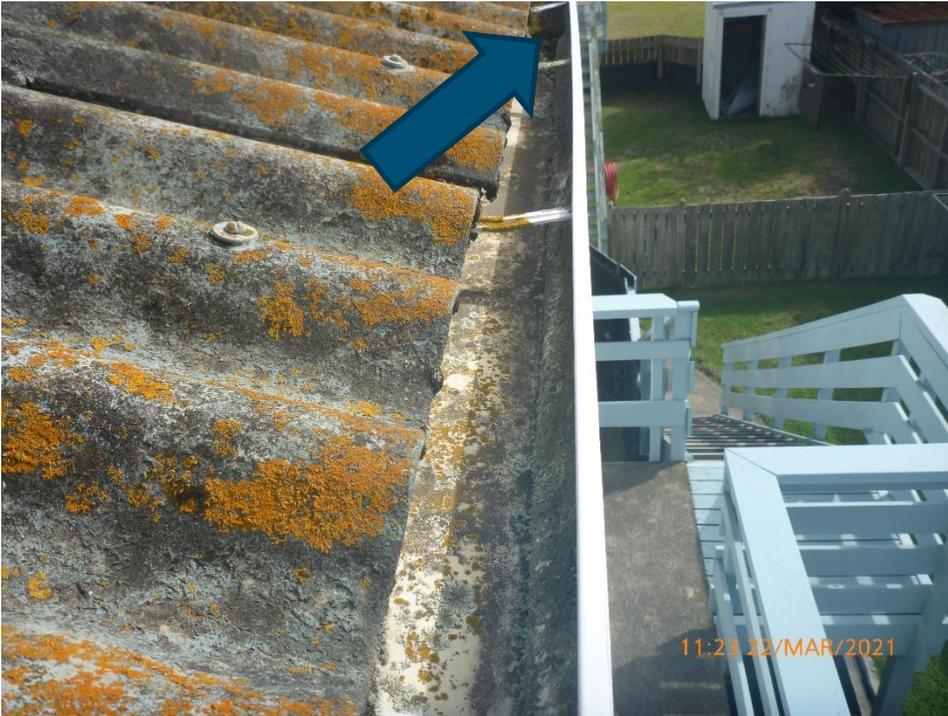
B4. The gutter of the neighboring unit had moss growth present. Moss growth will prevent water draining properly and can cause the gutters to flood. Cleaning of gutters should be performed by all parties on a regular bases.

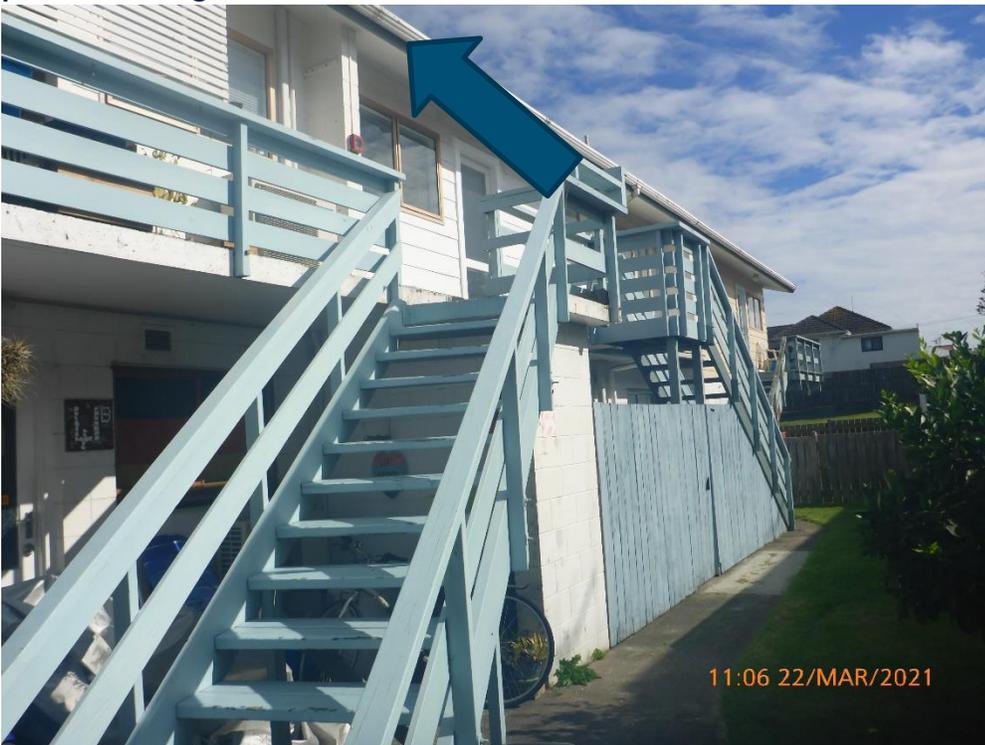
B5. The gutter has a crack. PVC gutters become brittle with aging. It is recommended to budget for replacement of the gutters within the next 3 to 5 years.

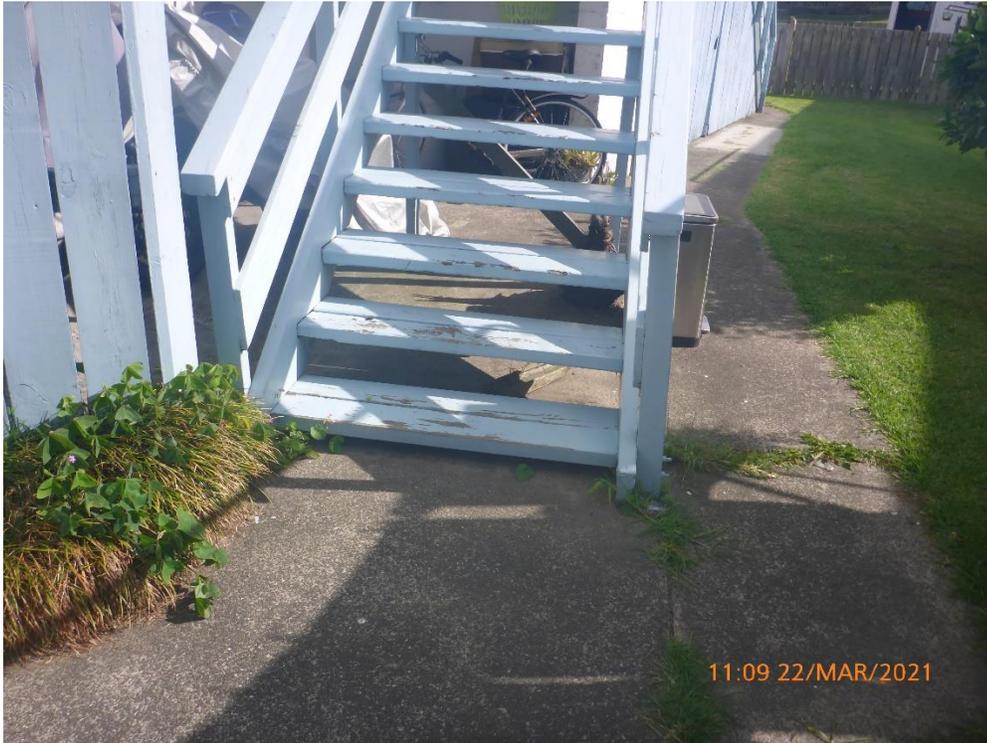
B6. All staircase risers should be the same height to prevent accidental trips and falls. The bottom riser is around half in height than the other risers.

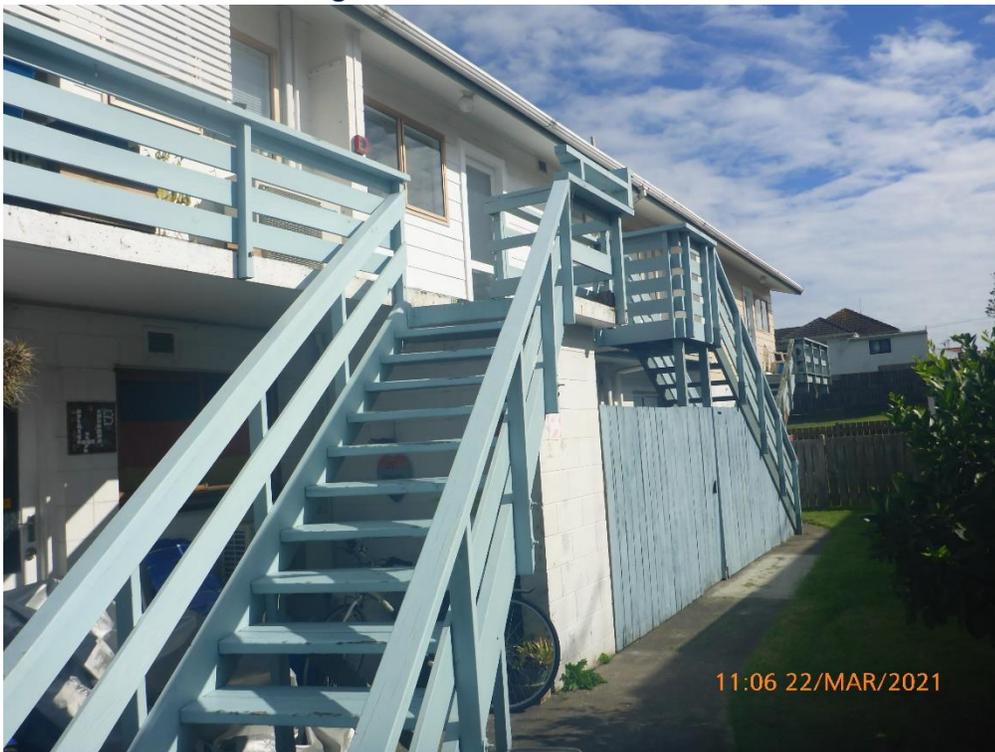
Stair case	✓				Although the staircase was constructed to the regulations of the time, these regulations are out dated by current the health and safety standards. The structure also have sign of decay. The recommendation would be to reconstruct the stair case to the building code and health and safety regulations.
Deck Barriers	✓				Although the deck barriers were constructed to the regulations of the time, these regulations are out dated and to not meet current health and safety standards. The recommendation would be to reconstruct the deck to the current building code and health and safety regulations.
Roof		✓			The roof cladding is a corrugated fiber cement material. It is suspected the material contains asbestos particles. The roof sheets are in a good condition for their age. The roof is painted, but has lots of moss and lichen growth visible. It is recommended to treat the roof with a moss remover.

B7. The stairs are moving, some wood rot was noticed in the support beam and nail are popping. Although the stairs might be constructed to the regulations of the time, the supporting post will not meet current standards. Comparing with current standards, the staircase will be considered a safety hazard. It is recommended to get a quote from a builder, deck builder or a carpenter to remove and reconstruct the stair case.

- The exterior of the building need some repairs and maintenance.
- The staircase and the barriers to the deck are dated and current regulations will not be met. It is recommended to obtain a quotation and replace the staircase and barriers as soon as possible for safety reasons.
- The dirt accumulation under the eaves could be water blasted.
- The gutter is in a stage where it is becoming brittle and may need replacement in 3 to 5 years. Gutters should be kept clean as regular maintenance on the property.
- Fences are in a good condition for their age. The owners should get clarity on the responsibility they have toward maintenance of the fence.

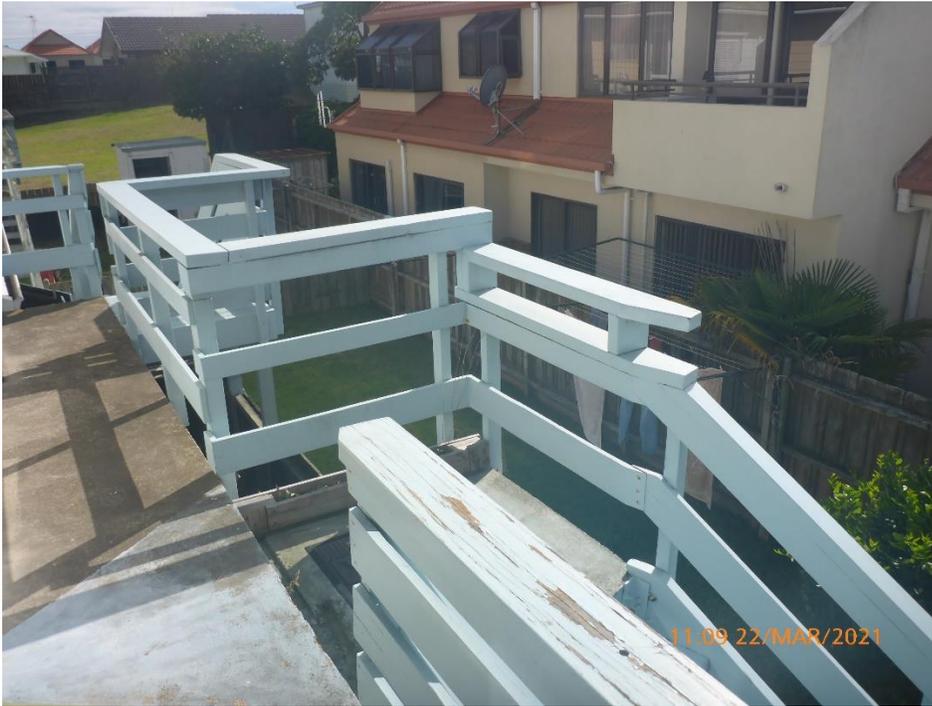
B8. Although the barriers may have been constructed to the regulations of the time, the barriers are not safe to children. As the stairs and barriers are communal area shared with the other cross lease holders, the recommendation is to replace the barriers to current regulations to prevent any accidental falls. A quote should be obtained from a builder, deck builder or a carpenter to ensure all the barriers meet current specifications.

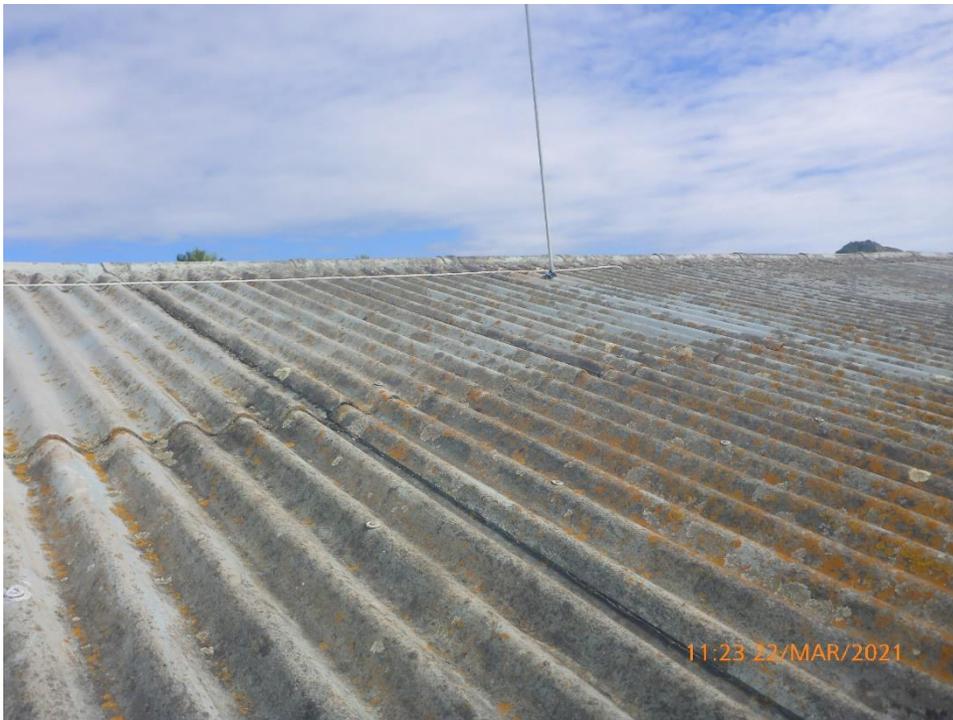
B9. The roof cladding is a corrugated fiber cement material. It is suspected that the material contains asbestos particles. The roof sheets are in a good condition for their age. The roof is painted, but has lots of moss and lichen growth visible. It is recommended to treat the roof with a moss remover.

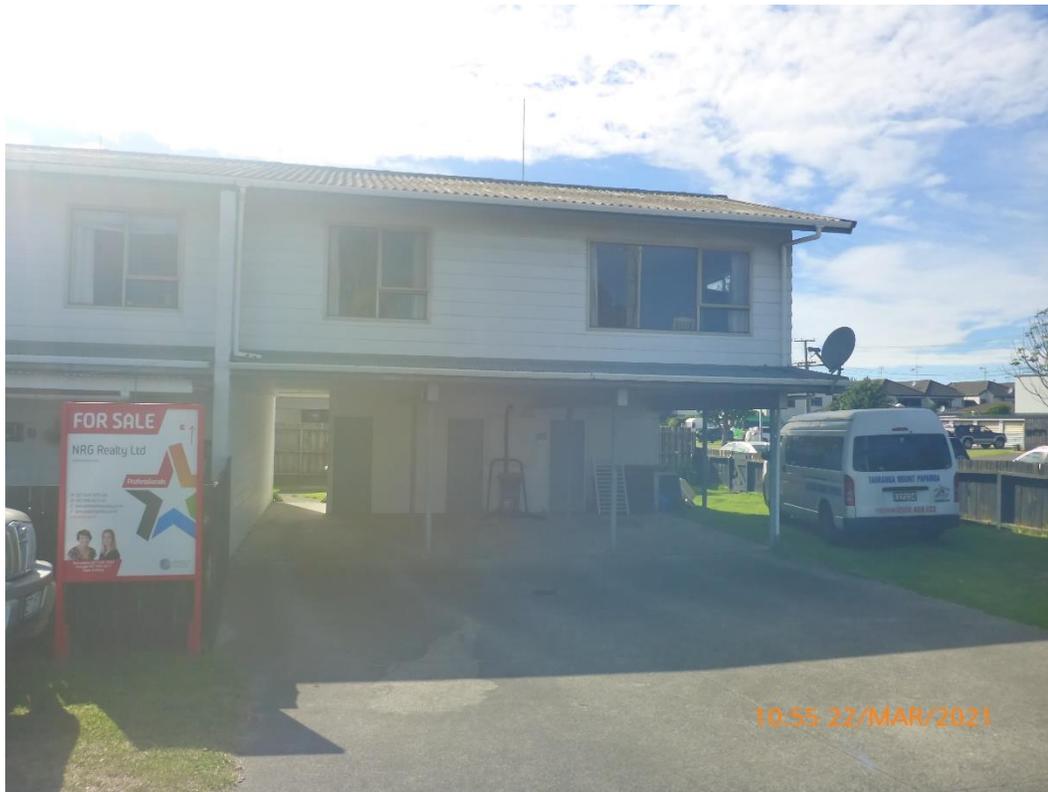
C1. The carport in the middle belongs to Apartment E

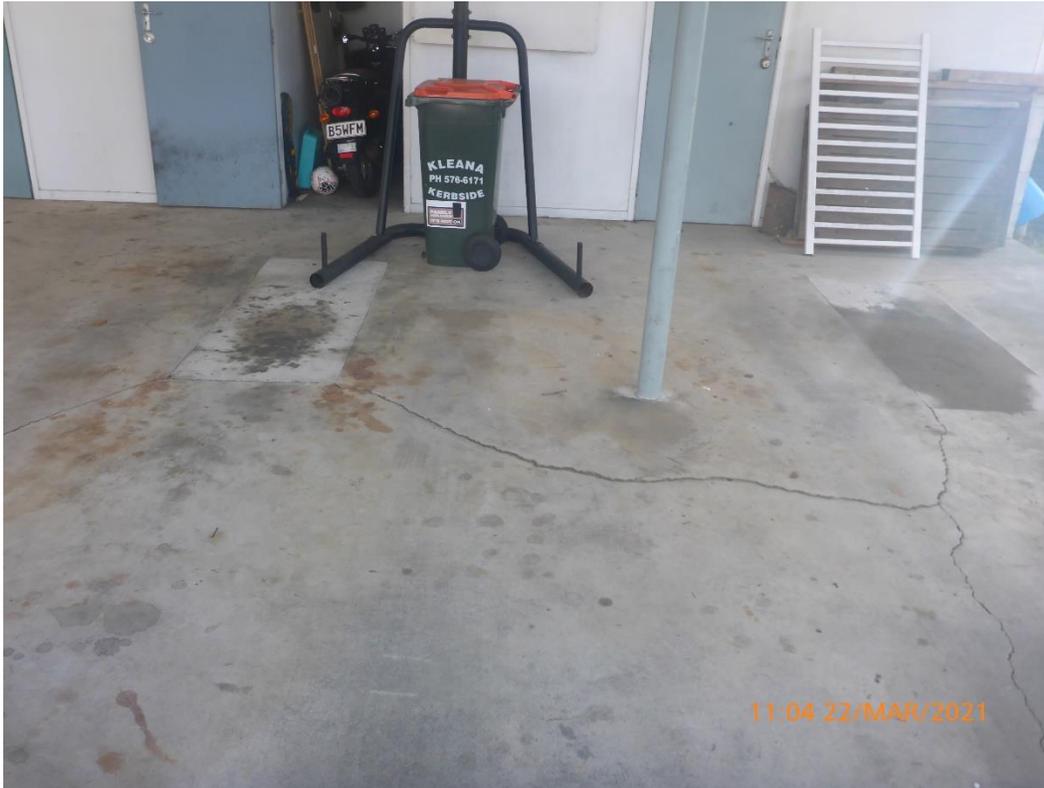
Garage interior/ Carport	<i>Significant</i>	<i>Minor</i>	<i>No Fault</i>	<i>N/A</i>	<i>Comments</i>
<i>Carport</i>				✓	
<i>Concrete slab</i>	✓				A few large cracks occurred in the concrete slab of the carport (parking area). It is recommended to monitor the cracks in future for any undulations. If a height difference occurs, a slip and trip hazard can present itself.

C2. A few large cracks were noticeable in the concrete slab (parking area) of the carport's floor slab. These cracks should be monitored. When a height difference occurs, a trip hazards can be possible.

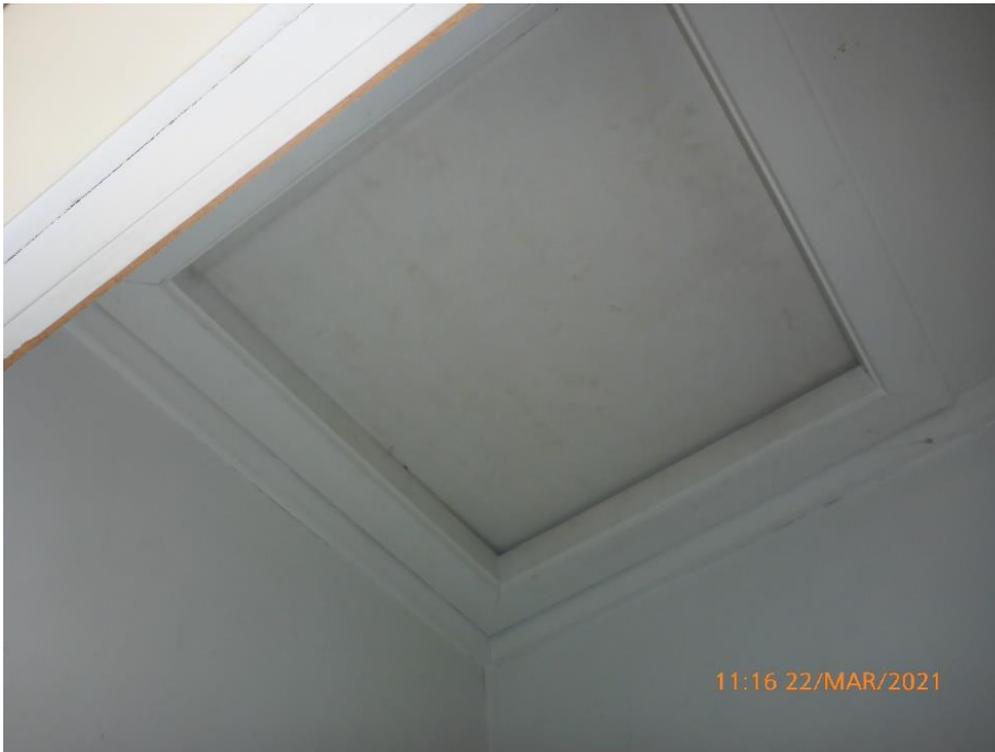
D1. The manhole to the roof space is located in the bathroom cupboard.

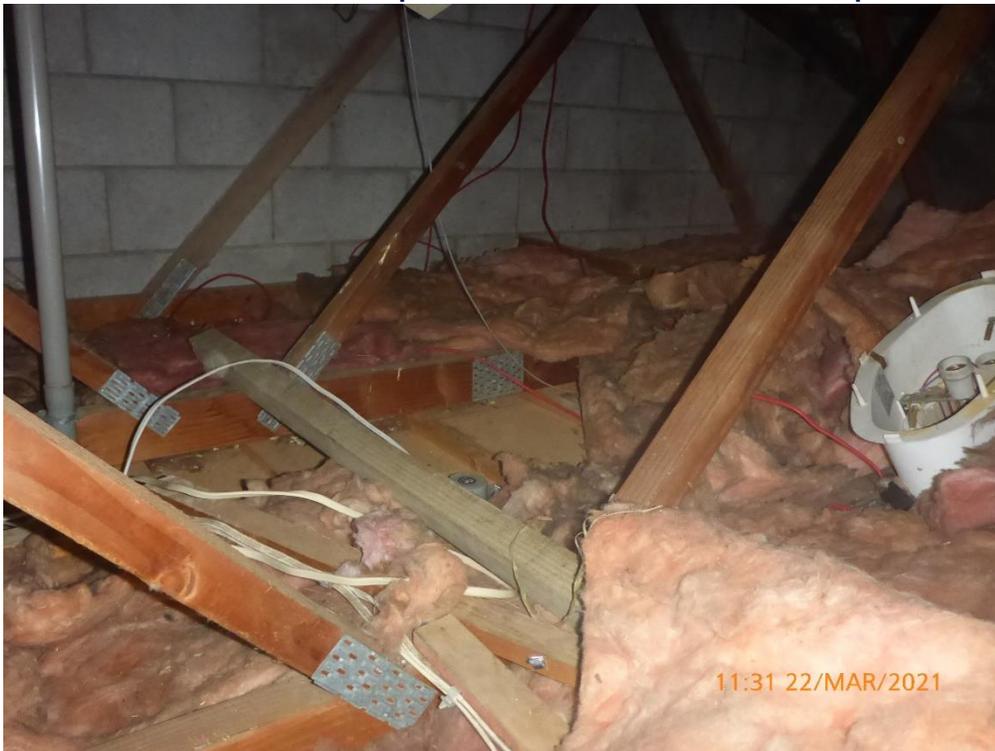
D2. Some debris and stored items were present in the roof space. The insulation has been moved in some places and should be replaced correctly to work effectively. Some electrical cables were visible, but most of them were hidden by the insulation.

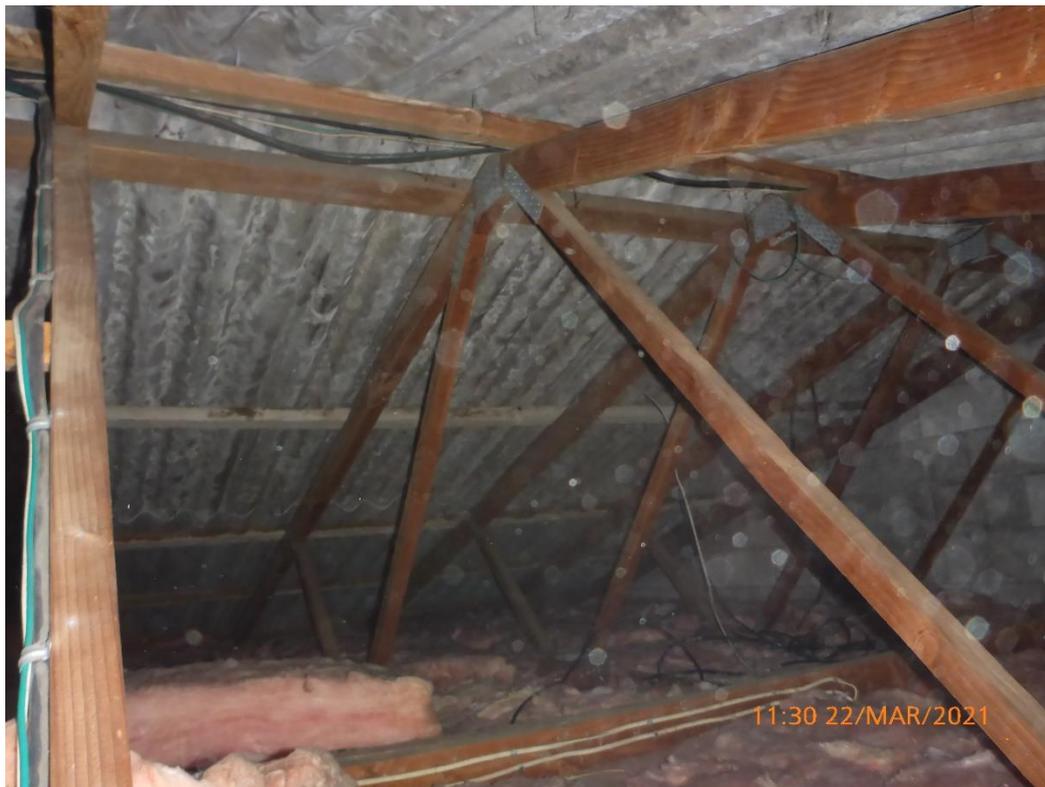
D3. The roof timbers are in a good condition for their age. No sarking has been installed underneath the corrugated fiber cement sheets.

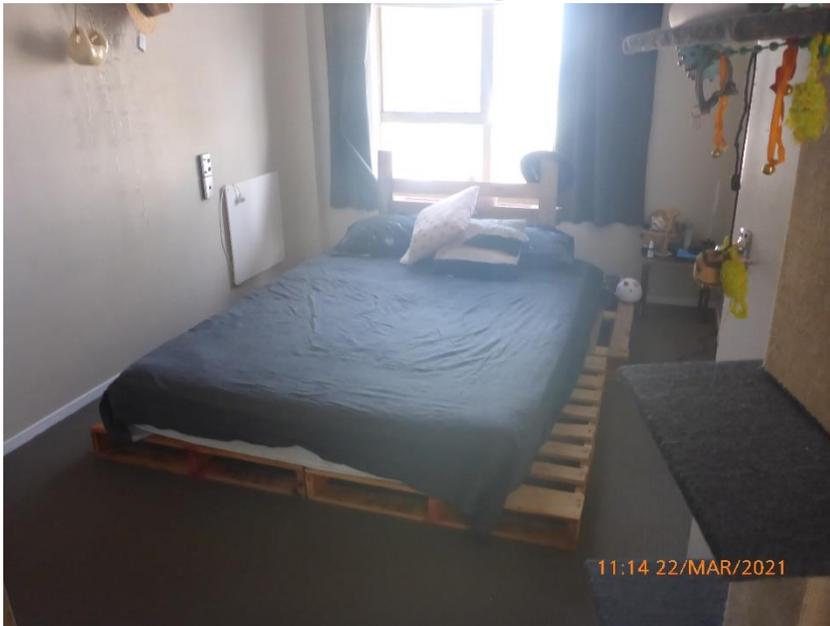
E1. The carpet on the concrete floor is in a good condition for its age.

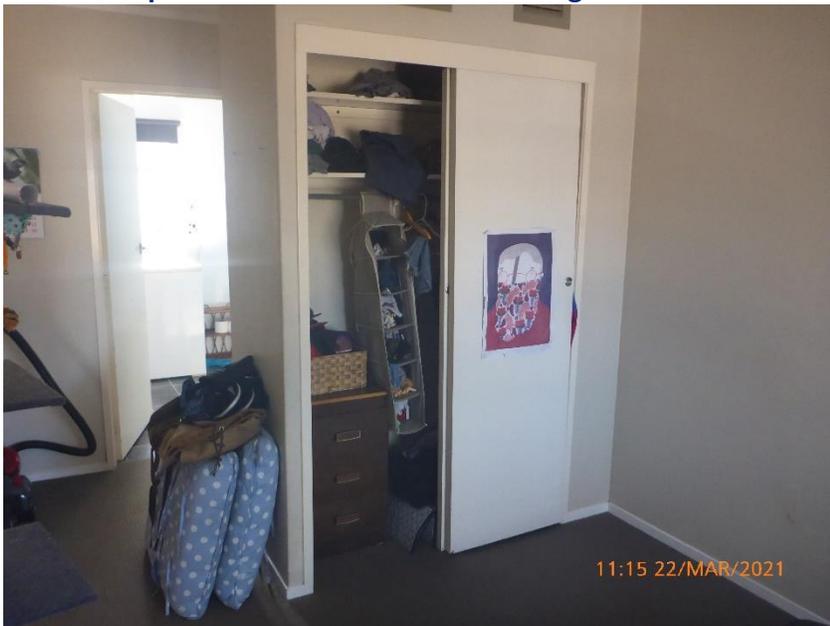
E2. Wall linings and joinery are in a good condition for their age.

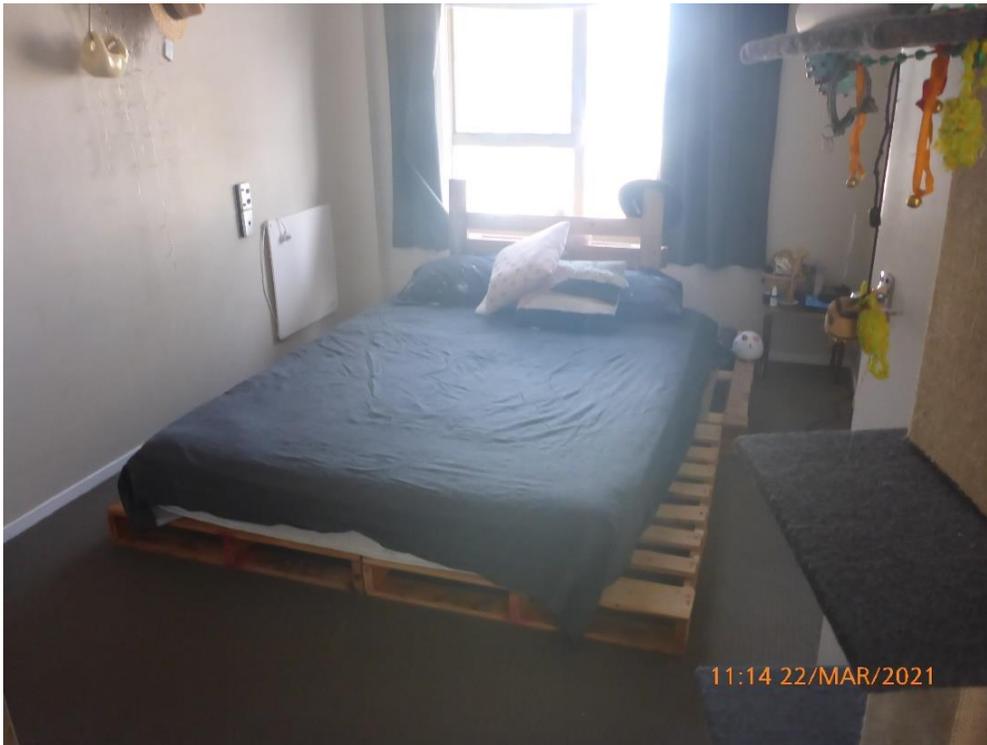
E3. The aluminium window is in a good condition for its age. The window is single glazed and is slightly stiff to open and close. A lubricant such as CRC might ensure smooth opening and closing.

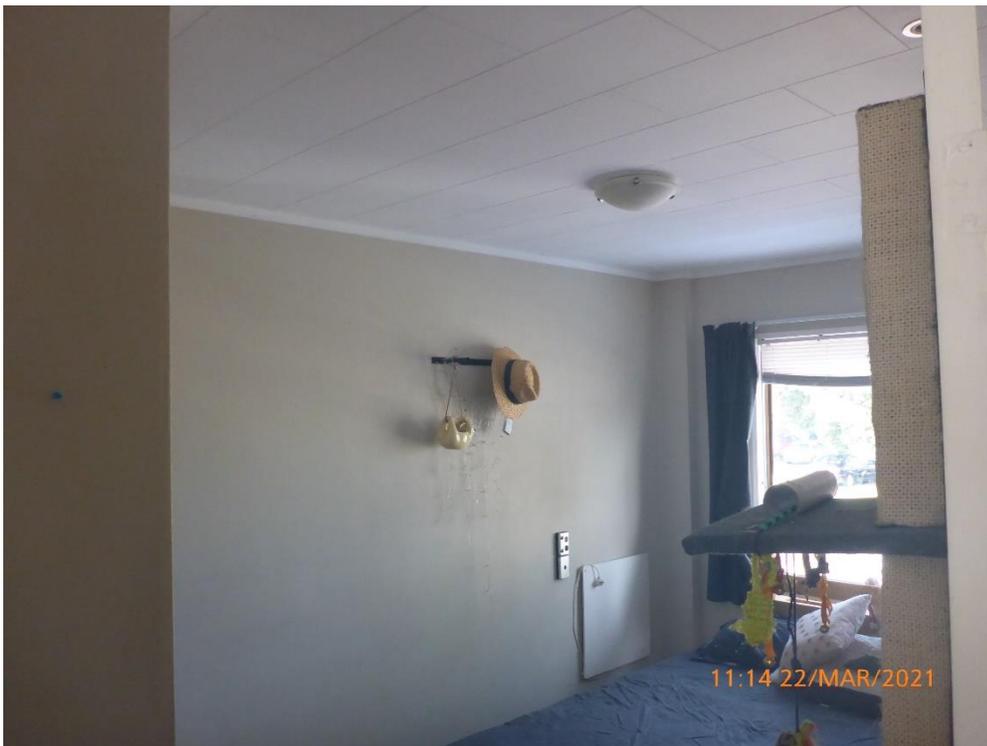
E4. The soft board ceiling tiles in the bedroom are in a good condition for its age.

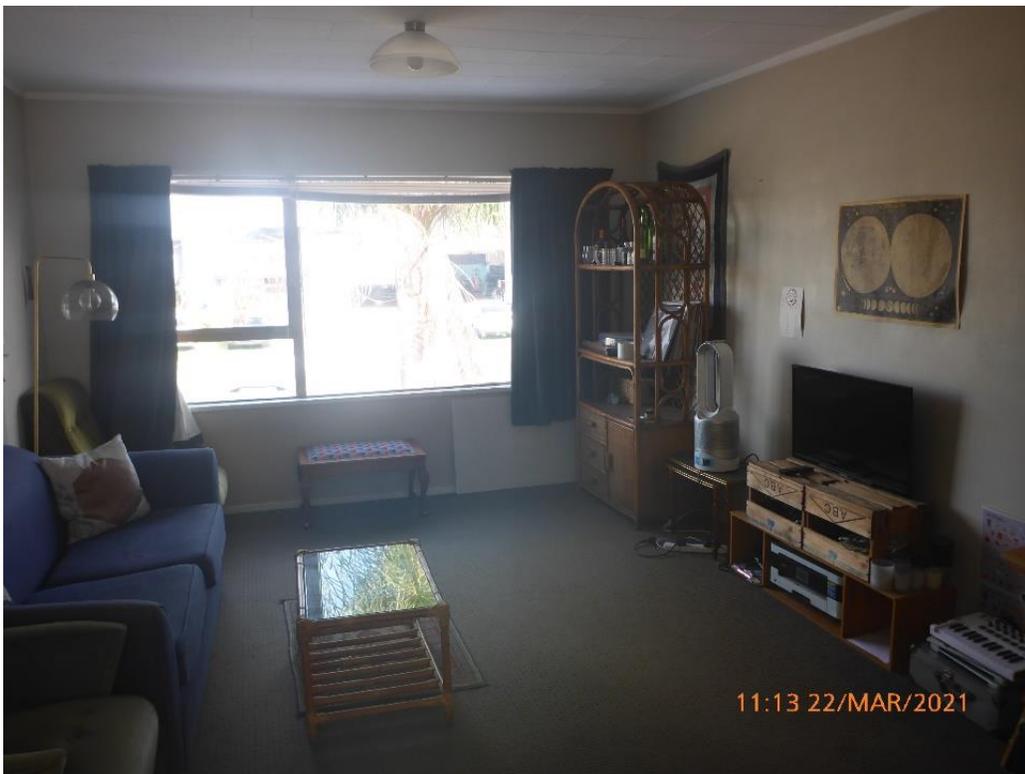
F1. The concrete flooring is covered with carpet. The carpet is in a good condition for its age.

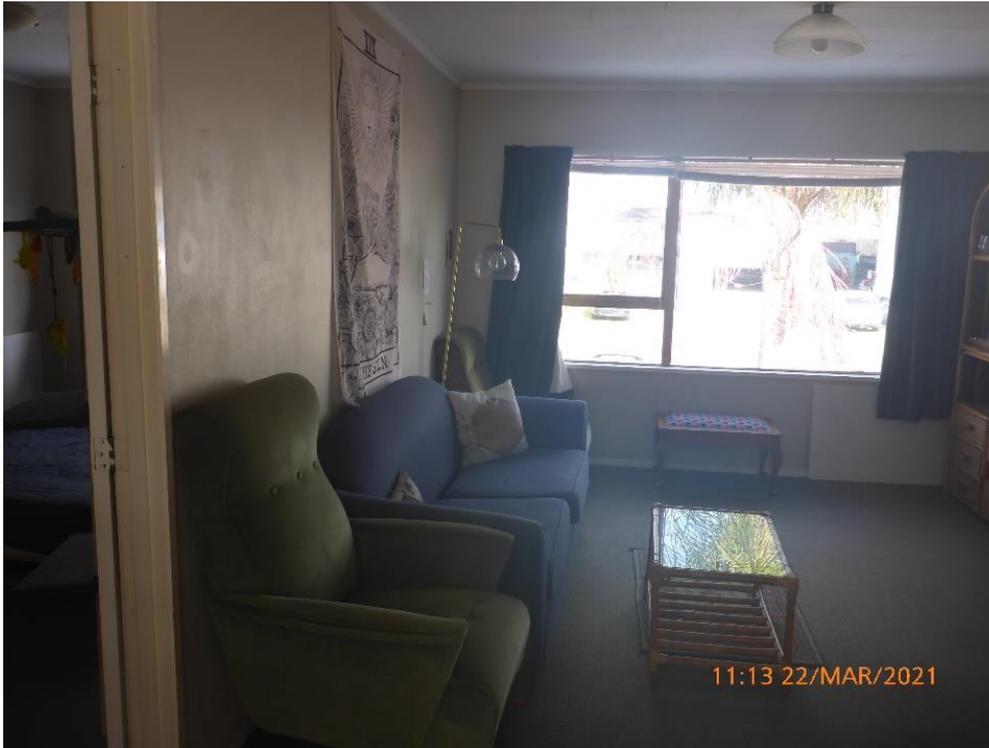
F2. The wall linings are in a good condition for their age.

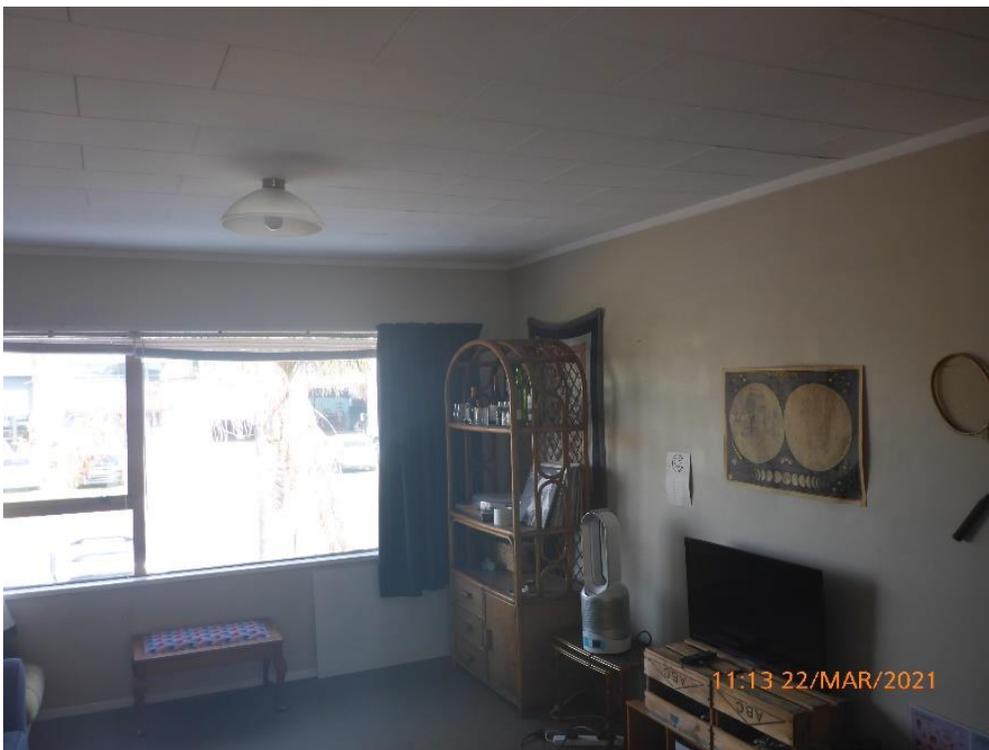
F3. A few deterioration marks were present on the ceiling lining. No elevated moisture readings were recorded at these marks.

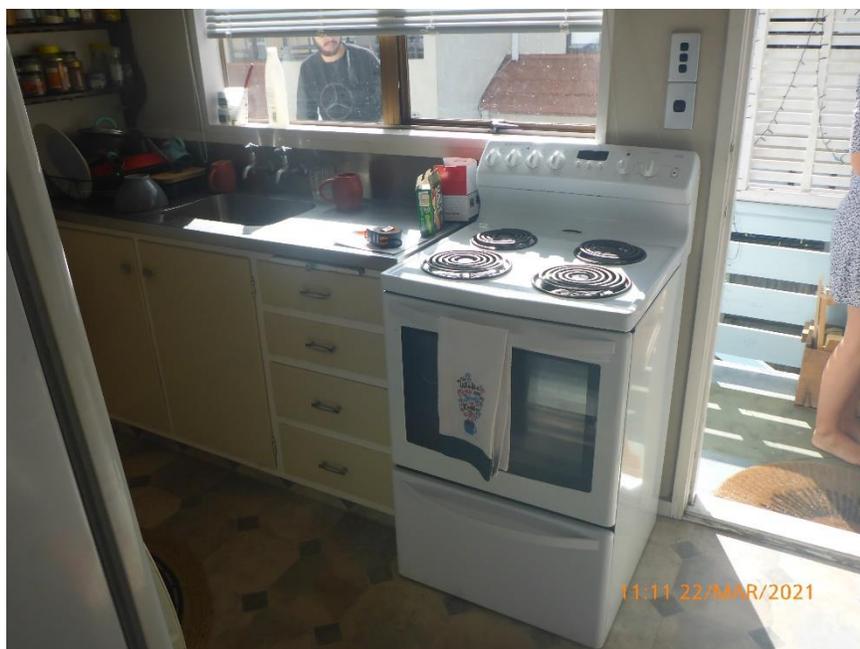
G1. The kitchen floor has vinyl covering.

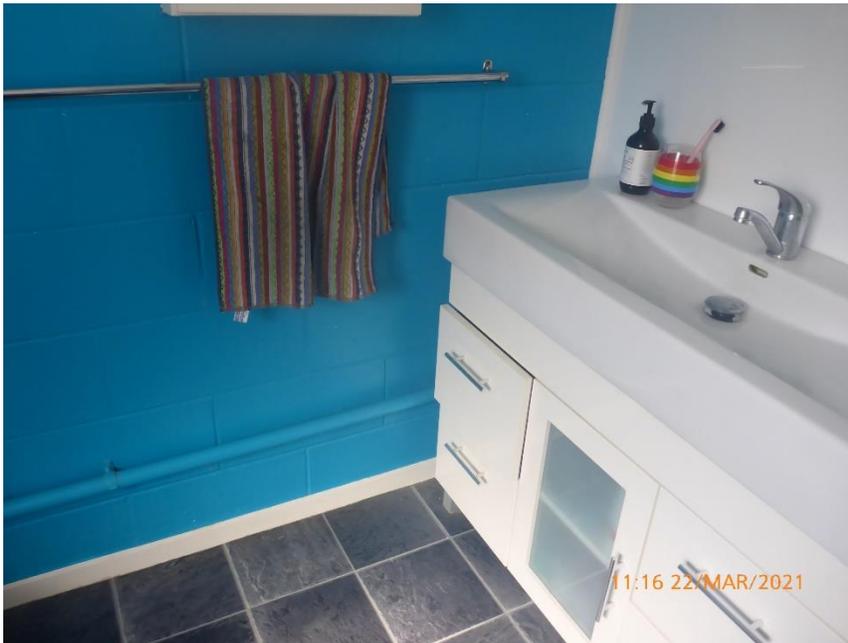
G2. The bathroom floor is tiled.

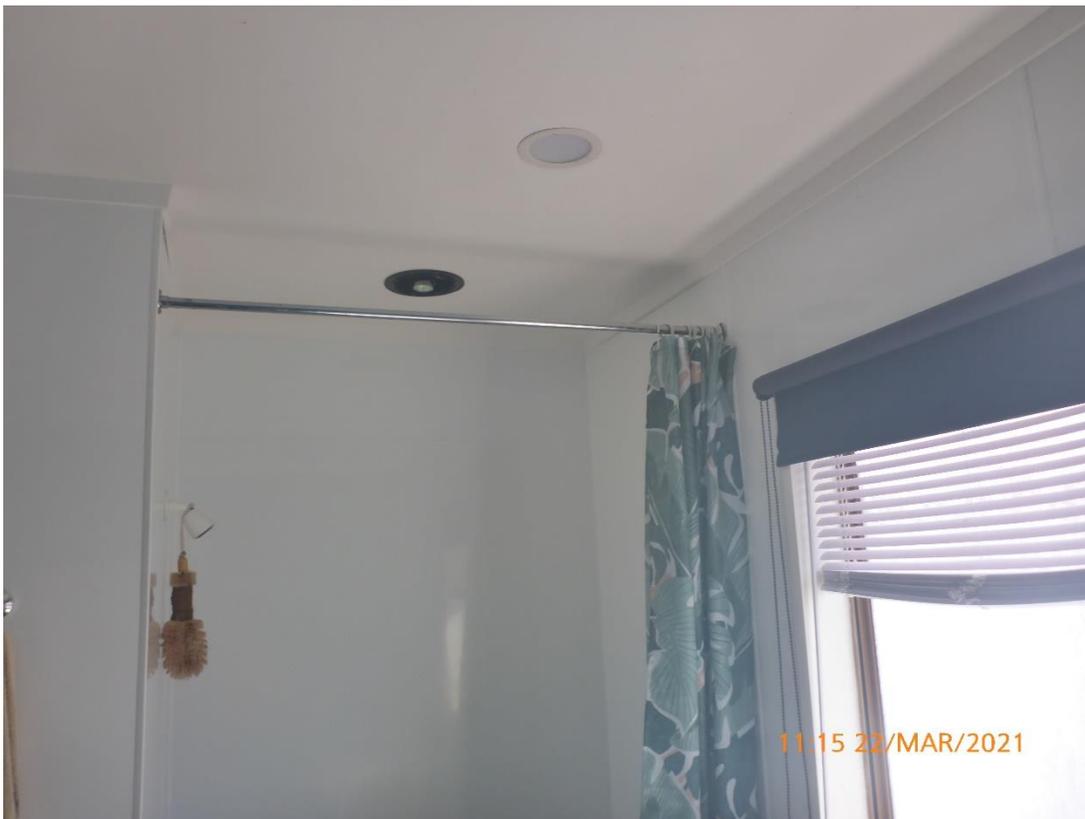
G3. The wall linings in the bathroom are in a good condition.

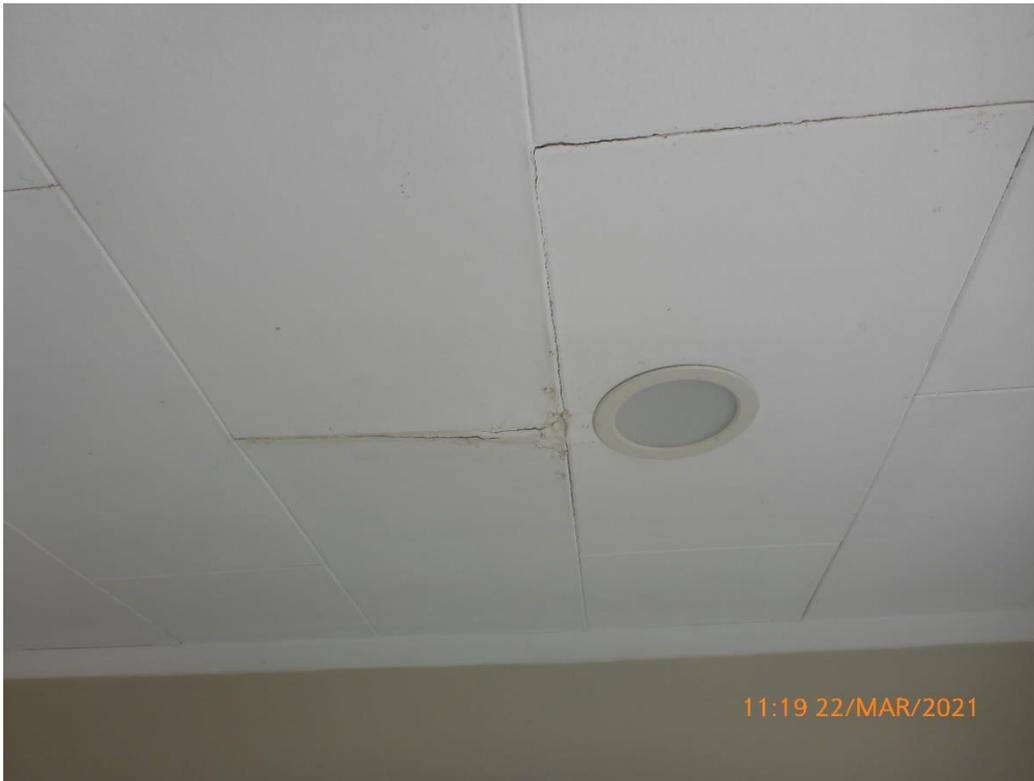
G4. The ceiling in the kitchen has a deteriorated spot. No elevated moisture levels were found.

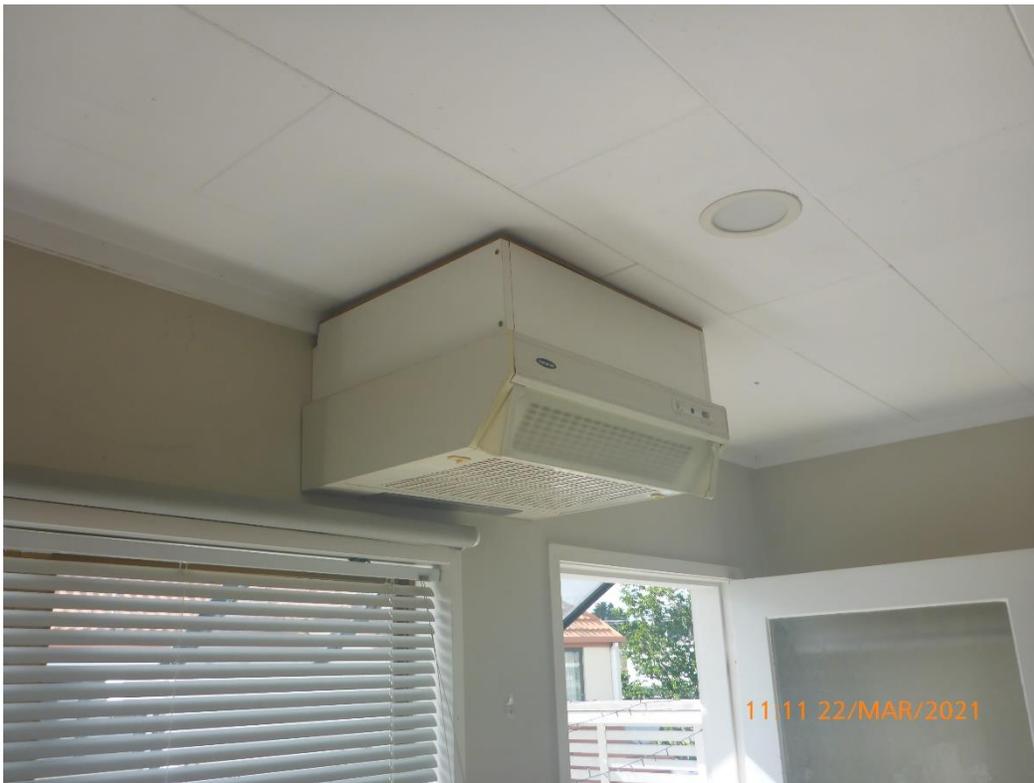
G5. The extractor fan in the kitchen.

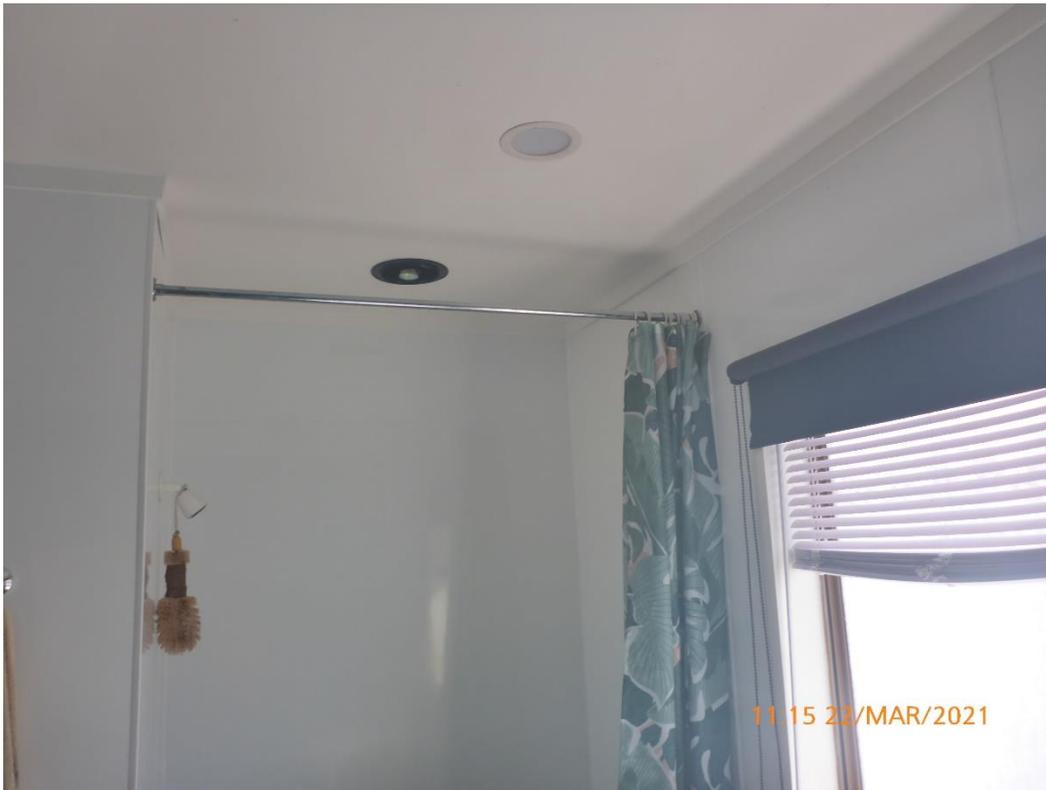
G6. The extractor fan in the bathroom/laundry cupboard.

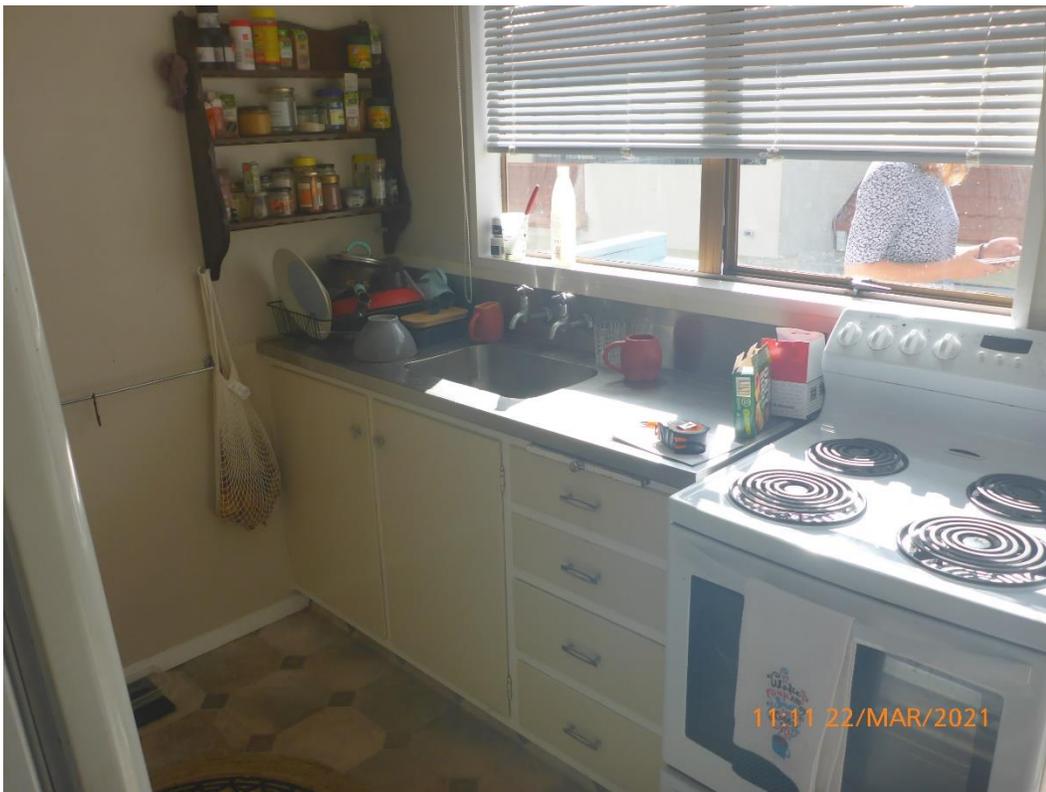
G7. The tapware in the kitchen is aged, but free of drips.
