Residential Apartment Inspection Report

41e Tawa Street MT MAUNGANUI

Date of inspection: 22 March 2021

Type of inspection: Pre-purchase Residential Apartment Inspection

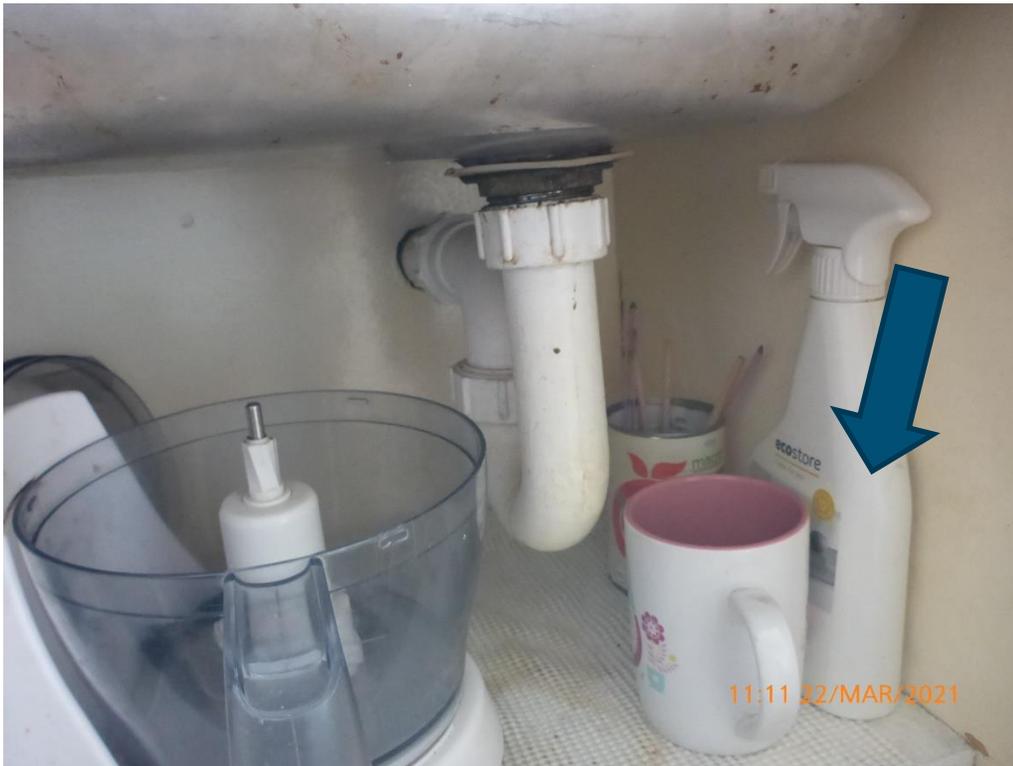
G8. The kitchen plumbing was free of leaks.

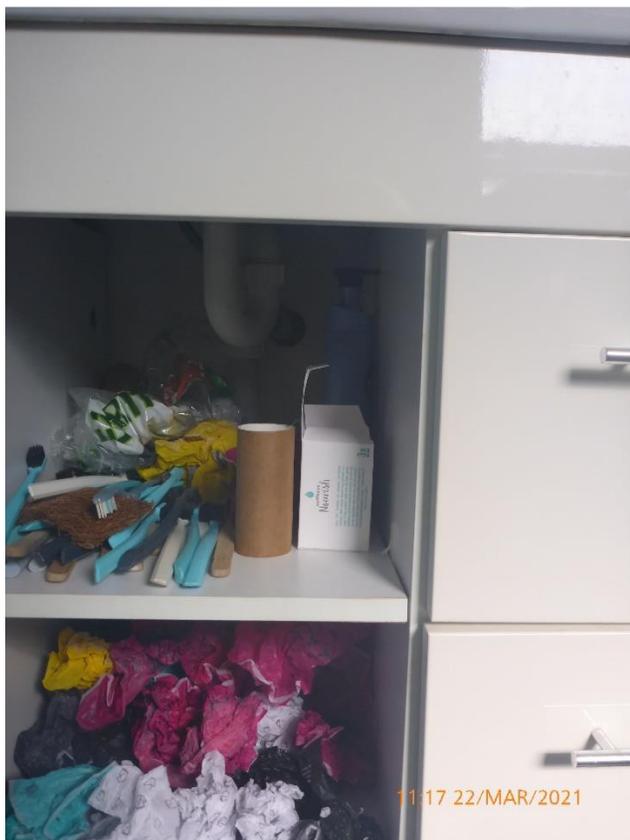
G9. The outlet pipe in the bathroom appears to be leak free.

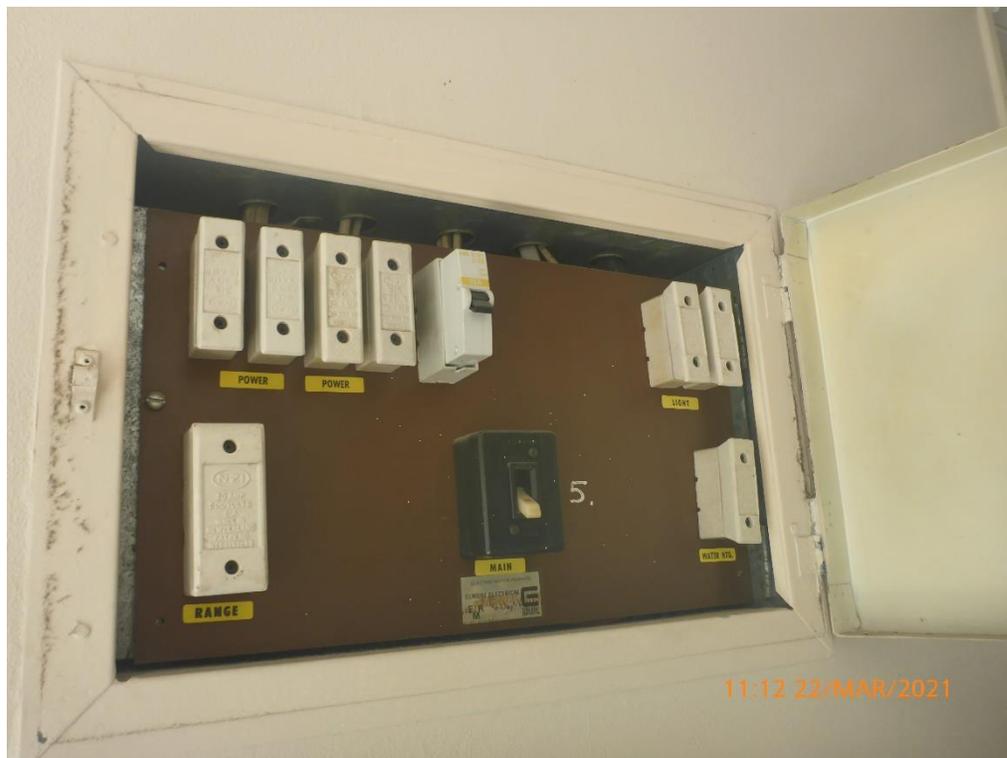
2. Electrical Switch Board

The apartment has one electrical switch board hosting the trip switches/isolators.

The switch board is aged with no RCDs installed.
