Presence of Methamphetamine – Presumptive & Laboratory Analysis Sampling

Inspection Date: 22 March 2021

Property Address: 41E Tawa Street Mt. Maunganui

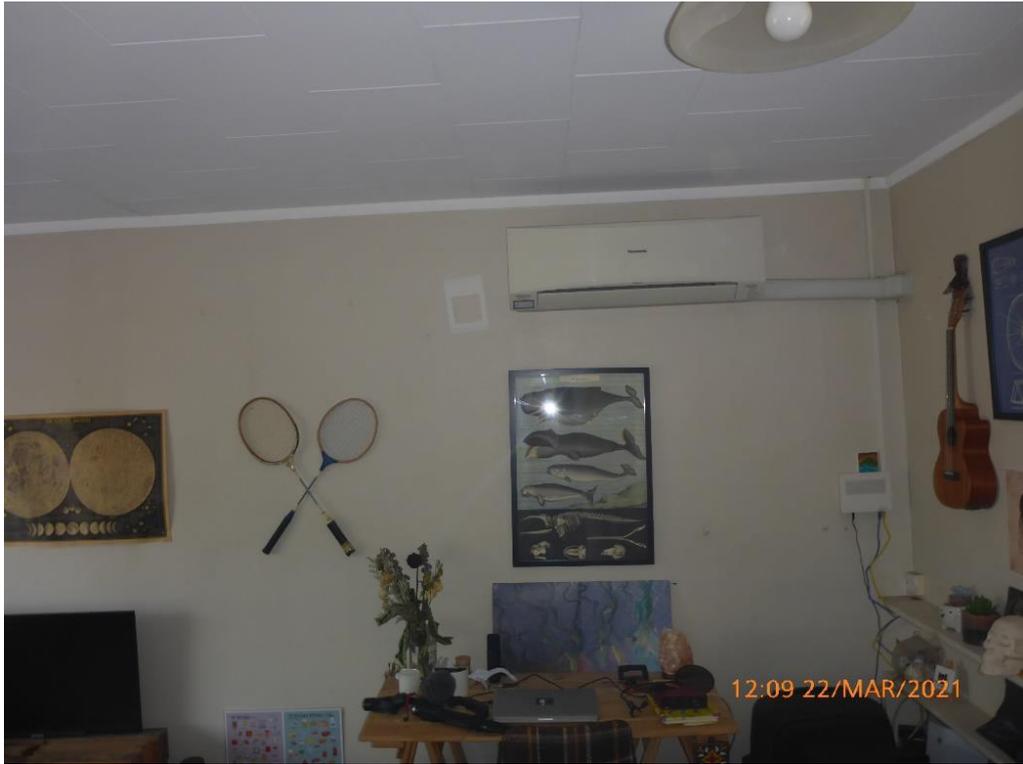
Lounge – next to the air conditioner.

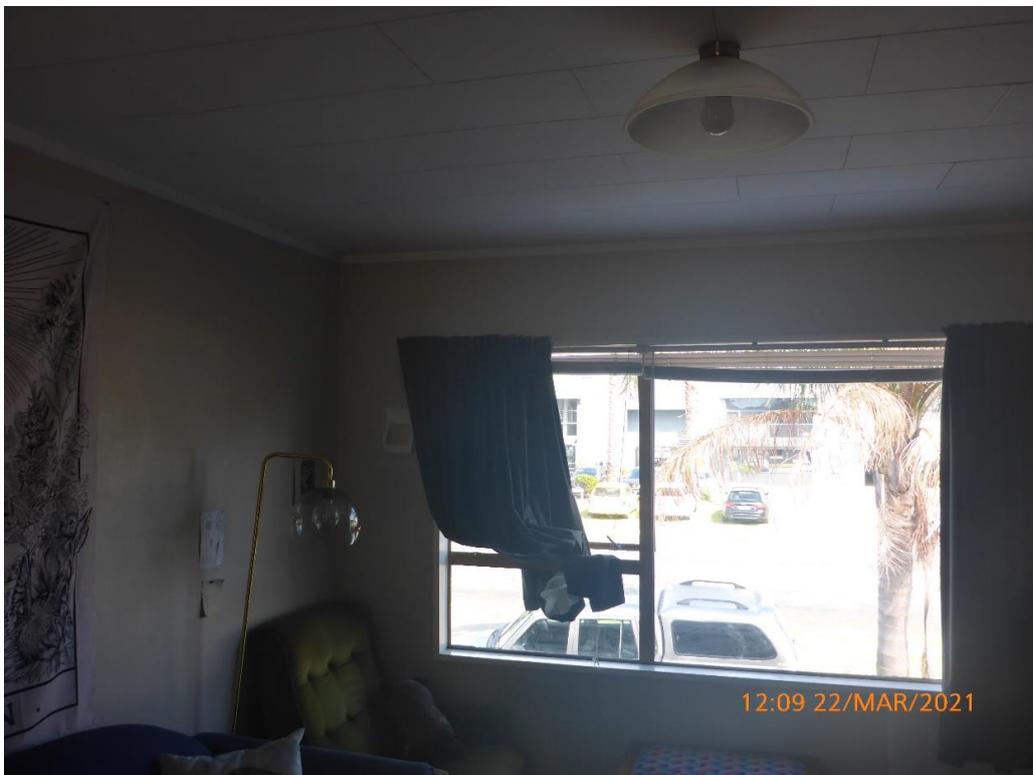
Lounge – next to the opening window.
