RED LBP PRE-PURCHASE REPORT

Andy Vann

PRE-PURCHASE BUILDING REPORT

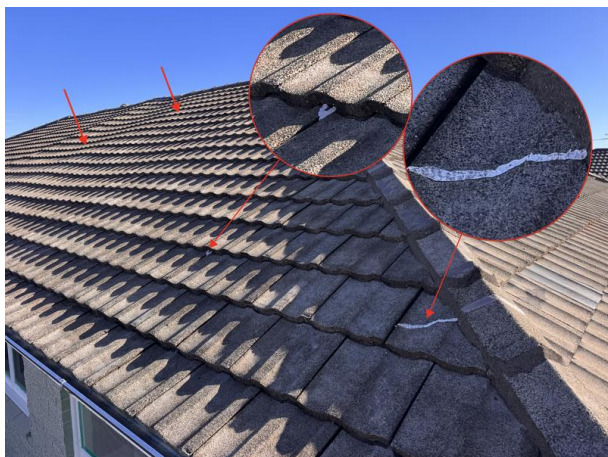
Photo 5
Sealant visible on what appears to be a tile crack and some roof line deflection on the south elevation.

The masonry tile roofing exhibits surface deterioration and requires professional cleaning and recoating to restore its protective finish. To ensure the ongoing integrity and weathertightness of the roof system, it is recommended that a Licensed Building Practitioner (Roofing) be engaged to assess the full extent of deterioration and undertake the required recoating and maintenance works in accordance with the manufacturer's specifications and good trade practice.

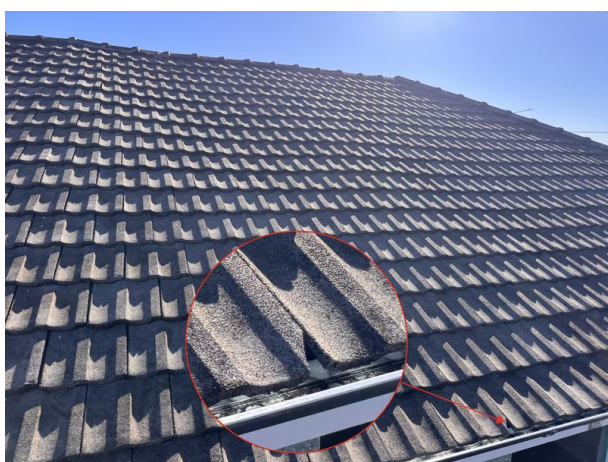
Photo 6
Masonry tile hip roof south elevation broken bottom row tile visible.

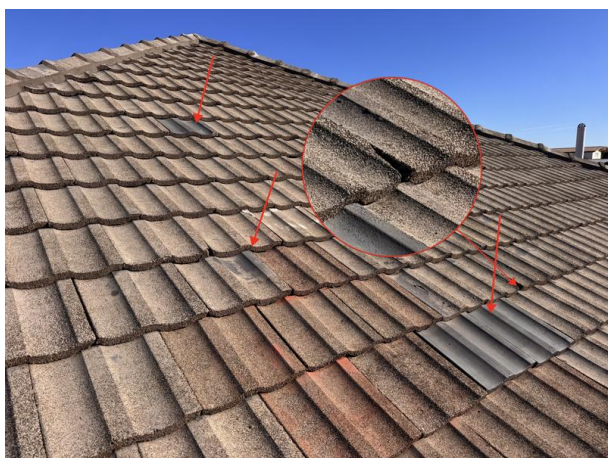
Photo 7
Some tile resurfacing visible on the north elevation, also chip bottom corner visible.

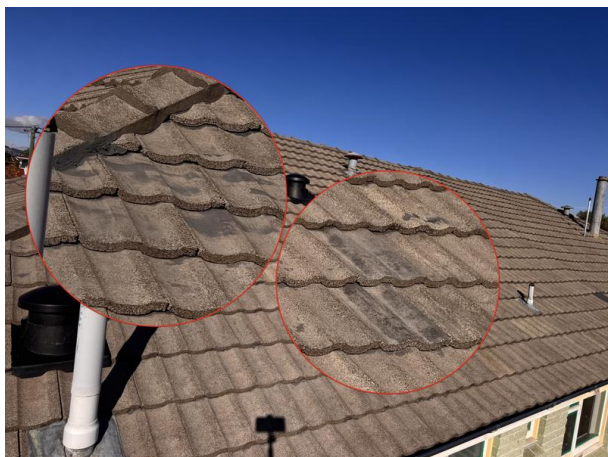
Photo 8
Areas of tile surface repairs visible on the north elevation.

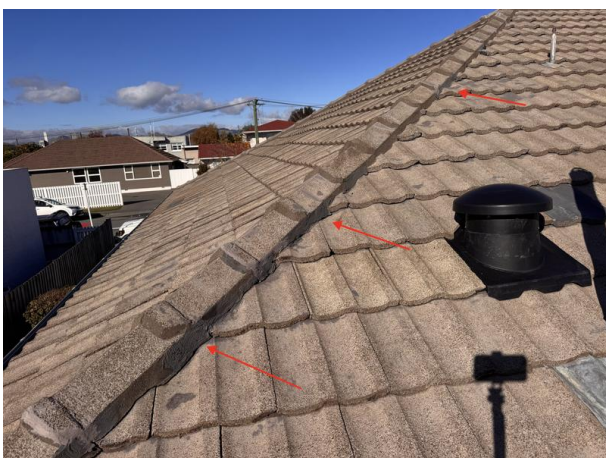
Photo 11
Hip cap mortar repairs visible.

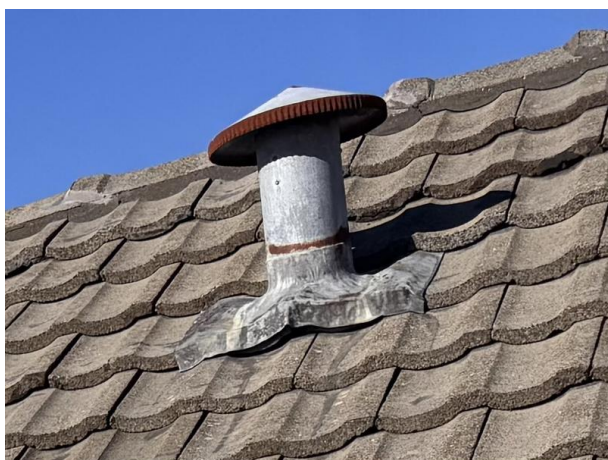
Photo 14
Metal vent penetration with a lead base flashing, corrosion visible.

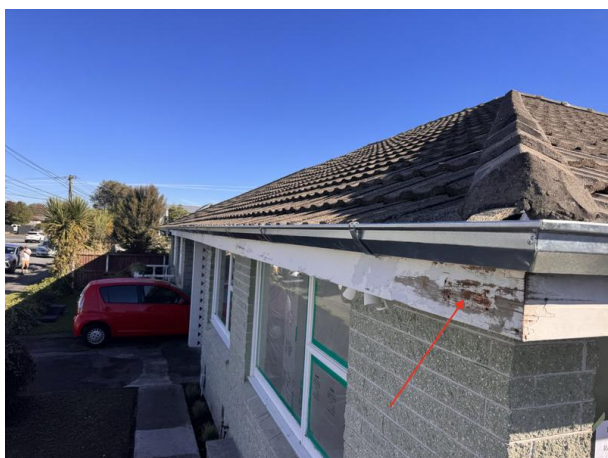
Photo 18
Timber fascia boards with a paint finish, deterioration visible recommend resealing.

There are areas of the timber fascia that require sanding back any loose flaky paint, apply a sealer coat then redecoration to prevent further deterioration.

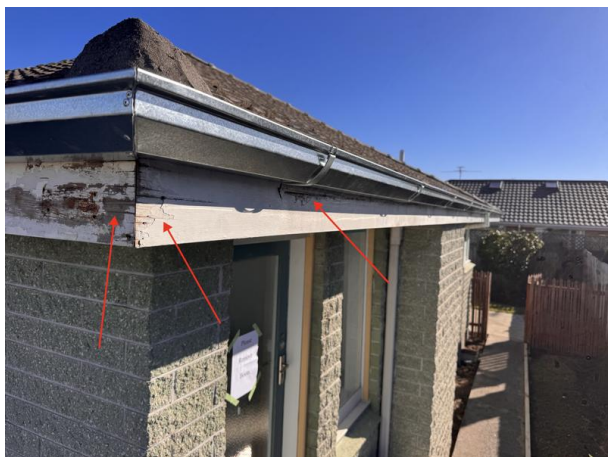
Photo 19
Timber fascia boards with a paint finish, surface deterioration visible.

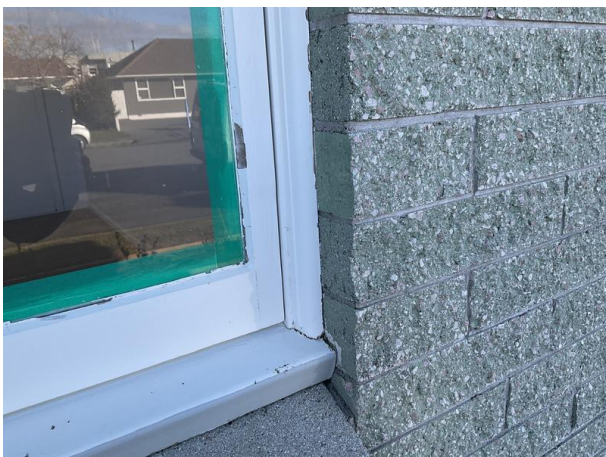
Photo 27
Timber quarter round bead installed, recommend sealing to the cladding.

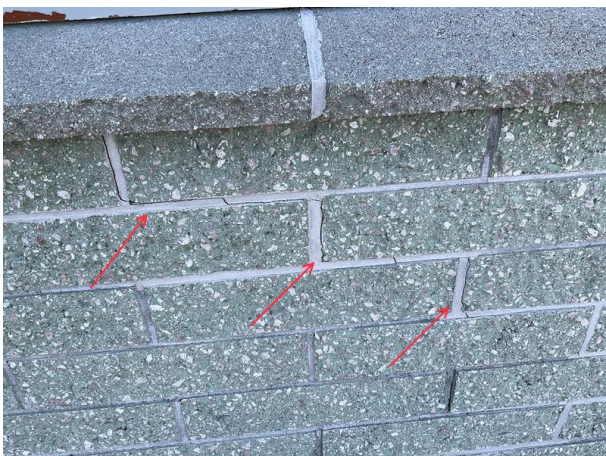
Step cracking has been observed within the brick veneer. At this stage, the cracks are non-displaced, indicating that no significant movement or structural failure has occurred. The cracking appears consistent with localised shrinkage or minor settlement, rather than progressive structural movement.

Photo 29
Stepped mortar cracking visible on the south elevation.

Remedial action can be undertaken by carefully repointing and remortaring the affected joints to reinstate weather protection and maintain the veneer's durability. This work should be completed using a mortar compatible in strength, colour, and texture with the existing, to ensure an effective repair and a uniform finish. Ongoing monitoring is recommended to confirm no further movement occurs. Should cracks widen, become displaced, or reappear after repair, further investigation by a suitably qualified practitioner would be warranted to determine any underlying structural cause.

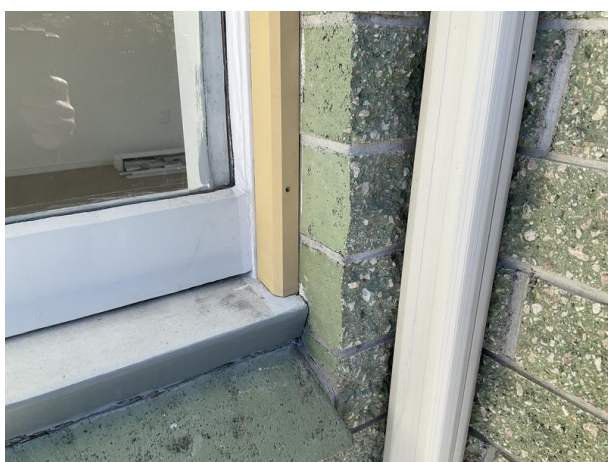
Photo 31
New timber joinery side seal bead installed on the east elevation, recommend sealing to the cladding.

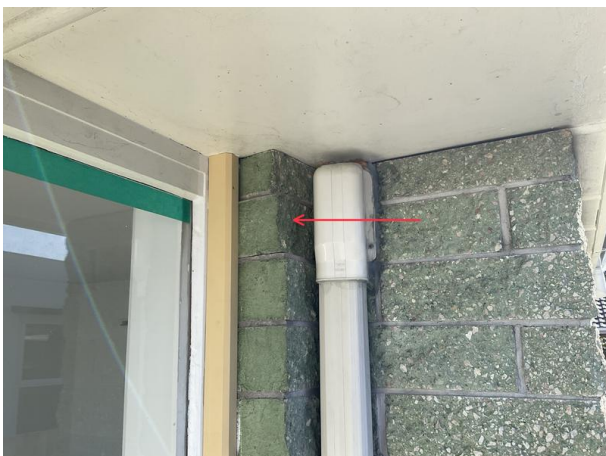
Photo 35
Loose brick visible near the heat pump
wall penetration east elevation.

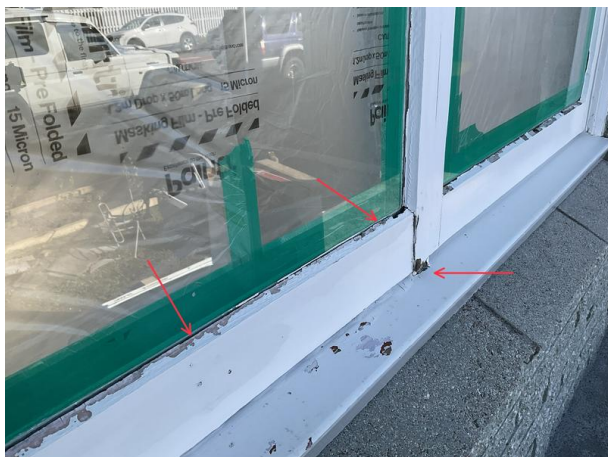
Photo 37
Glazing putty and paint damage visible.

The paint is flaking on the window sills and other exposed exterior timbers. This may allow moisture to be absorbed into the timber, potentially leading to swelling, deterioration, or decay over time. Correct surface preparation, including sanding back defective coatings, treating any bare or weathered timber, and applying a suitable exterior-grade primer and topcoat, is recommended to restore protection and prolong the life of the timber components.

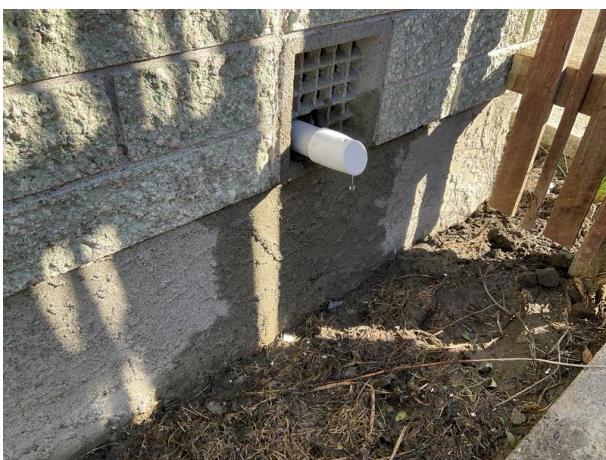
Photo 45
Dampness visible on the east elevation due to hot water cylinder drain back flowing.

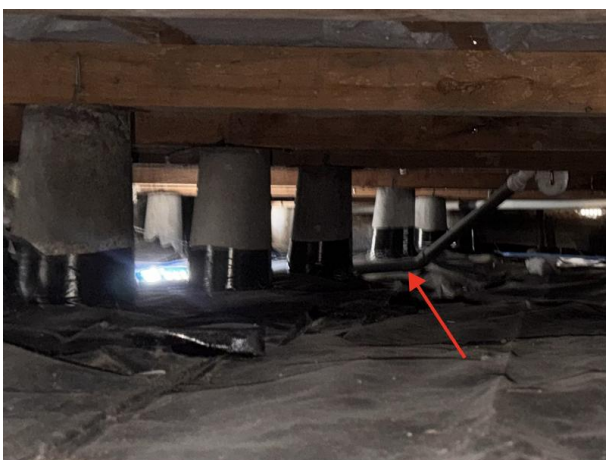
Photo 54
PVC waste pipe appears to be unsupported in the subfloor recommend further investigation from a licensed plumber.

It is recommended to support any piping that is unsupported.

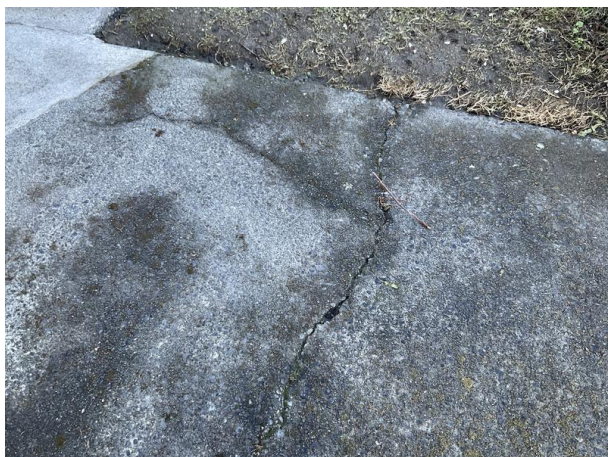
Photo 96
Cracking visible.

General upkeep and maintenance of the driveway is recommended, including cleaning it and keeping it free of debris.

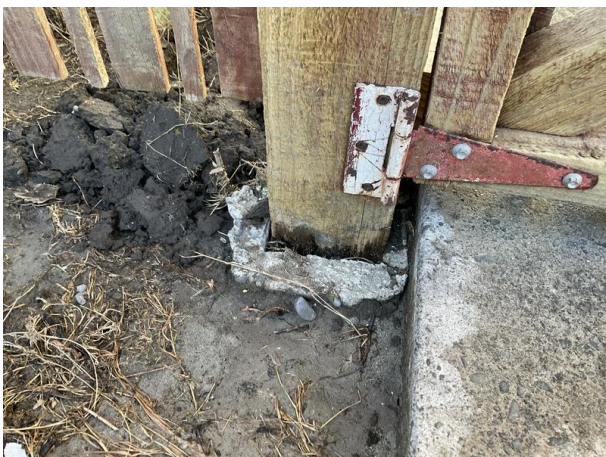
Photo 99
Timber post deterioration visible.

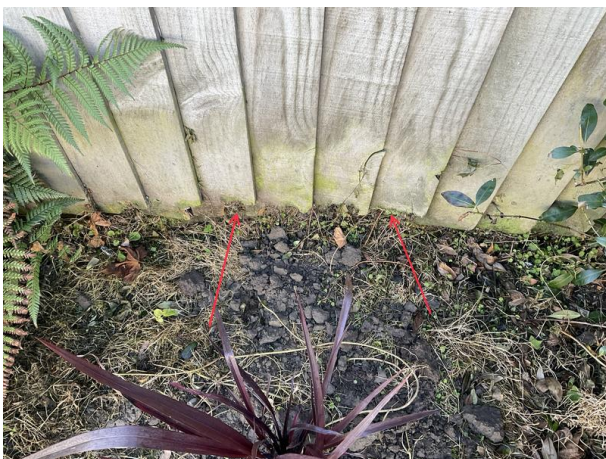
Photo 101
Timber palisade rot visible on the north boundary fence, due to contact with the ground.

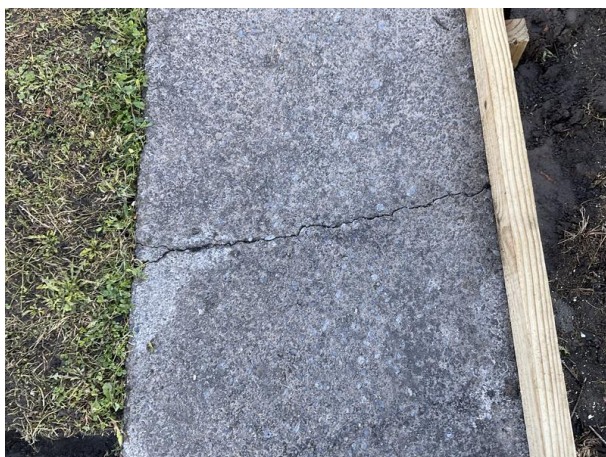
Photo 104
Cracking visible.

General upkeep and maintenance. Clean down to remove moss and reduce slip hazard as part of regular maintenance.

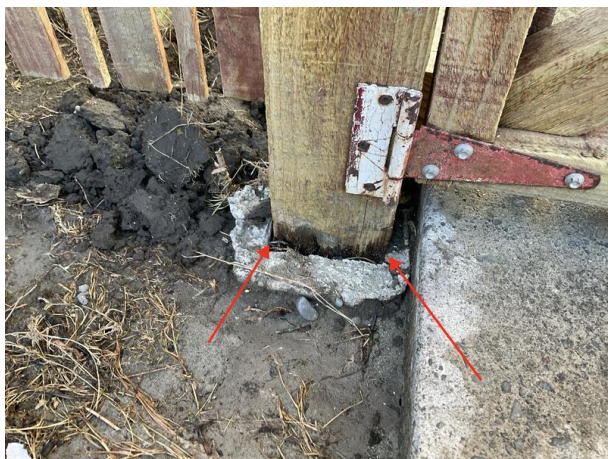
Photo 110
Timber post deterioration visible supporting the gate.

It is recommended to apply regular maintenance to hinges and latches to maintain smooth operation.
