Re: **Geotechnical Report – 1 Kaioruru Lane, Charteris Bay – Lot 11, Black Rock Development**

**Appendix A: Shallow Geotechnical Investigation Data – 1 Kaioruru Lane**

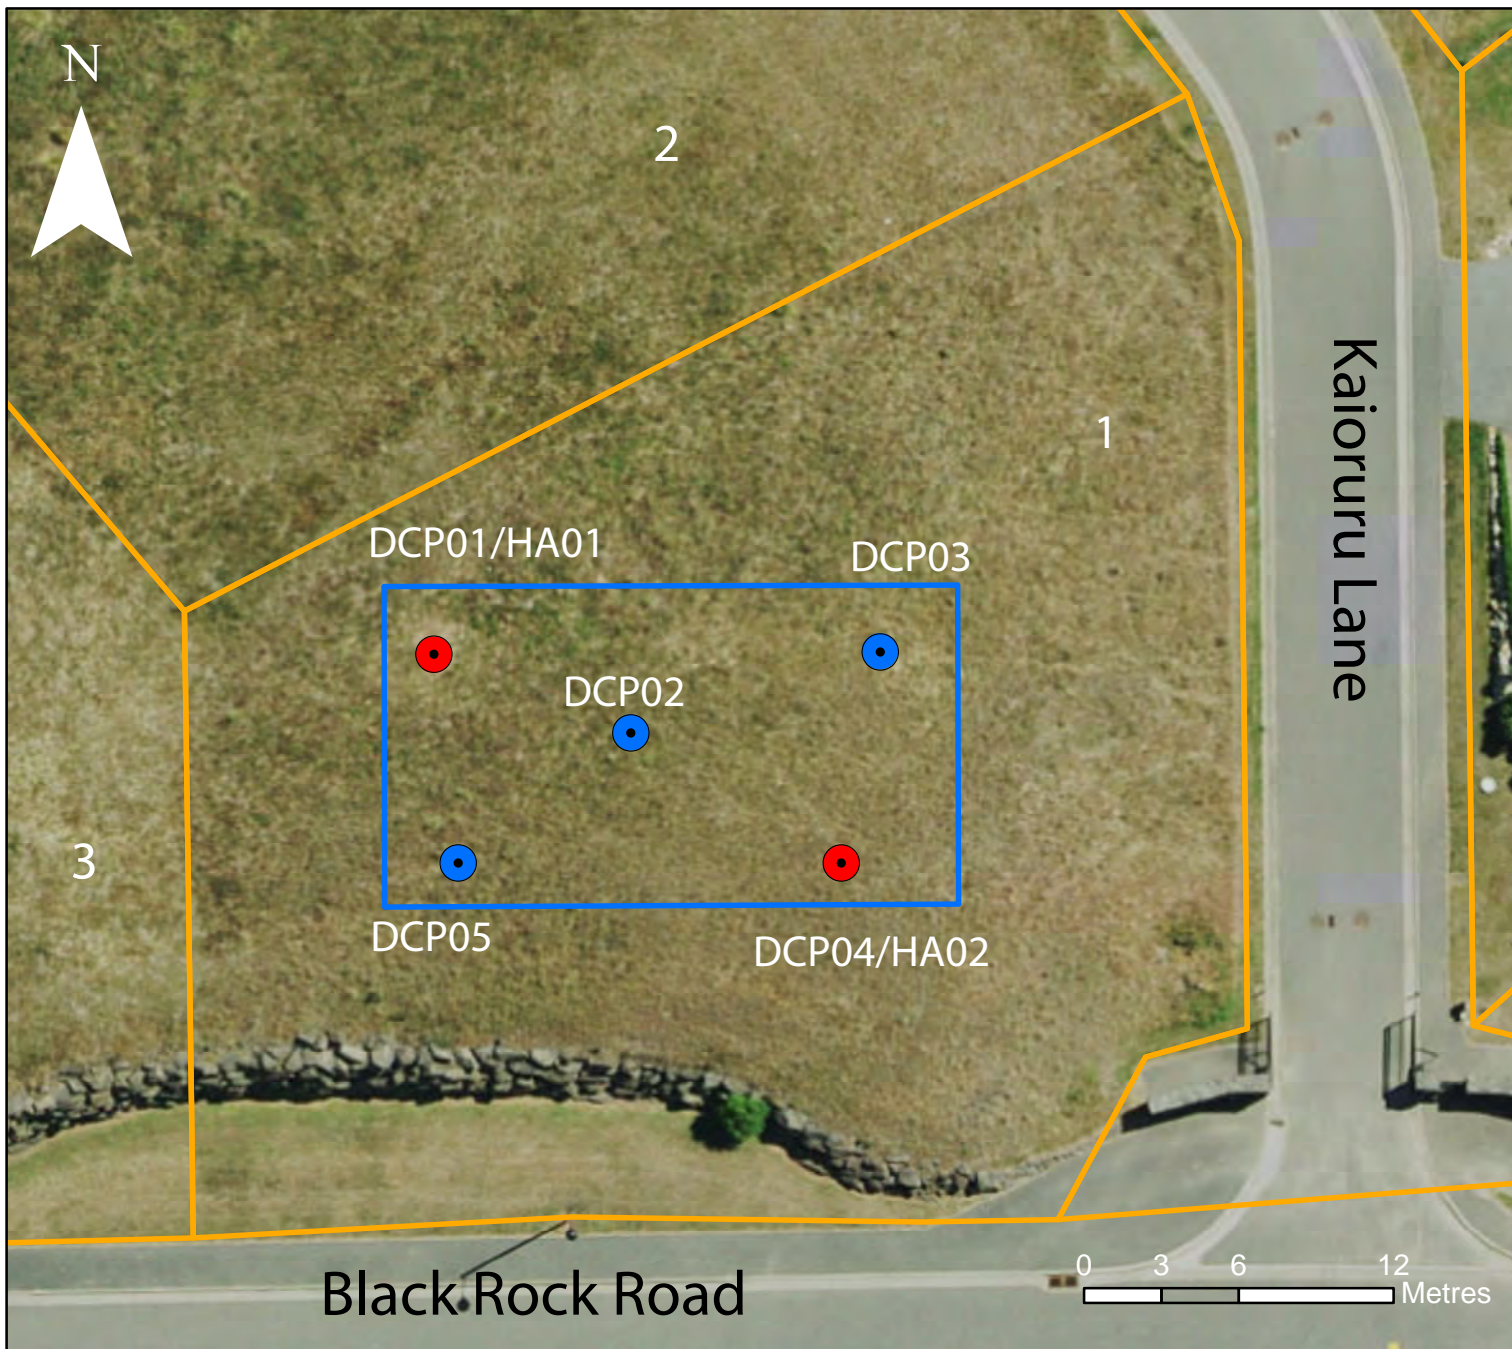
### Appendix A

Two hand augers and five Scala penetrometer (DCP) profiles have been completed within the planned dwelling footprint (Appendix A). The two hand augers (HA01 and HA02) terminated at depths of 0.7 and 0.8m below ground level (bgl), most probably due to proximity to the underlying volcanic conglomerate. The presence of angular basalt fragments to 30mm in size reflects engineered construction on the site during subdivision, and the 150-200mm of organic-rich topsoil was placed for erosion protection.

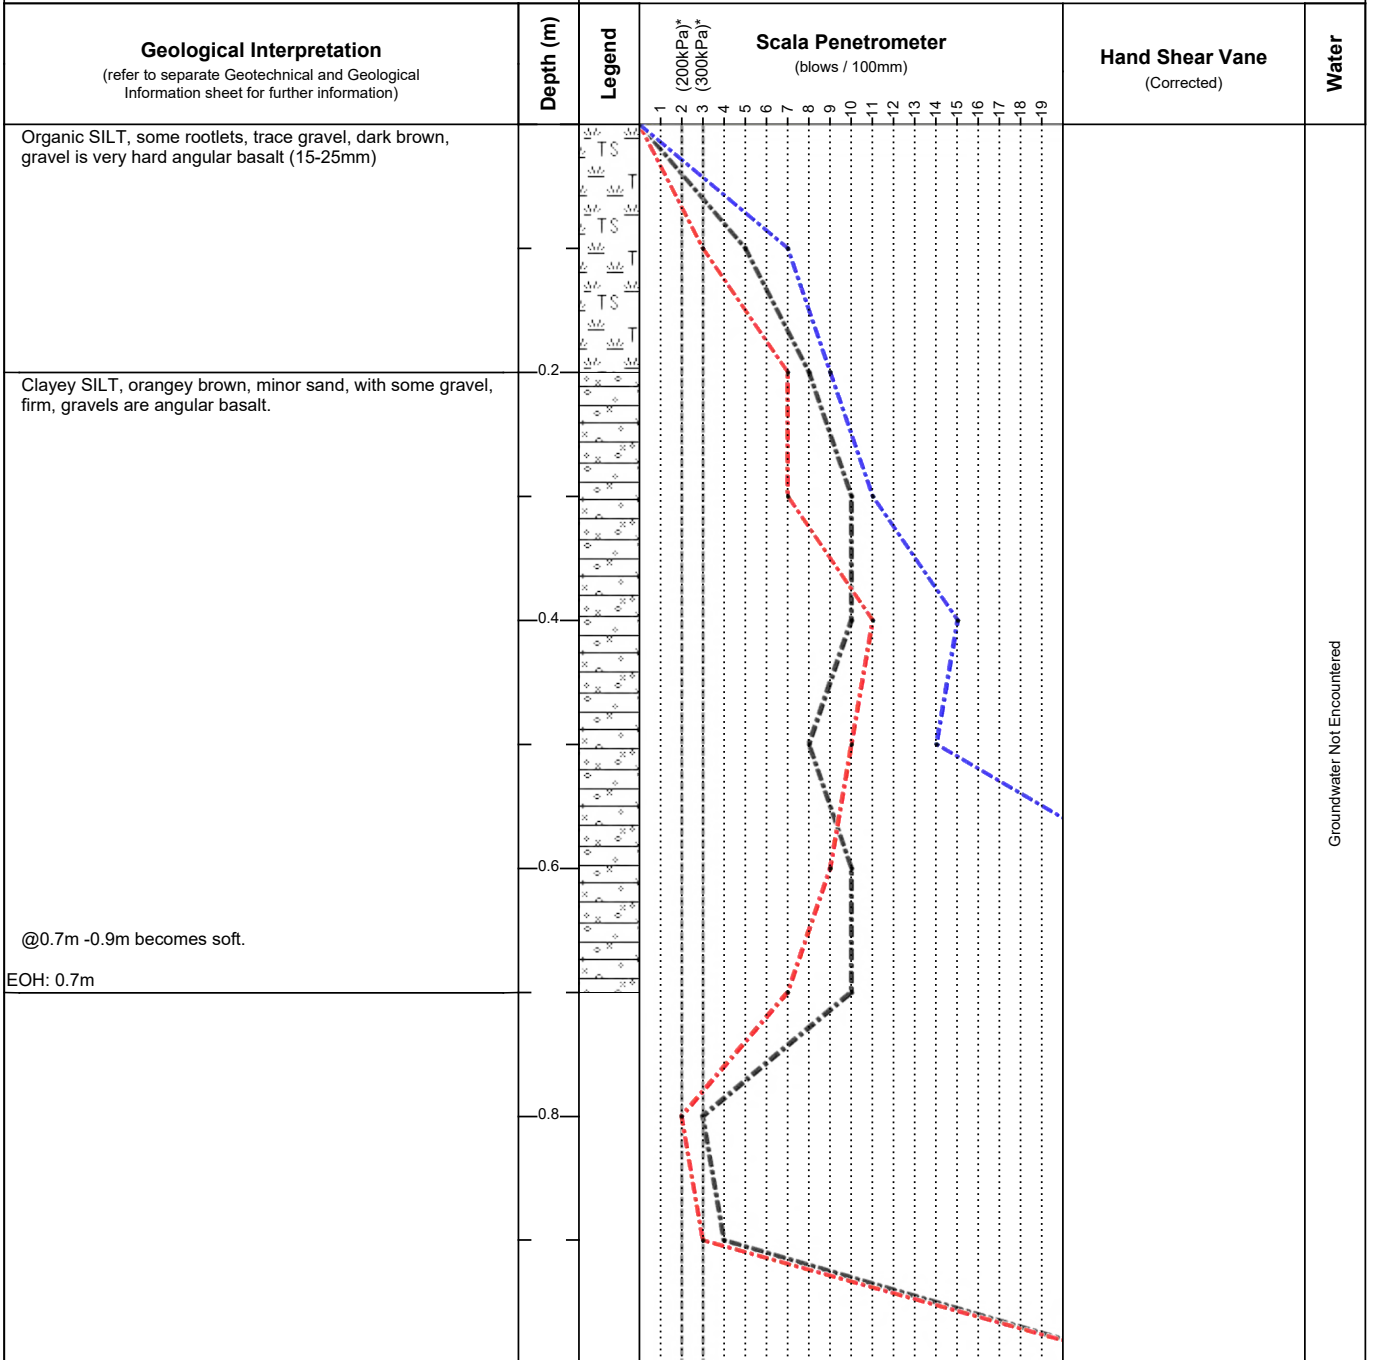
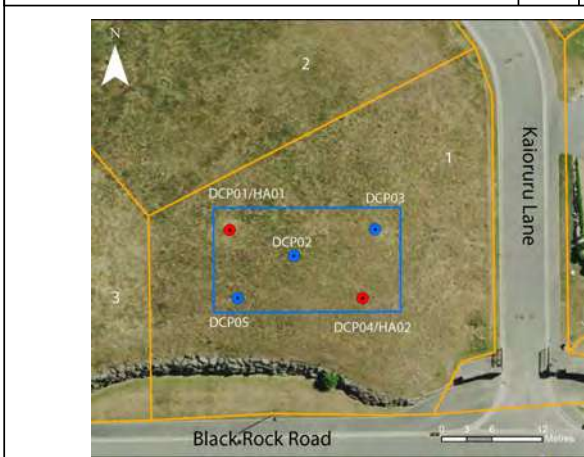
No.: DCP01 + DCP02 + DCP03

The Scala penetrometer (dynamic cone penetrometer or DCP) profiles show bearing increasing to effective refusal (20 blows/100mm) at depths between 0.5 and 1.0m bgl (Appendix A). DCP01 and DCP02 show a zone of low bearing between 0.8 and 0.9m bgl, before increasing rapidly in DCP02: this is interpreted as reflecting proximity to underlying weak bedrock at the two locations, but it is not evident in DCP03, DCP04 or DCP05. Ground bearing is considered satisfactory for a conventional gravel 'raft' foundation after stripping at least 200mm (including topsoil), and its replacement by AP65 or AP40.

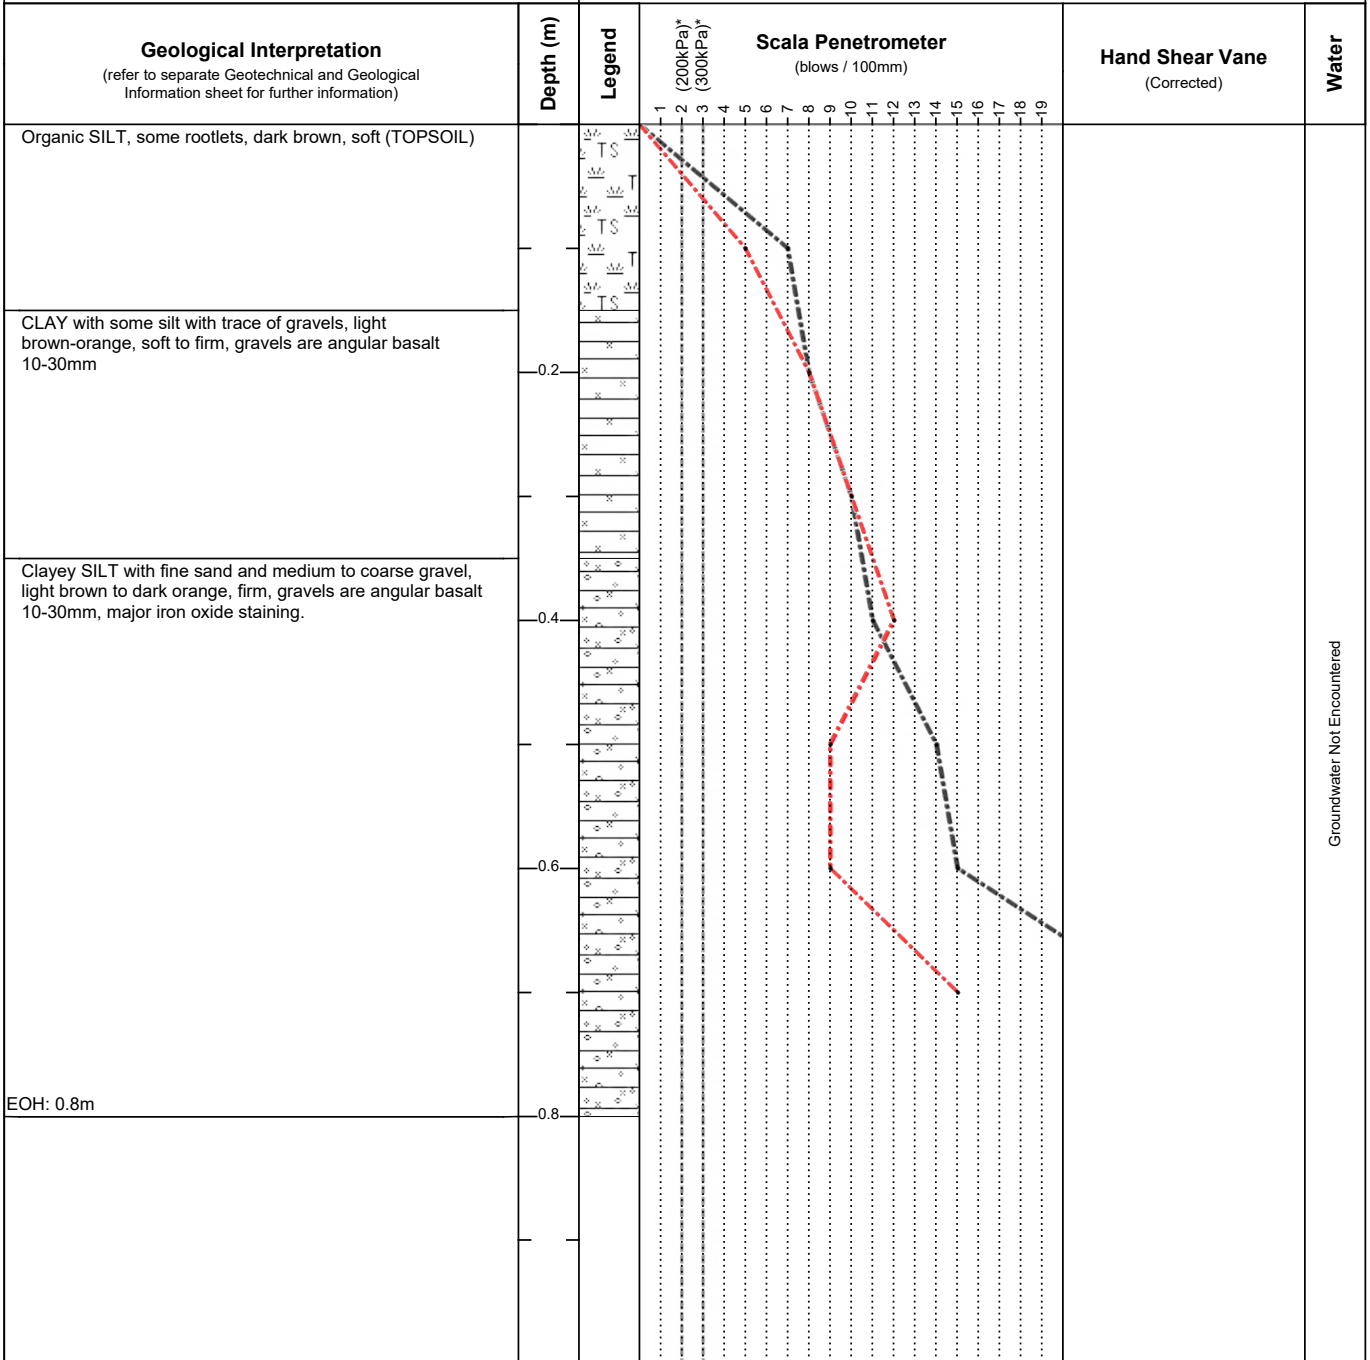
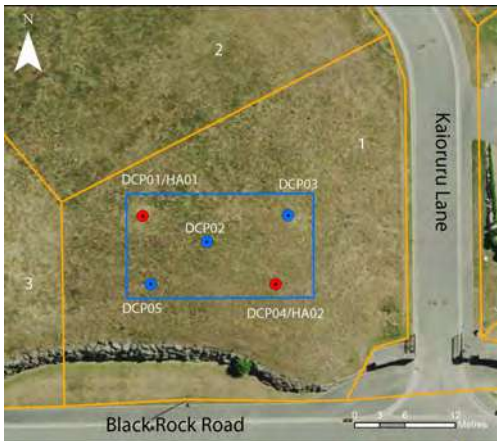
No.: DCP04 + DCP05

Groundwater Not Encountered
