GEOTECHNICAL INVESTIGATION REPORT

PROPOSED DWELLING

**35A VICTORIA AVENUE,
WHAKATANE**

Reference: 231001
Prepared: 4 October 2023
Issued to: Christina Tay
101/13 Surrey Crescent
Grey Lynn
Auckland 1021
christina.tay@outlook.com

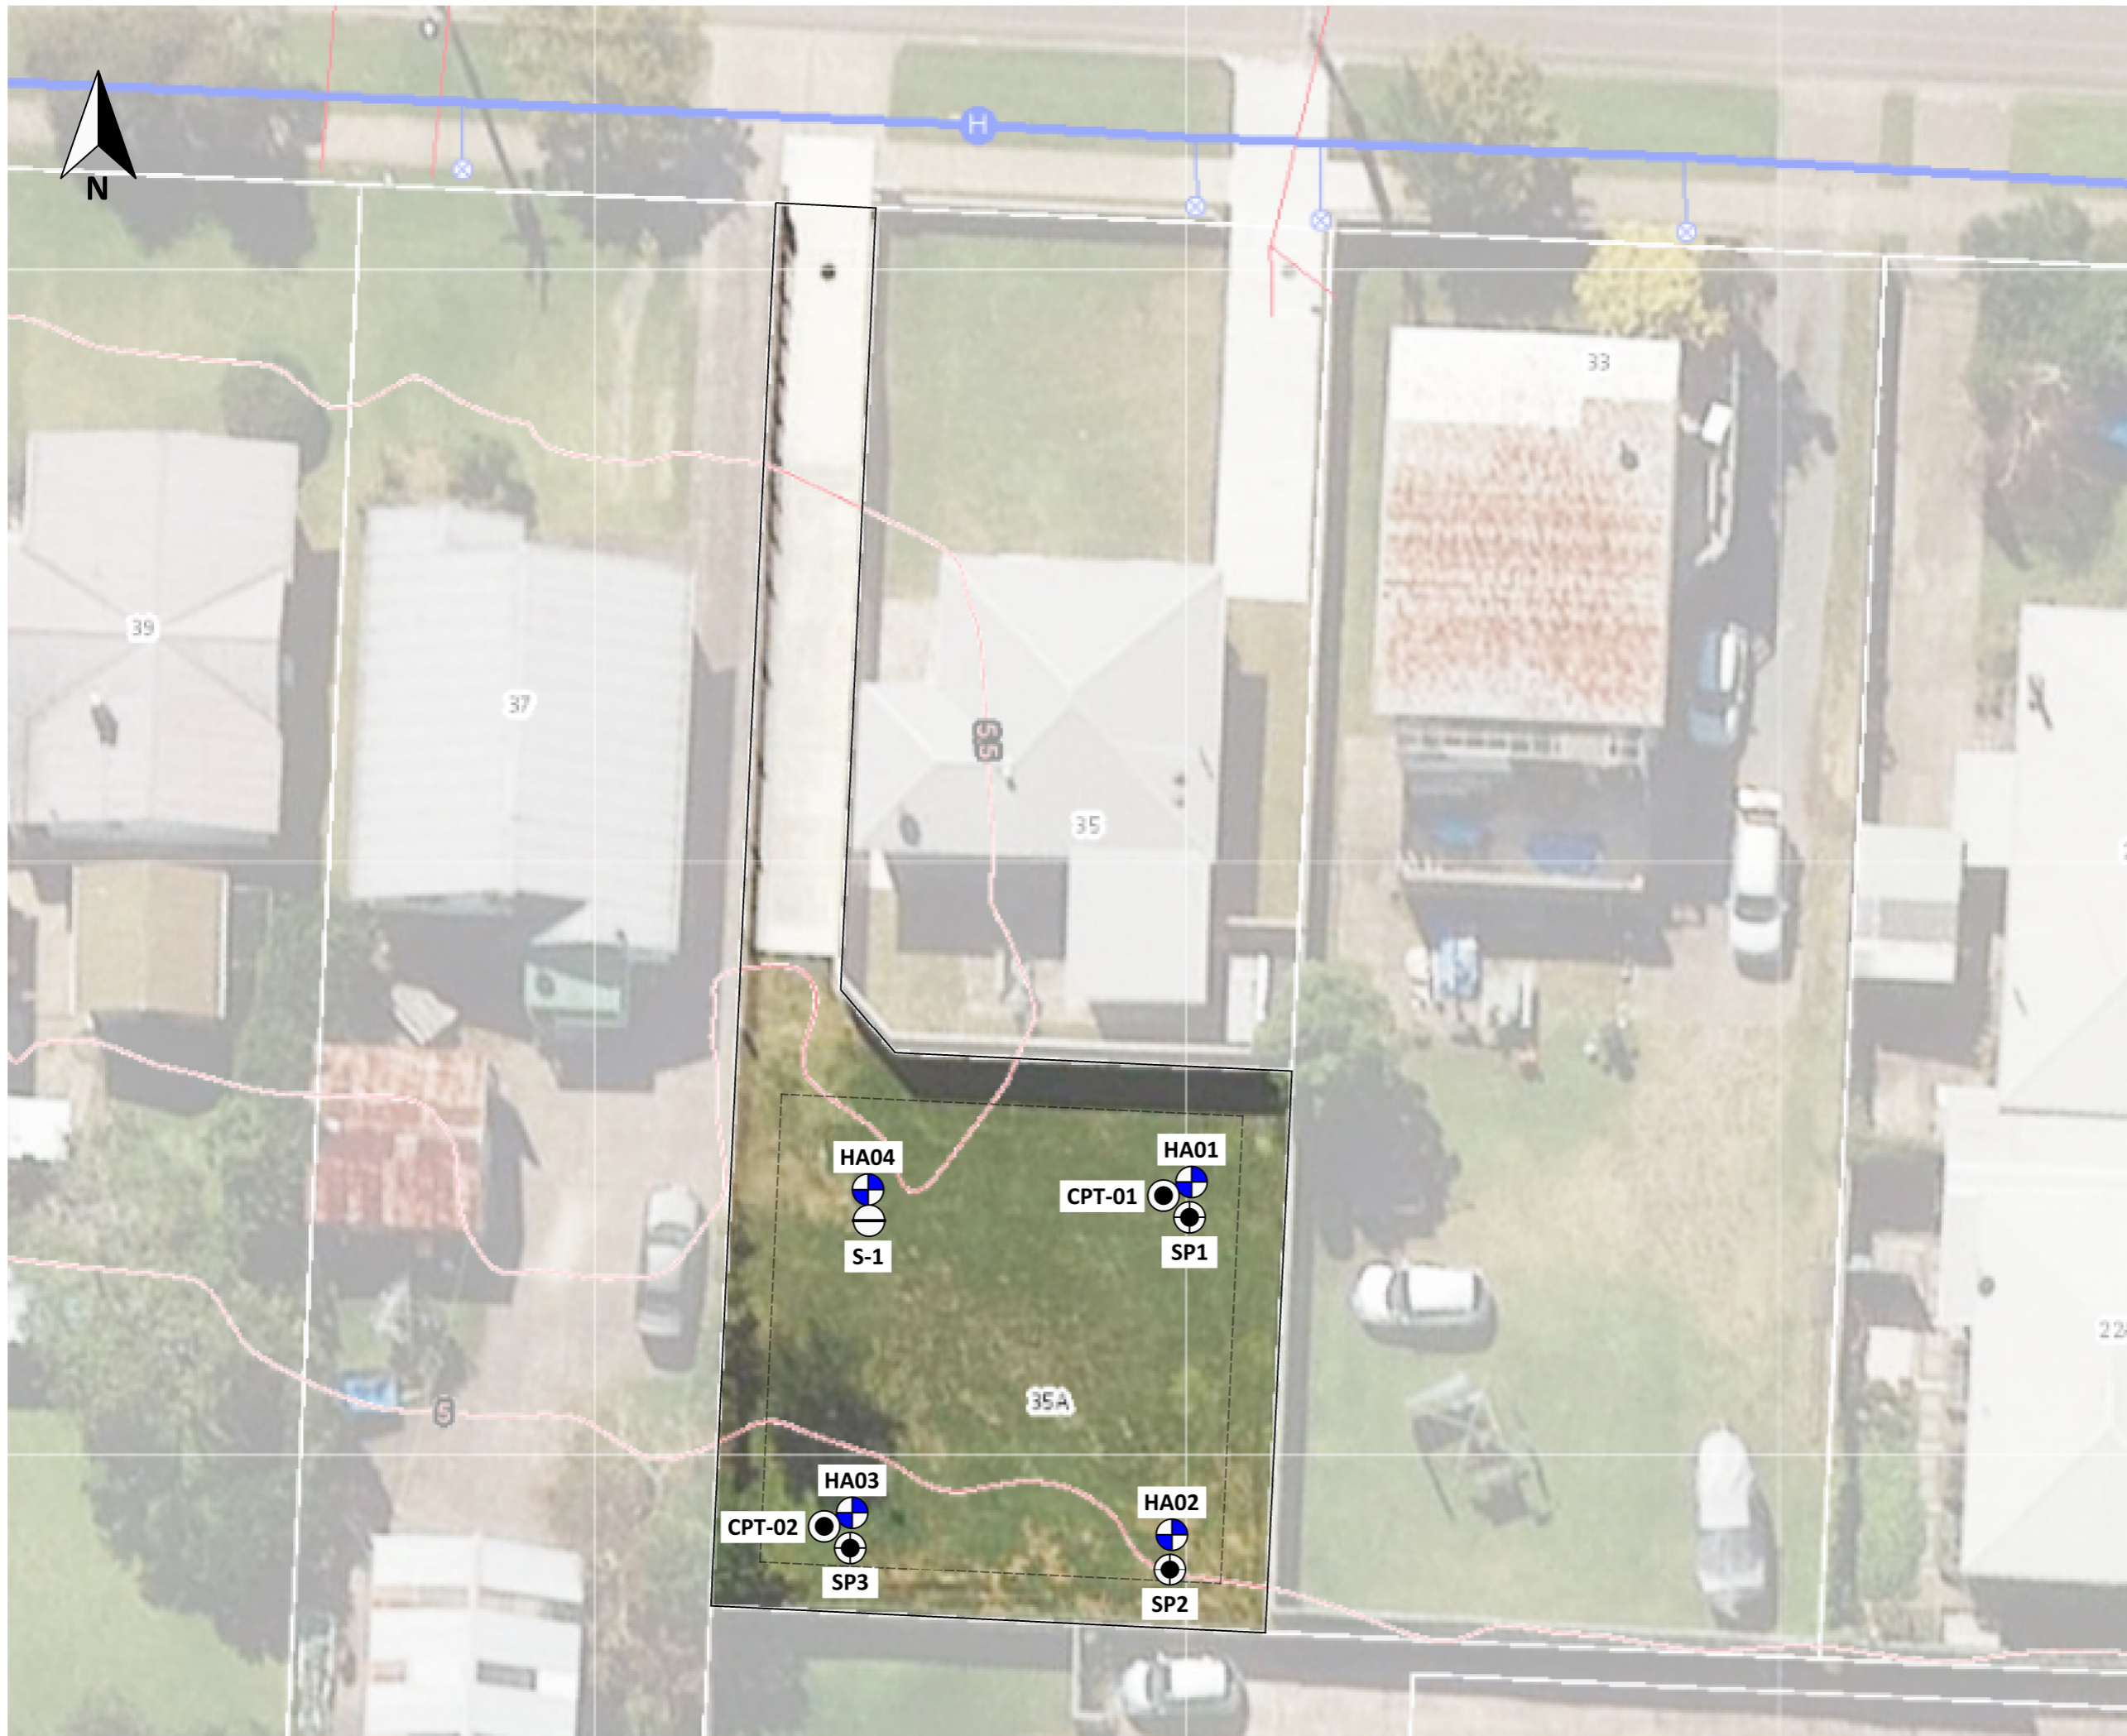
SCALE AT A3:	DATE:	DRAWN:	CHECKED:
1 : 200	OCT 2023	AD	JTH
SHEET NO:	DRAWING NO:	REVISION:	
1 OF 1	231001/1	-

A site plan is attached, drawing number 231001/1.

The approximate location of the proposed building platform is shown on the attached site plan, drawing number 231001/1.

The approximate locations of all test positions are shown on our attached site plan, drawing number 231001/1. The borehole logs, Scala penetrometer, soakage and CPT results are also attached. The soil descriptions given on the logs are in general accordance with the New Zealand Geotechnical Society's

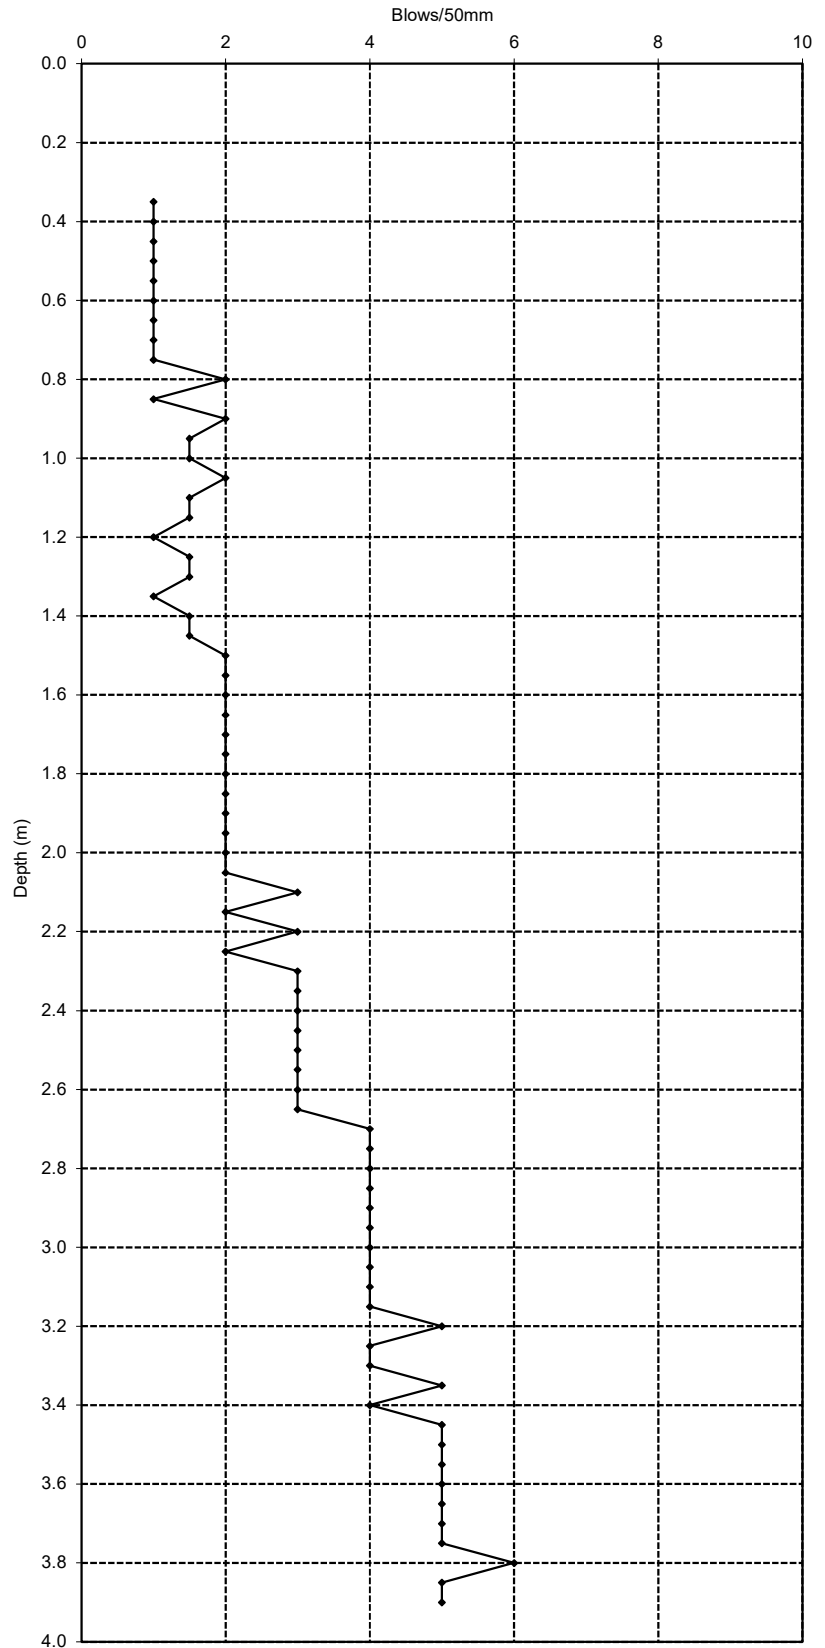
No. **SP1**

Scala penetrometer tests were carried out from the ground surface immediately adjacent to selected hand auger boreholes to confirm the relative density of the shallow granular subsoils. The granular soils typically achieved values between 1 and 3 blows per 100 mm over the upper 1.5 m before increasing to between 4 and 7 blows per 100 mm to depths of 2.7 and 2.3 m in SP1 and SP2, respectively, and to the termination of testing (1.9 m) in SP3. The sands over the remainder of the tested depth in SP1 (3.9 m) and SP2 (2.9 m) are dense with blow counts between 8 and 11 blows per 100 mm.

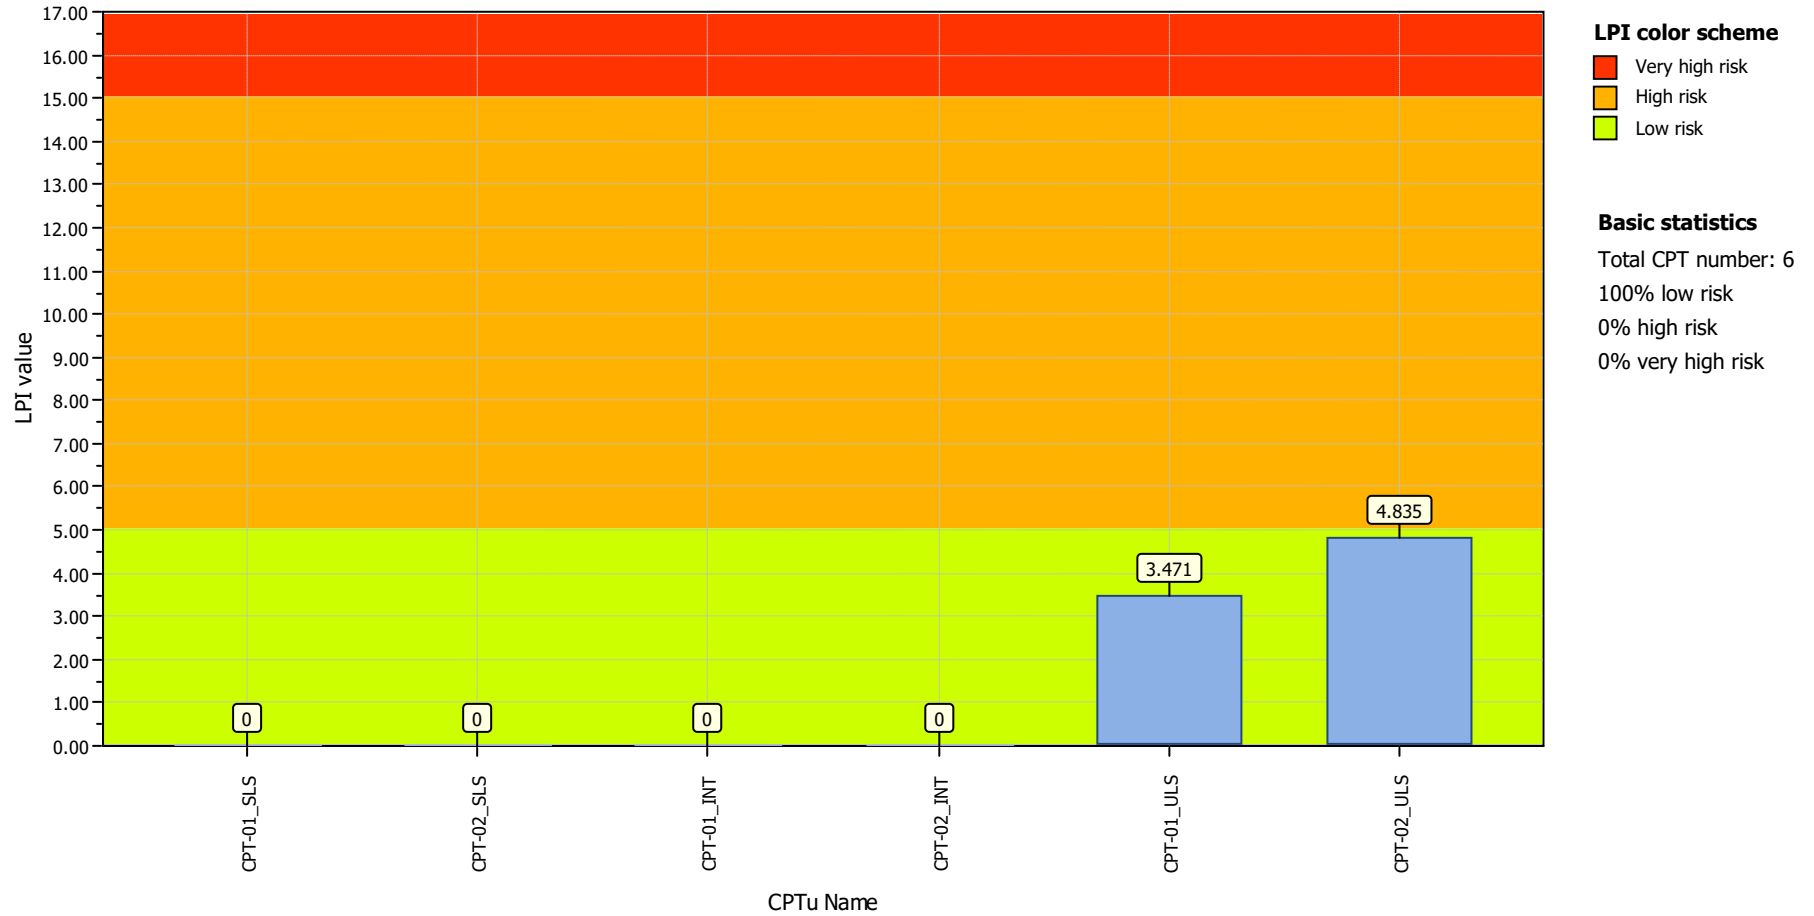
Overall Liquefaction Potential Index report

The results indicate that during an SLS earthquake event negligible settlement (<5 mm) is predicted (refer Table 8.2.3 for details). The liquefaction potential index is classified as low risk with little to no expression of liquefaction (i.e. sand boils or ejecta) expected at the surface.

During a ULS earthquake event, approximately 60 to 70 mm of settlement due to liquefaction is predicted over the tested depth (15 m) with 10 to 15 mm occurring within the upper 10 m. The liquefaction potential index is classified as low risk with minor expression of liquefaction expected at the surface (i.e. sand boils or ejecta). The analysis indicates that the potentially liquefiable soils below the groundwater are generally below 10 m where cone resistance values of 15 MPa or less were encountered.

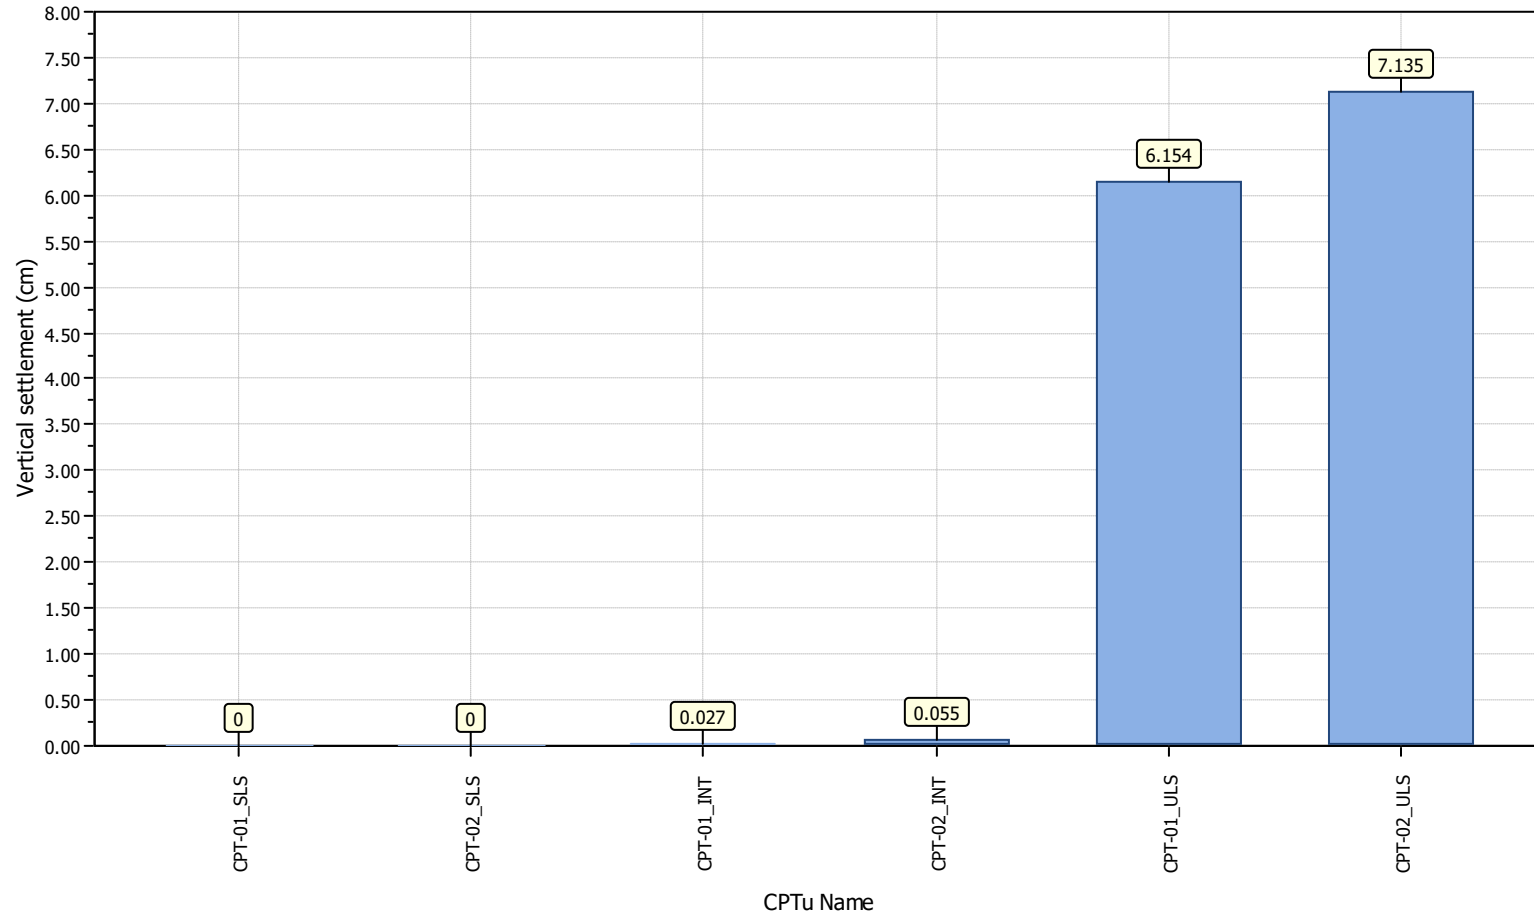
Overall vertical settlements report

Differential settlements in the order of one half to two thirds of the estimated values may be expected at the ground surface. The liquefaction analysis outputs are attached with results summarised below.

Based on our analysis, liquefaction induced settlements under a SLS design event are estimated to be negligible, while under the ULS design conditions less than 25 mm of settlement can be expected over the upper 10 m. Comparing these results with the information provided in the MBIE Guidance for construction and repair of residential buildings in the Canterbury region following the 2010 earthquake sequence, gives the equivalent of a TC1 site.

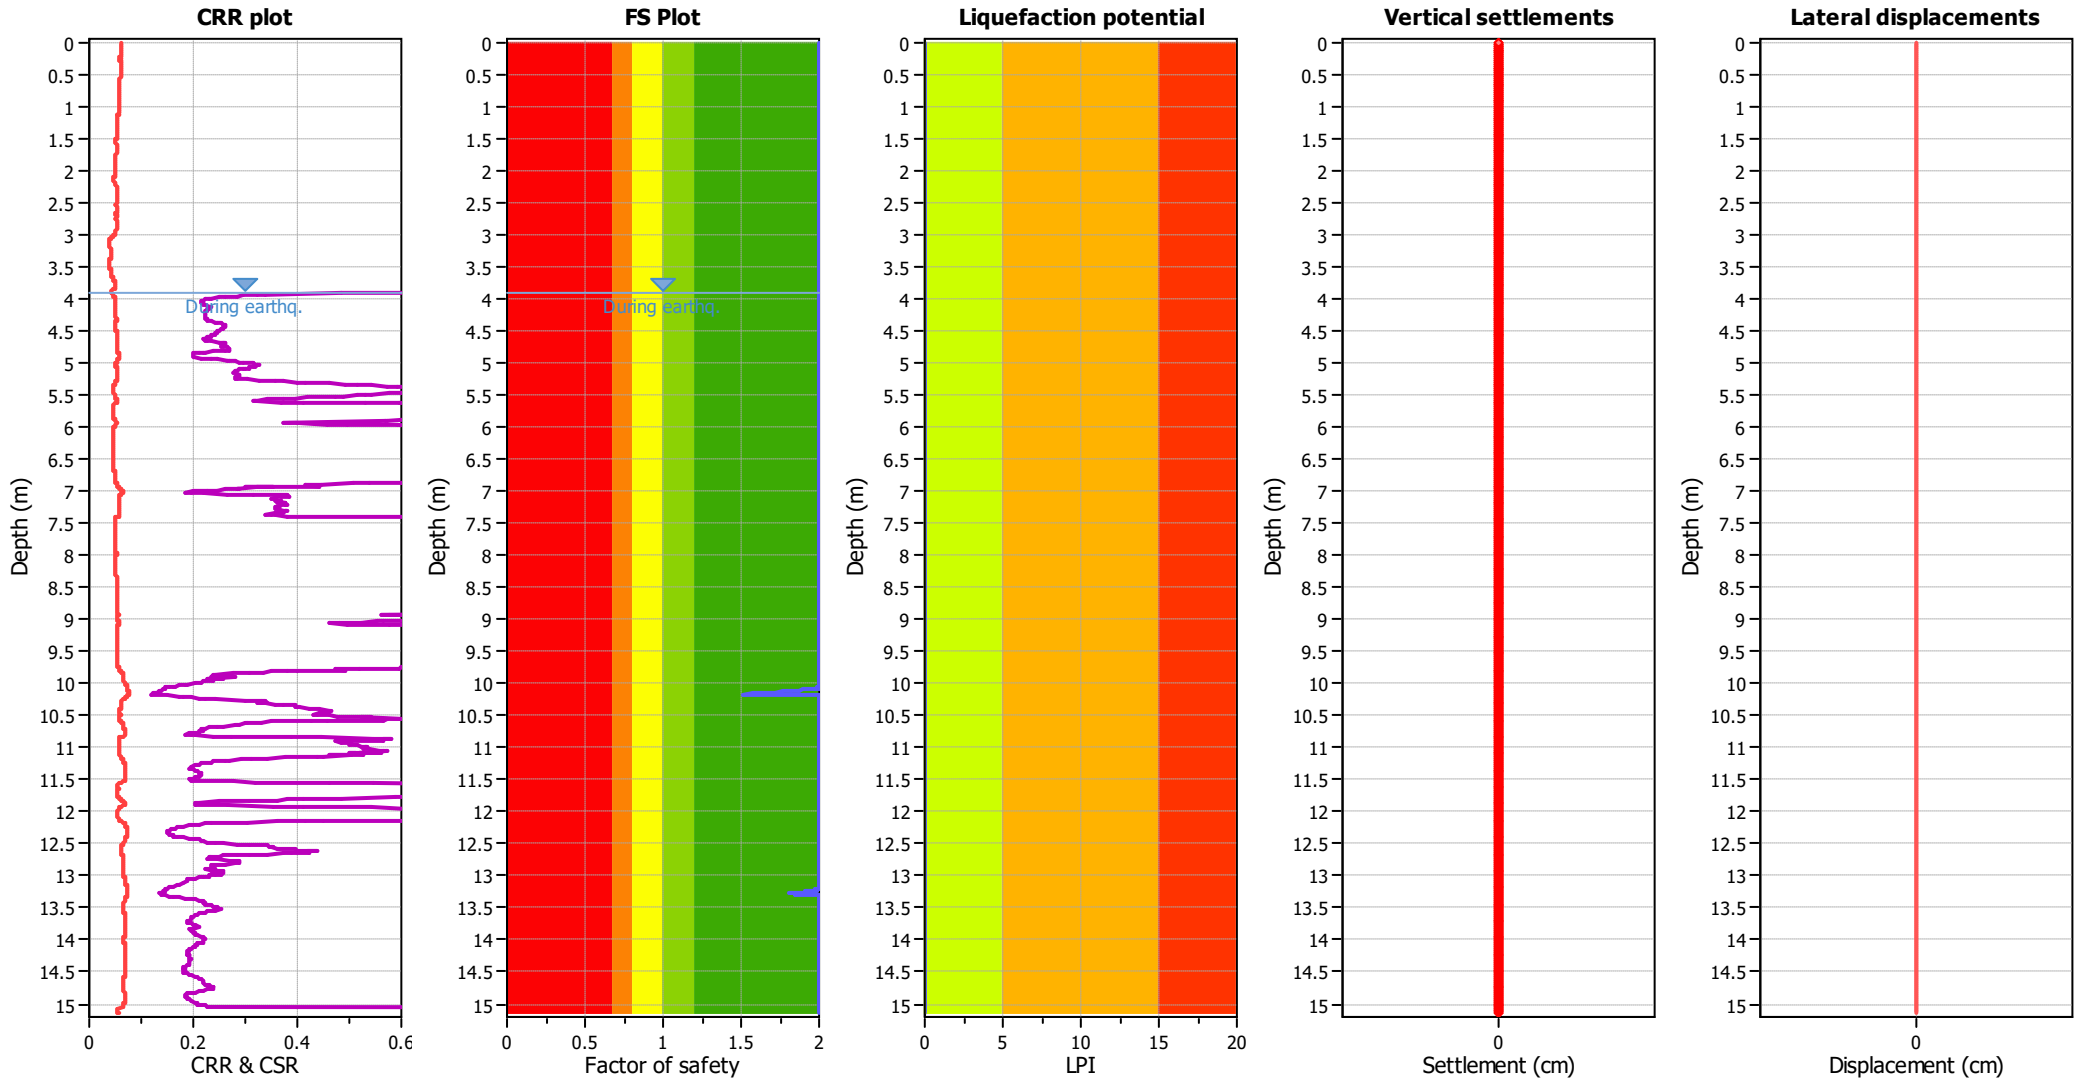
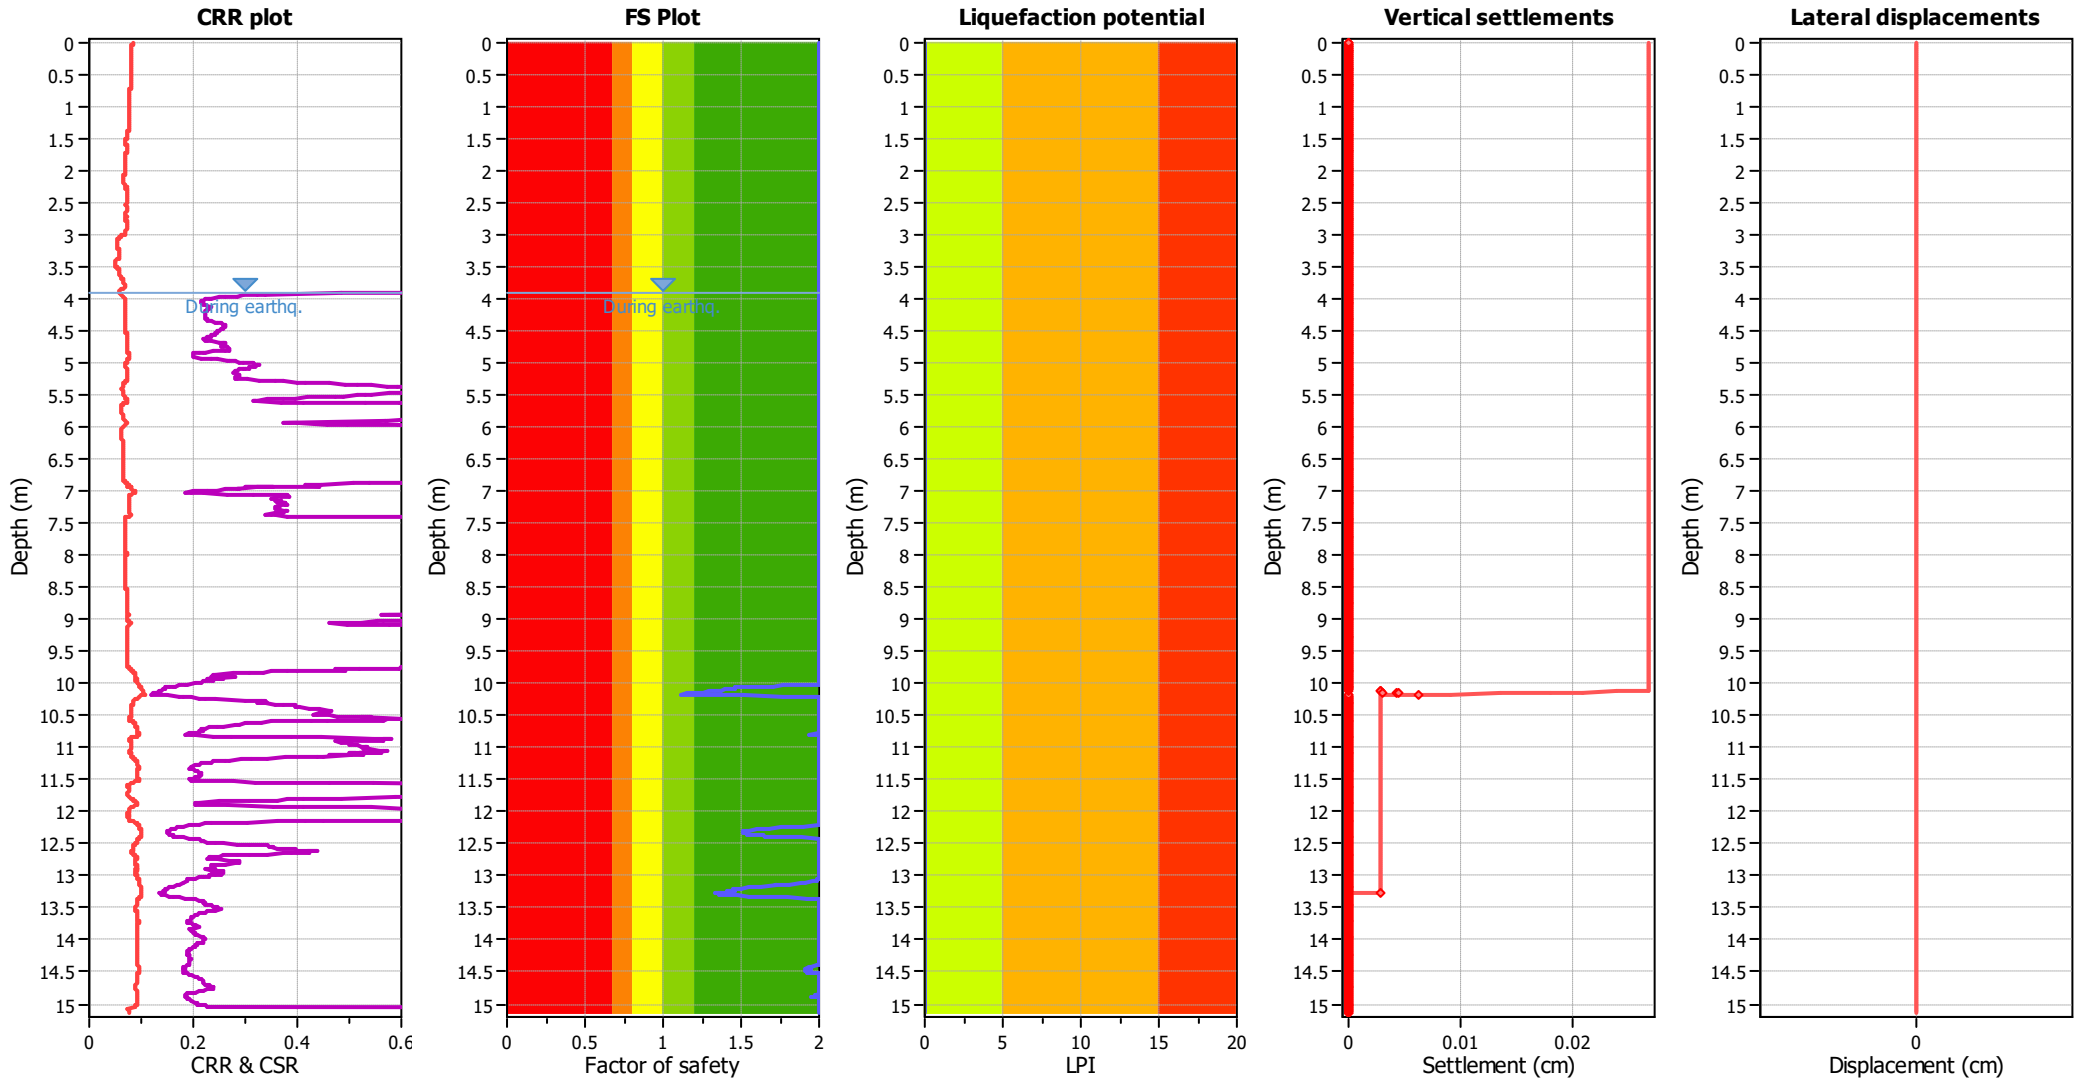
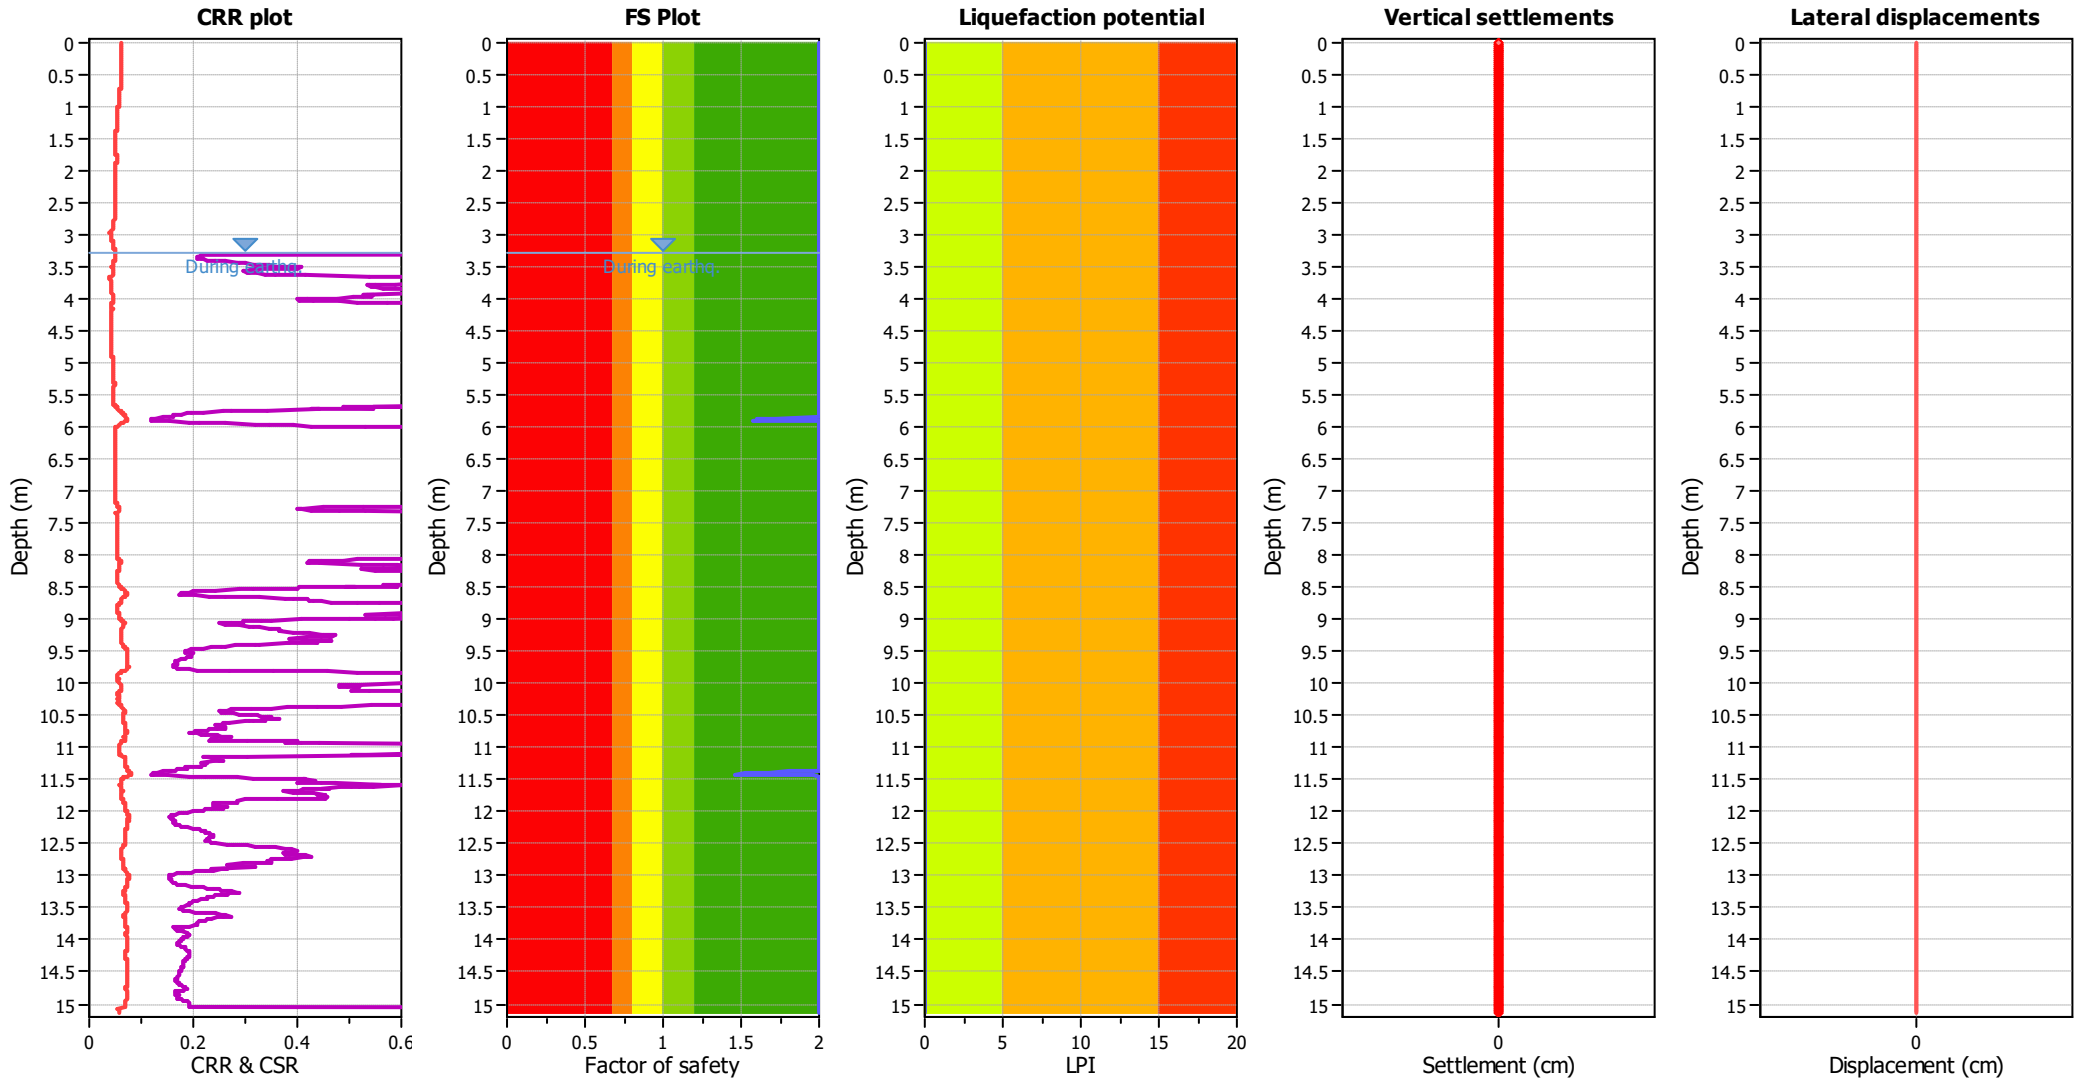
Liquefaction analysis overall plots

Analyses were also completed for an optional intermediate level event (1 in 50 years) as this size of event should be expected to occur at least once during the design lifetime of the building. Settlements of less than 5 mm were predicted for this event with little to no expression of the liquefaction predicted at the surface.

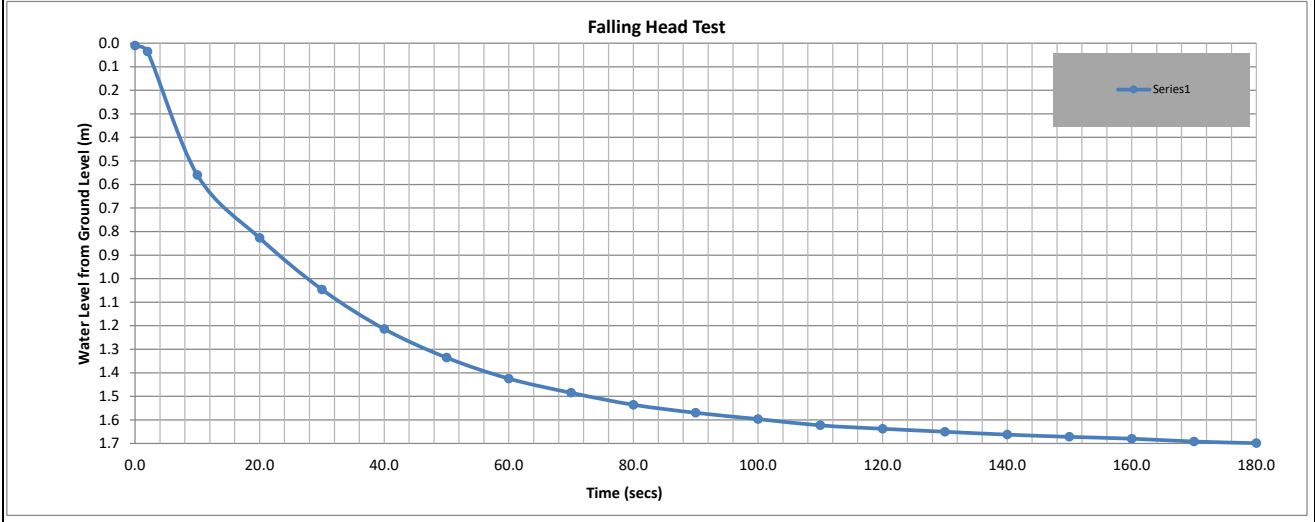
Soakage testing was conducted within the underlying natural soils to a depth of 1.7 m. Analysis of the falling head test data provided a soakage rate of 1,998 L/hr/m². For design purposes a soakage rate reduction factor of 0.5 should be applied.

The site is considered geotechnically suitable for disposal of stormwater runoff via on-site ground soakage. The soakage system should be located a sufficient distance from building foundations and the property boundaries.
