## GEOTECHNICAL ENGINEERING INVESTIGATION REPORT

Proposed Shed and Future Dwelling  
263 Wellsford Valley Road,  
Wellsford

Ref No. J1222-1

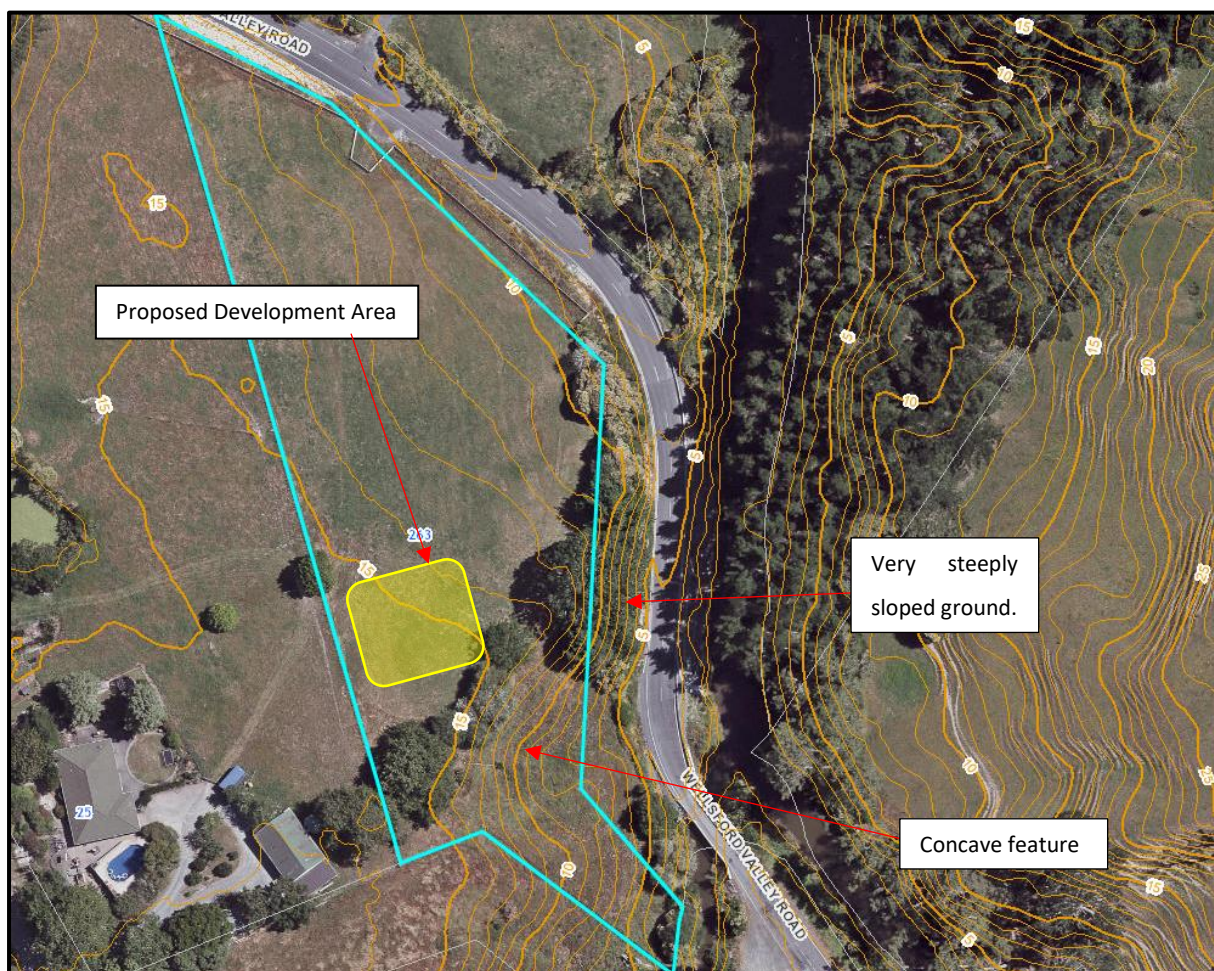
Figure 1: Subject Property and Proposed Development Area (Taken from Auckland Council GeoMaps; North Up Page)

The property is presently vacant, with the exception of a gravel driveway running parallel with the western property boundary to the proposed development area. The approximate development area at the property is shown on Figure 1 below.

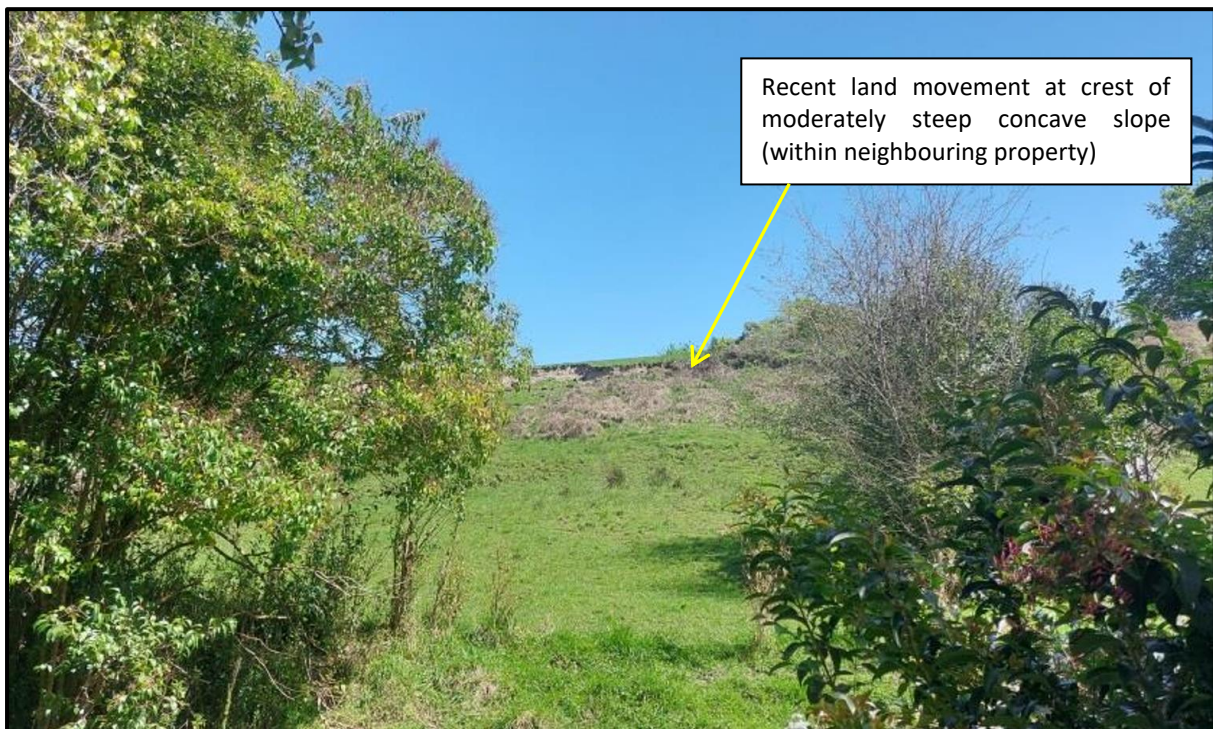
*Figure 2: Land Movement at Crest of Concave Slope in Neighbouring Property*

The steeply sloping concave feature extends southwards into neighbouring sites. During our walkover, we noted that in a property to the south (approximately 70m from the development area) had been subject to recent instability. A headscarp (estimated 1.5m depth) can be observed as shown on Figure 2 below.

As noted in the Site description and Geohazard Table, the concave feature to the southeast of the development may be prone to future instability, with recent instability being observed on the same topographic feature within the neighbouring property to the south.

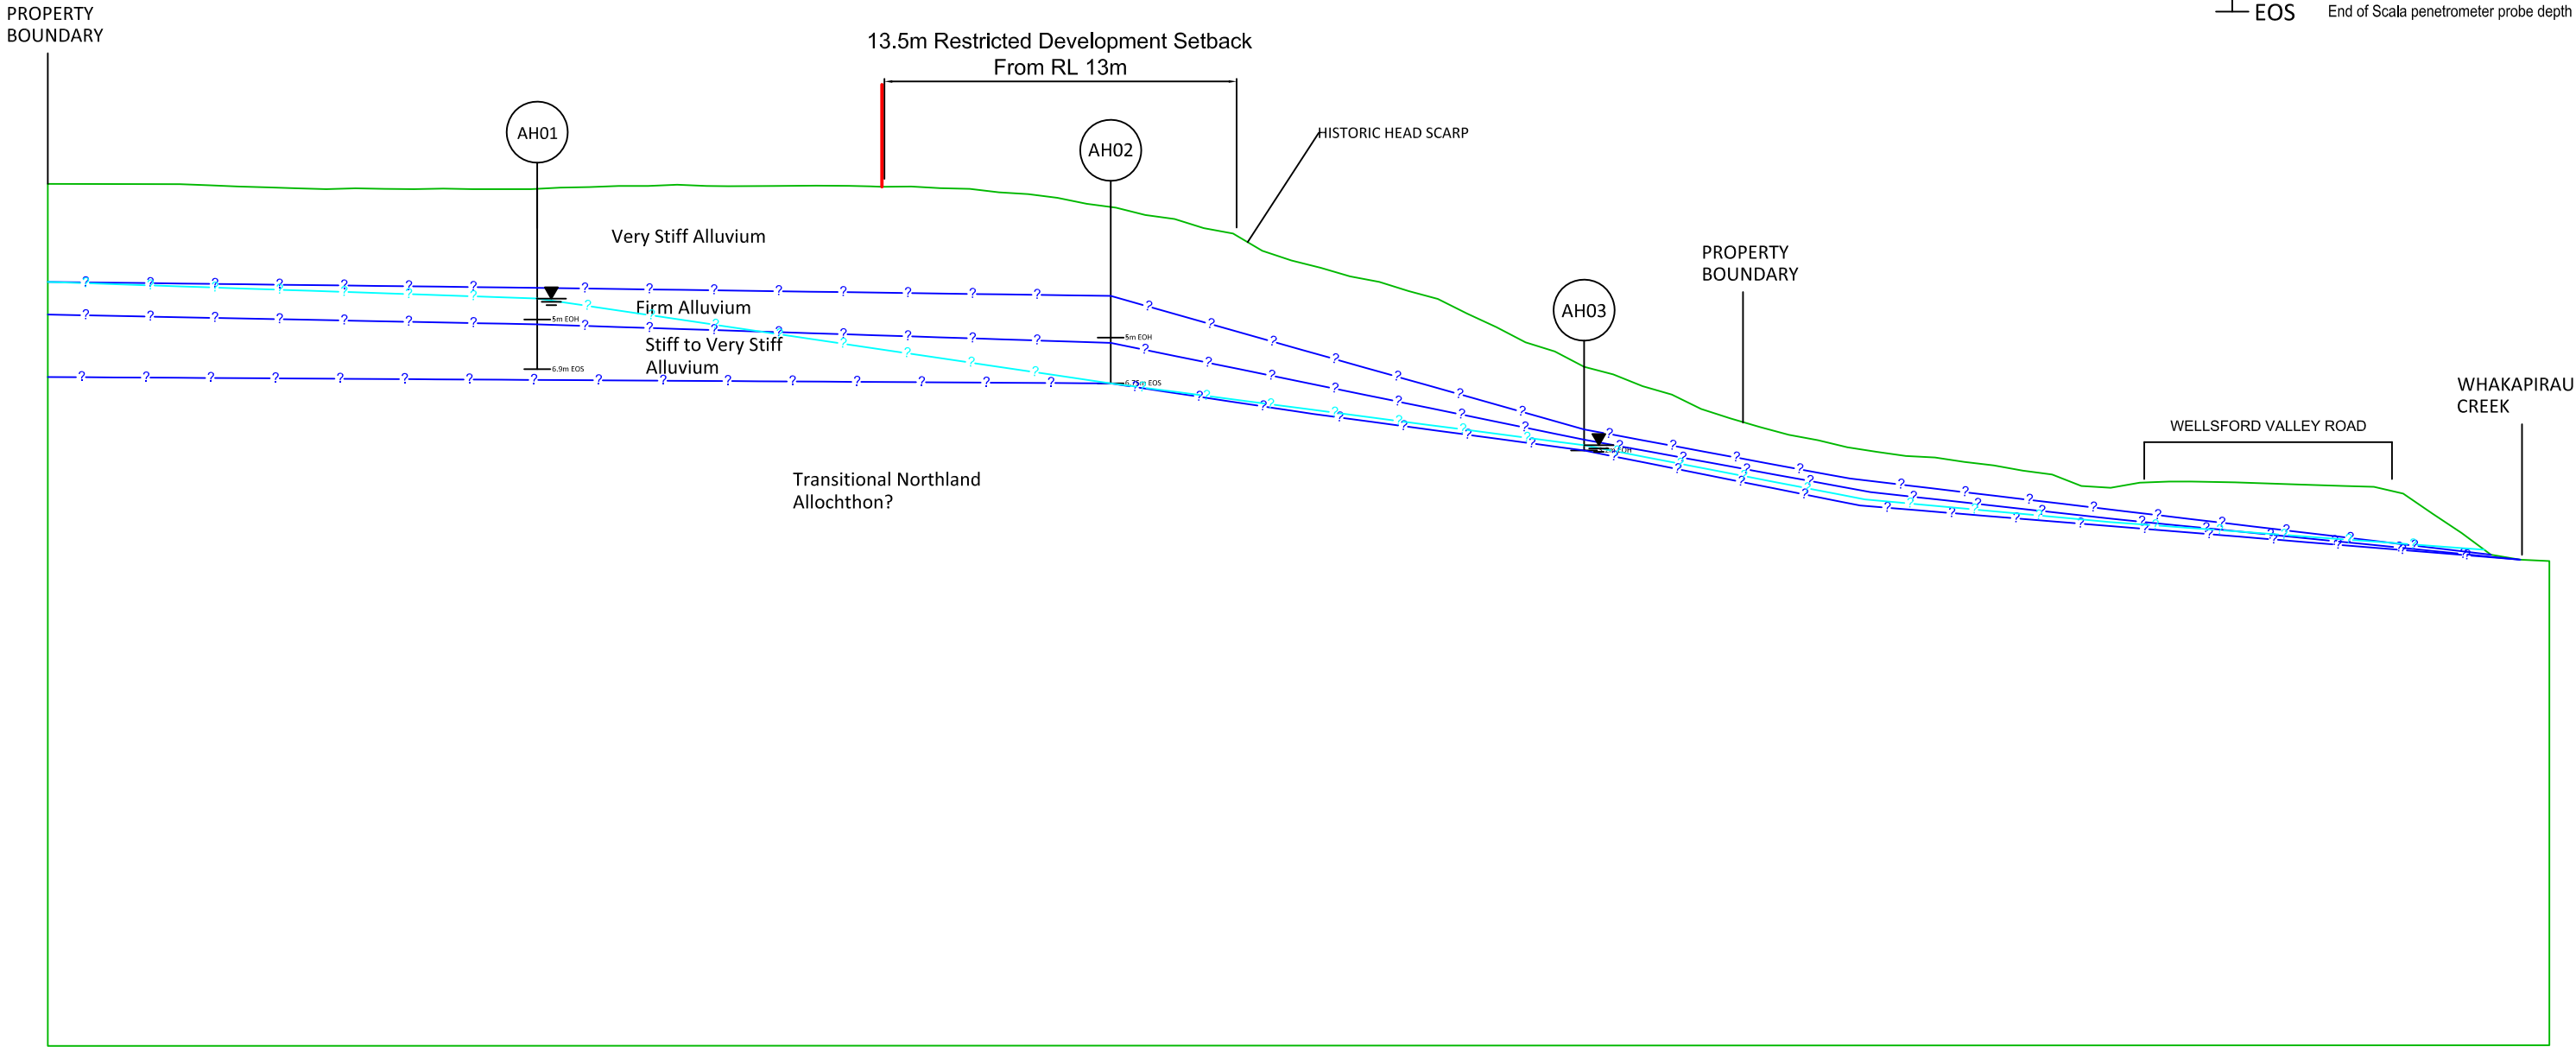
- Notes:
- Locations of features approximate only.
  - Ground profile based on 2016 LIDAR aerial survey.
  - For detailed subsurface conditions, refer to borehole logs.

In order to carry out the global stability assessment we have created a geological cross section through the development site and into the concave feature. The location of the geological cross section is shown on Sheet 1 as Section AA’. We have created a geological cross-section, attached as Sheet 3.

The surface profile has been generated based on the 2016 LIDAR Digital Elevation Model (DEM) data, publicly available on the LINZ website. The subsurface conditions have been extrapolated from our hand auger borehole investigation to create our ground model for the stability assessment; with geotechnical soil strength parameters detailed in Table 2 used for the ground profile.

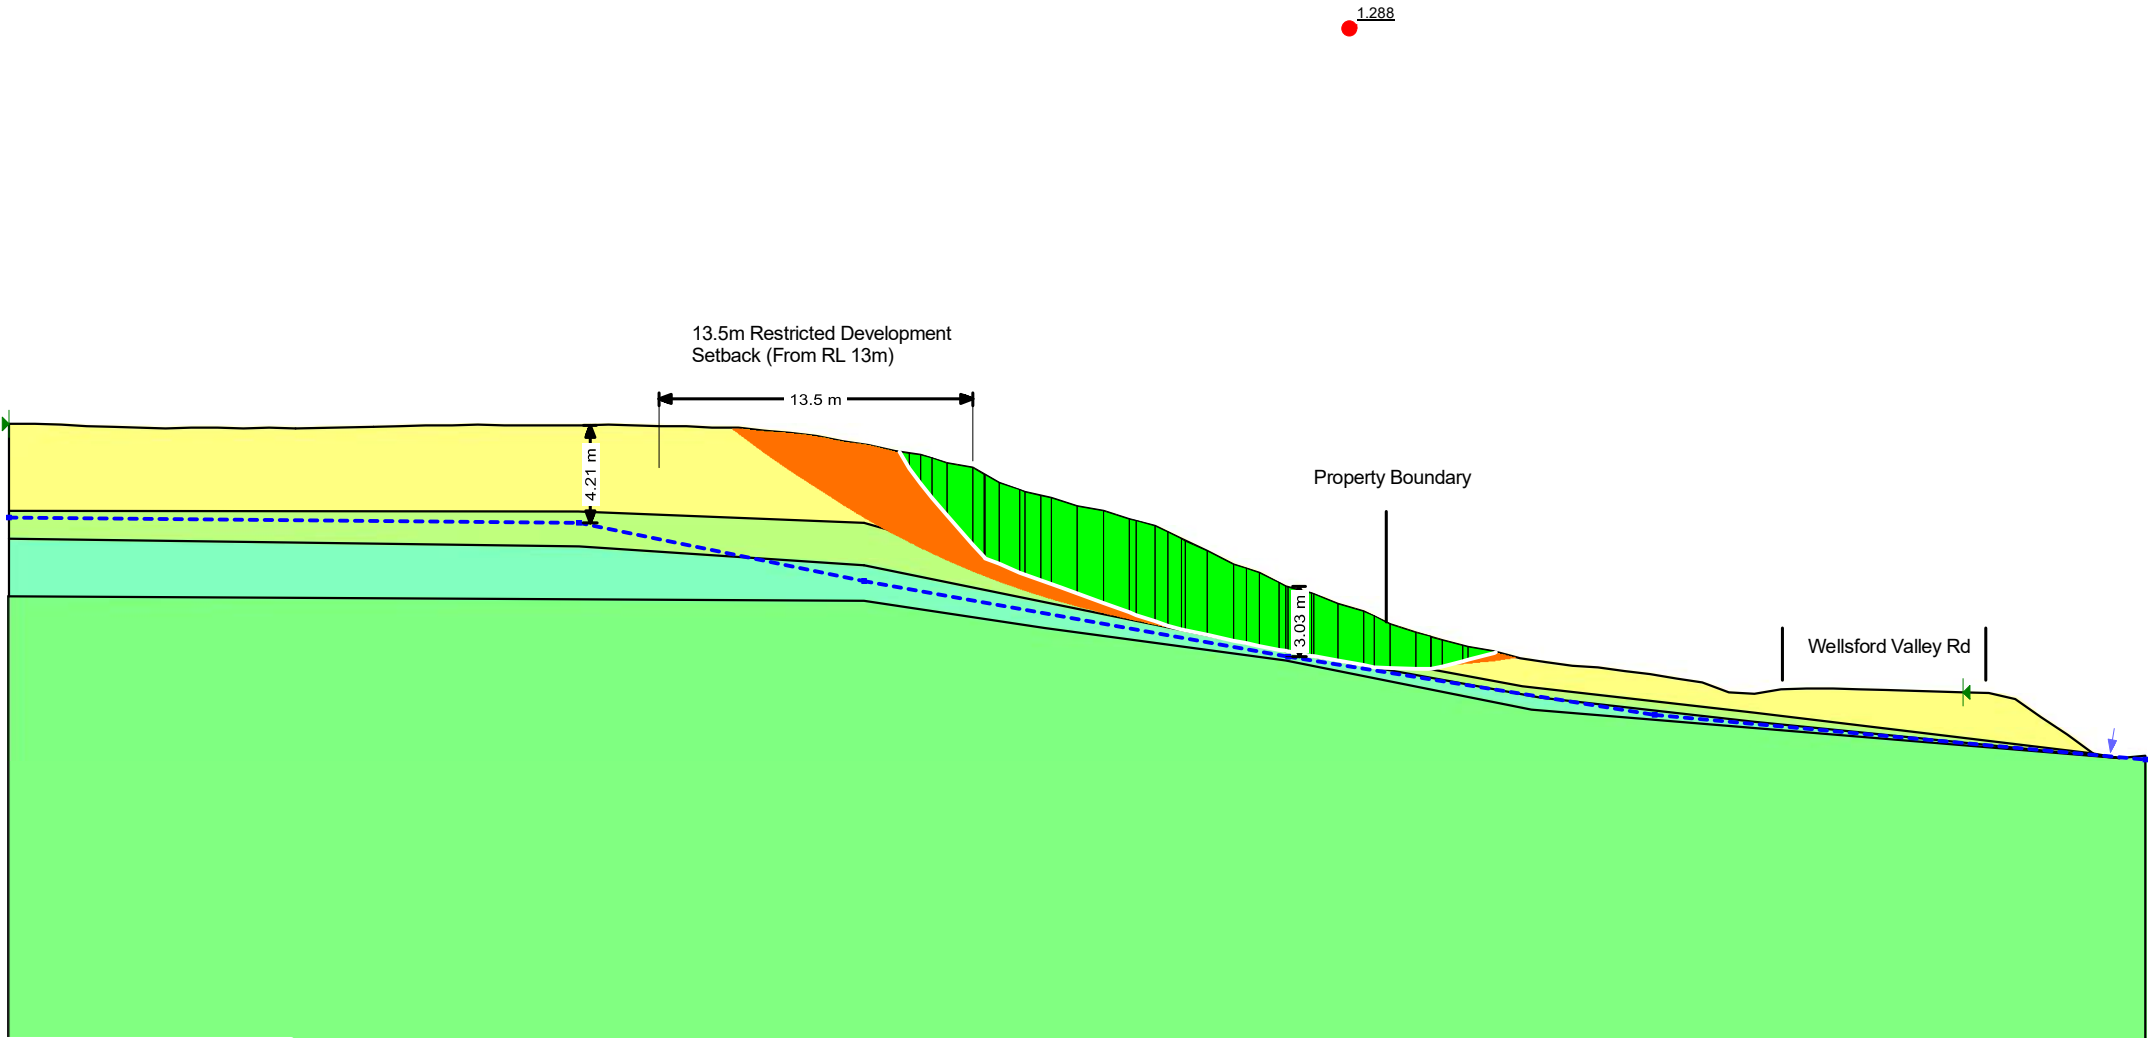
Color	Name	Slope Stability Material Model	Unit Weight (kN/m³)	Effective Cohesion (kPa)	Effective Friction Angle (°)	Phi-B (°)	Piezometric Surface
<div></div>	Dense NORTHLAND ALLOCTHON?	Mohr-Coulomb	18	4	28	0	1
<div></div>	Firm ALLUVIUM	Mohr-Coulomb	18	1	18	0	1
<div></div>	Stiff to Very Stiff ALLUVIUM	Mohr-Coulomb	18	1	28	0	1
<div></div>	Very Stiff ALLUVIUM	Mohr-Coulomb	18	4	28	0	1

Quantitative slope stability analysis has been carried out using the computer-based program SLOPE-W using the Spencer analysis method.

The minimum (critical) slip circle FoS values calculated in the slope stability analysis of Section AA', extending to the slope crest is shown in Table 4 below.

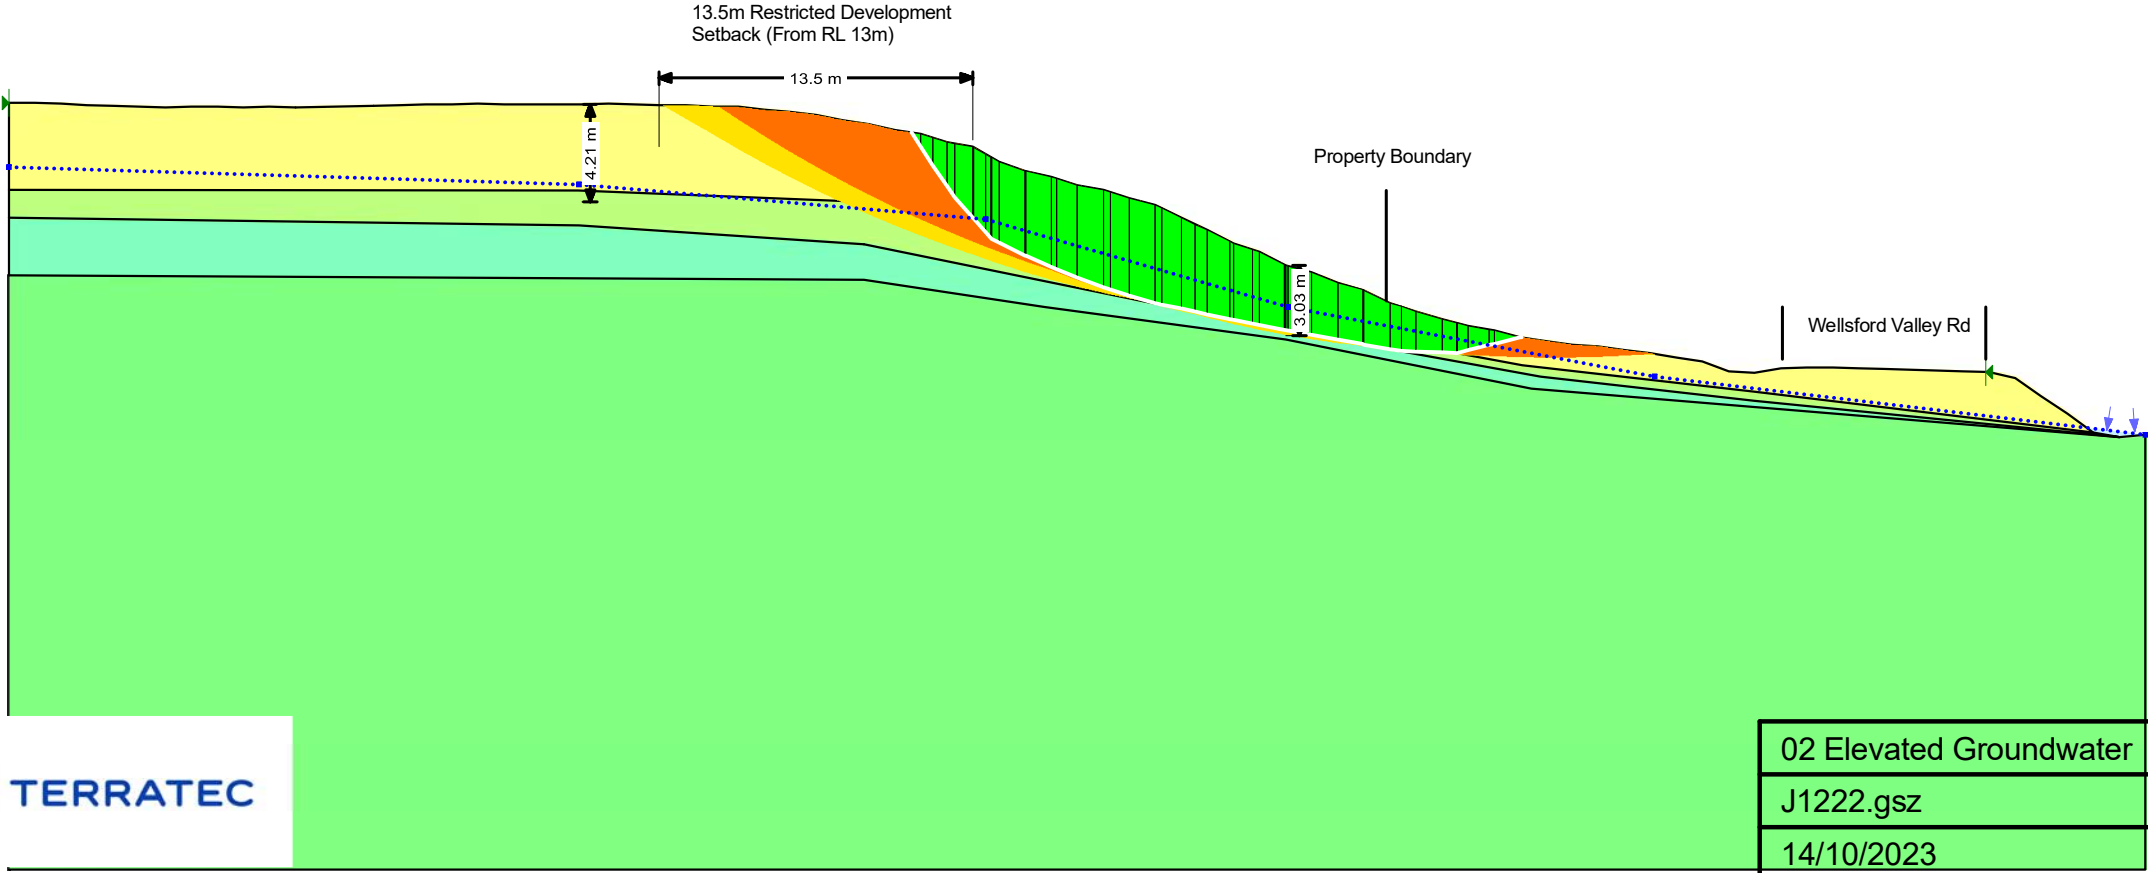
1.052

Color	Name	Slope Stability Material Model	Unit Weight (kN/m³)	Effective Cohesion (kPa)	Effective Friction Angle (°)	Phi-B (°)	Piezometric Surface	Ru	Include Ru in PWP
<div></div>	Dense NORTHLAND ALLOCTHON?	Mohr-Coulomb	18	4	28	0	1		No
<div></div>	Firm ALLUVIUM	Mohr-Coulomb	18	1	18	0	1		No
<div></div>	Stiff to Very Stiff ALLUVIUM	Mohr-Coulomb	18	1	28	0	1		No
<div></div>	Very Stiff ALLUVIUM	Mohr-Coulomb	18	4	28	0	1	0.25	Yes

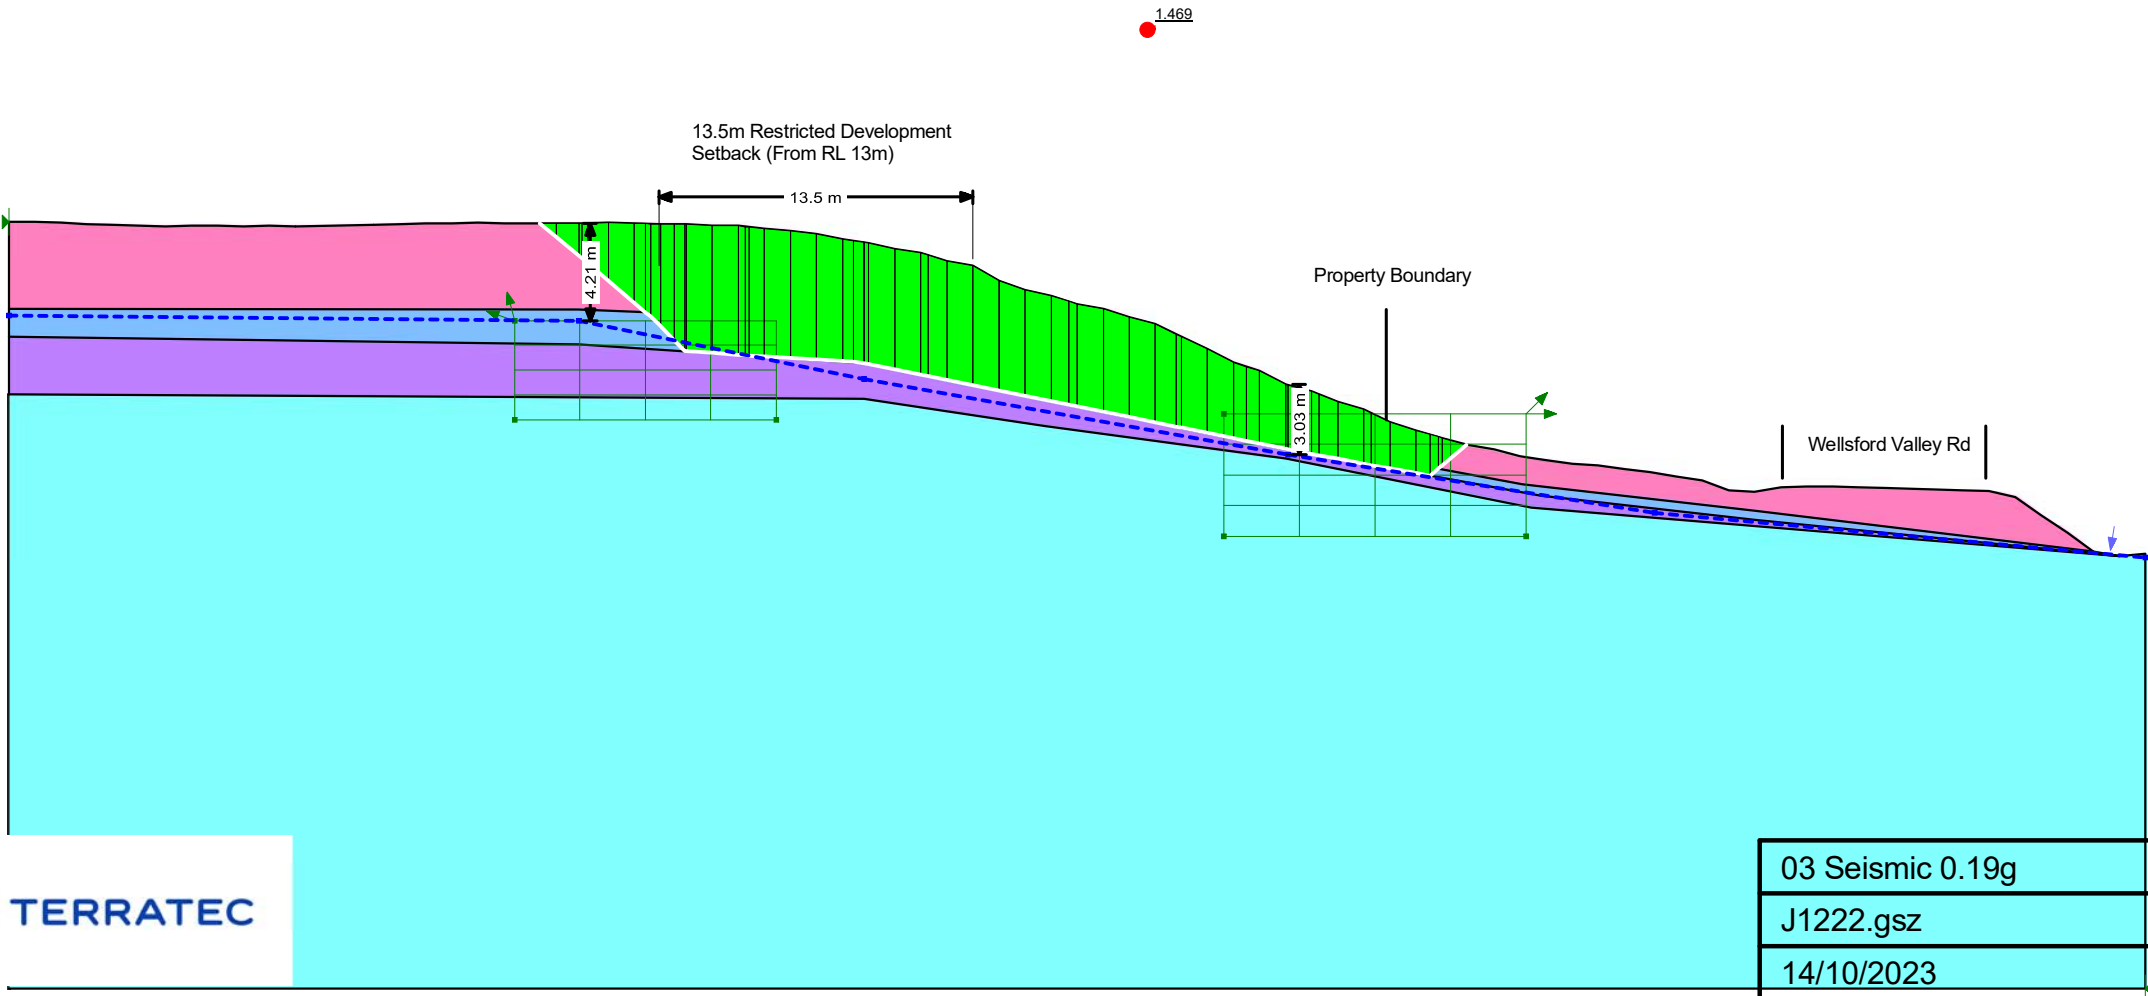
Color	Name	Slope Stability Material Model	Unit Weight (kN/m³)	Total Cohesion (kPa)	Piezometric Surface
<div></div>	Dense NORTHLAND ALLOCTHON? (Su)	Undrained (Phi=0)	18	100	1
<div></div>	Firm ALLUVIUM (Su)	Undrained (Phi=0)	18	25	1
<div></div>	Stiff to Very Stiff ALLUVIUM (Su)	Undrained (Phi=0)	18	60	1
<div></div>	Very Stiff ALLUVIUM (Su)	Undrained (Phi=0)	18	80	1
