LIM

Land Information Memorandum

Applicant	Toni Craig
Property Address	6 Philomel Crest Tauranga
Legal Description	LOT 134 DPS 41633
Application Date	19 June 2025

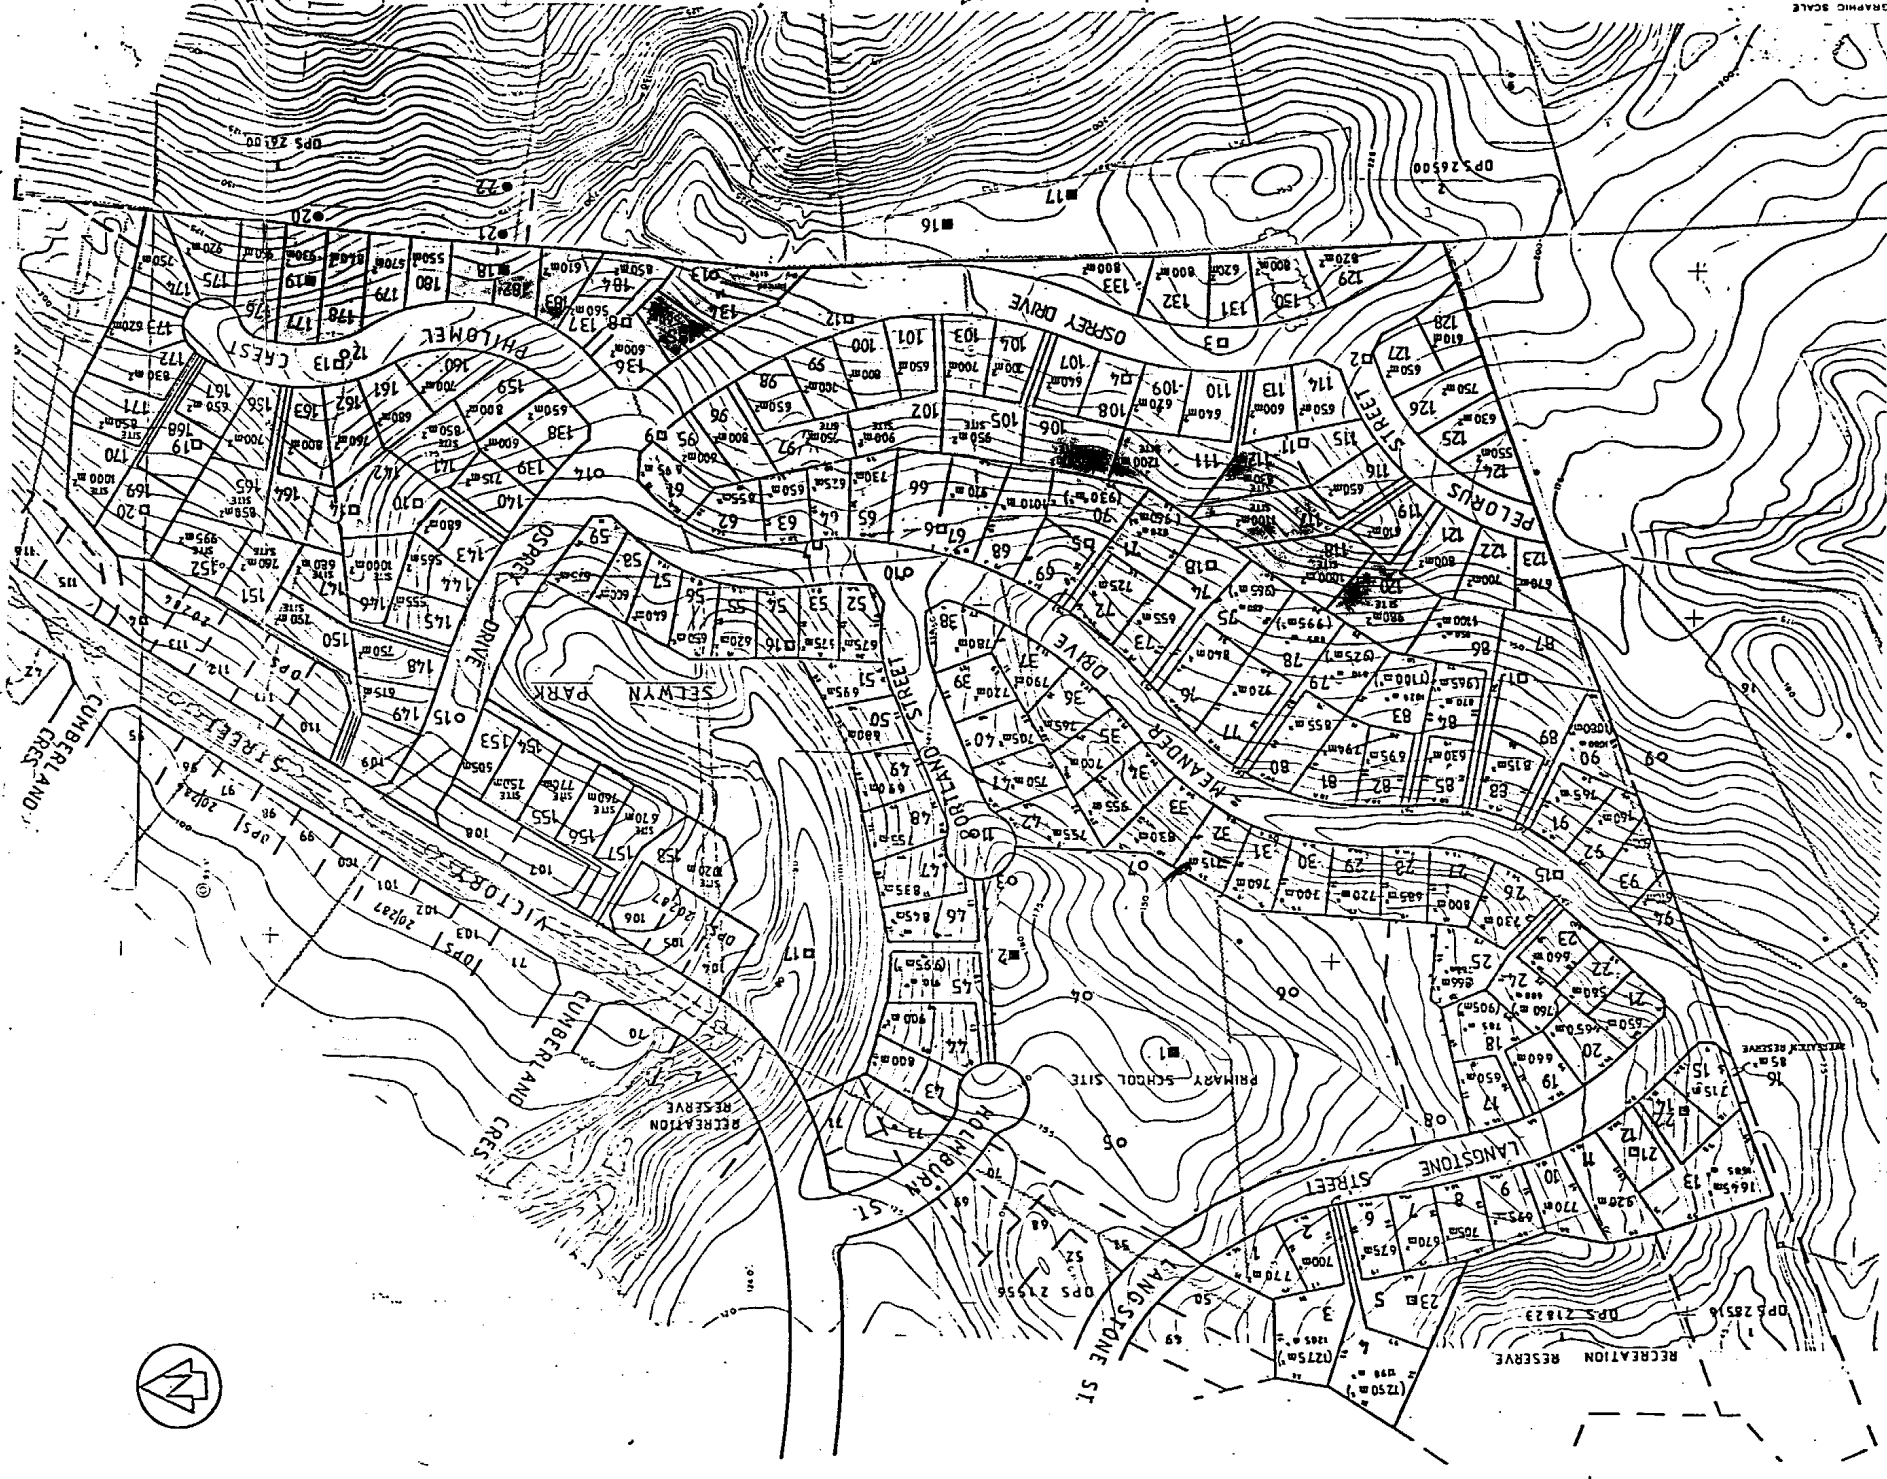
- - Hand Auger Bore
- - Power Auger Bore
- - Rotary Test Rig
- - Test pit

Test pits and auger holes put down during the site investigation work have been fixed and plotted as accurately as practicable on drawing S.L.5800/H1. Backfilling of these test holes has also been done under our supervision. It is possible however that the sites of these test positions may coincide with house foundations. At the time of foundation excavation or subsequent inspections due regard should be taken of the presence of test locations in certain properties. If these test locations are encountered in foundations and the formation integrity is compromised the matter should be referred back to us.
