25 KAHAWAI PLACE, OMOKOROA

Land Information Memorandum

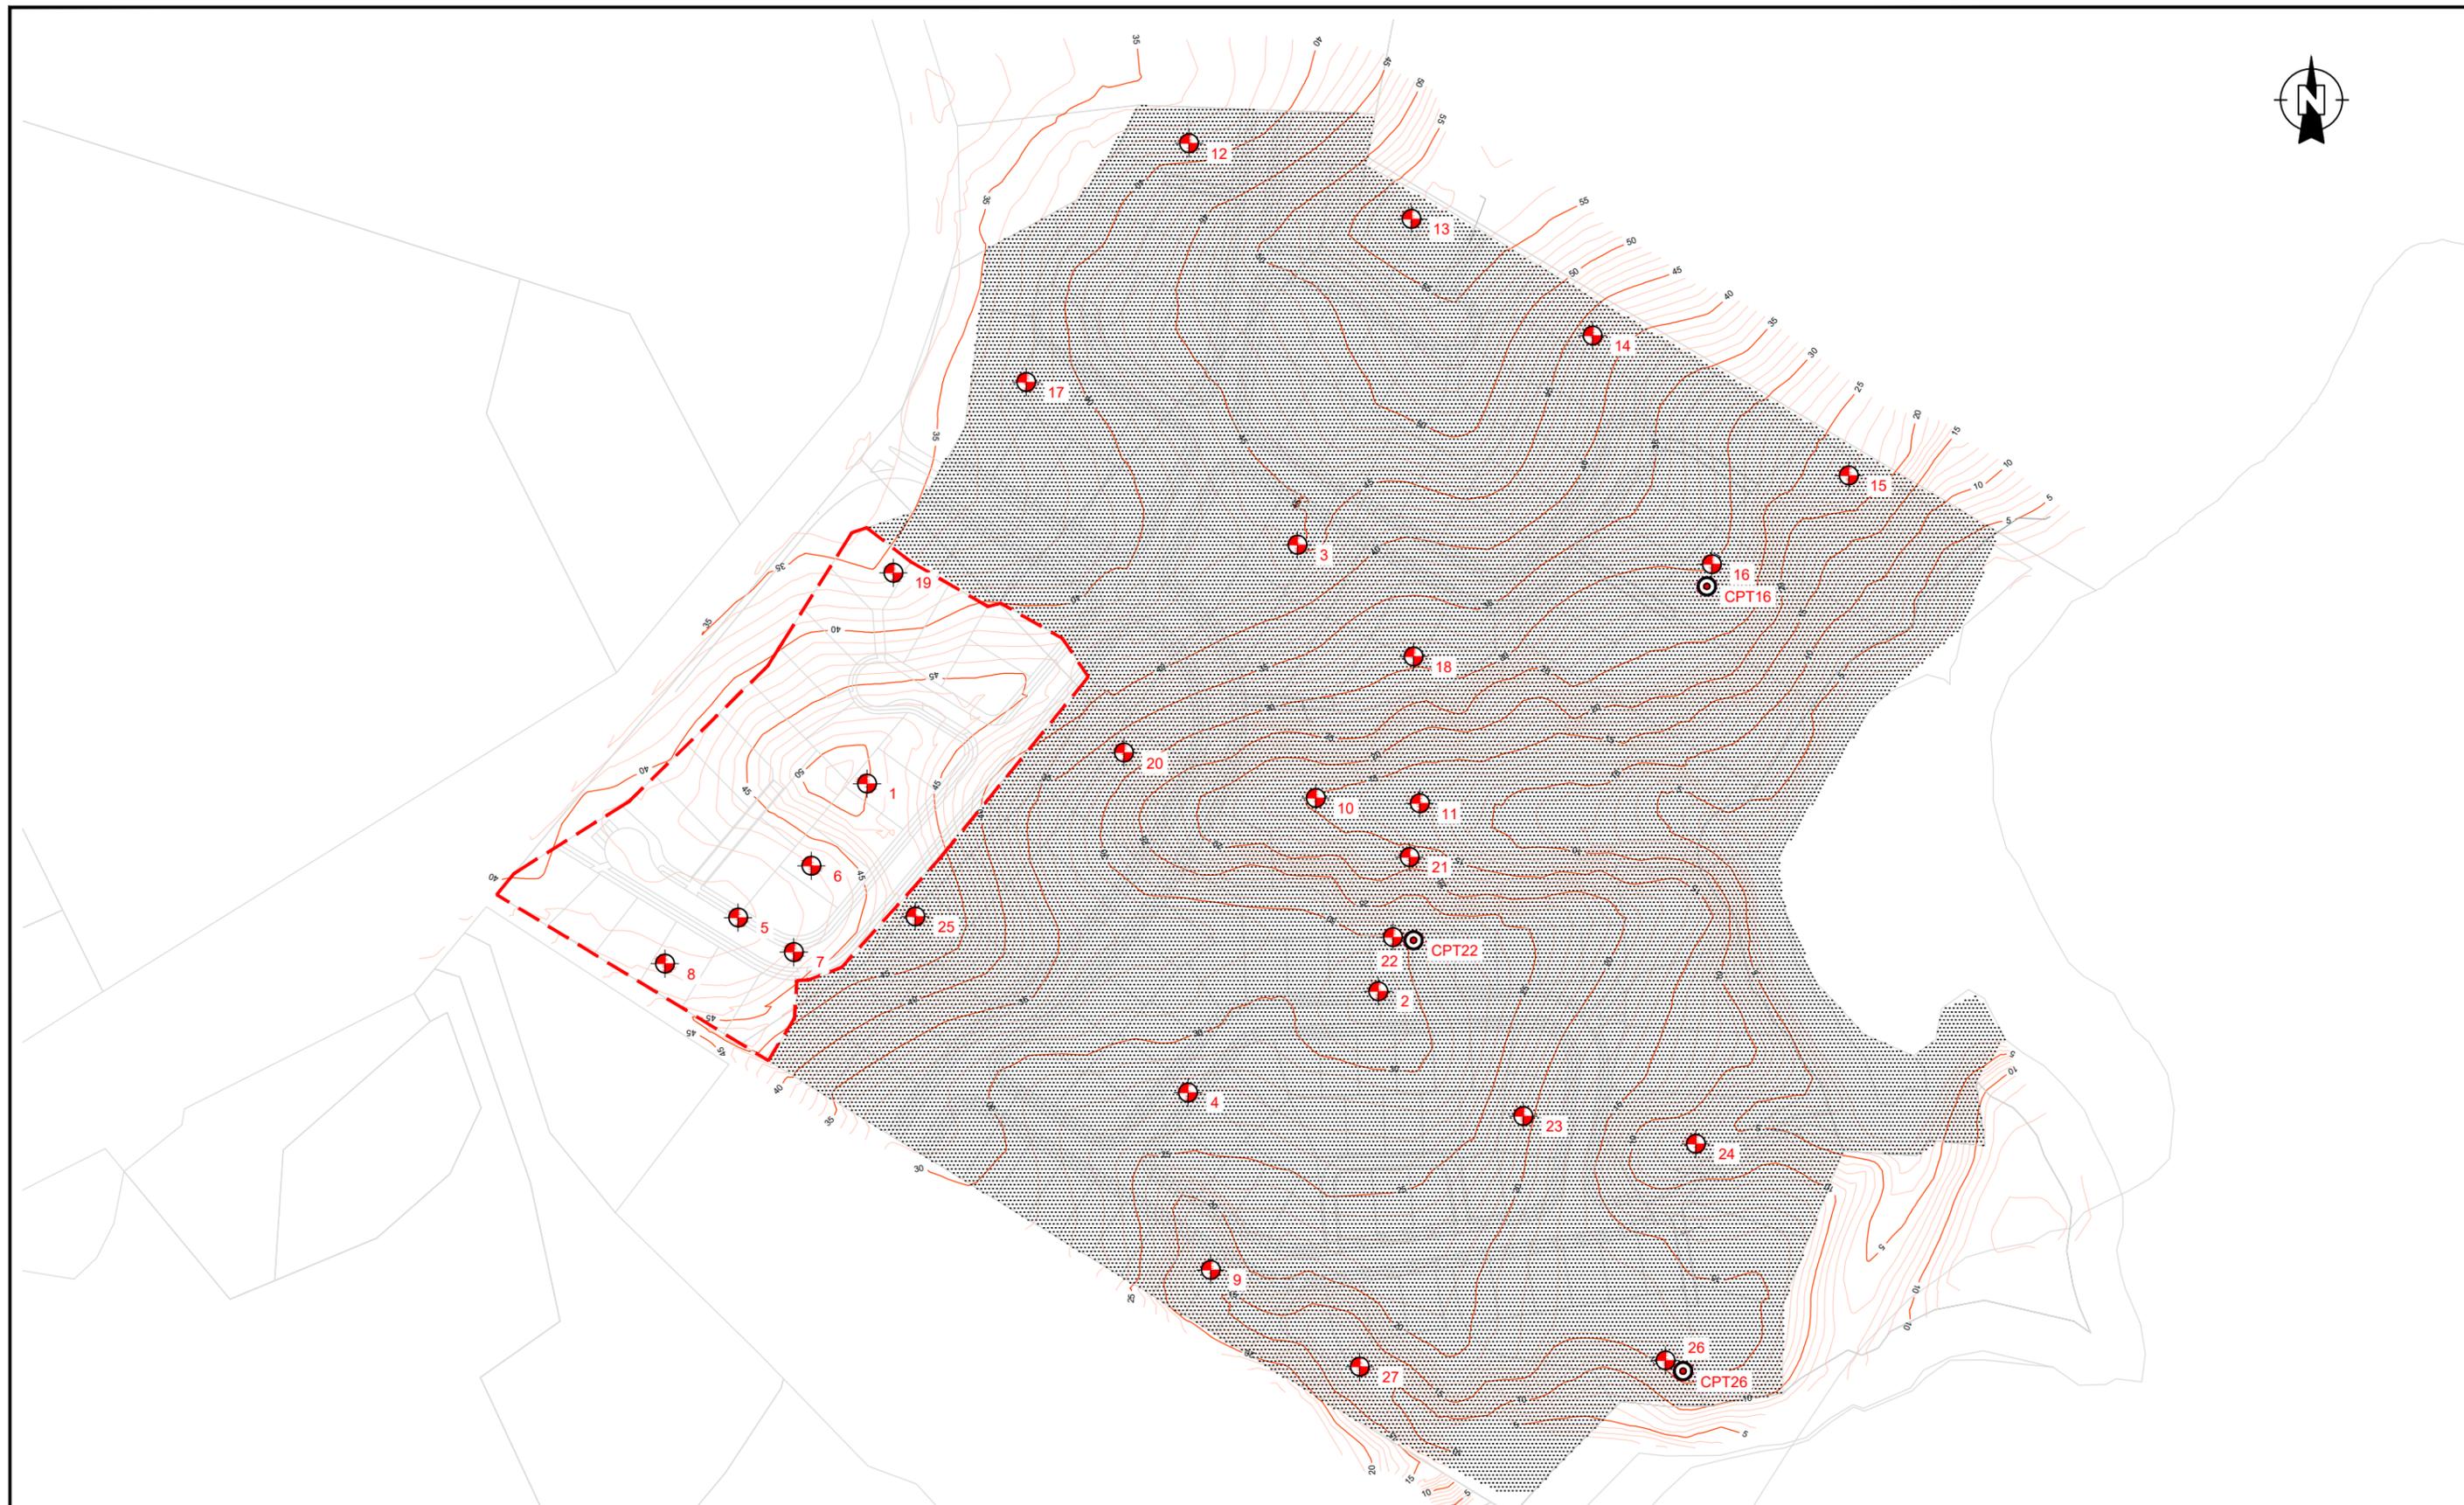
CLIENT:	NEIL CONSTRUCTION LIMITED	DRAWN:	FMS	PROJECT No:	TGA2018-0199(AB)
PROJECT:	TE AWANUI WATERS SUBDIVISION, STAGE 2	CHECKED:	GS	DRAWING:	01
TITLE:	OVERALL SITE LOCATION PLAN	REVISION:	0	SCALE:	1:2500
		DATE:	02/08/2019	SHEET:	A3

- 15 S&L HAND AUGER (HA) LOCATION
- CPT22 S&L CONE PENETROMETER TEST (CPT) LOCATION
- STAGE 2 SITE BOUNDARY
- EXISTING CONTOUR (MAJOR)
- EXISTING CONTOUR (MINOR)

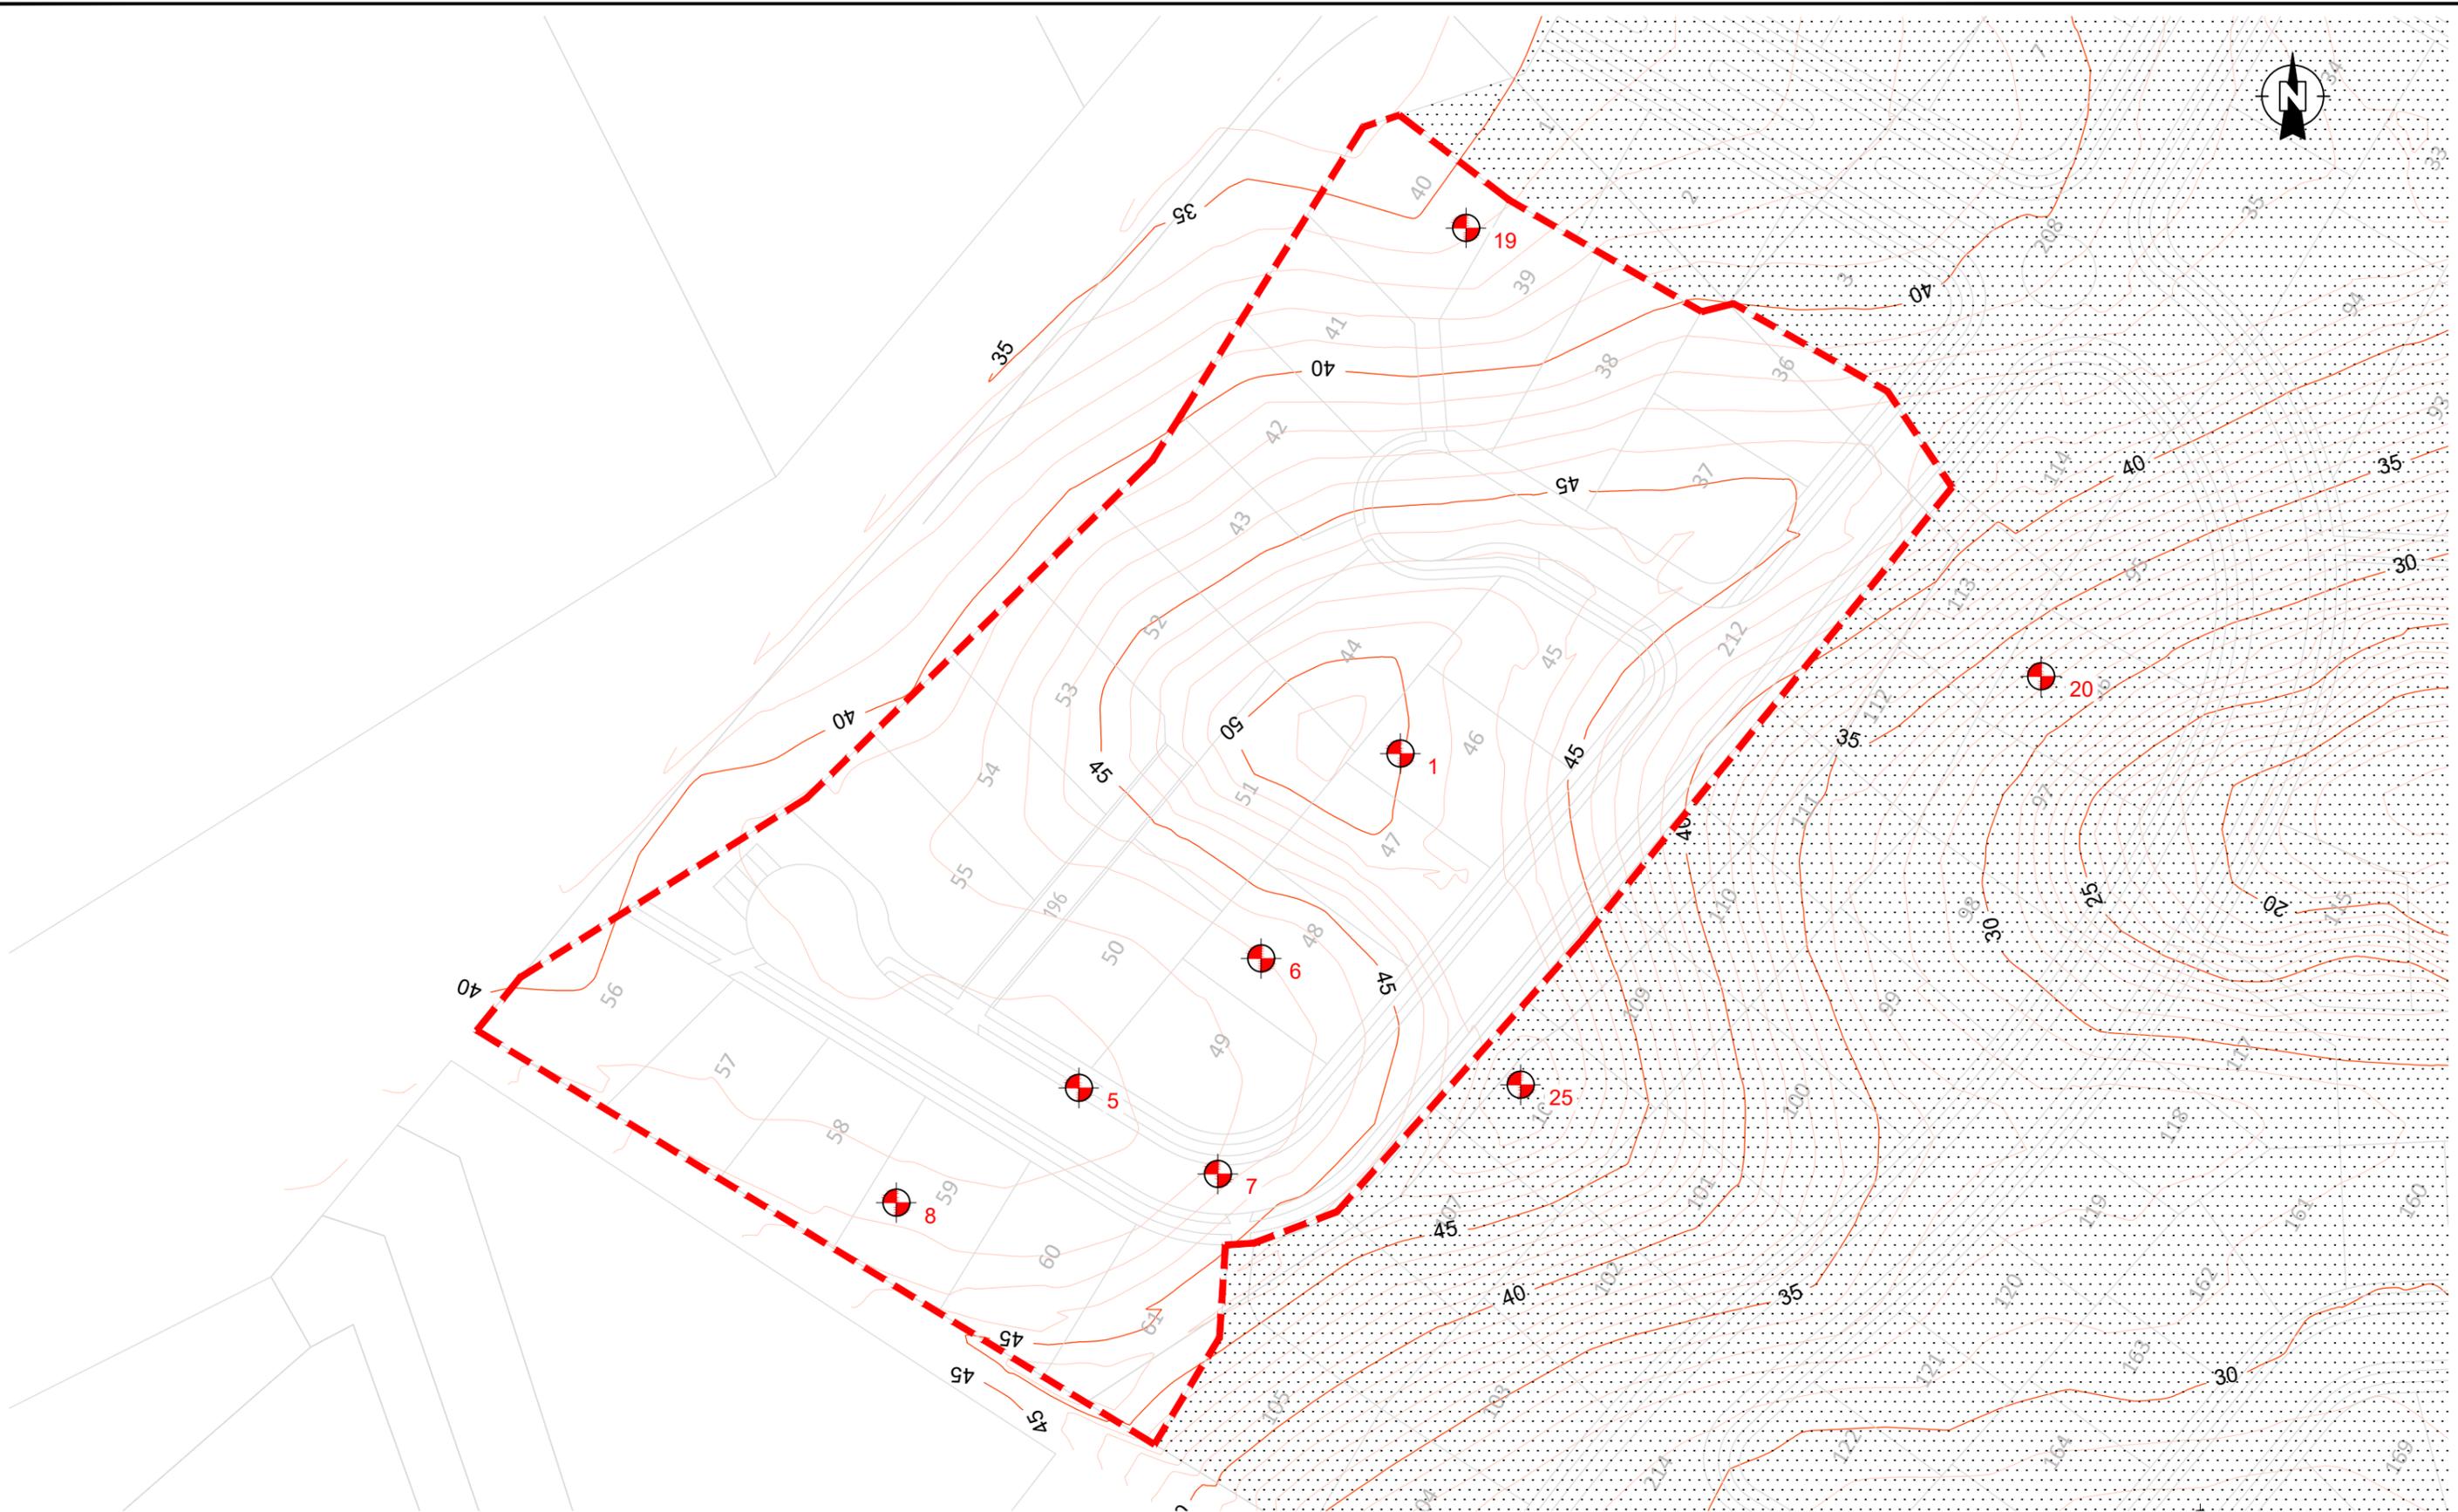
CLIENT:	NEIL CONSTRUCTION LIMITED	DRAWN:	FMS	PROJECT No:	TGA2018-0199(AB)
PROJECT:	TE AWANUI WATERS SUBDIVISION, STAGE 2	CHECKED:	GS	DRAWING:	02
TITLE:	SITE LOCATION PLAN - STAGE 2	REVISION:	0	SCALE:	1:1000
		DATE:	02/08/2019	SHEET:	A3

15	S&L HAND AUGER (HA) LOCATION
	CPT22	S&L CONE PENETROMETER TEST (CPT) LOCATION
		STAGE 2 SITE BOUNDARY
	10	EXISTING CONTOUR (MAJOR)
		EXISTING CONTOUR (MINOR)

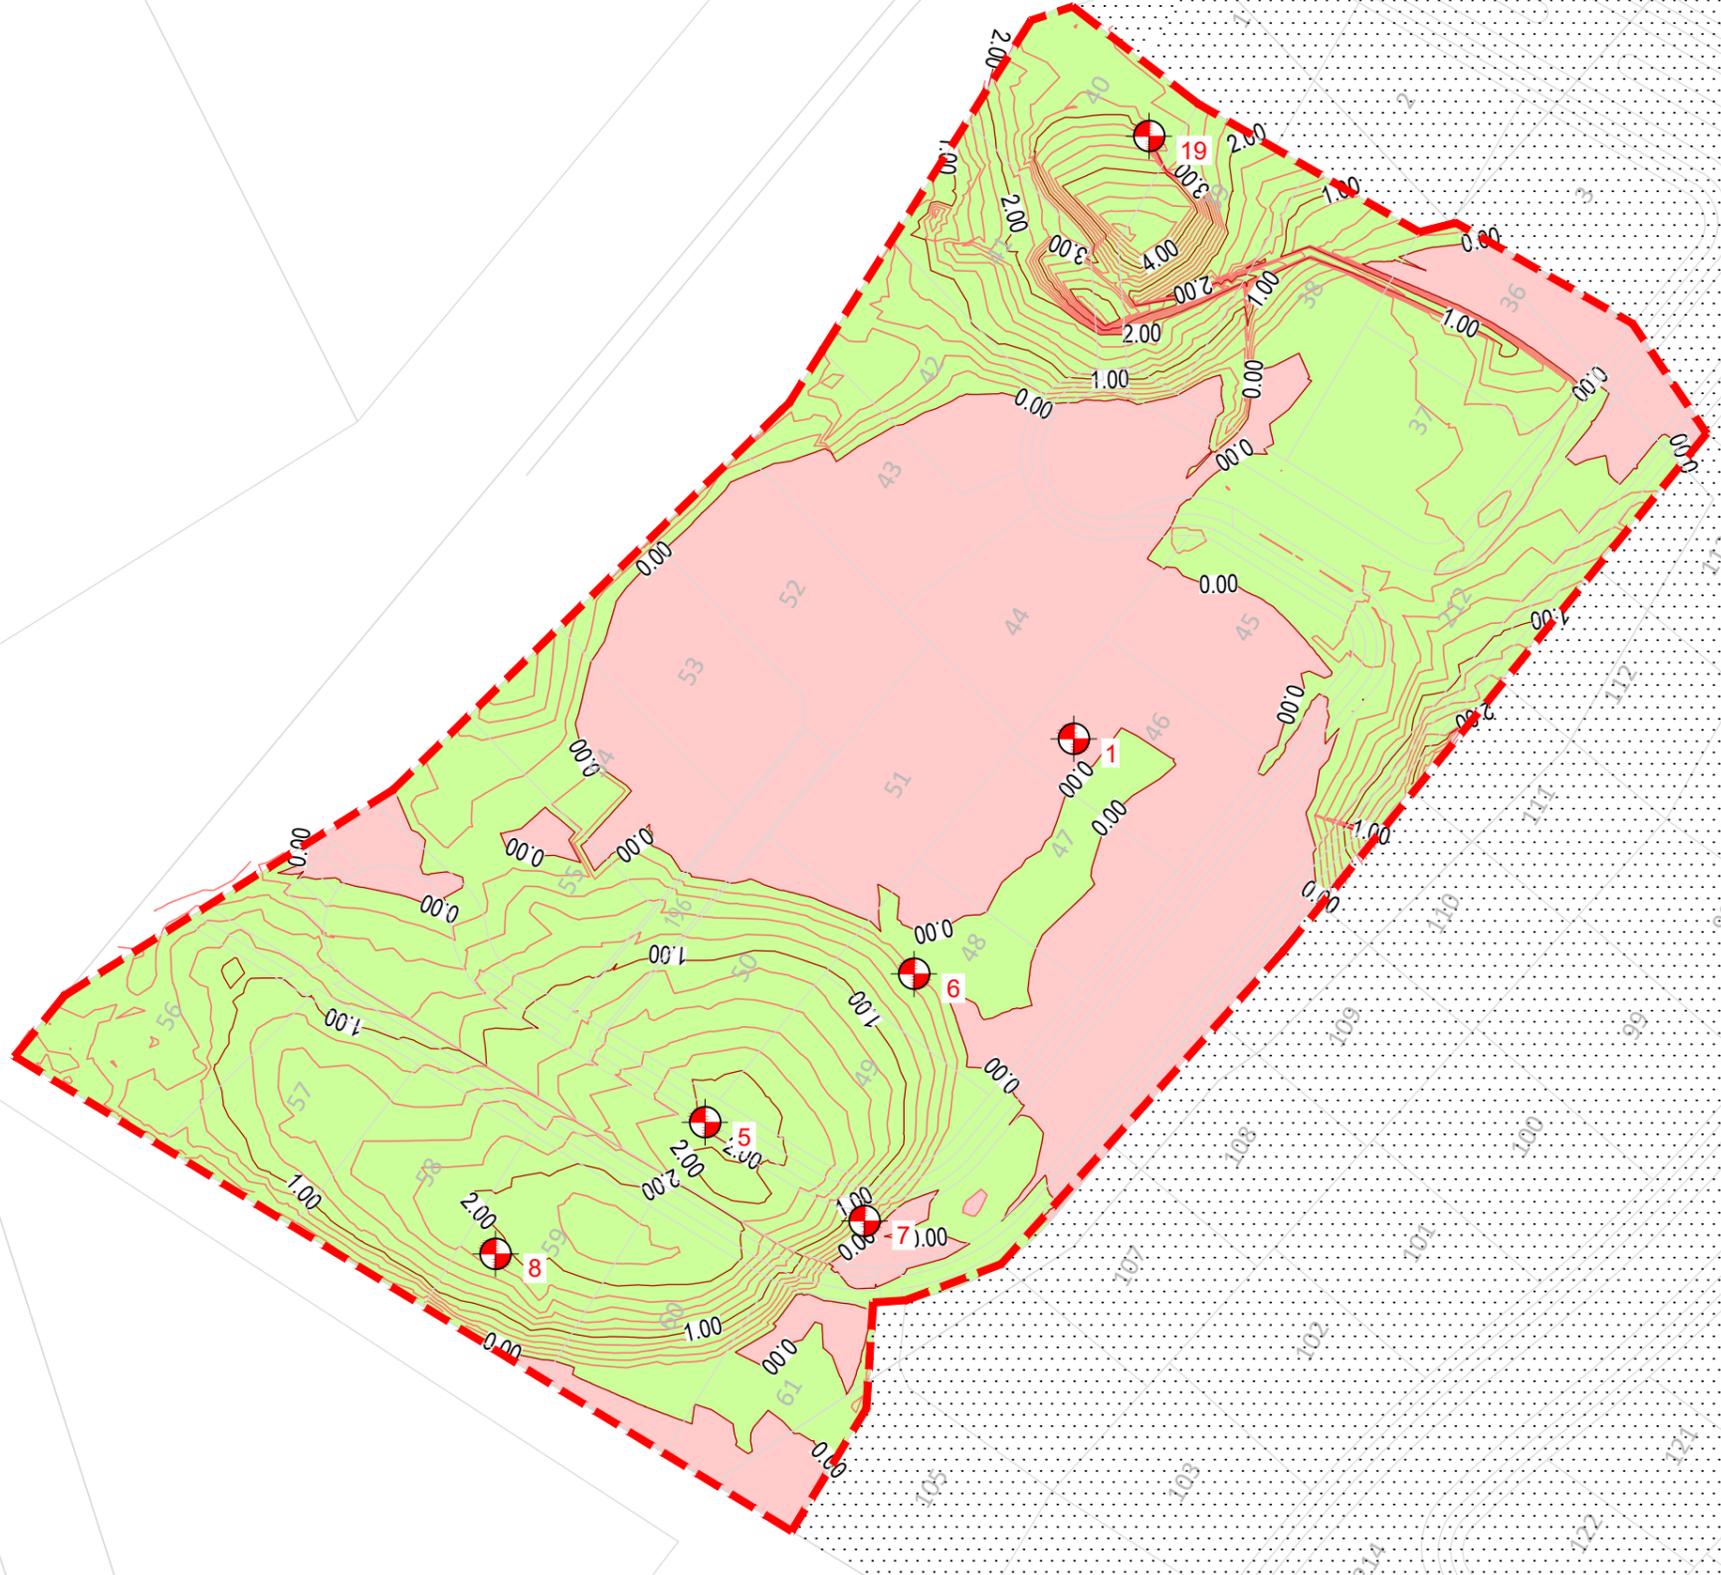
CLIENT:	NEIL CONSTRUCTION LIMITED	DRAWN:	FMS	PROJECT No:	TGA2018-0199(AB)
PROJECT:	TE AWANUI WATERS SUBDIVISION, STAGE 2	CHECKED:	GS	DRAWING:	03
TITLE:	TOTAL FILL AS-BUILT CONTOUR PLAN	REVISION:	0	SCALE:	1:1000
		DATE:	02/08/2019	SHEET:	A3

WSP OPUS FILL TEST LOCATION		CUT AREA
	STAGE 2 SITE BOUNDARY		FILL AREA
	FILL CONTOUR (MAJOR)		
	FILL CONTOUR (MINOR)

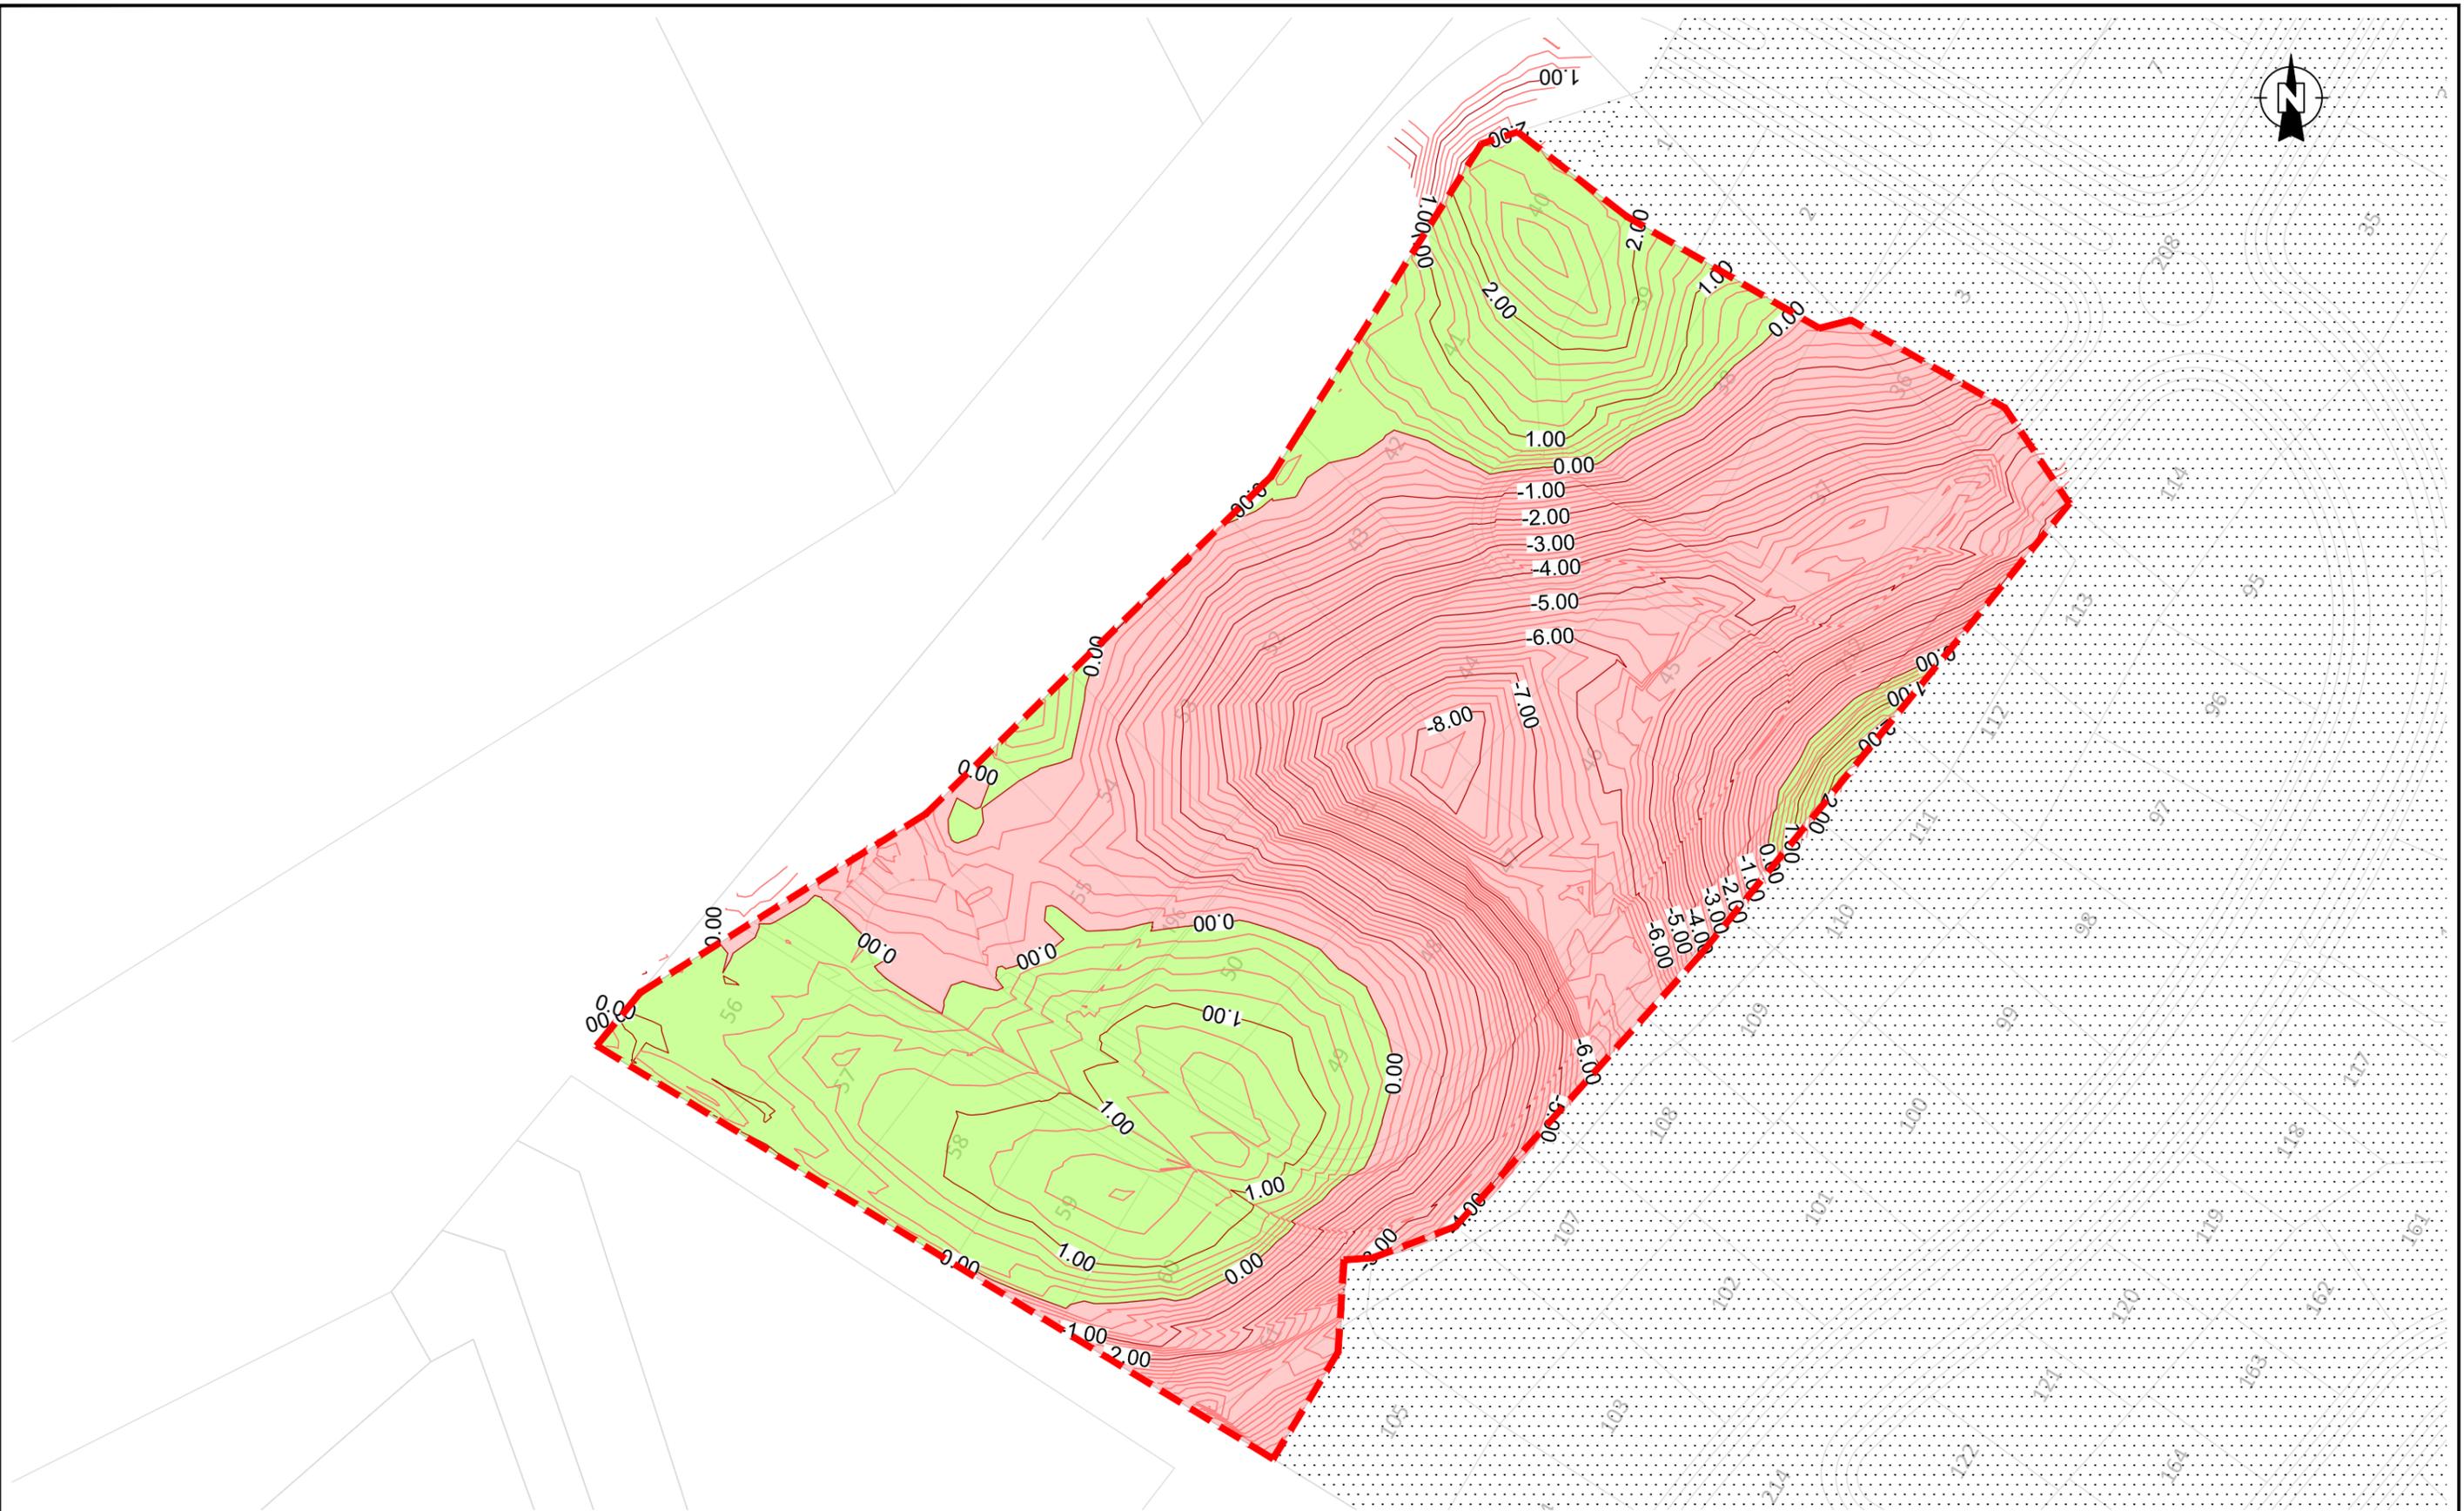
CLIENT:	NEIL CONSTRUCTION LIMITED	DRAWN:	FMS	PROJECT No:	TGA2018-0199(AB)
PROJECT:	TE AWANUI WATERS SUBDIVISION, STAGE 2	CHECKED:	GS	DRAWING:	04
TITLE:	CUT FILL (ORIGINAL TO FINAL) AS-BUILT PLAN	REVISION:	0	SCALE:	1:1000
		DATE:	02/08/2019	SHEET:	A3

WSP OPUS FILL TEST LOCATION		CUT AREA
	STAGE 2 SITE BOUNDARY		FILL AREA
	CUT FILL CONTOUR (MAJOR)		
	CUT FILL CONTOUR (MINOR)

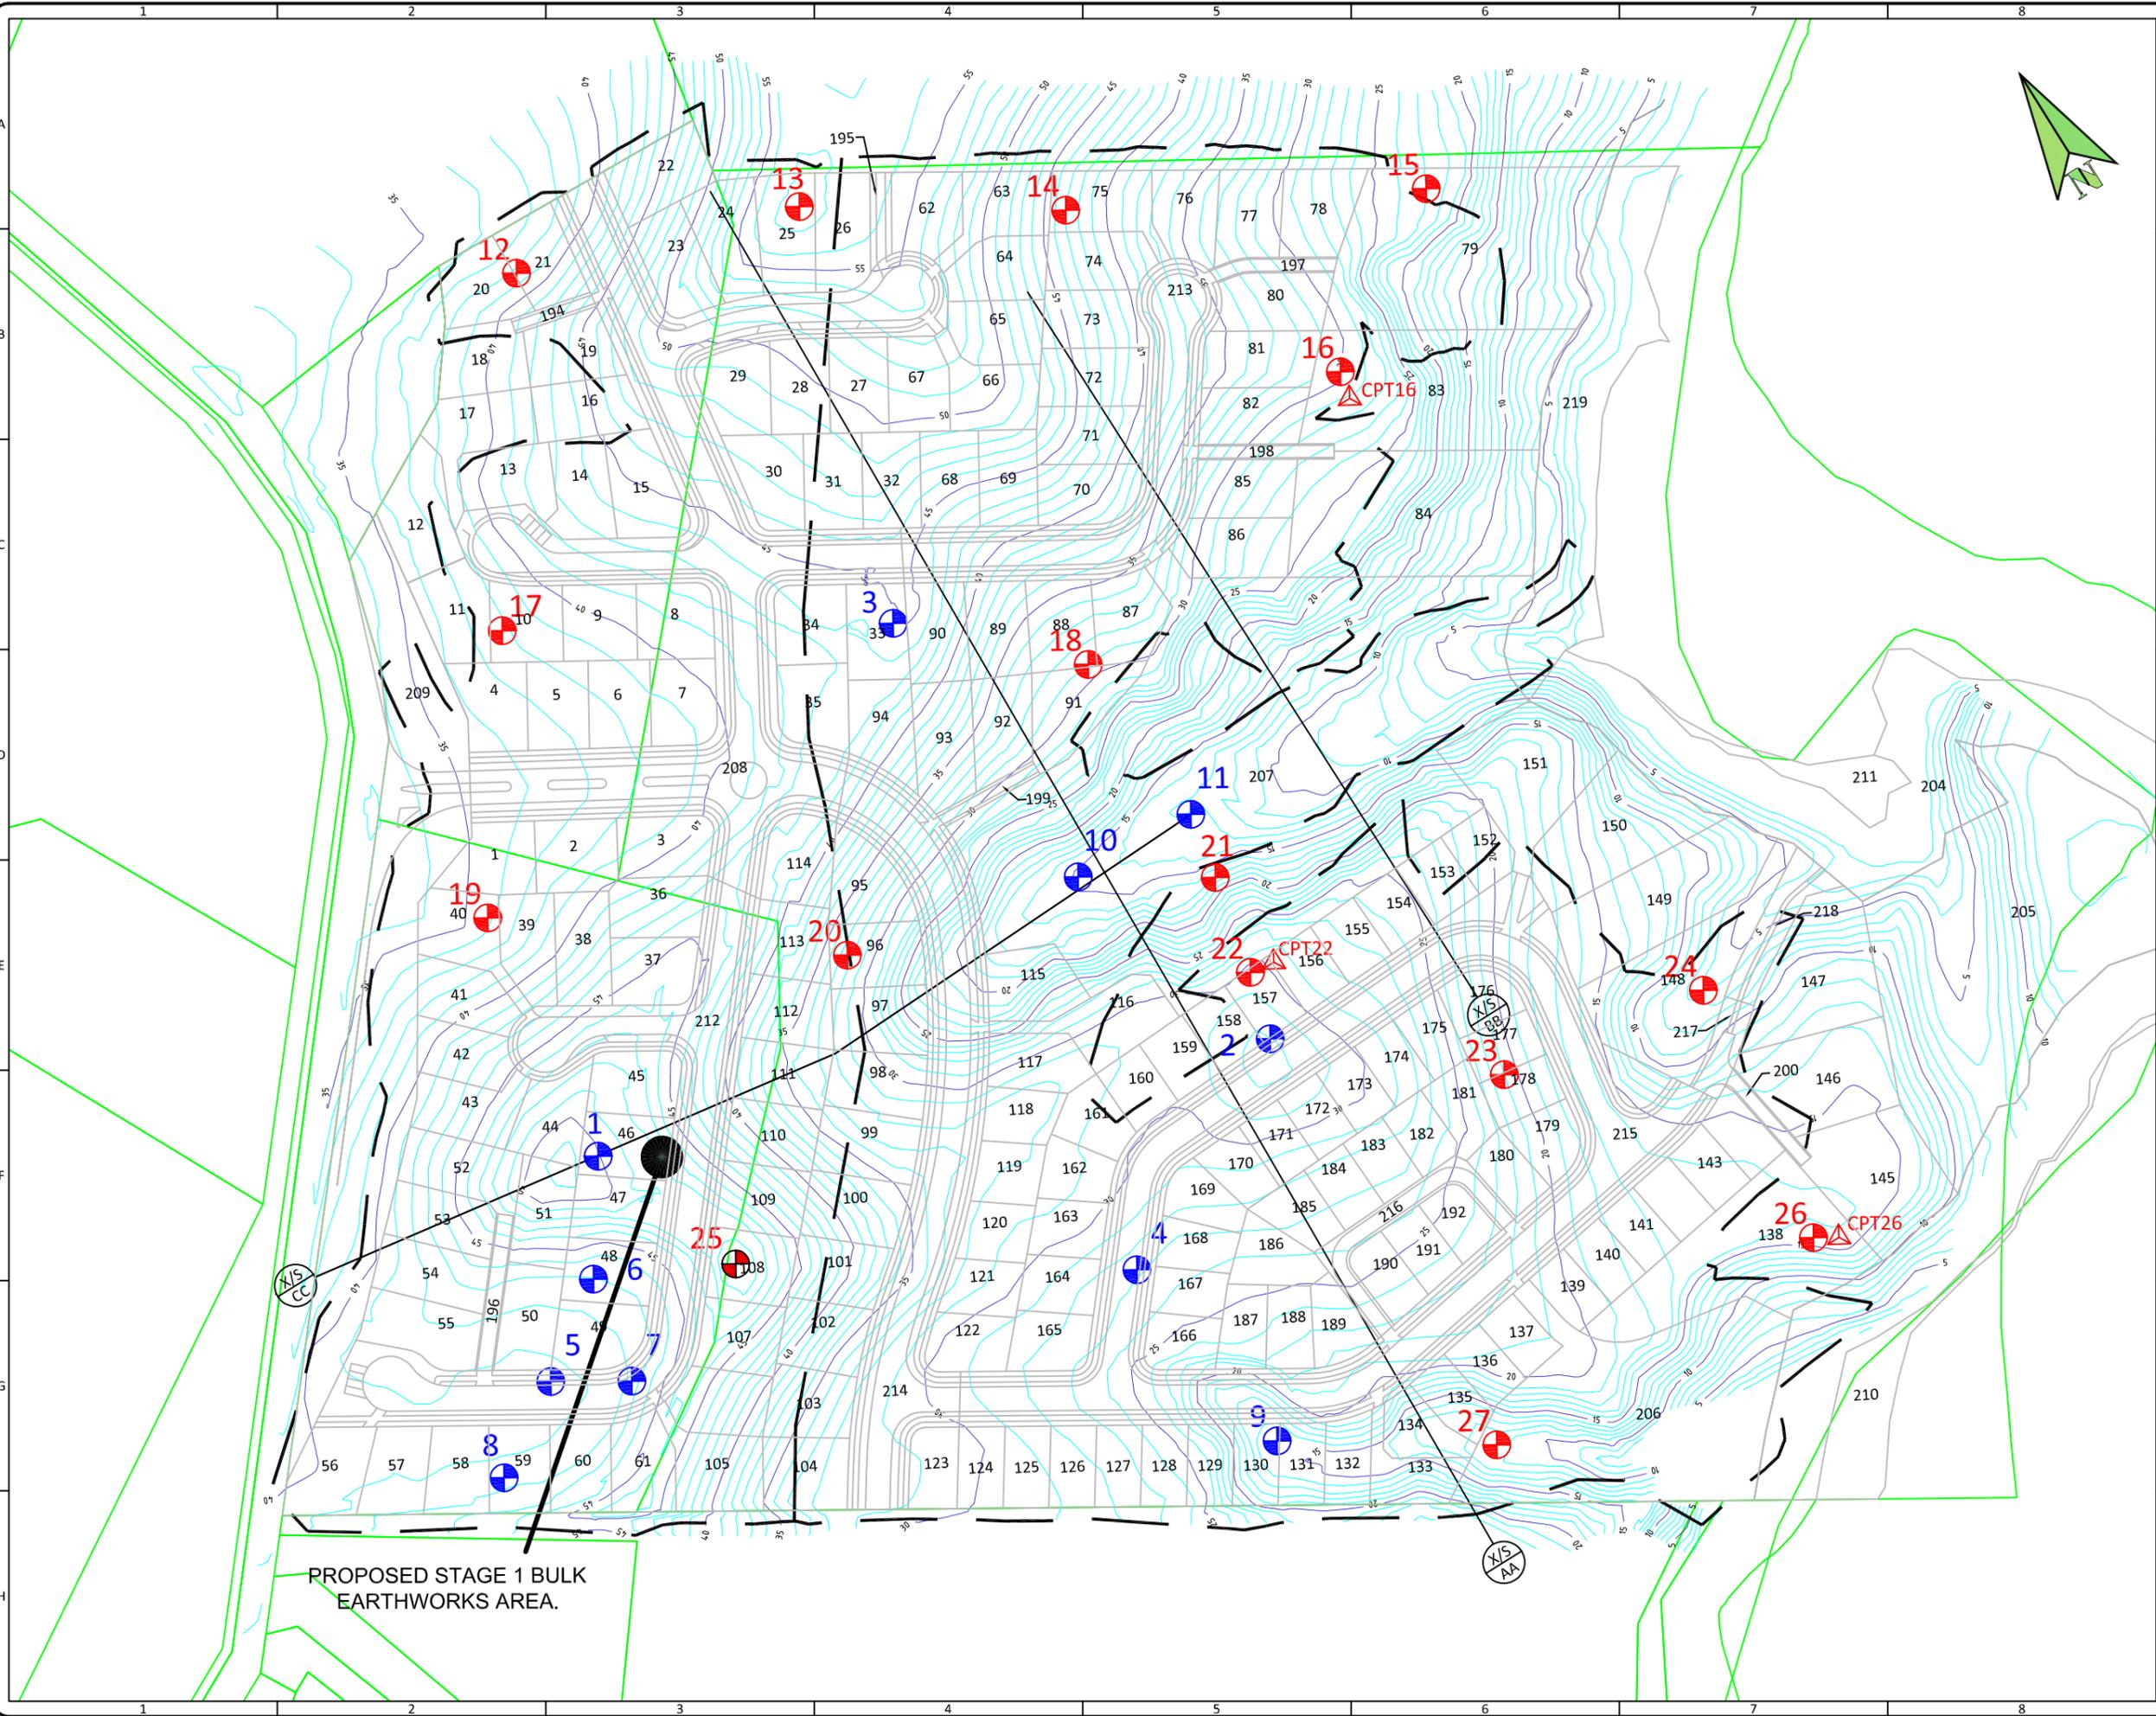
Original Scales @ A3	Date
1:2000	11/15
Do Not Scale Dimensions	
Drawing No	Revision
21118 - G03	1

- Key**
- Borehole Location (30/11/2006 - 20/12/2006)
 - Borehole Location (16/6/2015-22/6/2015)
 - ▲ CPT Location
 - X/S
AA Geotechnical Cross-Section
 - 14 — Existing Ground Level Contour

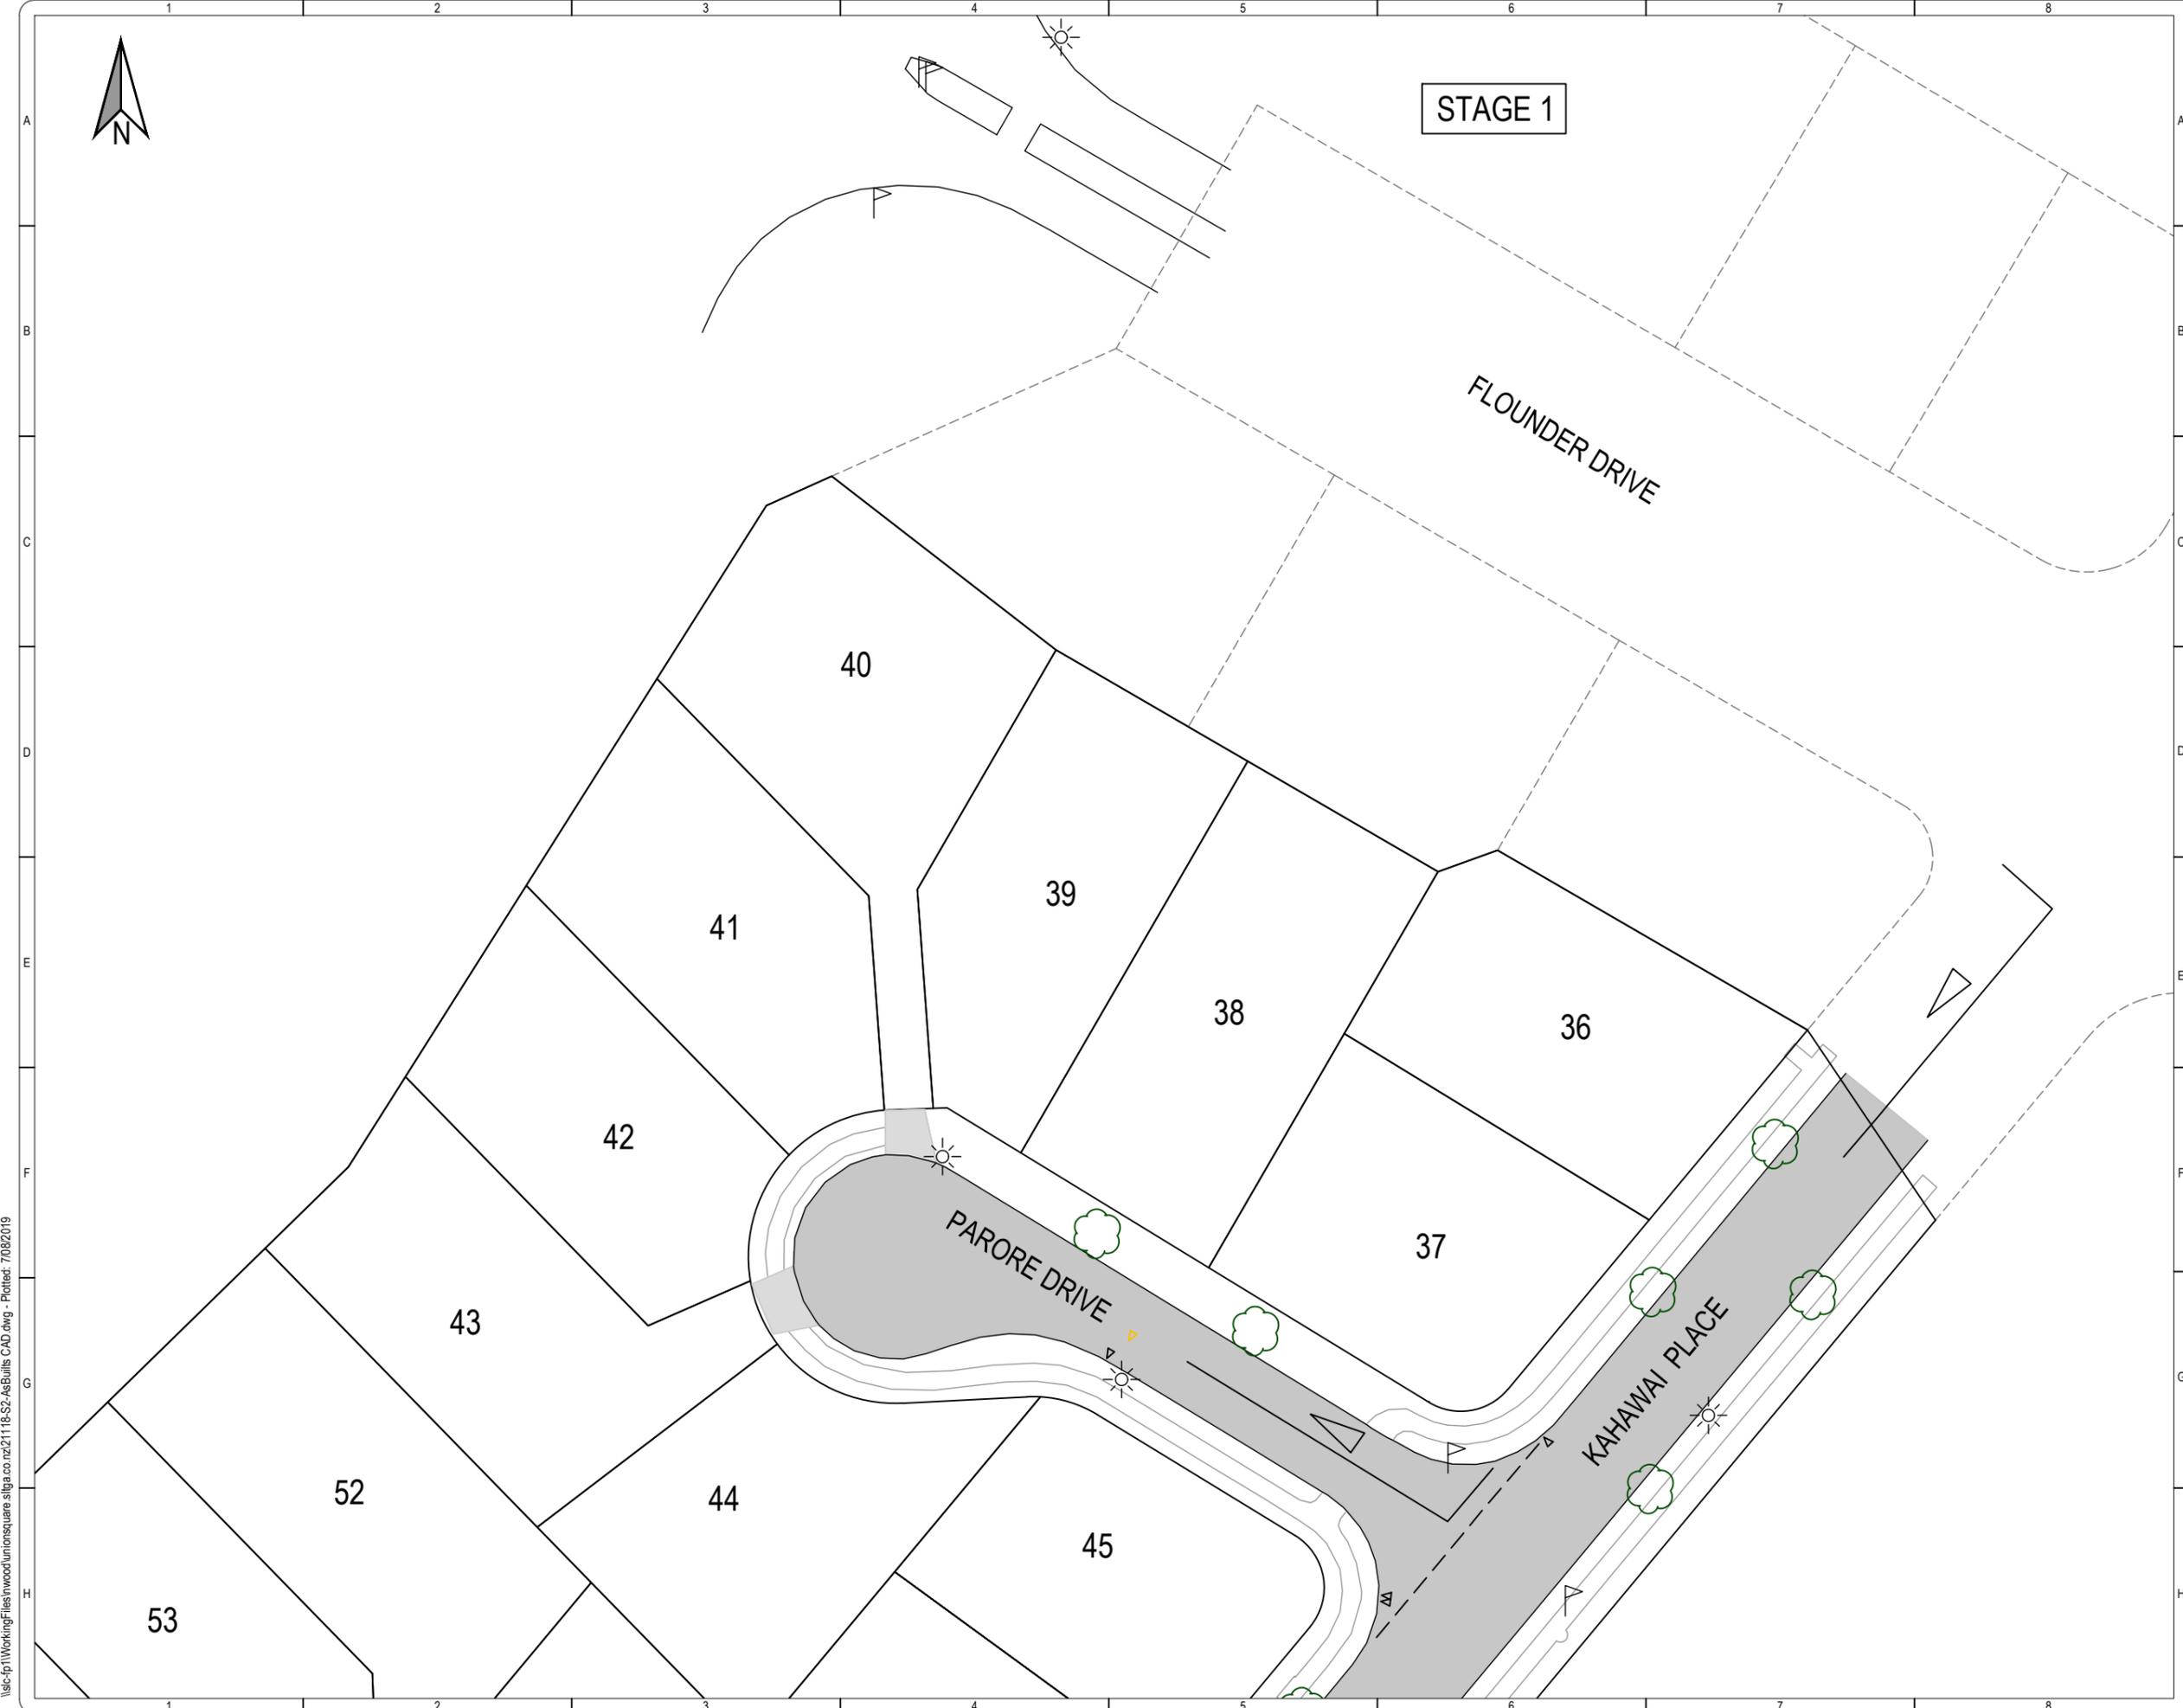
Original Scales @ A3 1:500 Do Not Scale Dimensions Drawing No	Status AS-BUILT	Revision AB
2118-S2-R01

**OMOKOROA DEVELOPMENT
 STAGE 2**
