25 KAHAWAI PLACE, OMOKOROA

Land Information Memorandum

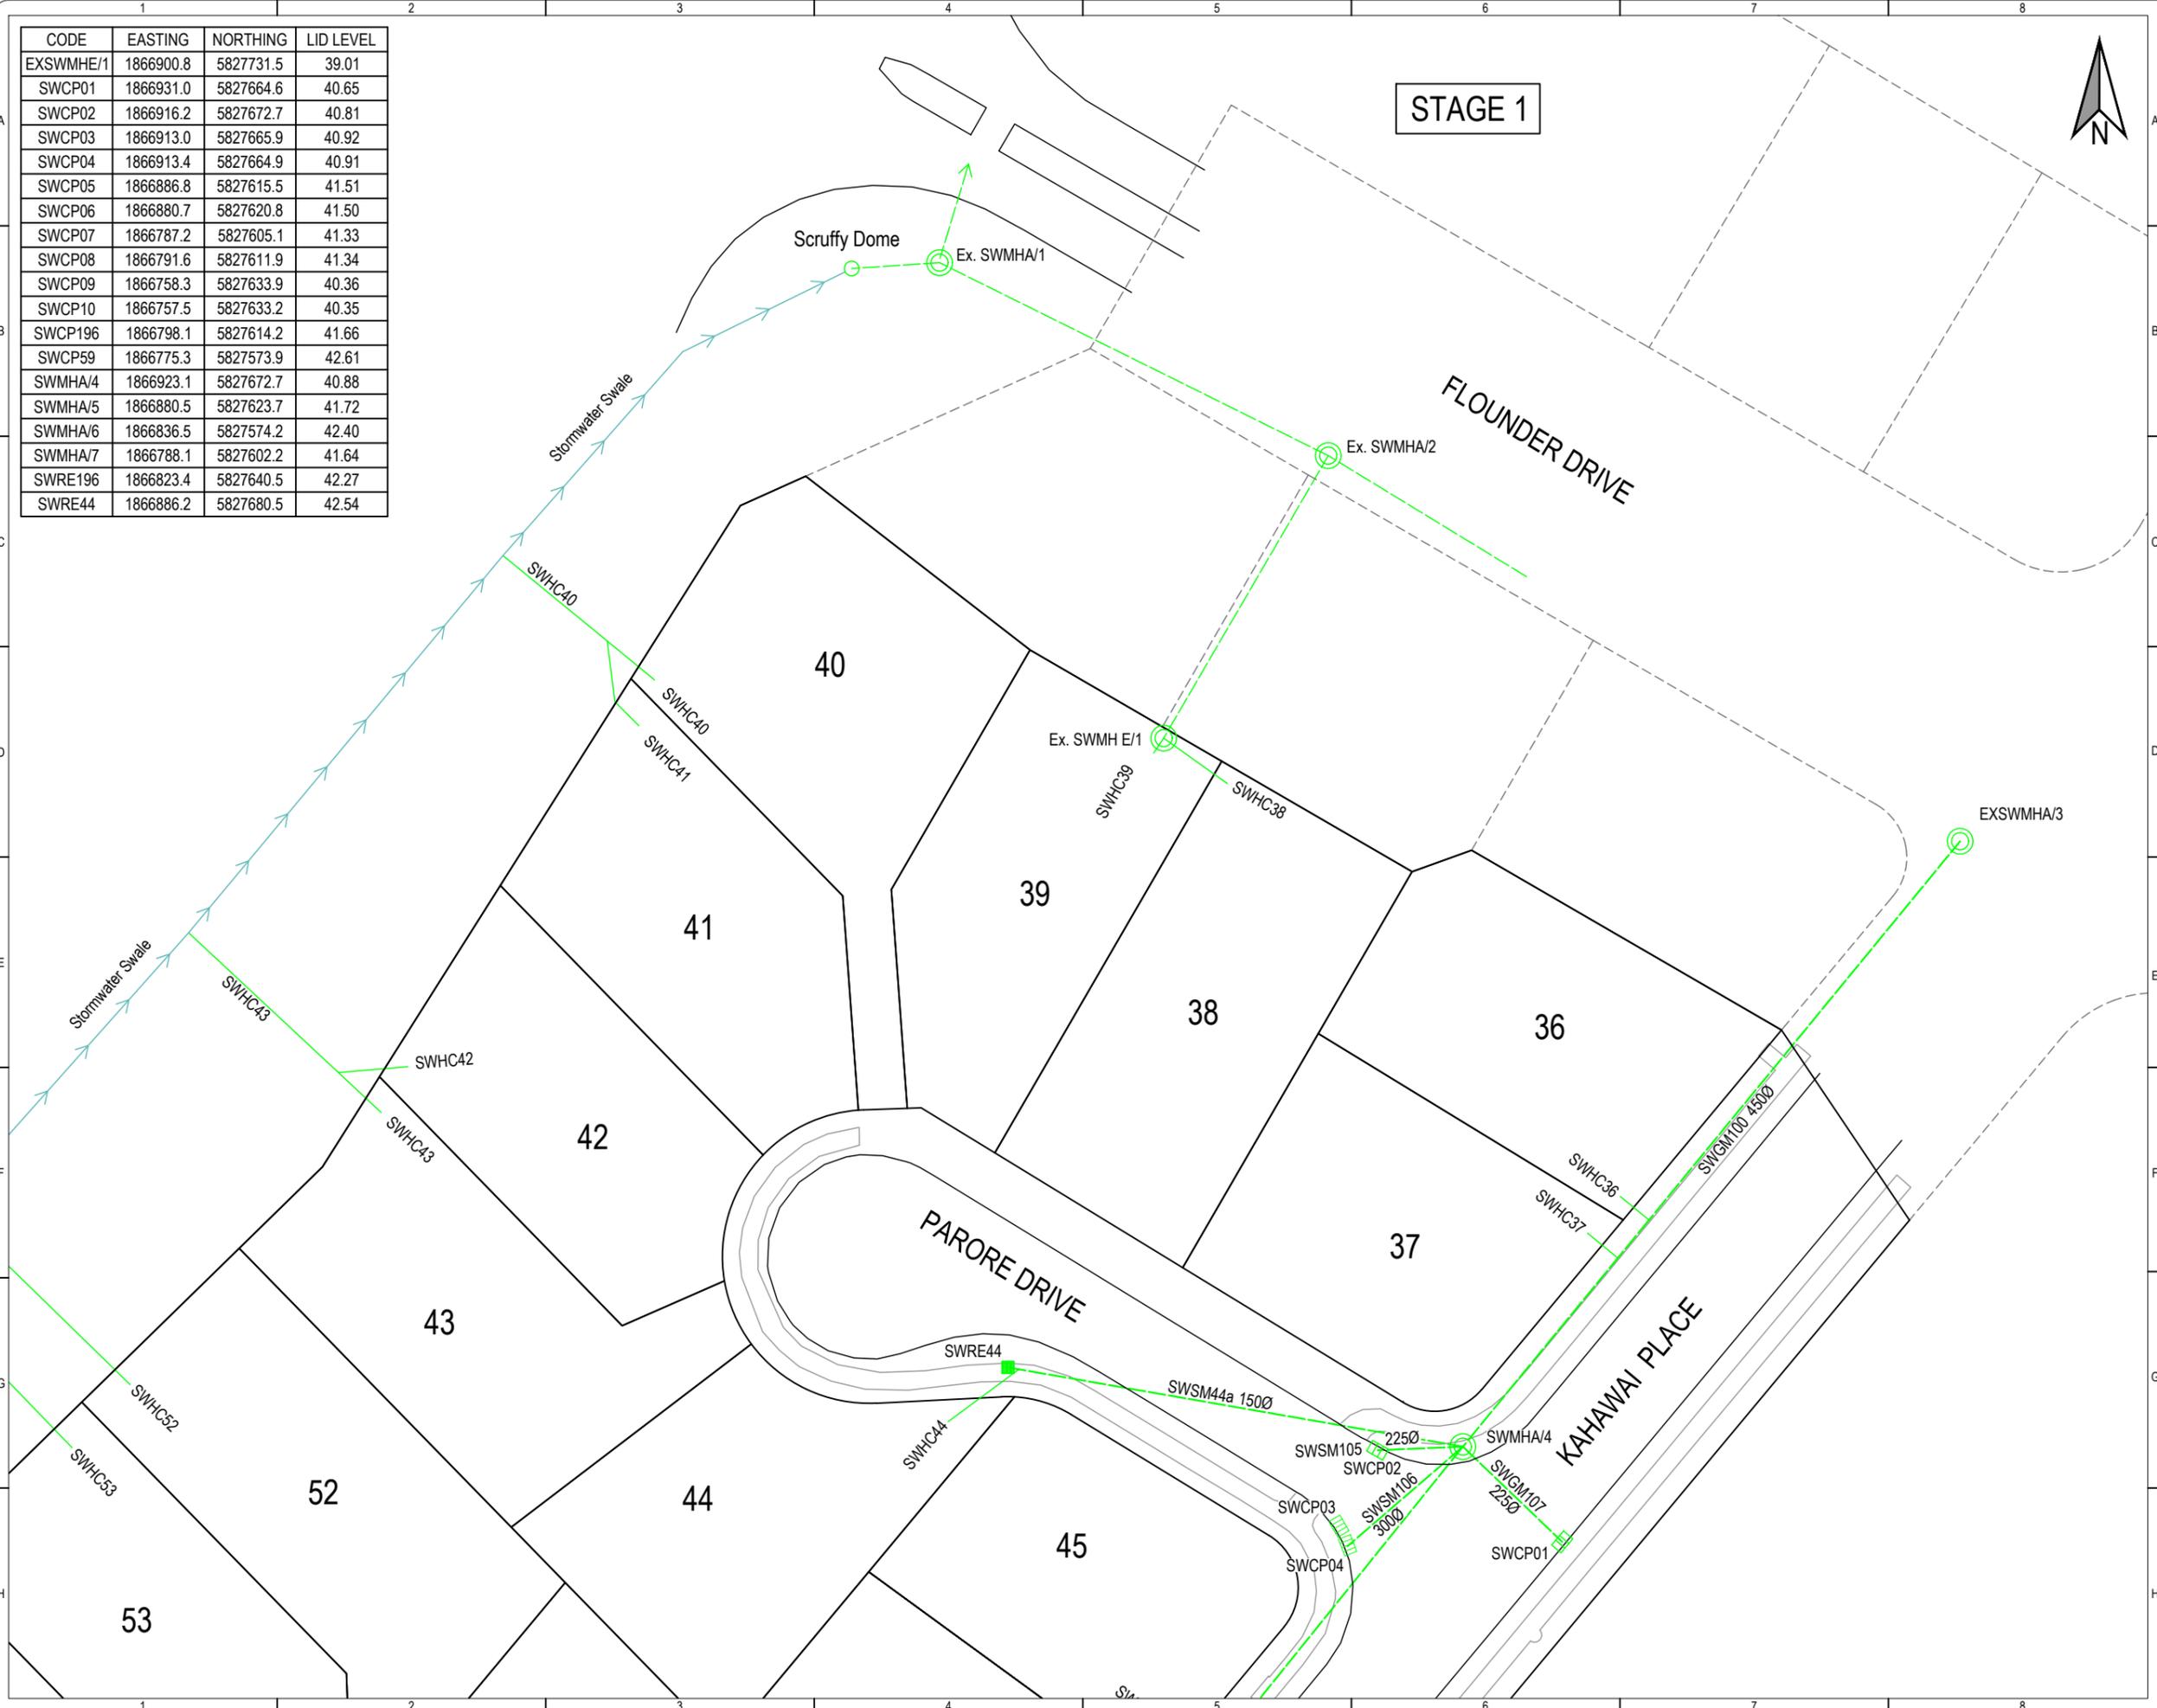
Original Scales @ A3	Status
1:500	AS-BUILT
Drawing No	Revision
21118-S2-SW01	AB

CODE	EASTING	NORTHING	LID LEVEL
EXSWMHE/1	1866900.8	5827731.5	39.01
SWCP01	1866931.0	5827664.6	40.65
SWCP02	1866916.2	5827672.7	40.81
SWCP03	1866913.0	5827665.9	40.92
SWCP04	1866913.4	5827664.9	40.91
SWCP05	1866886.8	5827615.5	41.51
SWCP06	1866880.7	5827620.8	41.50
SWCP07	1866787.2	5827605.1	41.33
SWCP08	1866791.6	5827611.9	41.34
SWCP09	1866758.3	5827633.9	40.36
SWCP10	1866757.5	5827633.2	40.35
SWCP196	1866798.1	5827614.2	41.66
SWCP59	1866775.3	5827573.9	42.61
SWMHA/4	1866923.1	5827672.7	40.88
SWMHA/5	1866880.5	5827623.7	41.72
SWMHA/6	1866836.5	5827574.2	42.40
SWMHA/7	1866788.1	5827602.2	41.64
SWRE196	1866823.4	5827640.5	42.27
SWRE44	1866886.2	5827680.5	42.54

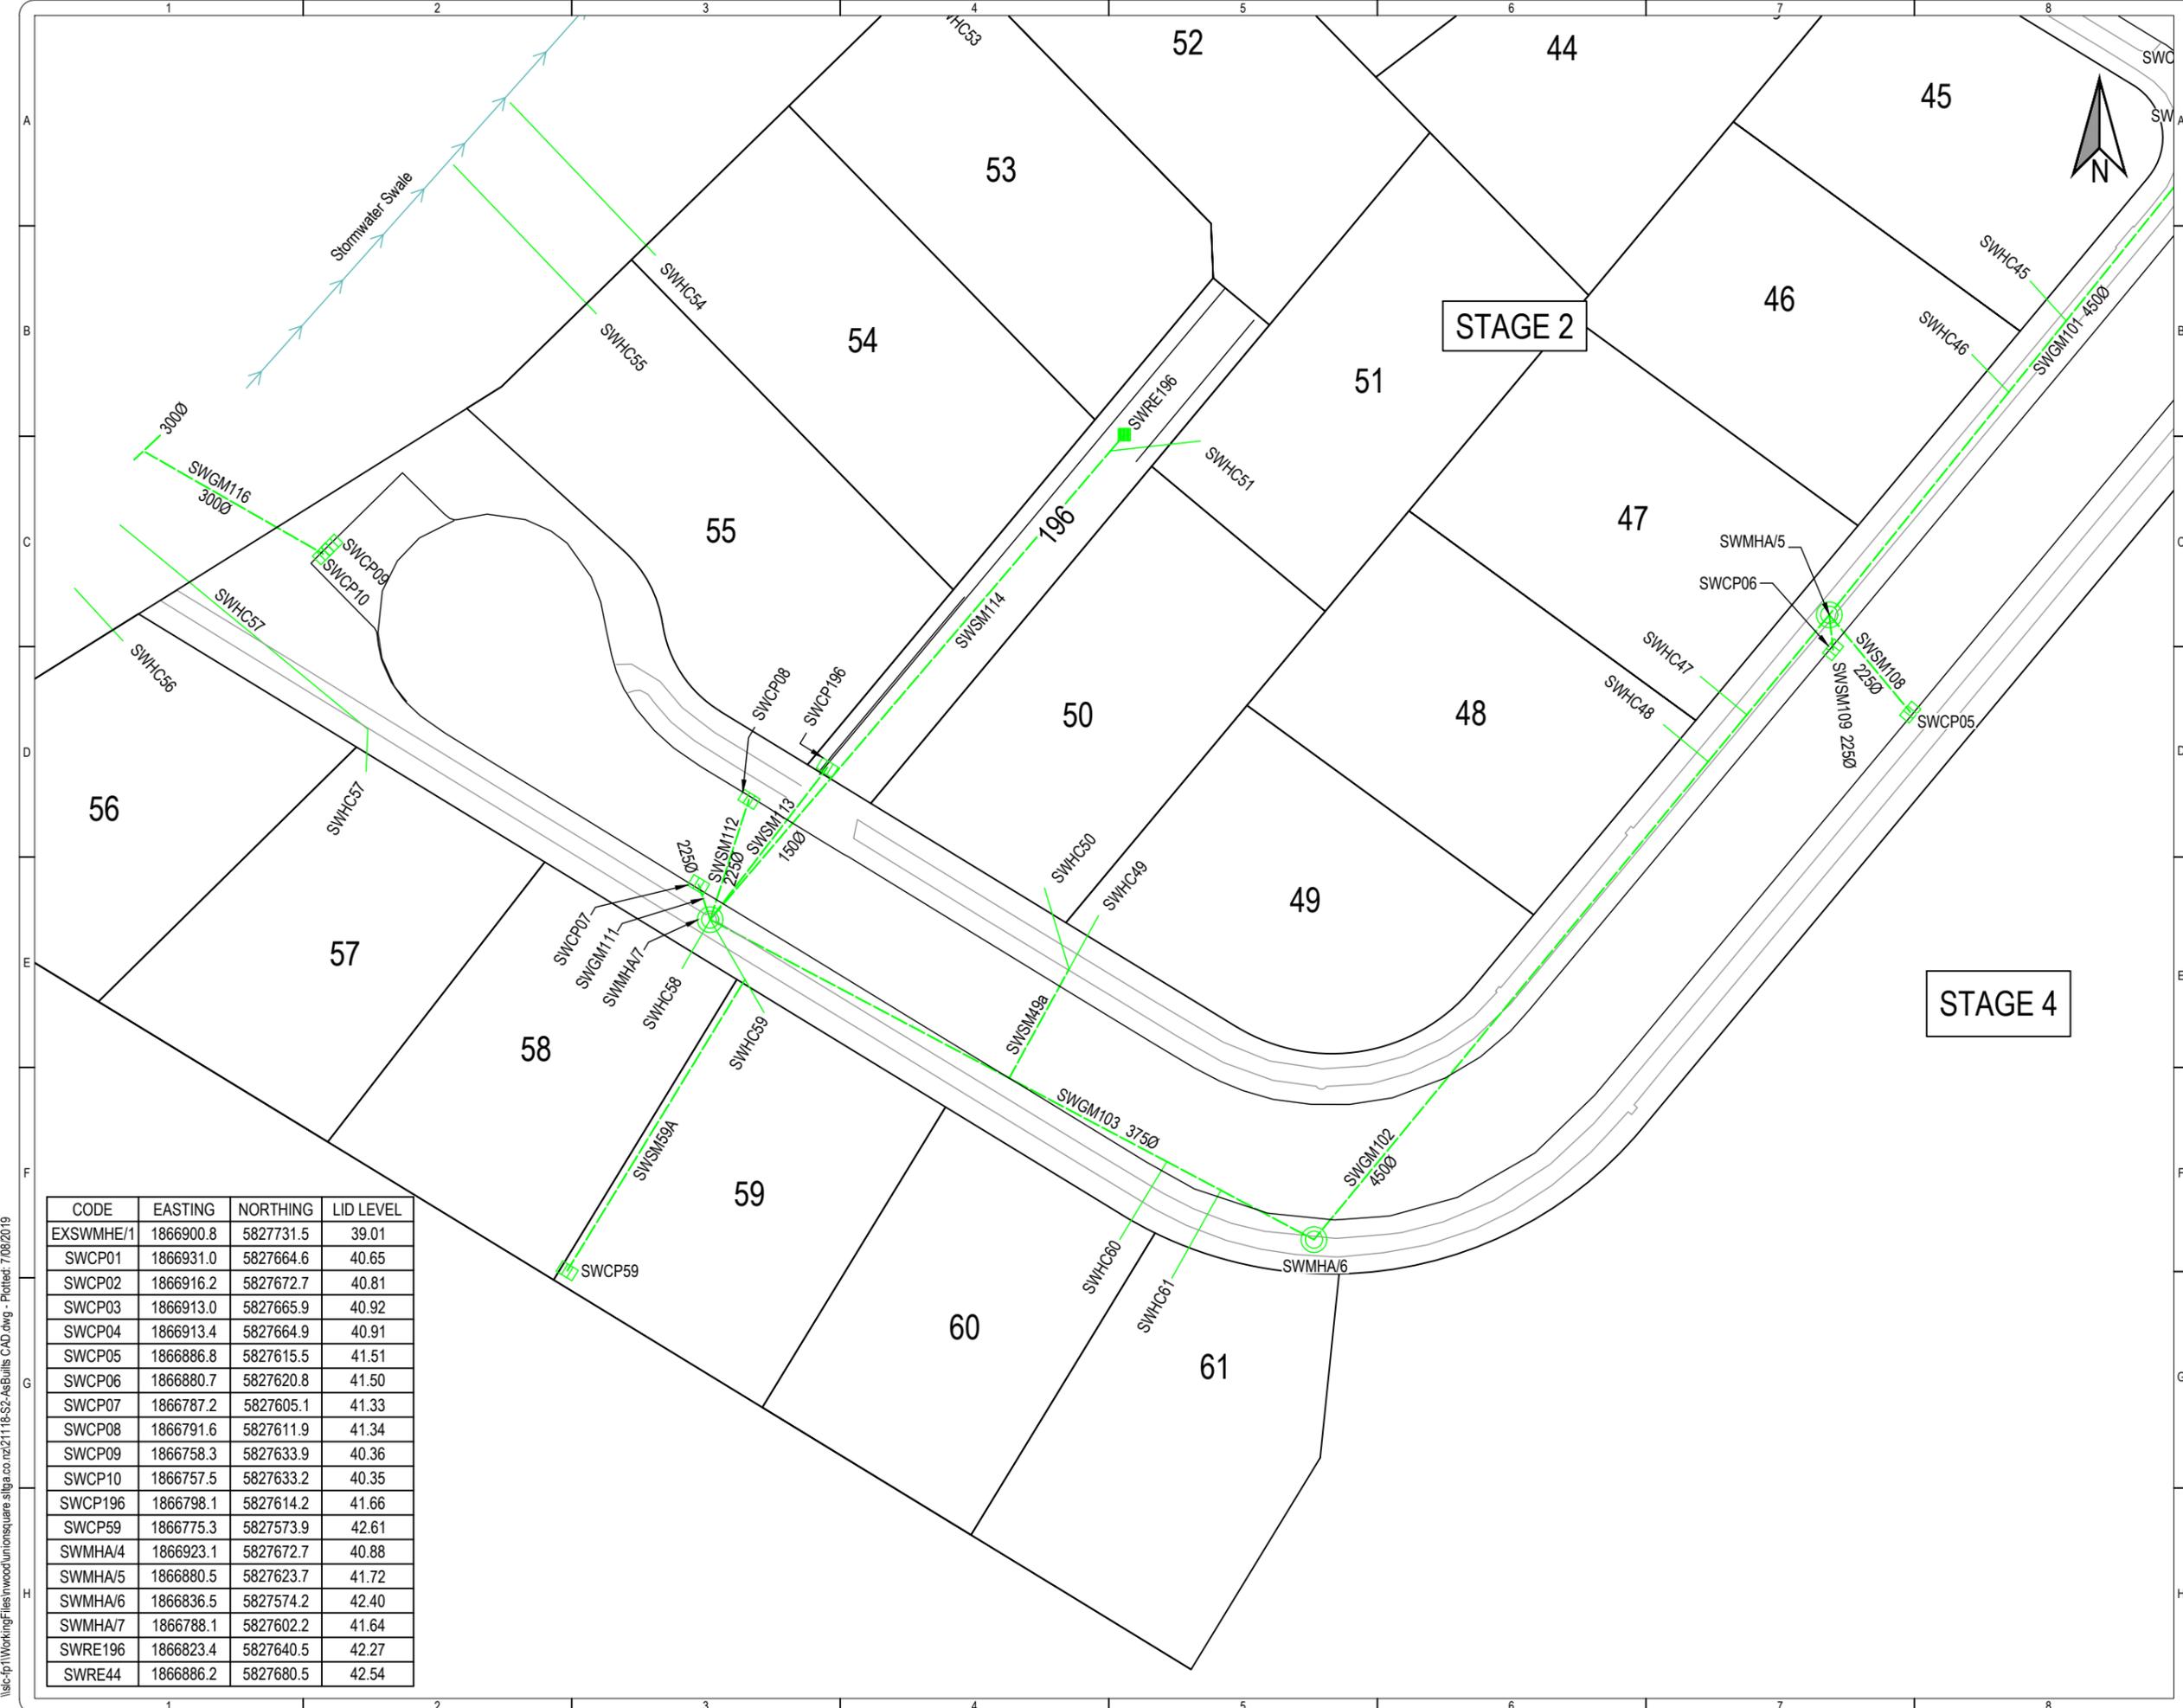
Notes:
 SWHC - Stormwater House Connection
 SWMH - Stormwater Manhole
 SWCP - Stormwater Catchpit
 SWGM - Stormwater Gravity Main
 SWSM - Stormwater Service Main
 SWRE - Stormwater Rodding Eye

CODE	EASTING	NORTHING	LID LEVEL
EXSWMHE/1	1866900.8	5827731.5	39.01
SWCP01	1866931.0	5827664.6	40.65
SWCP02	1866916.2	5827672.7	40.81
SWCP03	1866913.0	5827665.9	40.92
SWCP04	1866913.4	5827664.9	40.91
SWCP05	1866886.8	5827615.5	41.51
SWCP06	1866880.7	5827620.8	41.50
SWCP07	1866787.2	5827605.1	41.33
SWCP08	1866791.6	5827611.9	41.34
SWCP09	1866758.3	5827633.9	40.36
SWCP10	1866757.5	5827633.2	40.35
SWCP196	1866798.1	5827614.2	41.66
SWCP59	1866775.3	5827573.9	42.61
SWMHA/4	1866923.1	5827672.7	40.88
SWMHA/5	1866880.5	5827623.7	41.72
SWMHA/6	1866836.5	5827574.2	42.40
SWMHA/7	1866788.1	5827602.2	41.64
SWRE196	1866823.4	5827640.5	42.27
SWRE44	1866886.2	5827680.5	42.54

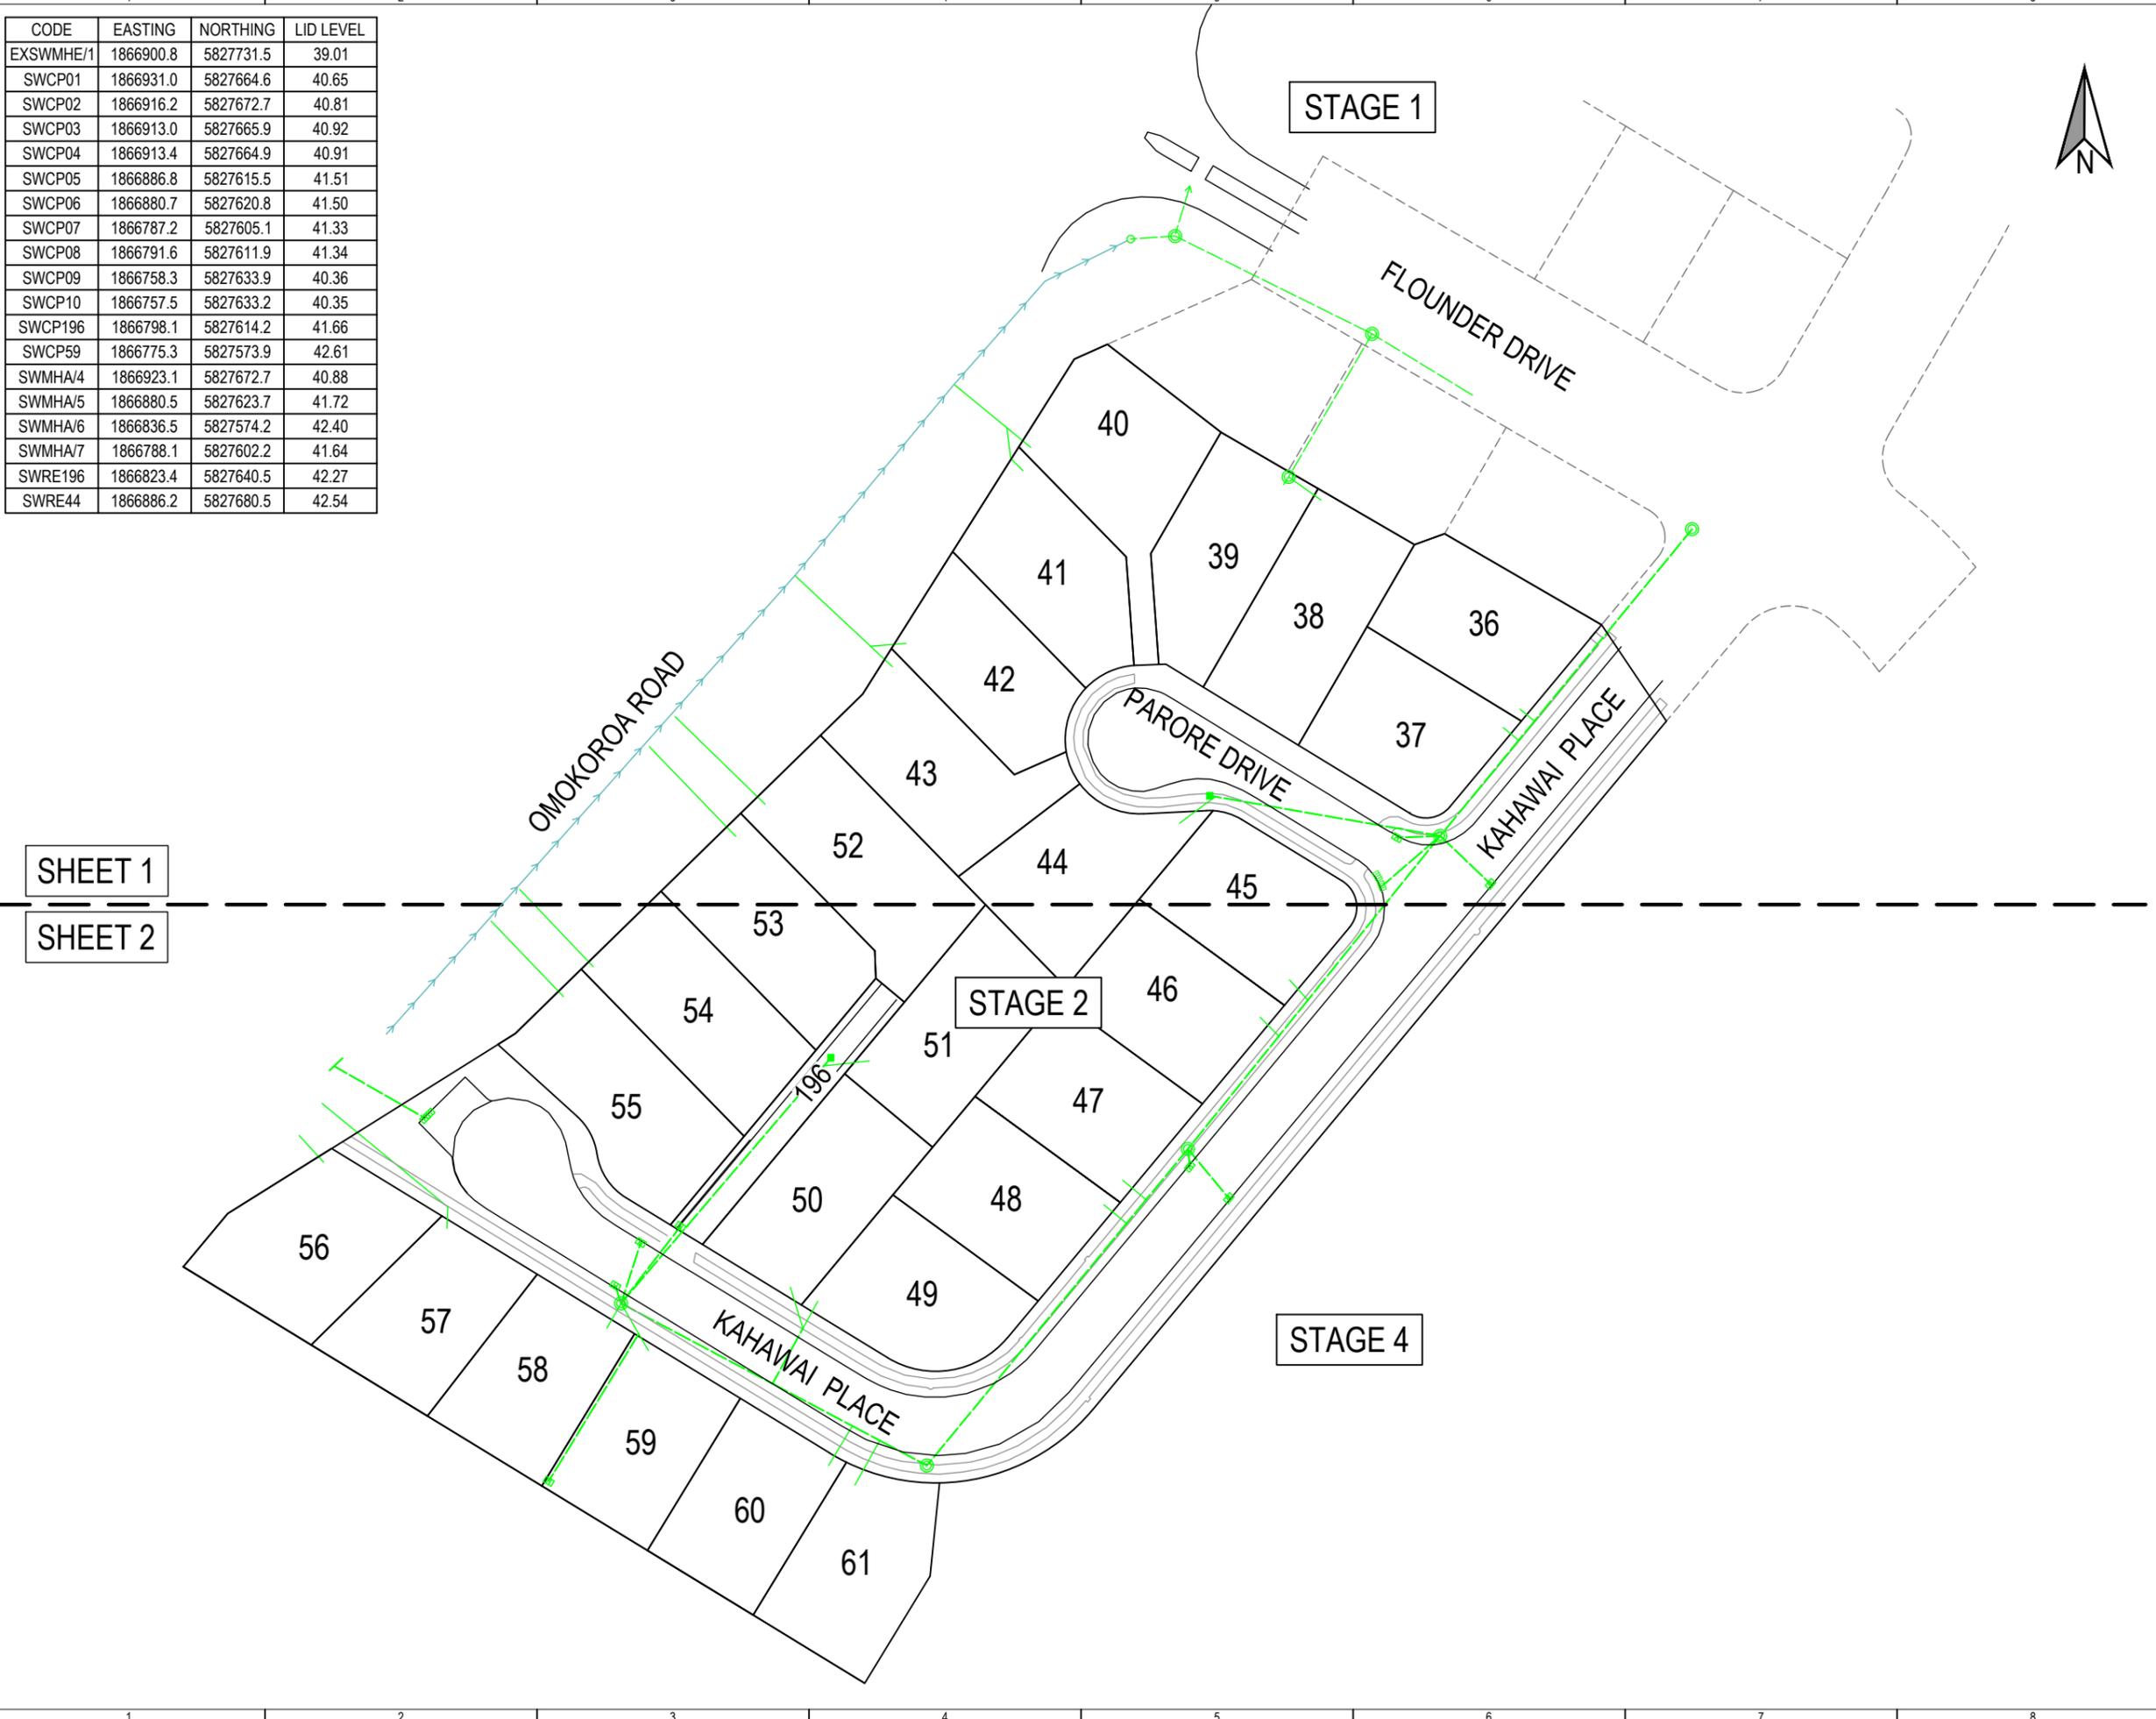
Abuttal	---
Boundary	---
Kerb & Channel	---
Stormwater Pipe	---
Stormwater House Connection	---
Stormwater Manhole	⊙
Double Catchpit	⊞
Catchpit	⊞
Rodding Eye	■

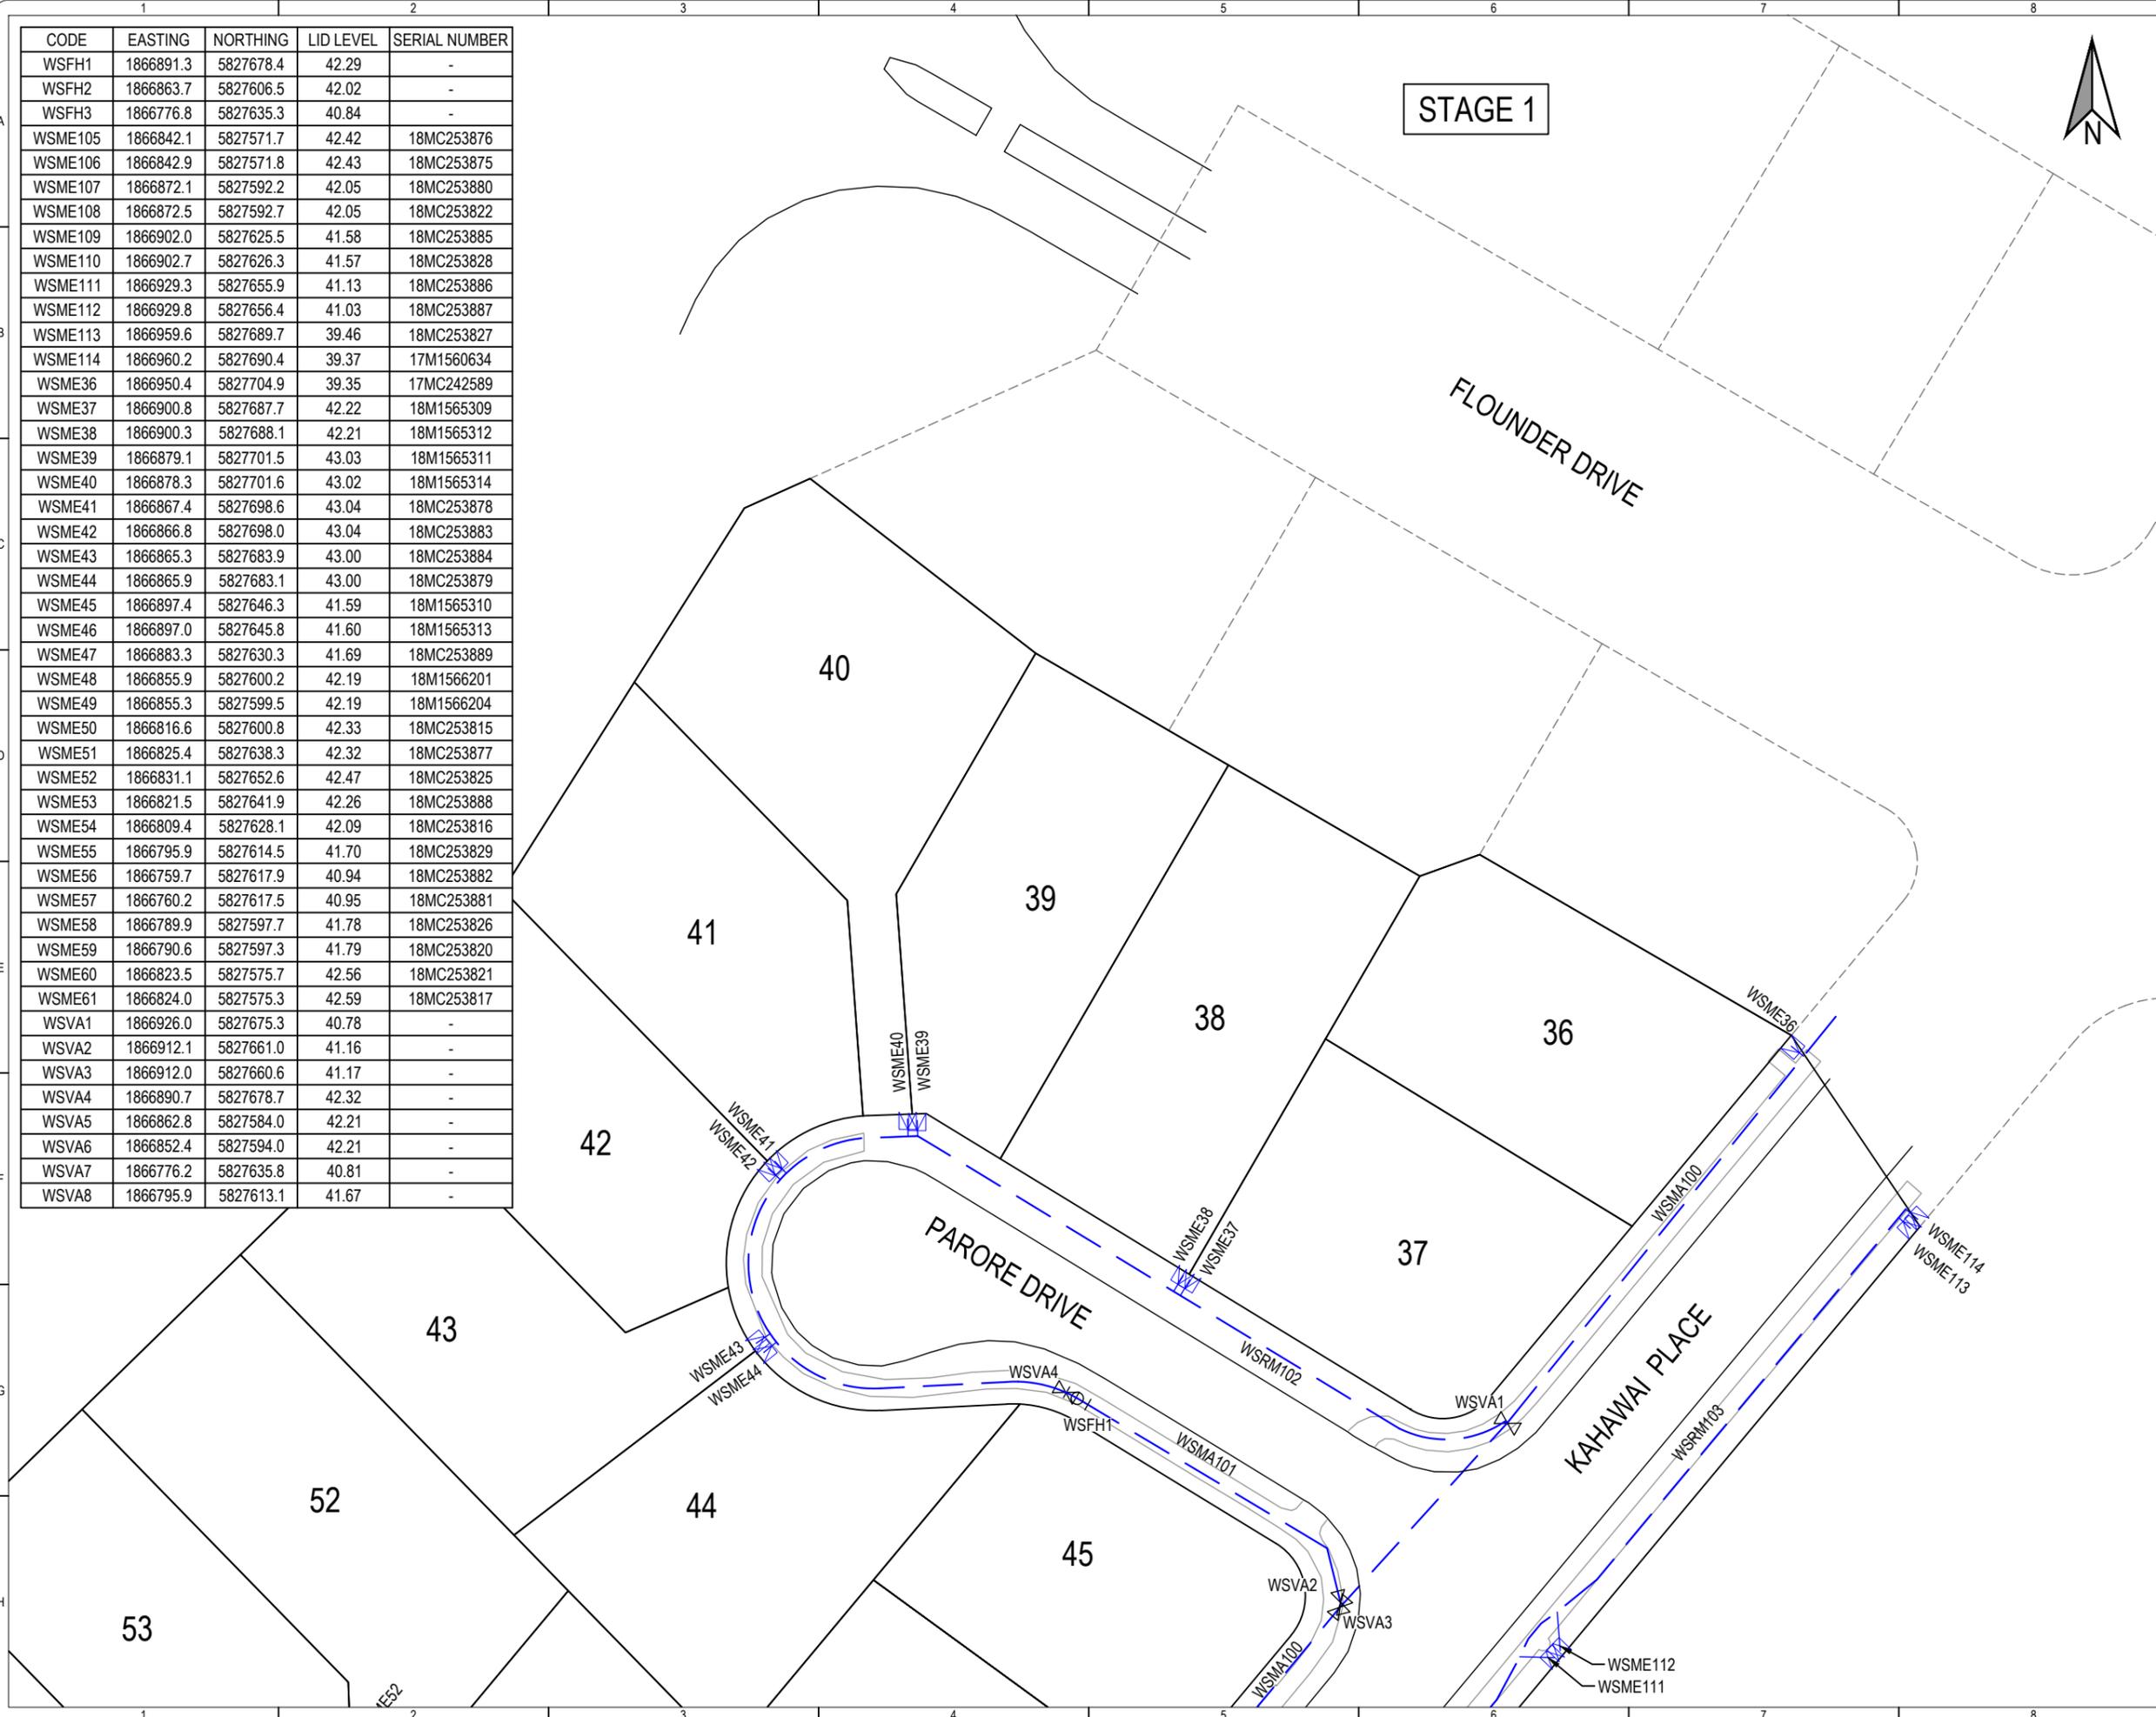
Original Scales @ A3	Status
1:500	AS-BUILT
Do Not Scale Dimensions	
Drawing No	Revision
21118-S2-W01	AB

CODE	EASTING	NORTHING	LID LEVEL	SERIAL NUMBER
WSFH1	1866891.3	5827678.4	42.29	-
WSFH2	1866863.7	5827606.5	42.02	-
WSFH3	1866776.8	5827635.3	40.84	-
WSME105	1866842.1	5827571.7	42.42	18MC253876
WSME106	1866842.9	5827571.8	42.43	18MC253875
WSME107	1866872.1	5827592.2	42.05	18MC253880
WSME108	1866872.5	5827592.7	42.05	18MC253822
WSME109	1866902.0	5827625.5	41.58	18MC253885
WSME110	1866902.7	5827626.3	41.57	18MC253828
WSME111	1866929.3	5827655.9	41.13	18MC253886
WSME112	1866929.8	5827656.4	41.03	18MC253887
WSME113	1866959.6	5827689.7	39.46	18MC253827
WSME114	1866960.2	5827690.4	39.37	17M1560634
WSME36	1866950.4	5827704.9	39.35	17MC242589
WSME37	1866900.8	5827687.7	42.22	18M1565309
WSME38	1866900.3	5827688.1	42.21	18M1565312
WSME39	1866879.1	5827701.5	43.03	18M1565311
WSME40	1866878.3	5827701.6	43.02	18M1565314
WSME41	1866867.4	5827698.6	43.04	18MC253878
WSME42	1866866.8	5827698.0	43.04	18MC253883
WSME43	1866865.3	5827683.9	43.00	18MC253884

WSME44	1866865.9	5827683.1	43.00	18MC253879
WSME45	1866897.4	5827646.3	41.59	18M1565310
WSME46	1866897.0	5827645.8	41.60	18M1565313
WSME47	1866883.3	5827630.3	41.69	18MC253889
WSME48	1866855.9	5827600.2	42.19	18M1566201
WSME49	1866855.3	5827599.5	42.19	18M1566204
WSME50	1866816.6	5827600.8	42.33	18MC253815
WSME51	1866825.4	5827638.3	42.32	18MC253877
WSME52	1866831.1	5827652.6	42.47	18MC253825
WSME53	1866821.5	5827641.9	42.26	18MC253888
WSME54	1866809.4	5827628.1	42.09	18MC253816
WSME55	1866795.9	5827614.5	41.70	18MC253829
WSME56	1866759.7	5827617.9	40.94	18MC253882
WSME57	1866760.2	5827617.5	40.95	18MC253881
WSME58	1866789.9	5827597.7	41.78	18MC253826
WSME59	1866790.6	5827597.3	41.79	18MC253820
WSME60	1866823.5	5827575.7	42.56	18MC253821
WSME61	1866824.0	5827575.3	42.59	18MC253817
WSVA1	1866926.0	5827675.3	40.78	-
WSVA2	1866912.1	5827661.0	41.16	-
WSVA3	1866912.0	5827660.6	41.17	-
WSVA4	1866890.7	5827678.7	42.32	-

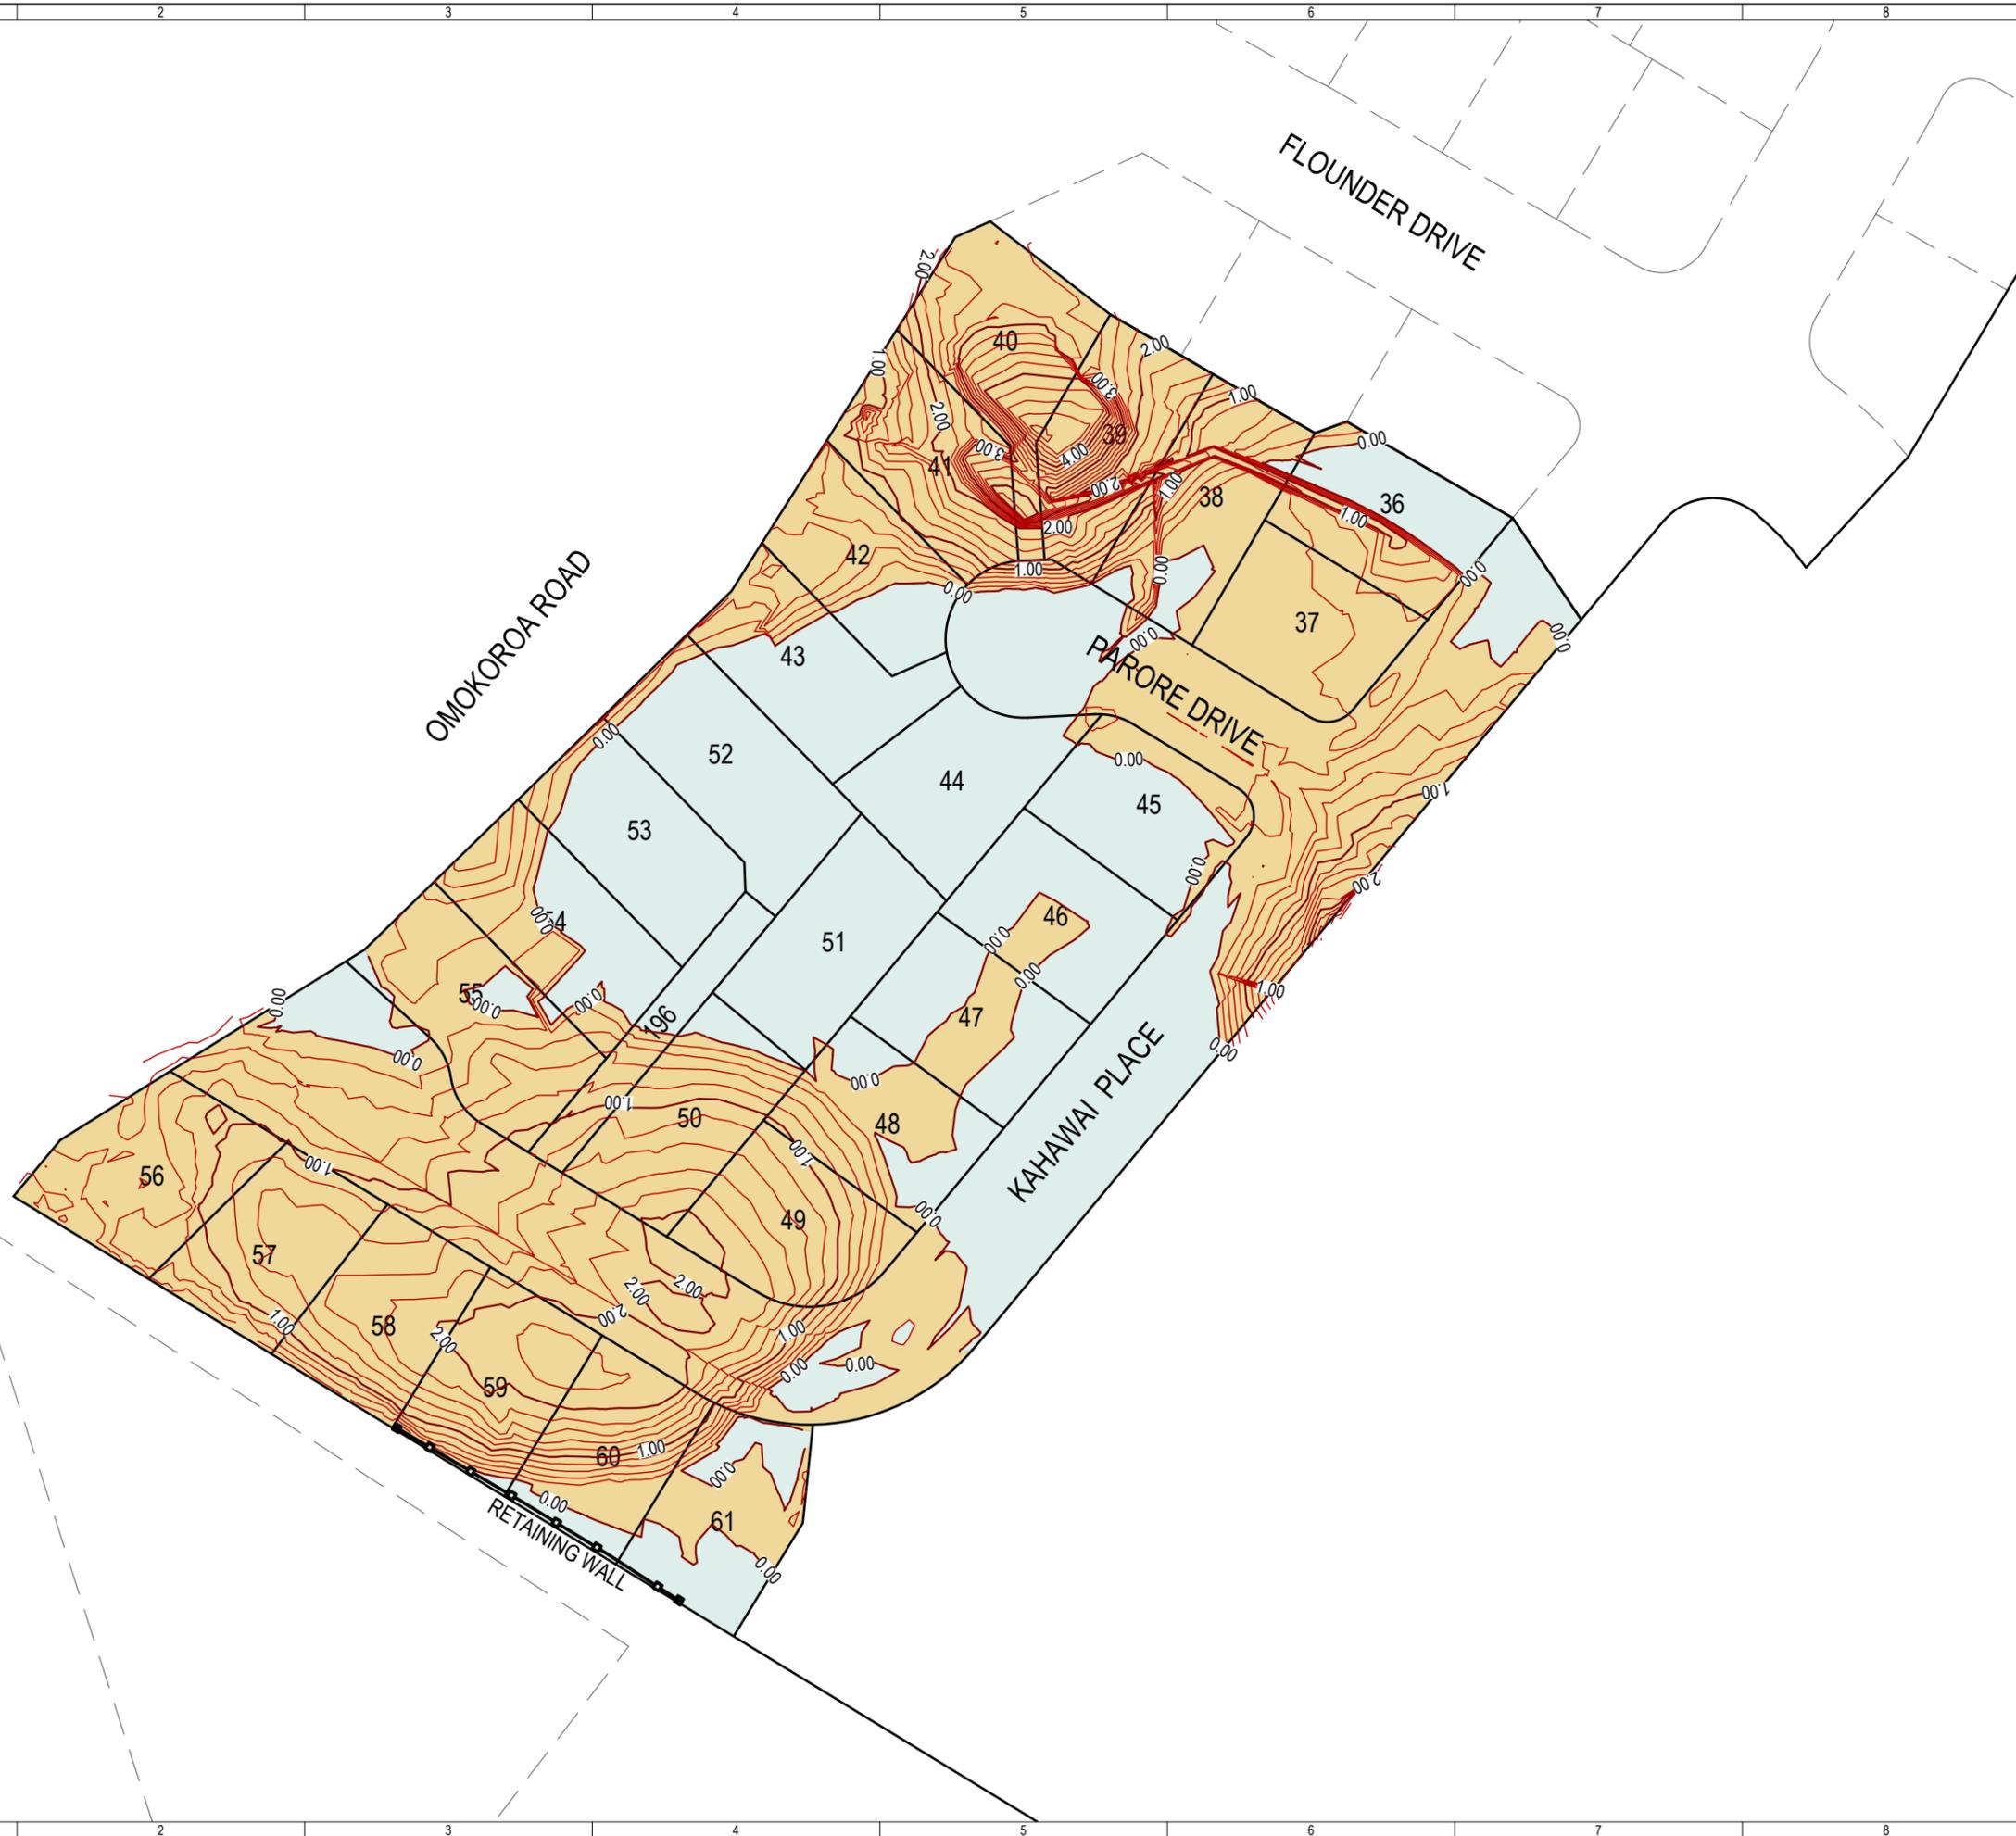
Original Scales @ A3 1:1000	Status AS-BUILT
Drawing No 21118-STG2-EW1	Revision AB1

Notes:
1. Contours shown are depths of fill.
