25 KAHAWAI PLACE, OMOKOROA

Land Information Memorandum

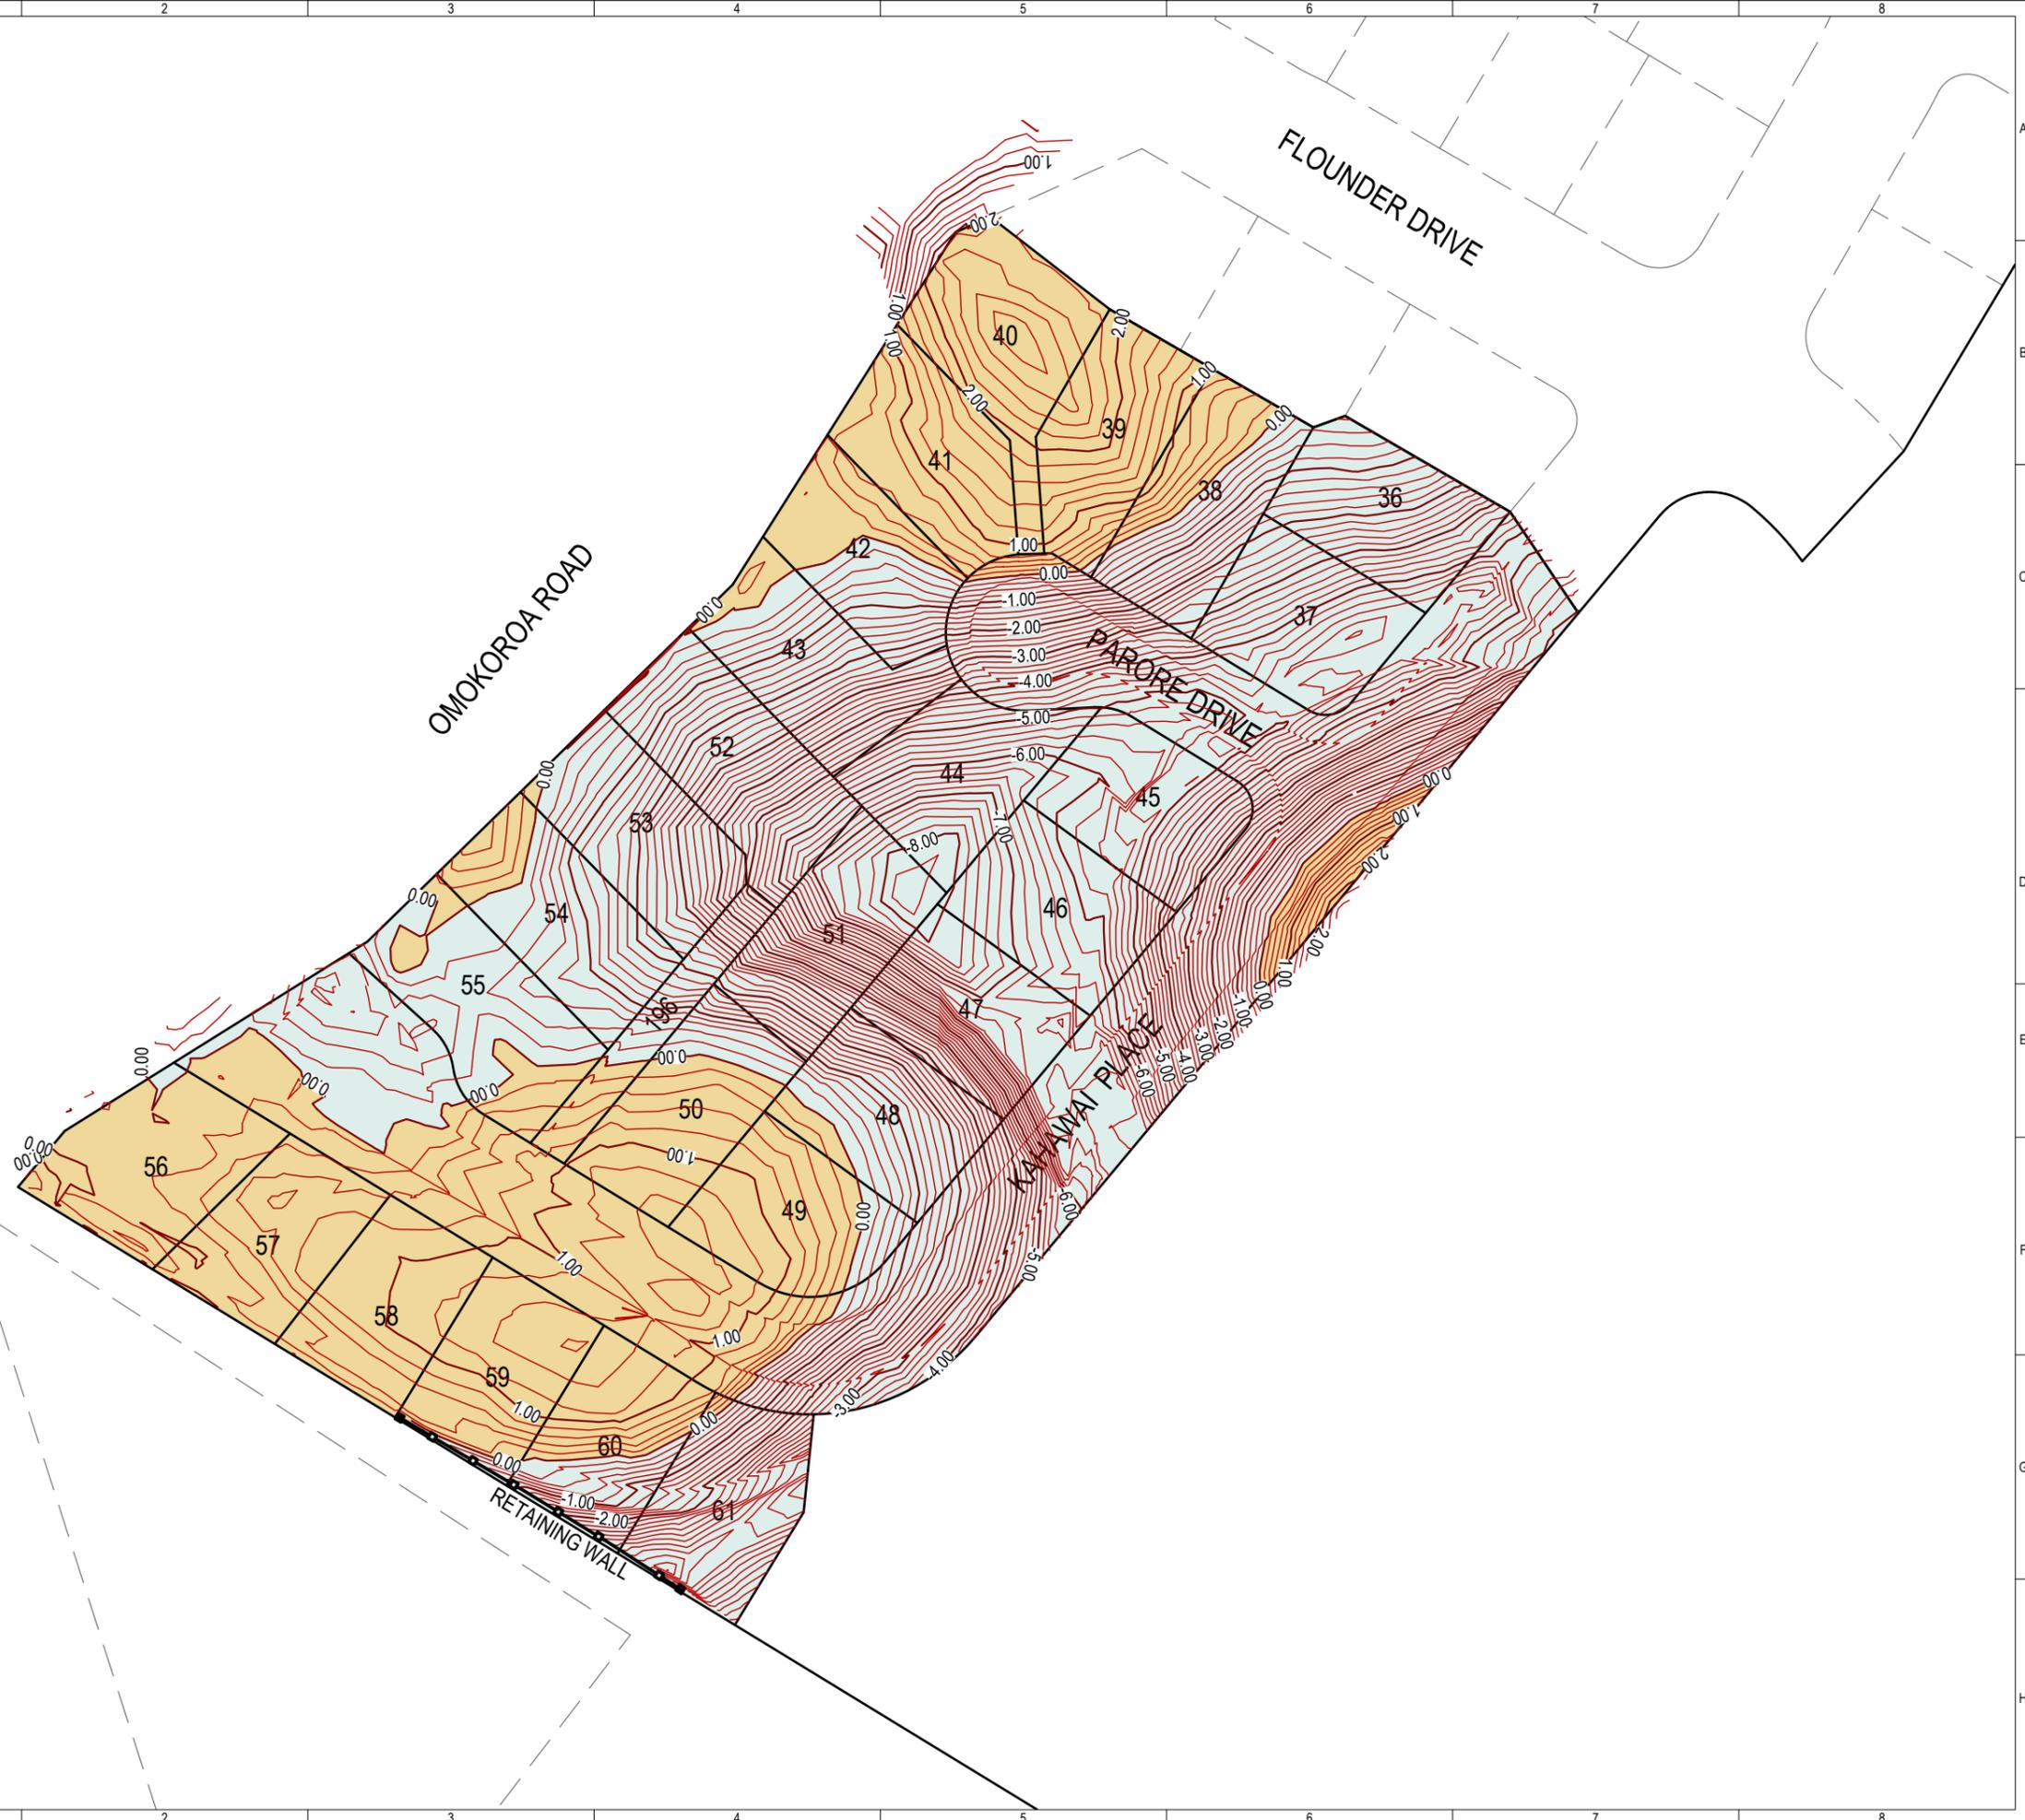
Notes:
1. Contours shown are cut and fill depths.

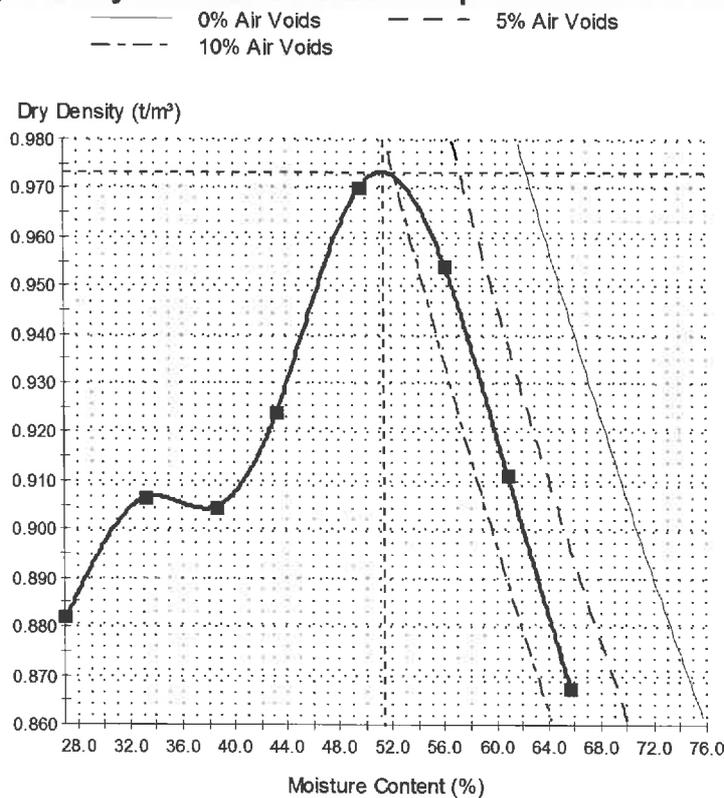
Dry Density - Moisture Relationship

NZS 4402:1986 Test 4.1.1 - 1986
Maximum Dry Density (t/m³): 0.97
Optimum Moisture Content (%): 51
Solid Density (t/m³): 2.480
Oversize Sieve (mm): 19.0
Oversize Material (%):
Sample History: <19mm

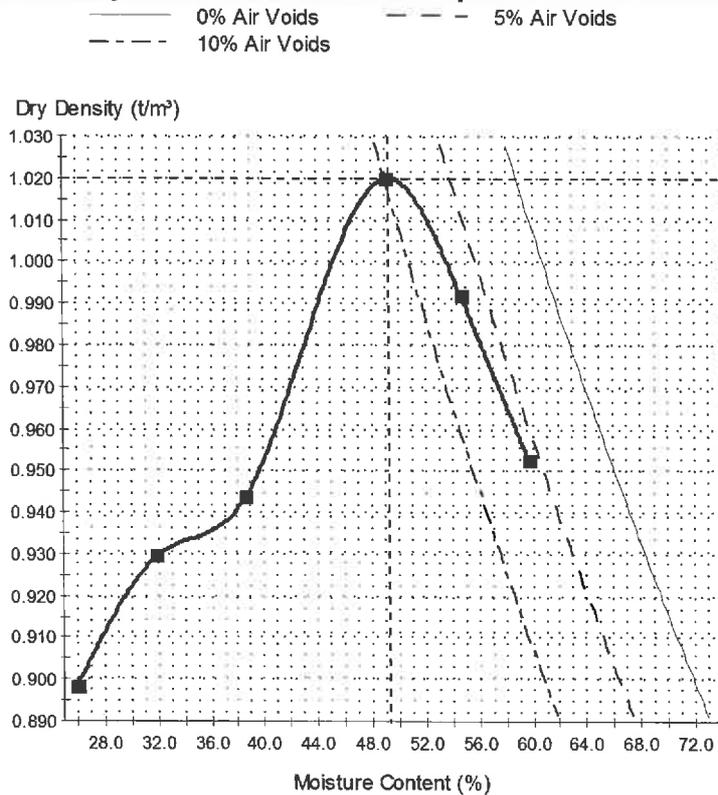
Dry Density - Moisture Relationship

NZS 4402:1986 Test 4.1.1 - 1986
Maximum Dry Density (t/m³): 1.02
Optimum Moisture Content (%): 49
Solid Density (t/m³): 2.550
Oversize Sieve (mm): 19.0
Oversize Material (%):
Sample History: <19mm

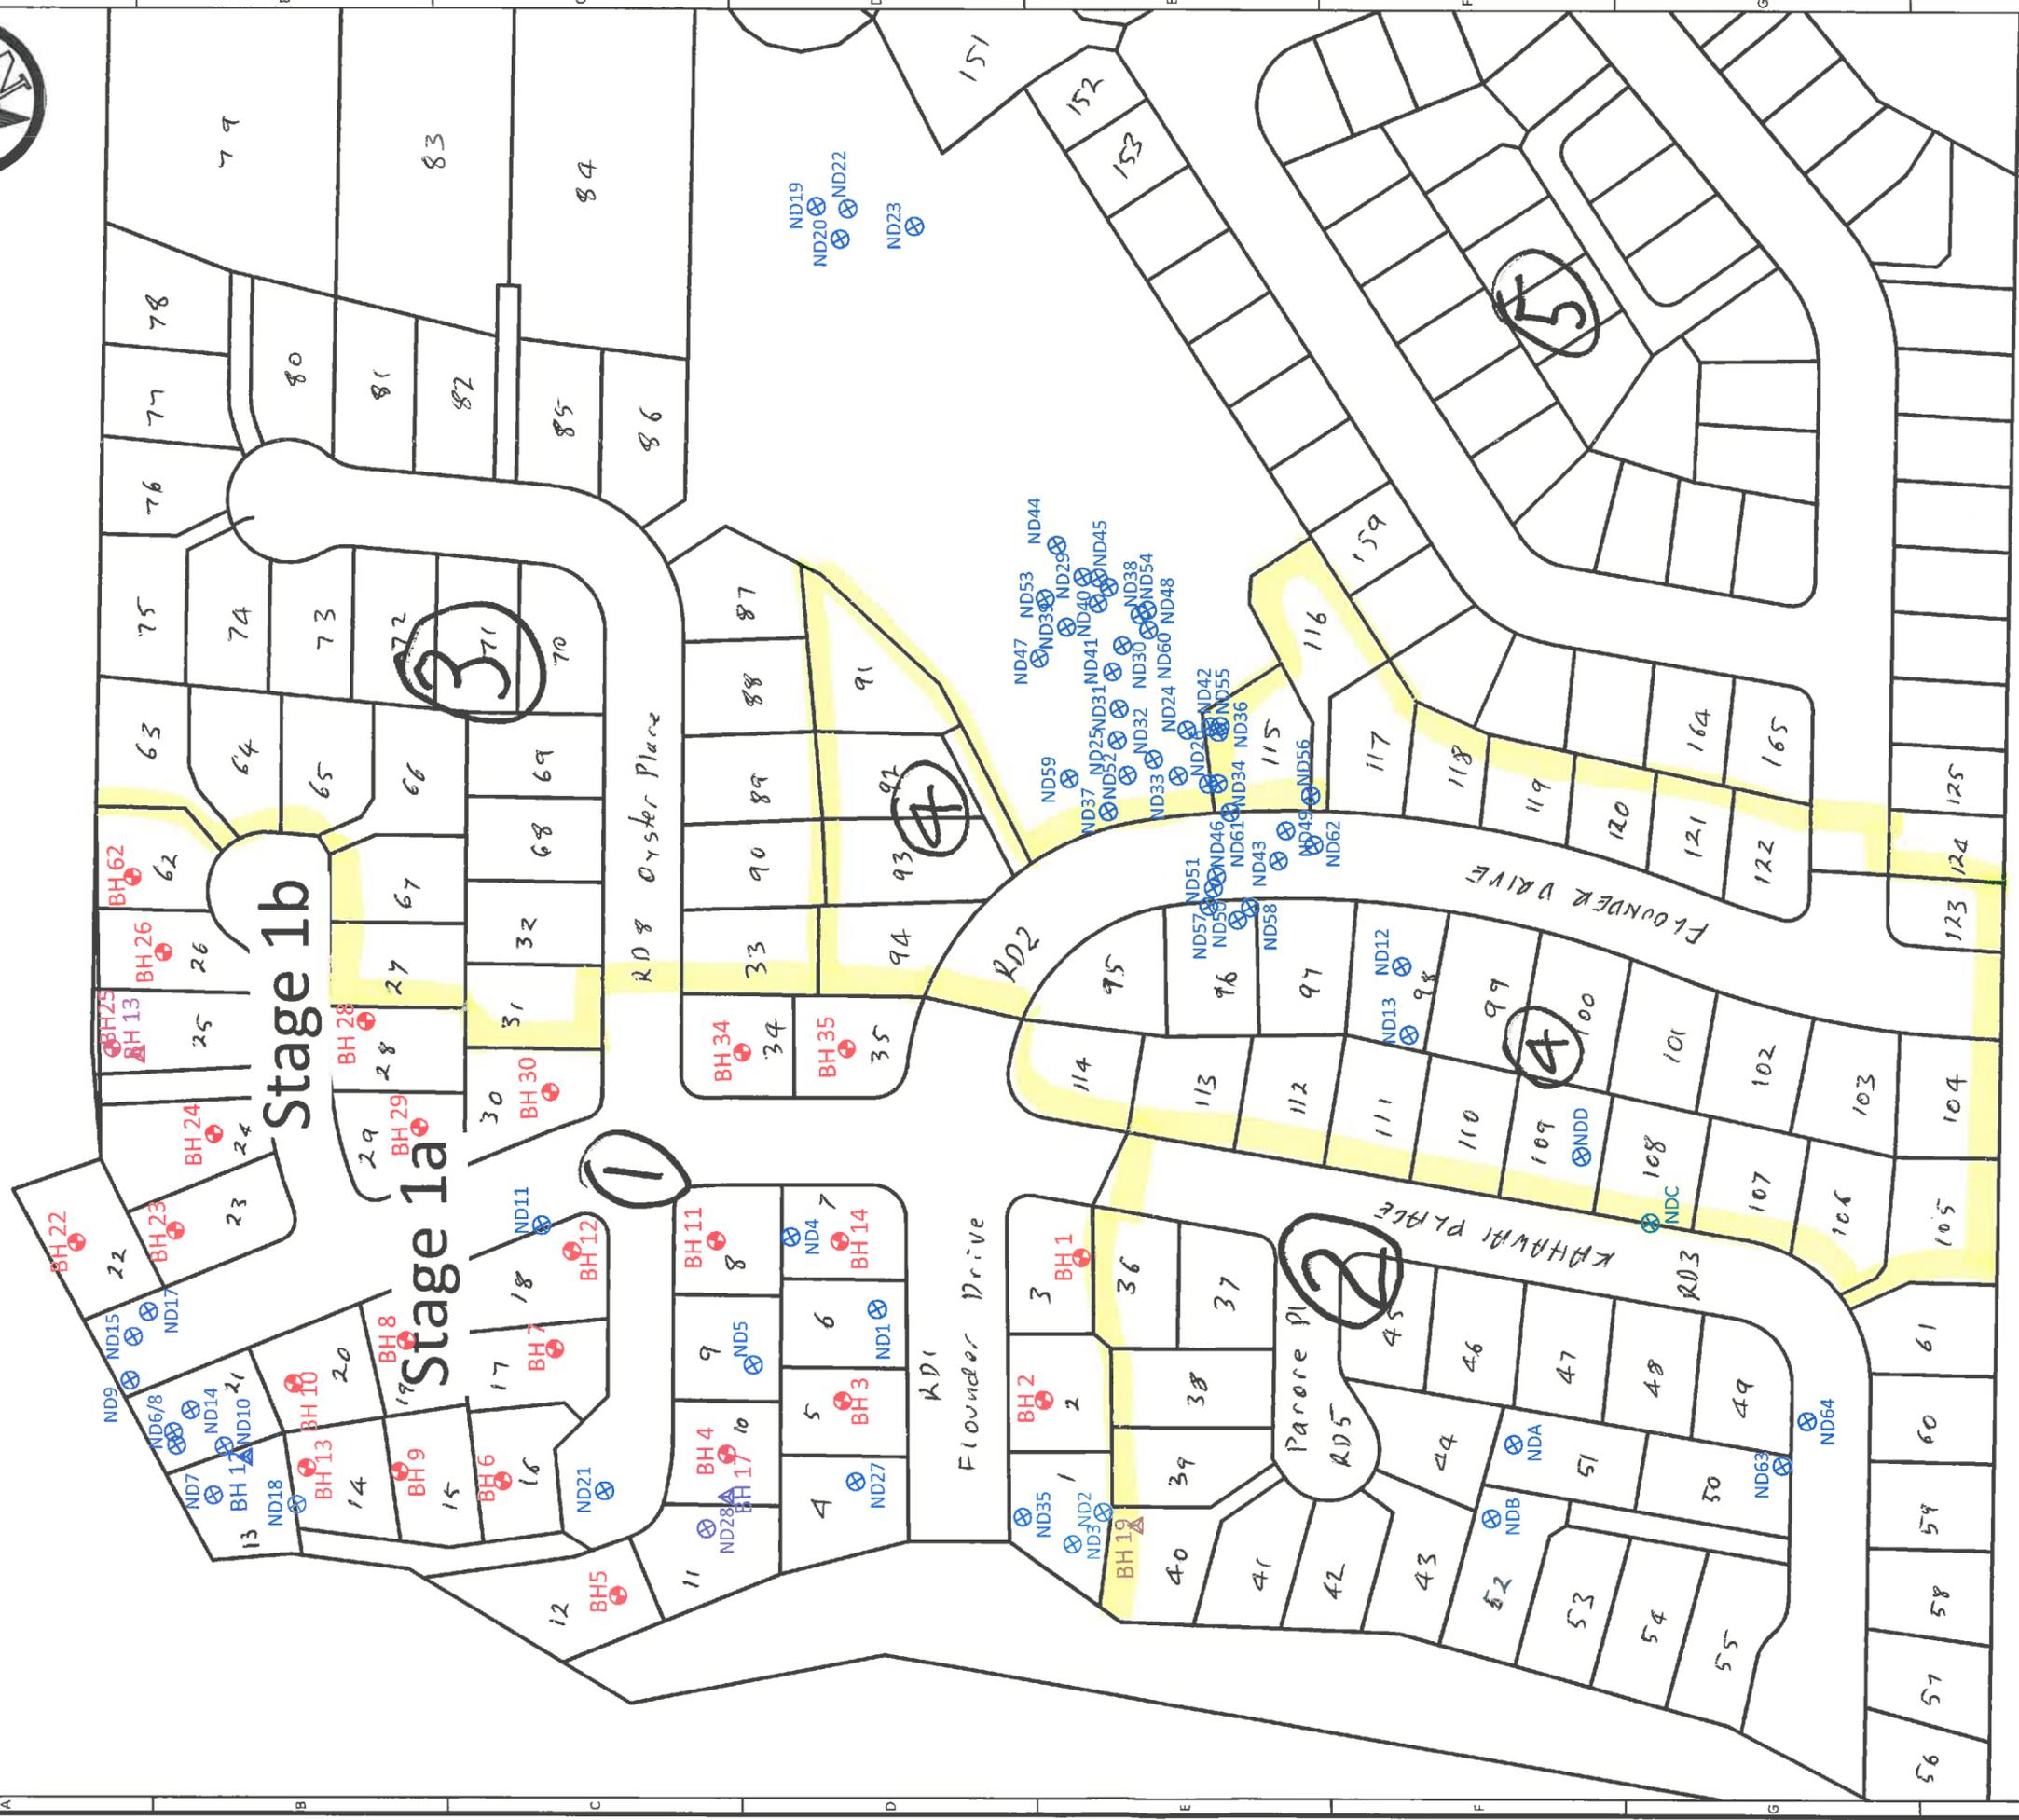
Note: Tests NDA, B, C & D Taken on the Natural Undisturbed Surface Soil
