Land Information Memorandum: 40 Victoria Street Coromandel

THAMES-COROMANDEL DISTRICT COUNCIL
LAND INFORMATION MEMORANDUM

Application Date:	6 November 2023
Property Number:	423536
Property Address:	40 Victoria Street Coromandel
Legal Description:	Lot 3 DP 471265
Area (ha):	0.0854

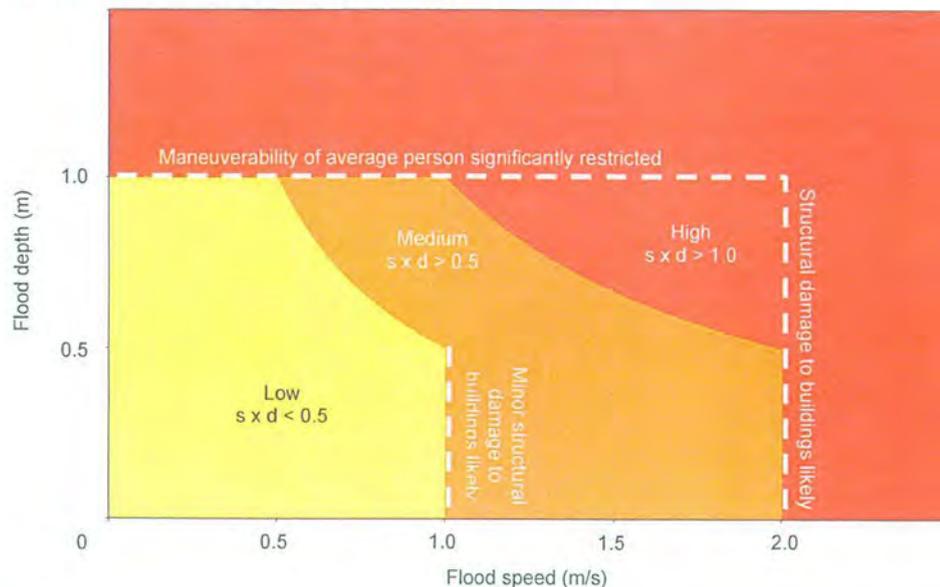
Figure 10: River flood hazard classification matrix

The three levels of river flood hazard (low, medium and high) have then been quantified through the creation of a matrix that assigns a river flood hazard level based on the predicted depth and speed of flooding (refer to Figure 10).

These considerations have been translated into a river flood hazard classification by first defining four distinct levels of river flood hazard based on the likely impact on people and property. These levels are outlined in Table 1.

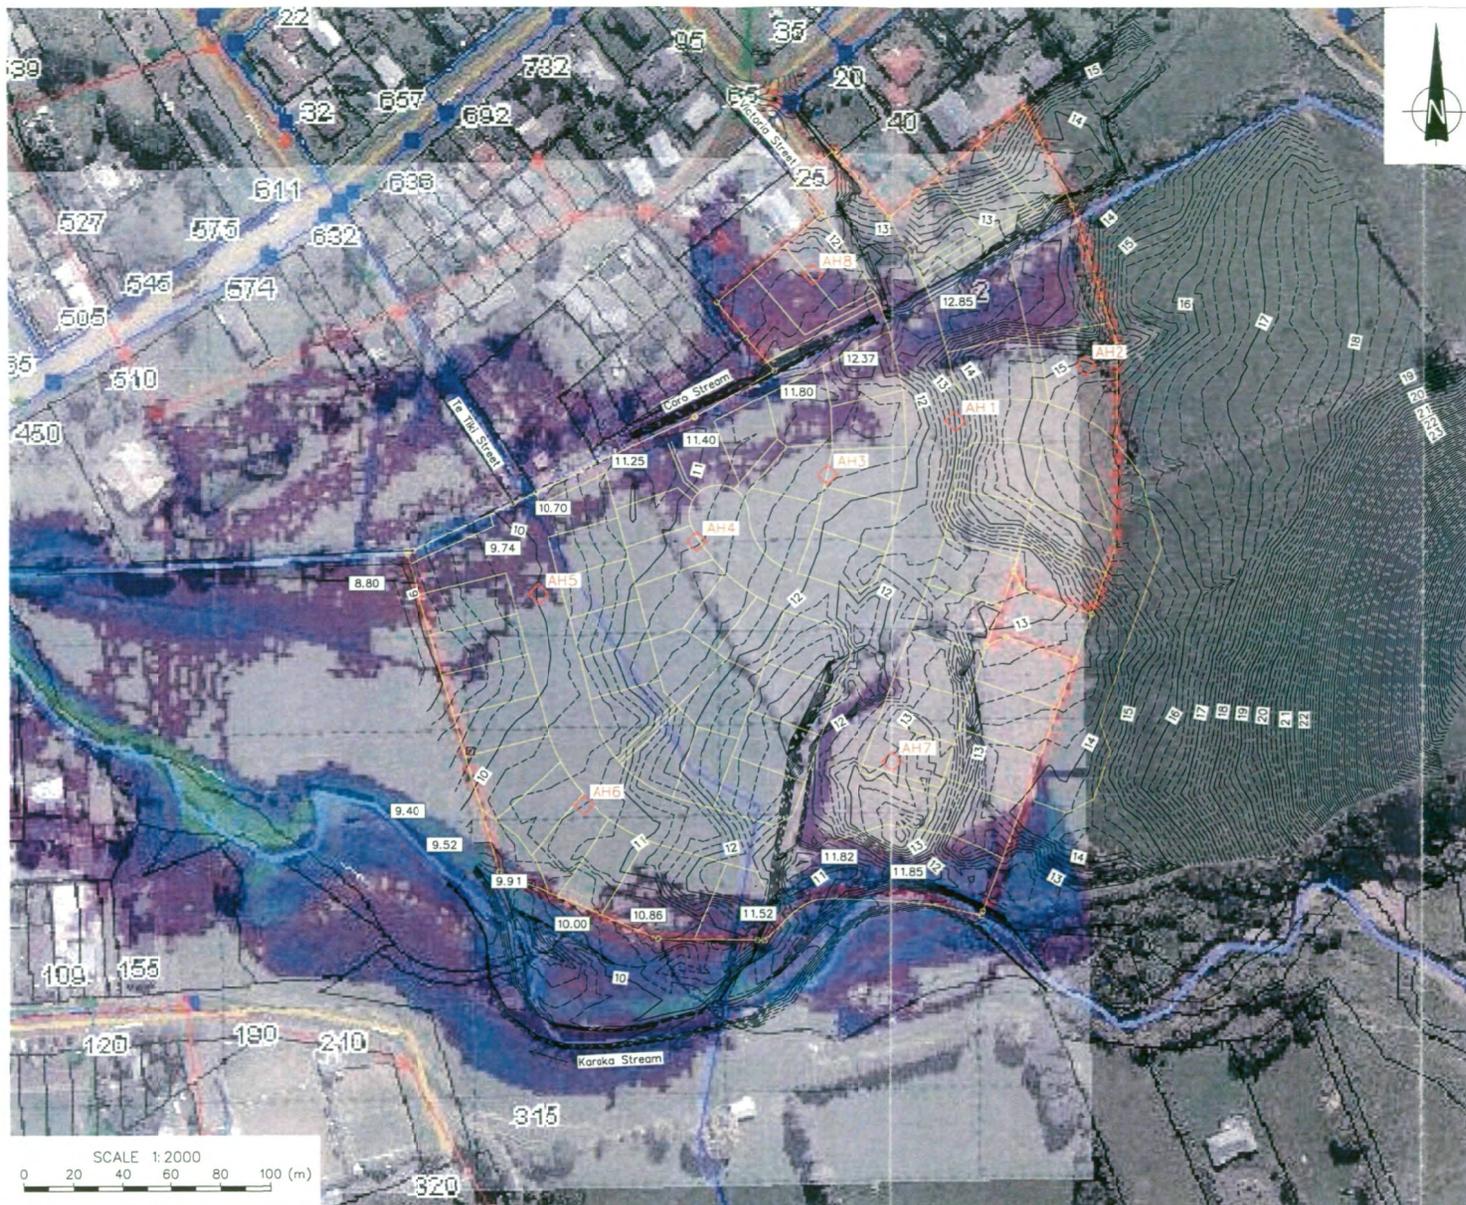
LEGEND	
	Environment Waikato Mike 21 100 year flood area
	Environment Waikato Mike 21 100 year flood level
	0.2 m contour
	1.0 m contour
	Subdivision layout
	Hand augerhole location

Subsequent work by EW has revised the flood flows and levels. A copy of the 100 year flood levels from the latest Mike 21 model was obtained from EW and used to set design flood levels at the site. These flood levels are shown on Figure 3.1. Note that the flood extents predicted by this model are assumed to supersede the flood hazard outlines shown in the Thames Coast report. The revised 100 year design flow for Karaka Stream is 82 m³/s at the site and 93 m³/s above the confluence with Whangarahi Stream.

We recommend that no houses are constructed within the 100 year flood area for Karaka Stream (see Figure 3.1). The exception to this would be the small gully at the midpoint on the southern boundary, which is shown to experience a backwater effect from Karaka Stream. Velocities in this area will be minimal, and the gully may be filled and built upon with no adverse effect on upstream or downstream flood levels. Floor levels should be set at a minimum of RL 12.35 m to RL 9.90 m, decreasing from upstream to downstream across the southern boundary.

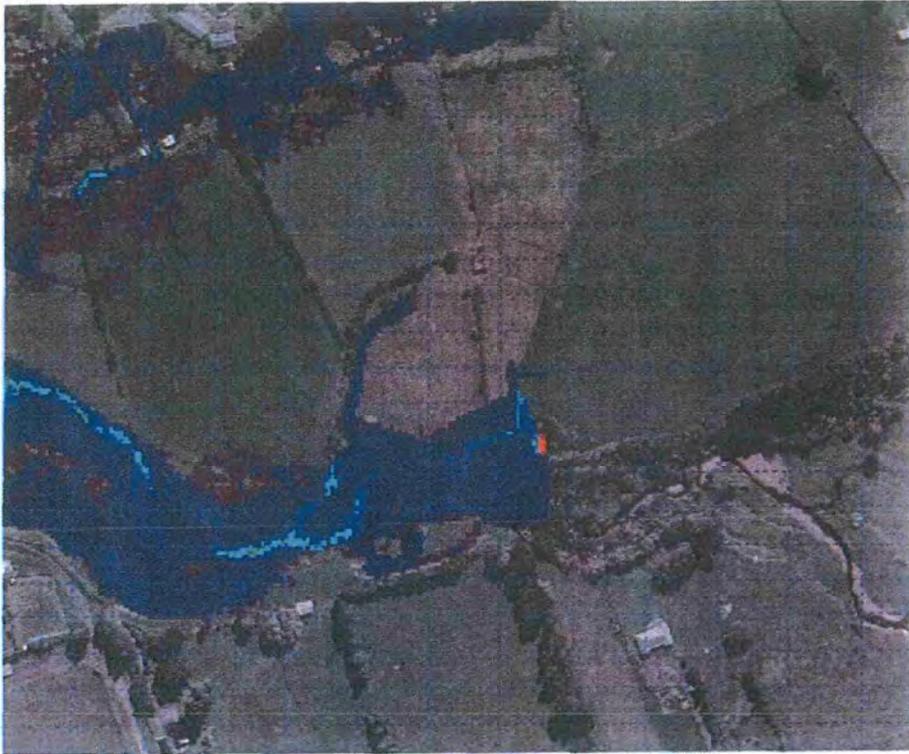
Figure 1 - Existing 1 in 100 year flood levels on Karaka Stream

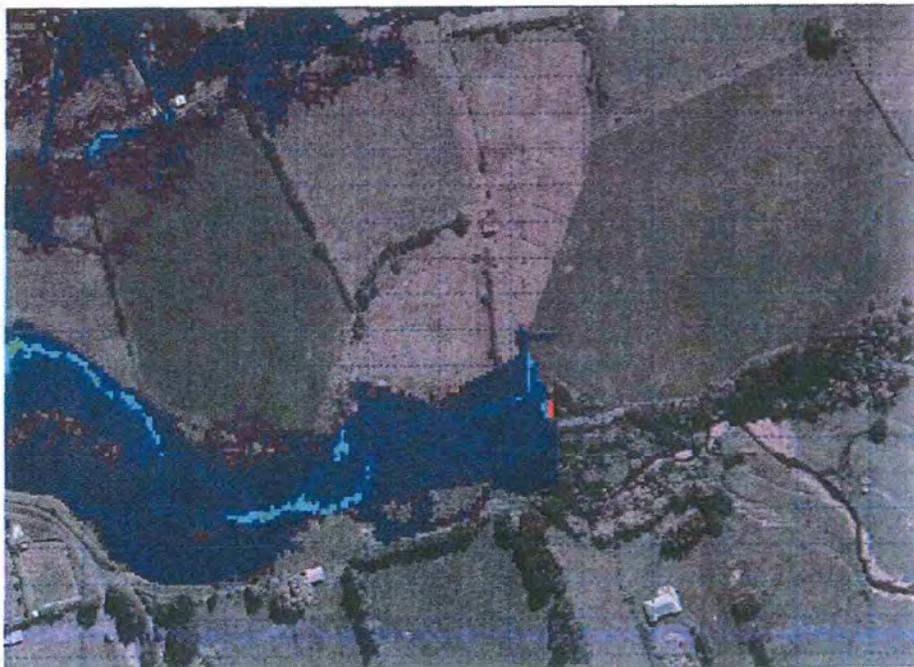
Figure 2 - Proposed 1 in 100 year flood levels on Karaka Stream with infilled gully

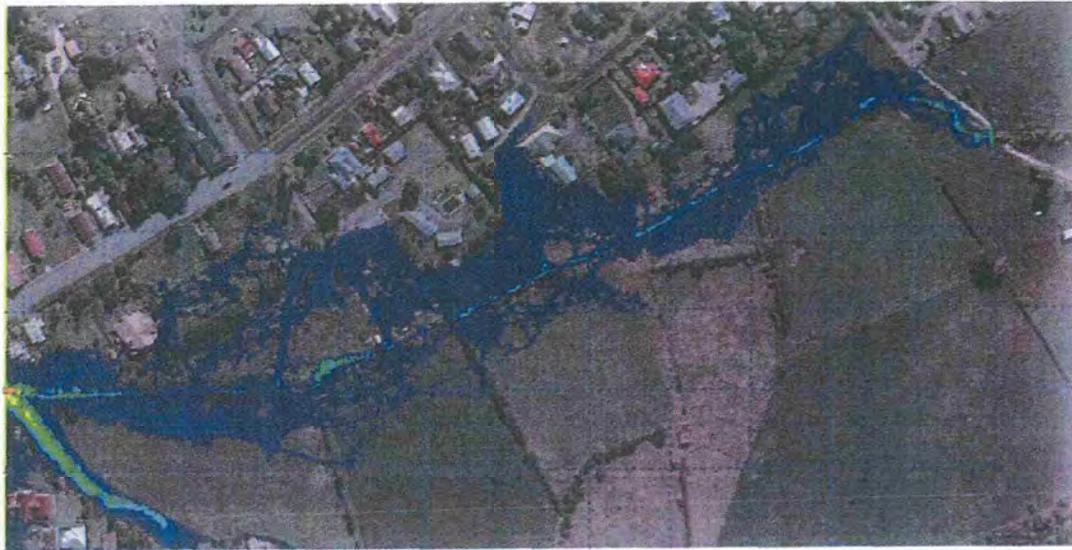
Figure 3 - Existing 1 in 100 year flood levels on Coro Stream

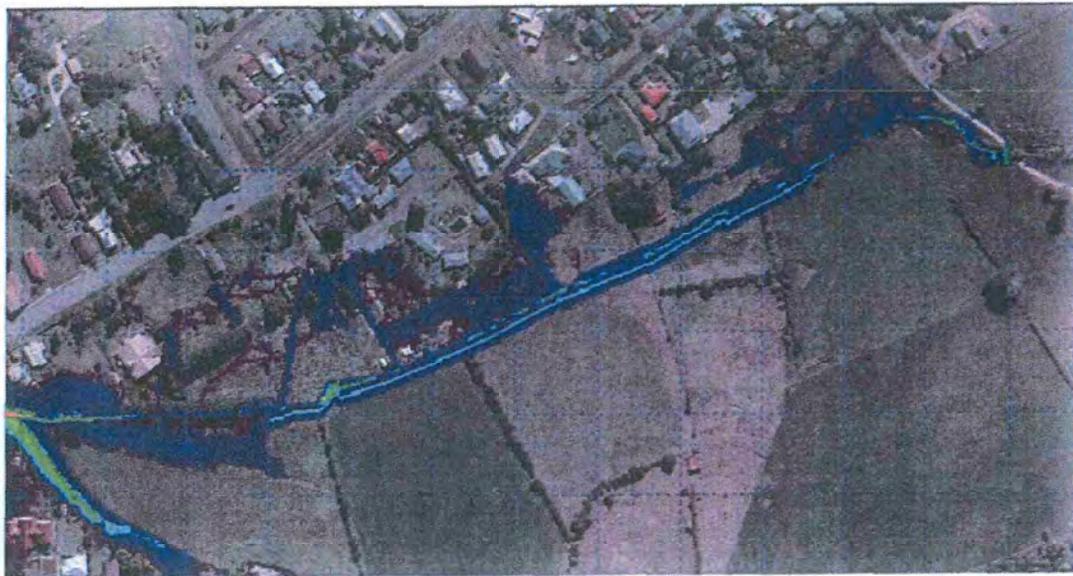
Figure 4 - Proposed 1 in 100 year flood levels on Coro Stream with enlarged channel, 3m floodway and 1m high building platforms

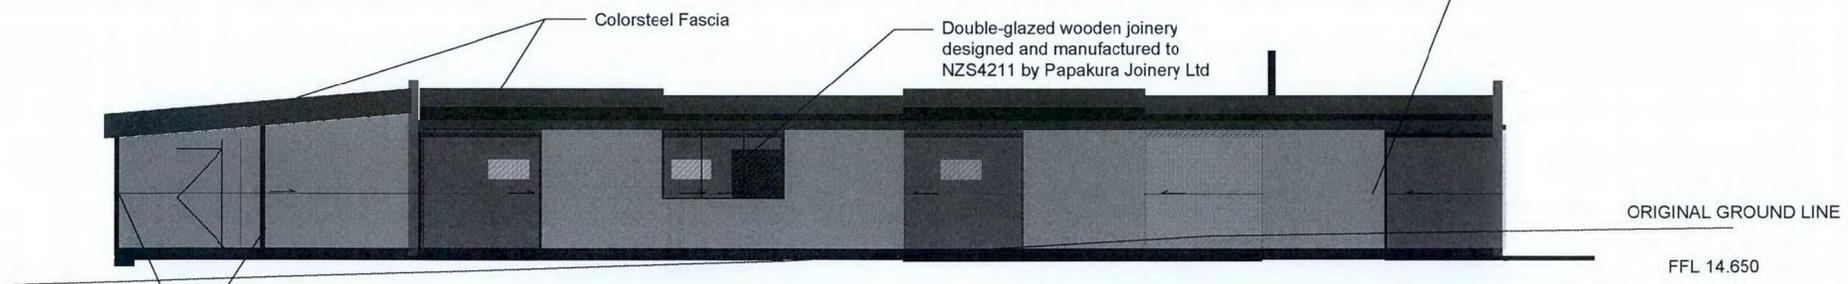
Northeast Elevation 1:100

Shadowclad
12mm H3.2 plywood cladding
over 20mm drained cavity
13mm exterior box corner flashing

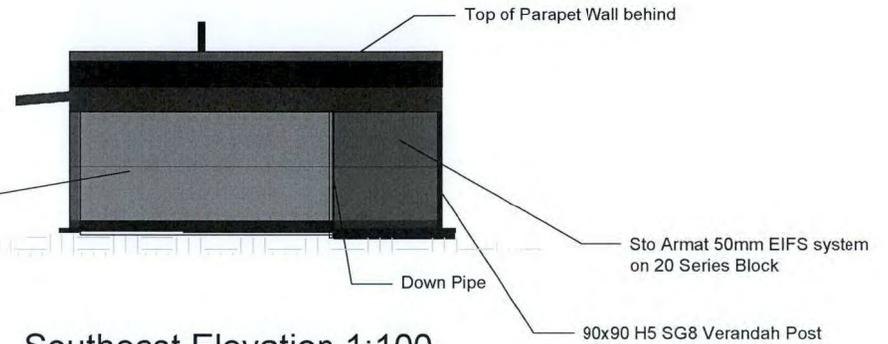
Southeast Elevation 1:100

Sto therm Armat EIFS system
with 50mm thick polystyrene sheet
Stolic K 1mm modified plaster

790Wx200H Slit in wall
Lintel: 2/D12 with R6 @ 50mm
Sill: cement plaster with acrylic paint

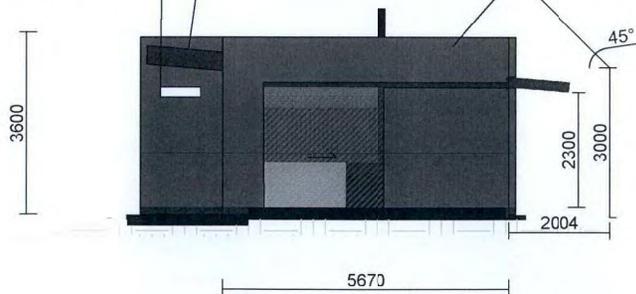
Northwest Elevation 1:100

Daylighting as required
TCDC District Plan
Section 54, Rule 21.1.g
