# Your Dilapidation Report

CONFIDENTIAL REPORT FOR  
Facundo Jagodnik  
ID 132891  
Monday, July 29, 2024

Jeff East has completed an assessment of **28 Raupeti Lane (Lot 17) Henderson Auckland 0612** on the **29/7/2024** and recorded any potential site hazards. Any Hazards marked as **RED** are of potential concern and may have resulted in the incompleteness of the report due to Health & Safety Concerns. Additional details relating to the Hazard can be found in the link next to the Hazard. It is our recommendation these Hazards are addressed where applicable.

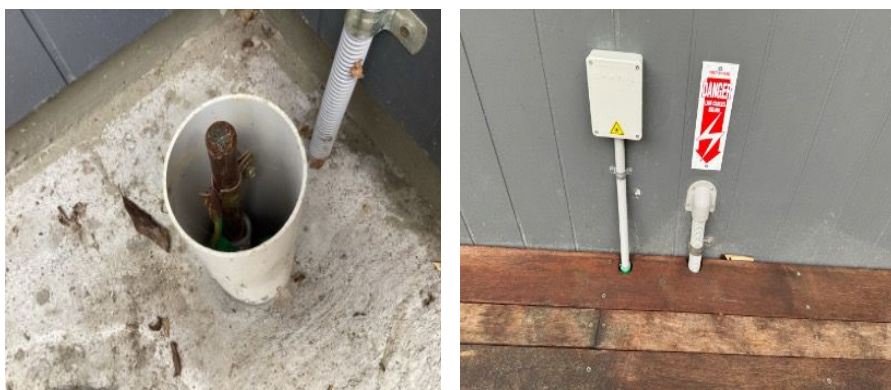
We cannot assess or comment on the condition of buried cables. We note that the power supply is functional.

This is the electrical earth.

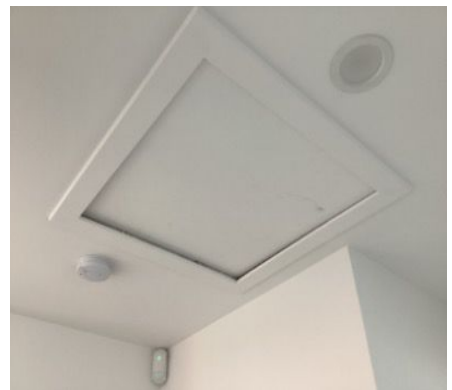
The manhole cover for the ceiling access will not seat properly needs trimming.

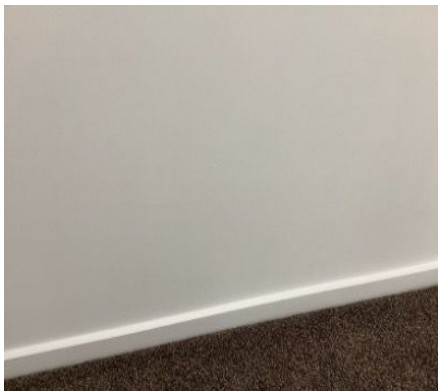
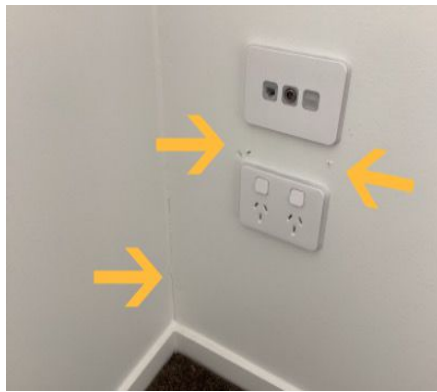
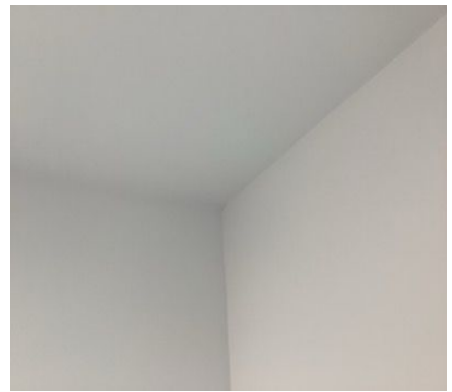
The wall linings have cracked. These appear to be aesthetic. These types of imperfections are generally not structural.

There is a crack in the plaster in the corner of bedroom two. We recommend this is filled and the paint touched up. Screw holes near the power point they should be filled and paint touched up.

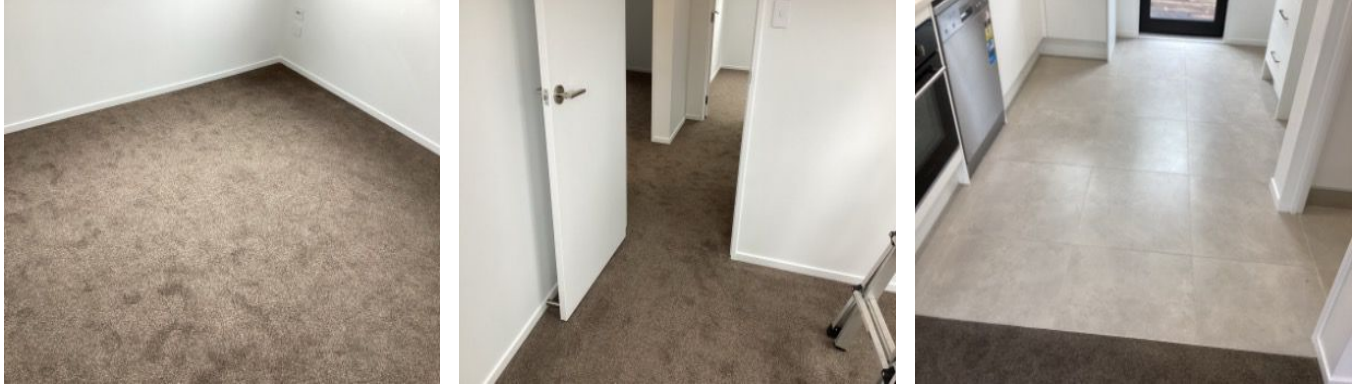
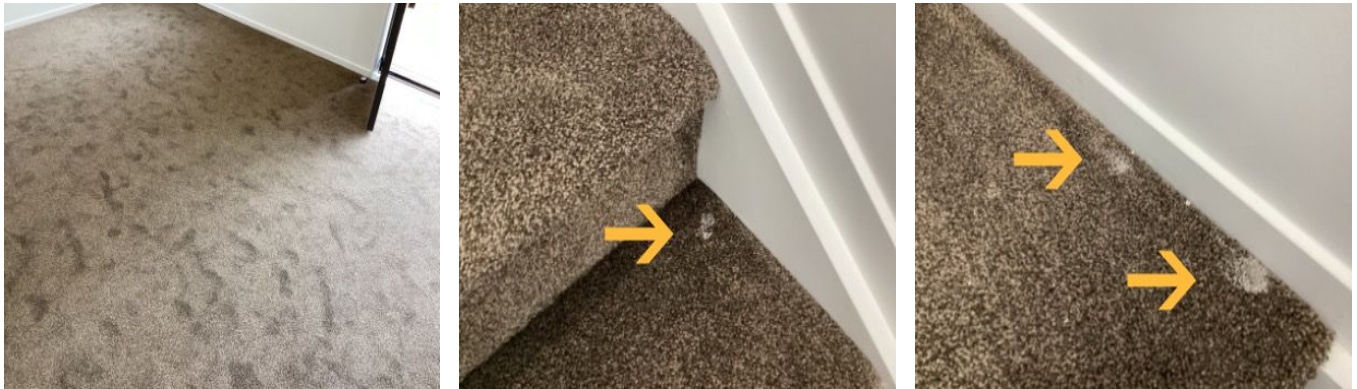
There were some paint marks on the carpet in the stairwell. We recommend this is cleaned off.

There appears to be some paint on the carpet in the stairwell.

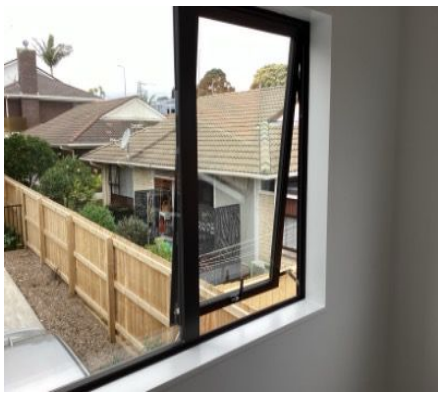
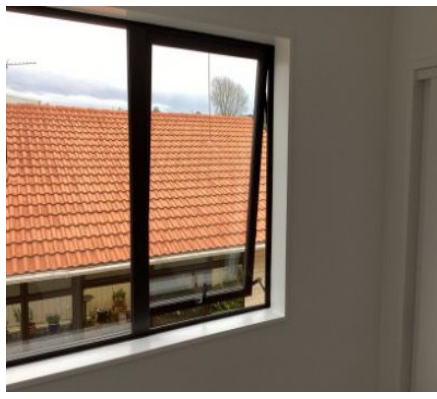
The window in the stairwell is too high to reach.
