Information request – CLM/2016/026078 - 4 Woodbank Road, Hanmer Springs 7334

Claim: CLM/2016/026078

4 Woodbank Road, Hanmer has suffered damage from the Kaikoura Earthquake sequence late in 2016. This Scope Report has been completed for insurance assessment and estimating only.

APPENDIX A | Architectural Damage and Remedial Plans

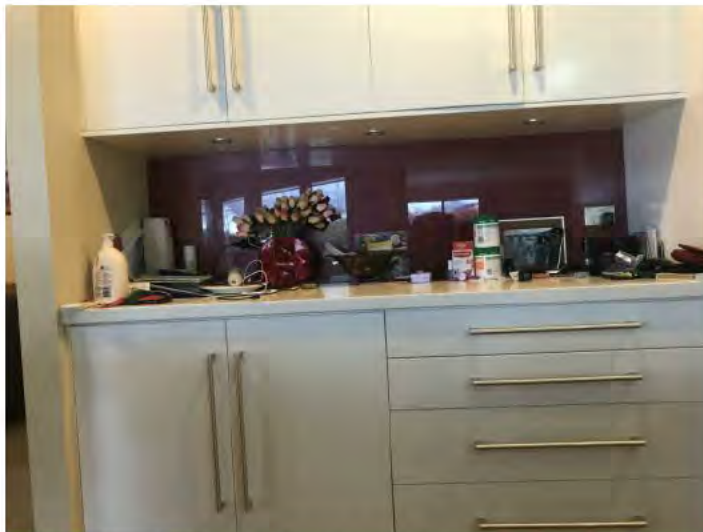
11. Kitchen (1.02) movement to joinery and splash back

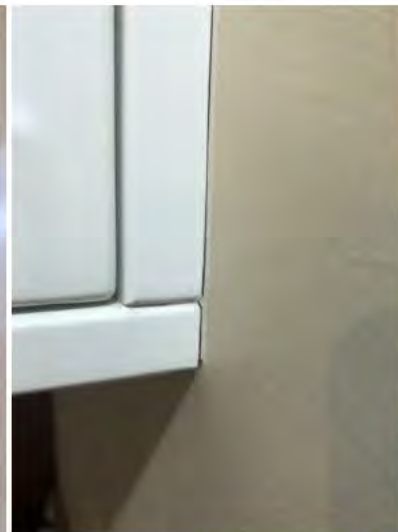
13. Kitchen (1.02) movement to joinery

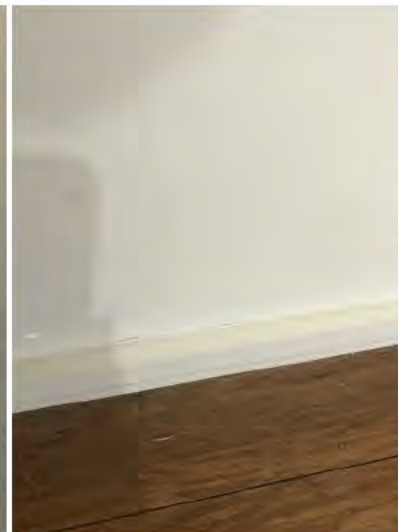
14. Kitchen (1.02) movement to skirting

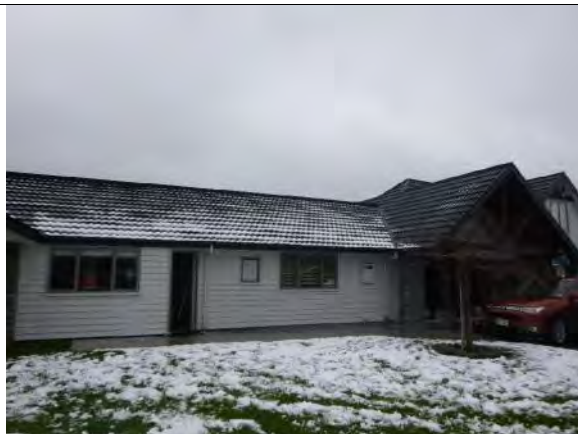
Photo 1: Managers' residence south elevation

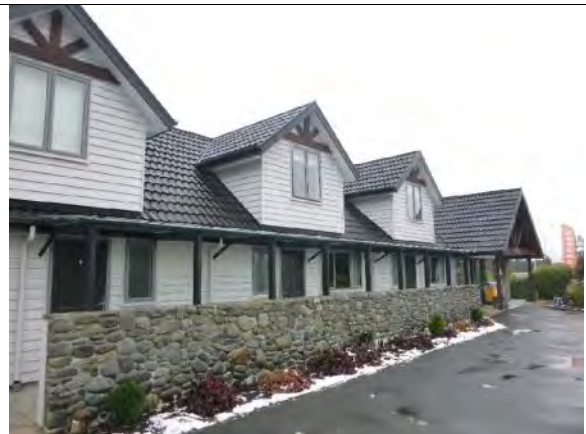
Photo 2: Adjoined apartment wing south elevation

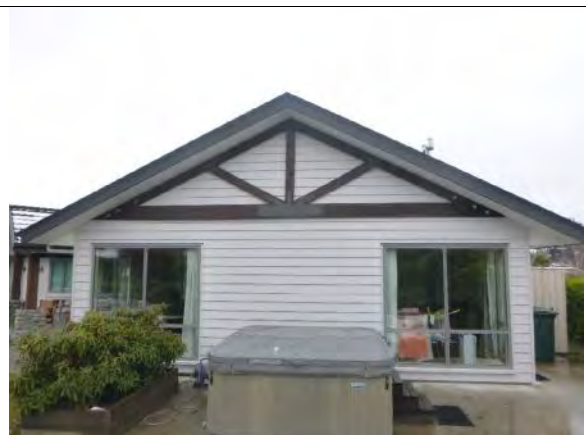
Photo 4: Managers' residence north elevation

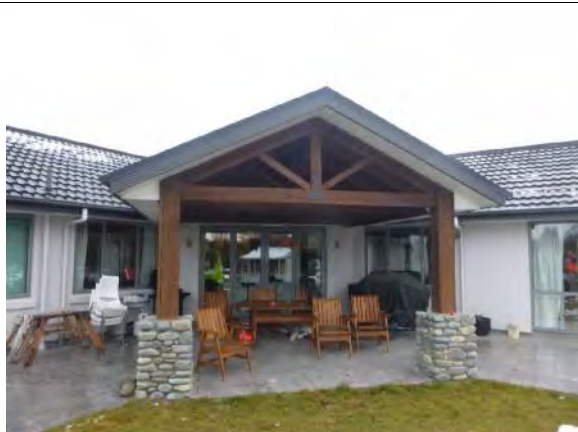
Photo 5: Managers' residence northeast elevation

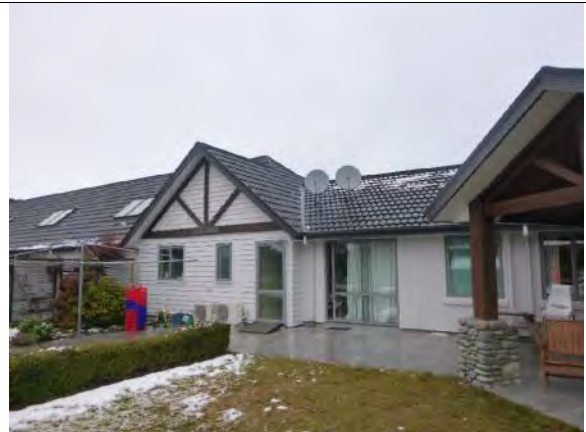
Photo 6: Managers' residence north elevation

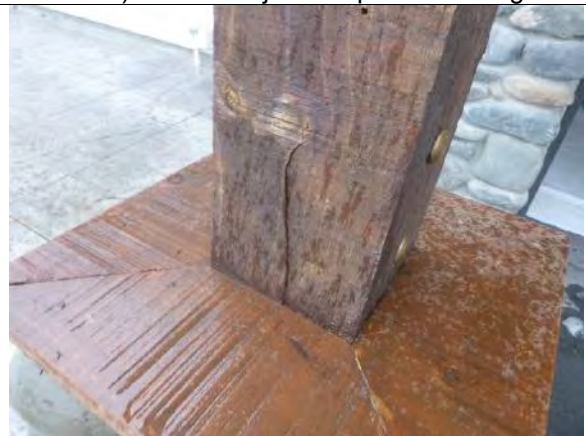
Cracking at the base of a post supporting a roof canopy was noted outside the garage; however, this damage is considered not be earthquake related (refer Photo 22).

Photo 22: Split within a timber post supporting the canopy extending beyond the garage (room 1.17)

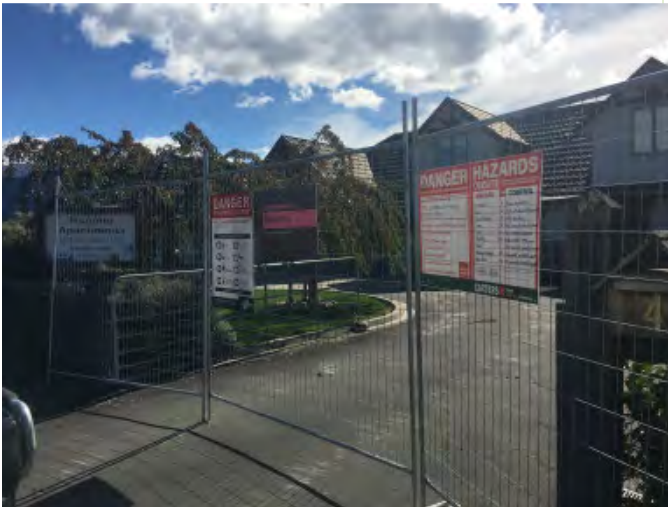
Site fencing/signage erected

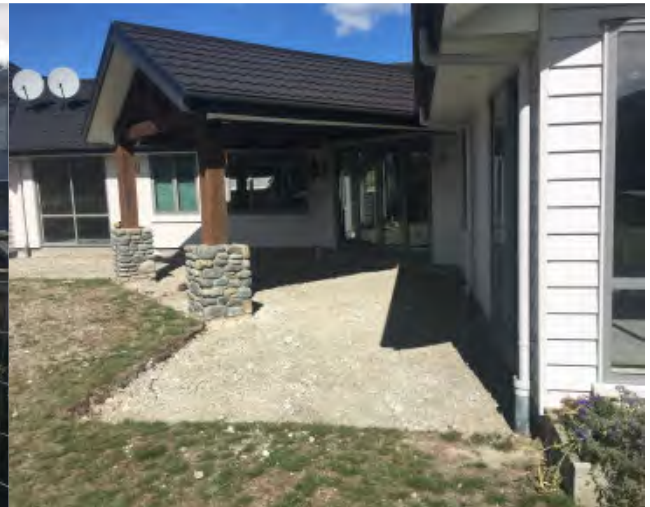
Northern Elevation - Concrete patios and pathways removed

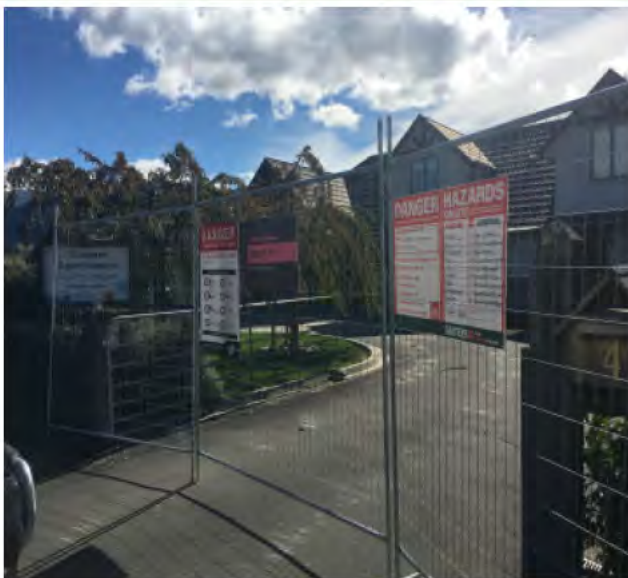
Site fencing, gate, signage

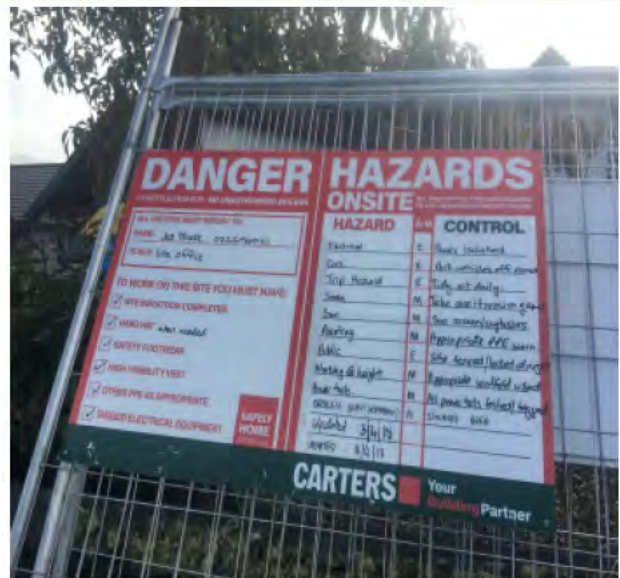
Up to date Hazard Board

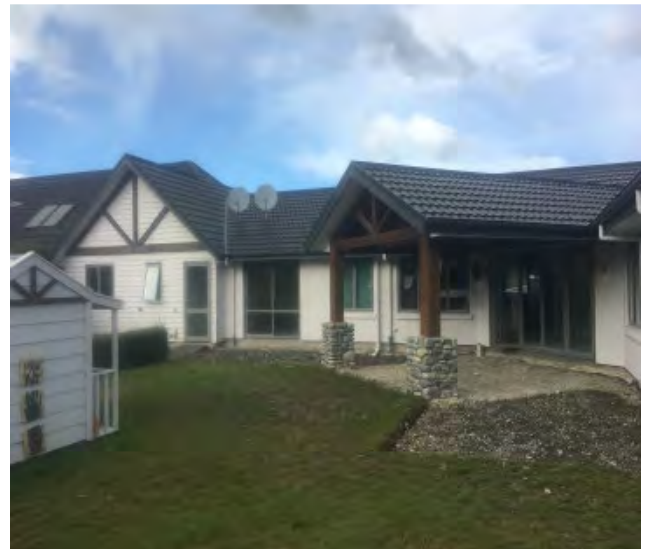
Clean and tidy worksite
