Standard Property Report

Report number:	7830807
Inspection date:	05th Nov, 2021
Property address:	4C Old Wairoa Road 2110 Auckland New Zealand

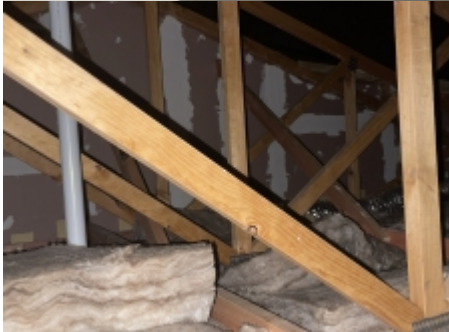
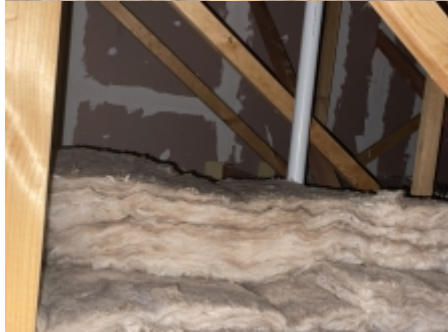
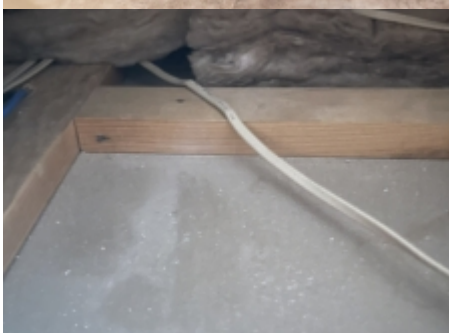
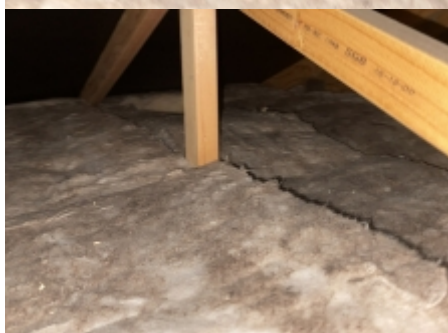
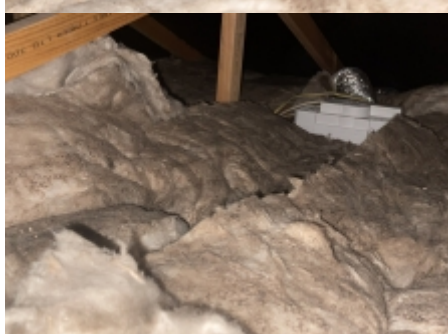
## D9 Roof Space

Room / Area Name	Interior Roof Space
Details	The interior roof space was inspected via the access hatch. The plumbing and electrical as well supported, there is thermal fibreglass insulation installed. There is a firewall. The Writer has not seen plans or documents so is unable to comment on construction specification. The interior roof framing has been completed to an acceptable standard.
