STRAIGHT UP
INSPECTIONS

CERTIFICATE OF INSPECTION

Client	Cari Hill
Address of Property	109 Shakespeare St, Cambridge
Inspector	Alistair Simpson
Company	Straight Up Inspections
Position	Director
Qualifications	Builder
Date of Inspection	20 Jul 2021

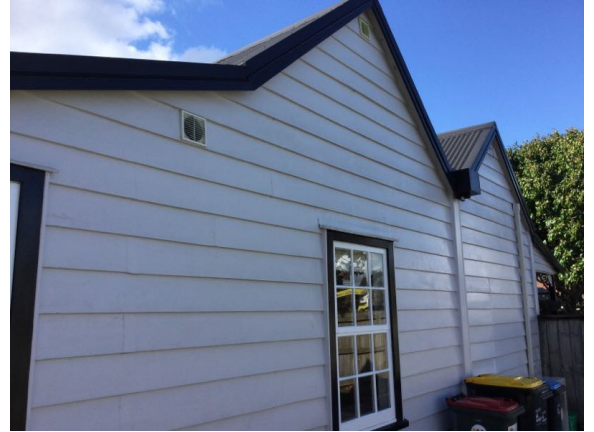
There is no cavity behind the cladding, this is common for a building of it's age.

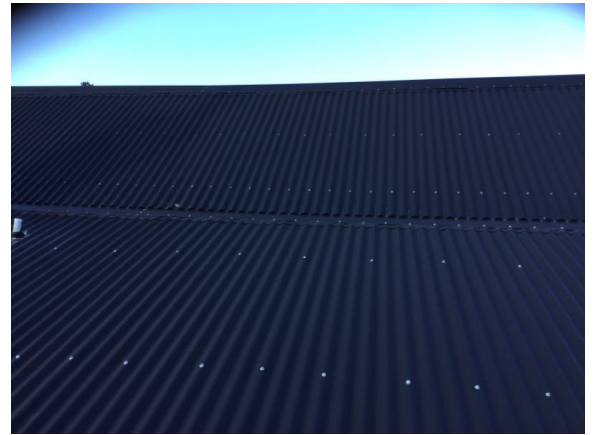
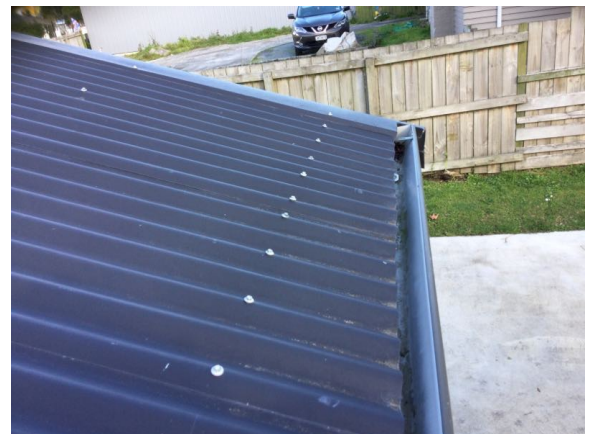
Roof - Profiled Metal Defects

The carport roof has areas of rust developing. These should be cleaned back and repainted to prevent further damage. There are also a number of holes that have been repaired with silicone which is a temporary solution and will fail in time.

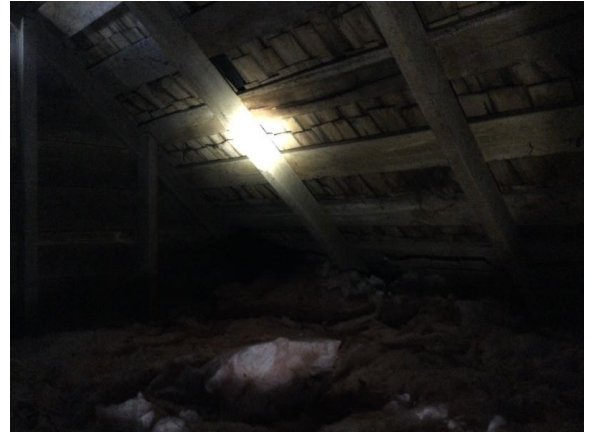
The construction of the roof frame:
timber rafters
The ceiling construction: timber ceiling
joists
The roof underlay: self supporting
bitumen-impregnated roofing underlay
The insulation: glass wool insulation
The insulation thickness: approx 180mm
The insulation coverage: present in the
whole roof space
R3.6

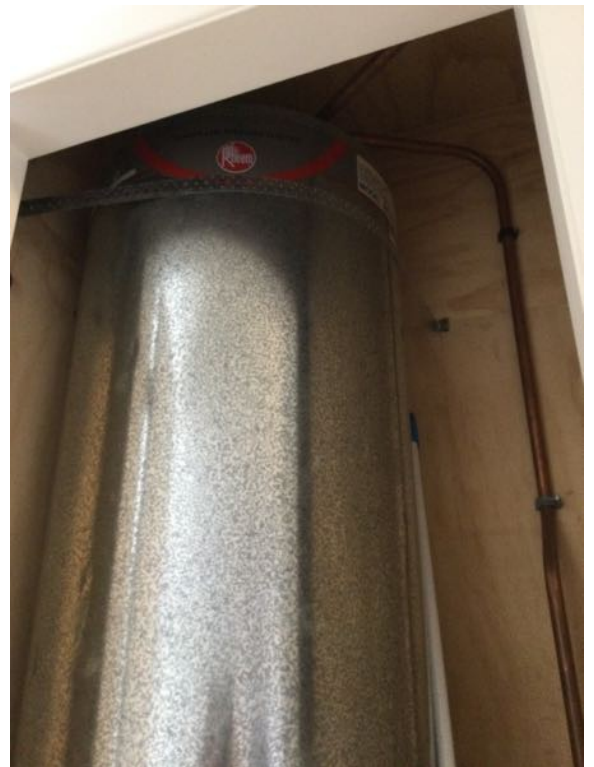
Services - Hot Water

Copper low pressure electric hot water cylinder.
Rheem, 180ltr, 10/01/2020.

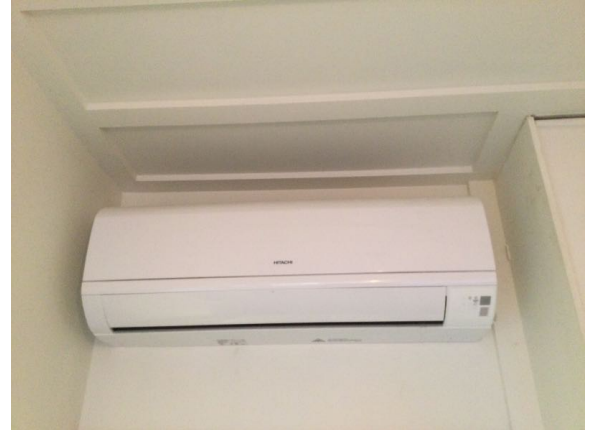
Entry - Heating

🔍 • Hitachi heat pump. We suggest the filters are cleaned regularly and serviced as per manufacturers instructions. No heating systems were checked on the day of the inspection. Heating systems are a specialist field which require a specialist to carry out a separate inspection.

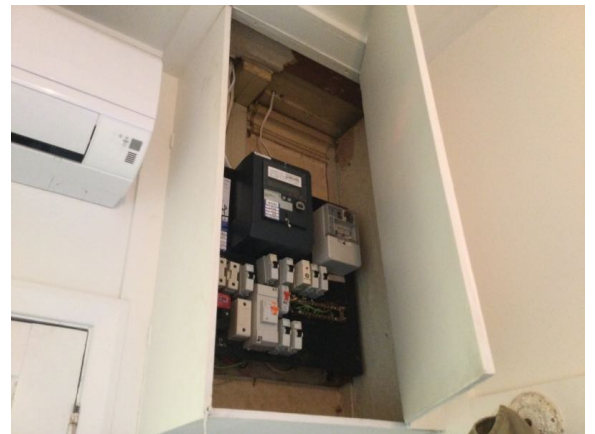
Entry - Switchboard/Fuseboard

🔍 The switchboard/meterboard is located on the eastern wall.

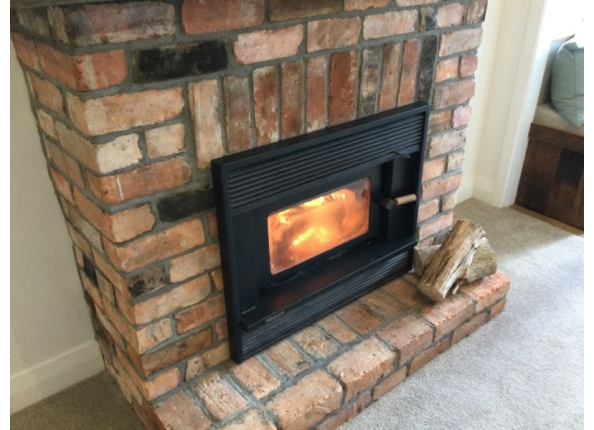
- 🔍 • built in wood burner.
No heating systems were checked on the day of the inspection. Heating systems are a specialist field which require a specialist to carry out a separate inspection.

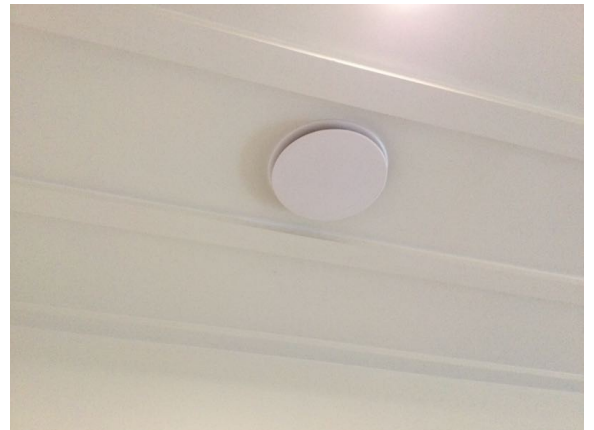
- 🔍 • ducted ventilation outlet in the ceiling.
No heating systems were checked on the day of the inspection. Heating systems are a specialist field which require a specialist to carry out a separate inspection.

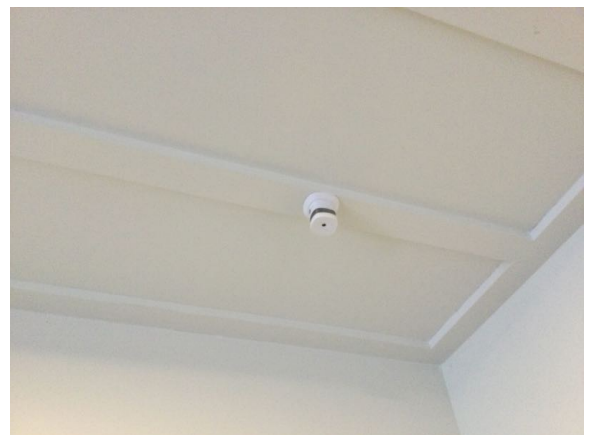
Lounge - Fire Security

- 🔍 Battery powered smoke alarm on the ceiling. Not tested.

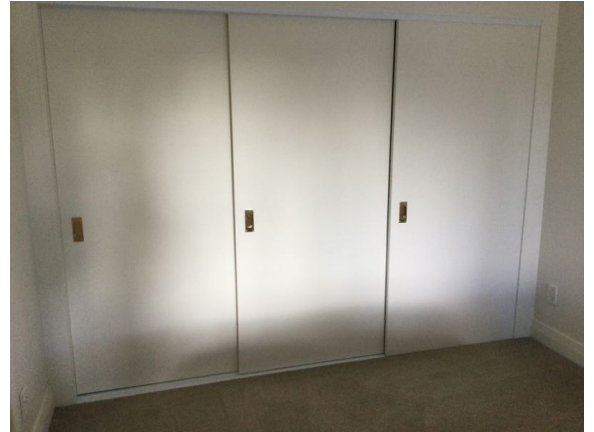
Average sized triple door wardrobe with wooden shelves and a clothes rail

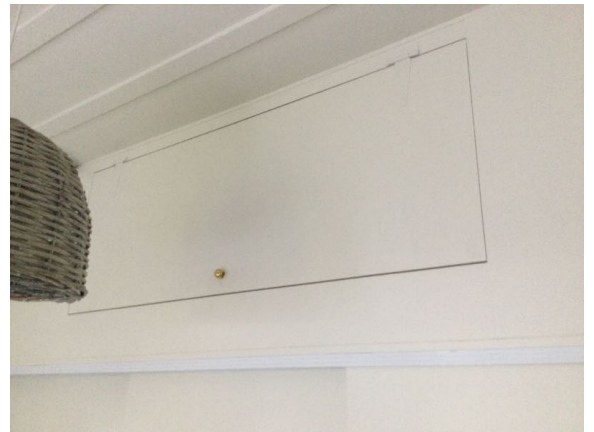
Small single door cupboard with no shelving

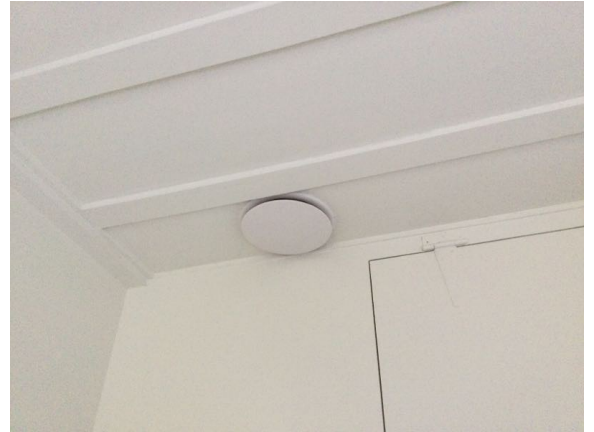
- ducted ventilation outlet in the ceiling. No heating systems were checked on the day of the inspection. Heating systems are a specialist field which require a specialist to carry out a separate inspection.

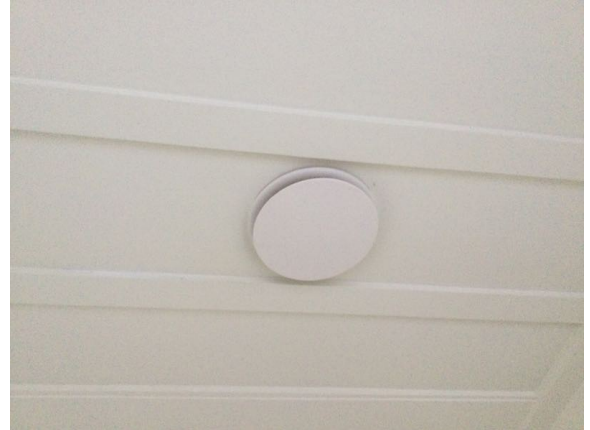
Bedroom 2 - Heating

- ducted ventilation outlet in the ceiling.
No heating systems were checked on the day of the inspection. Heating systems are a specialist field which require a specialist to carry out a separate inspection.
