Brian Marsh Property Inspection

9 Weatherdeck Close
Whitby
Wellington

**CERTIFICATE OF INSPECTION
IN ACCORDANCE WITH NZS 4306:2005**

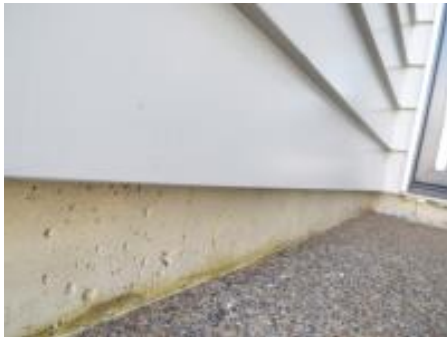
concrete slab in good order

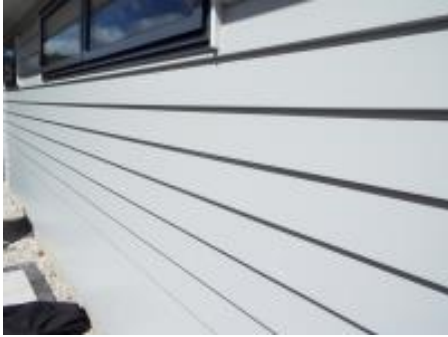
exterior well painted

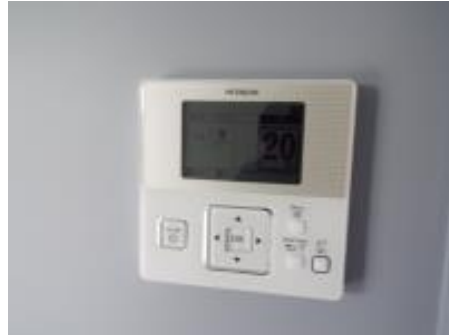
working at the time of inspection

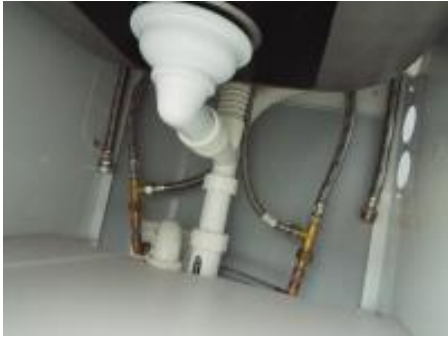
plumbing all good at the time of inspection
