Property Inspection Report

**23B
Burrows Street
Tauranga**

28 May 2024

INSPECTION REPORT: for: 23B Burrows Street, Tauranga

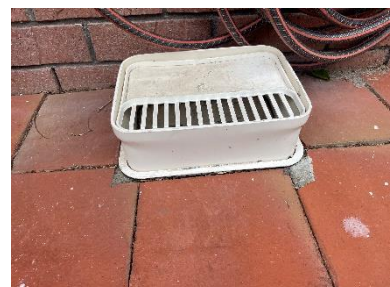
- **Type:** PVC & Clay Pipes
- **Condition:** *Acceptable*
- **Gully Trap Height:** *Acceptable.*

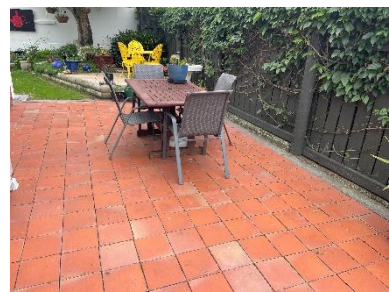
- **Type:** Tiles.
- **Condition:** *Average*

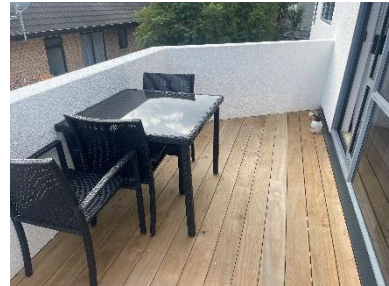
- **Type:** Timber.
- **Over 1m from ground level:** No
- **Condition:** *Acceptable*

- **Type:** Timber.
- **Over 1m from ground level:** Yes
- **Condition:** *Acceptable*

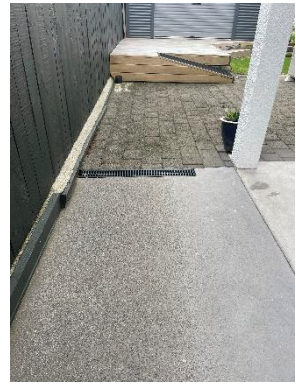
- **Type:** Concrete, Pavers, Tiles.
- **Condition:** *Acceptable.*

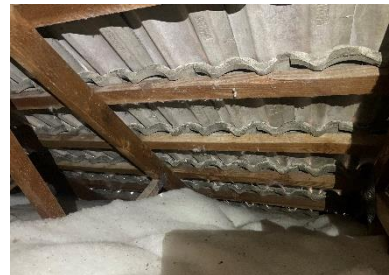
- **Condition:** *Acceptable & Dry.*
- **Underlay fitted:** No

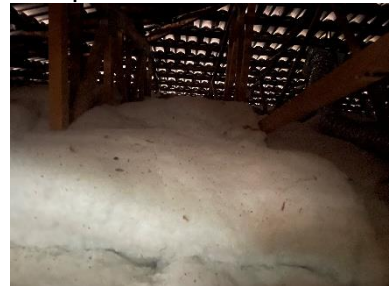
- **Type:** Pink Batts, Polyester.
- **Condition:** *Acceptable*

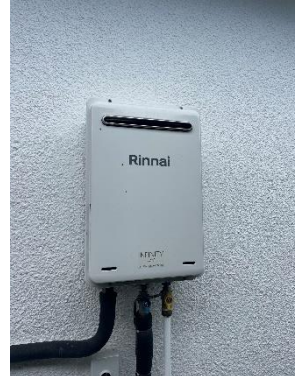
- **Type:** External gas.
- **Vented:** Yes
- **Capacity:** 26 liters per min.
- **Mains Pressure:** Yes
- **Condition:** *Acceptable*

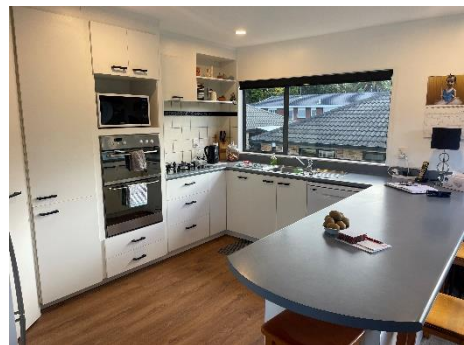
- **Condition:** *Acceptable.*
- **Condition of Cabinets:** *Acceptable.*
- **Condition of appliances:** *Average*
- **Hobbs:** Gas
- **Oven:** Electric
- **Door & Window Function:** *Acceptable*
- **Wastemaster:** Yes
- **Dishwasher:** Yes
- **Range Hood:** Yes
- **Noted:** The range hood extractor fan is a recirculating type.
- **Moisture Reading:** 16.3% ACCEPTABLE

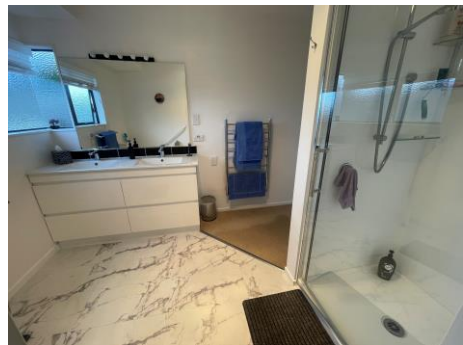
- **Plumbing:** PVC & Flexihose
- **Condition:** *Acceptable*
- **Condition of fixtures & fittings:** *Acceptable*
- **Shower:** Boxed Cubicle with PVC liner.
- **Door & Window Function:** *Acceptable*
- **Noted:** Ceiling fan vents to the exterior.
- **Moisture Reading:** 16.8% ACCEPTABLE

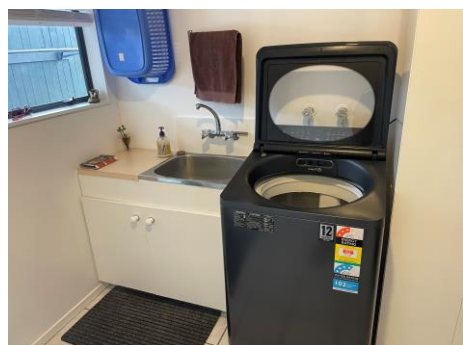
- **Condition:** *Acceptable*
- **Condition of fixtures & fittings:** *Acceptable*
- **Tub Type:** MDF unit with stainless tub
- **Door & Window Function:** *Acceptable*
- **Moisture Reading:** 16.3% ACCEPTABLE
