GeoSolve Reference: 260068

## Geotechnical Assessment 19b Esplanade, Warrington

In accordance with our Agreement (ref: 260068, dated: 27 January 2026), GeoSolve Limited (GeoSolve) has undertaken geotechnical investigations at the site in accordance with NZS 3604:2011. This letter report contains a summary of the investigations, as well as preliminary advice on site-specific geotechnical considerations and construction recommendations.

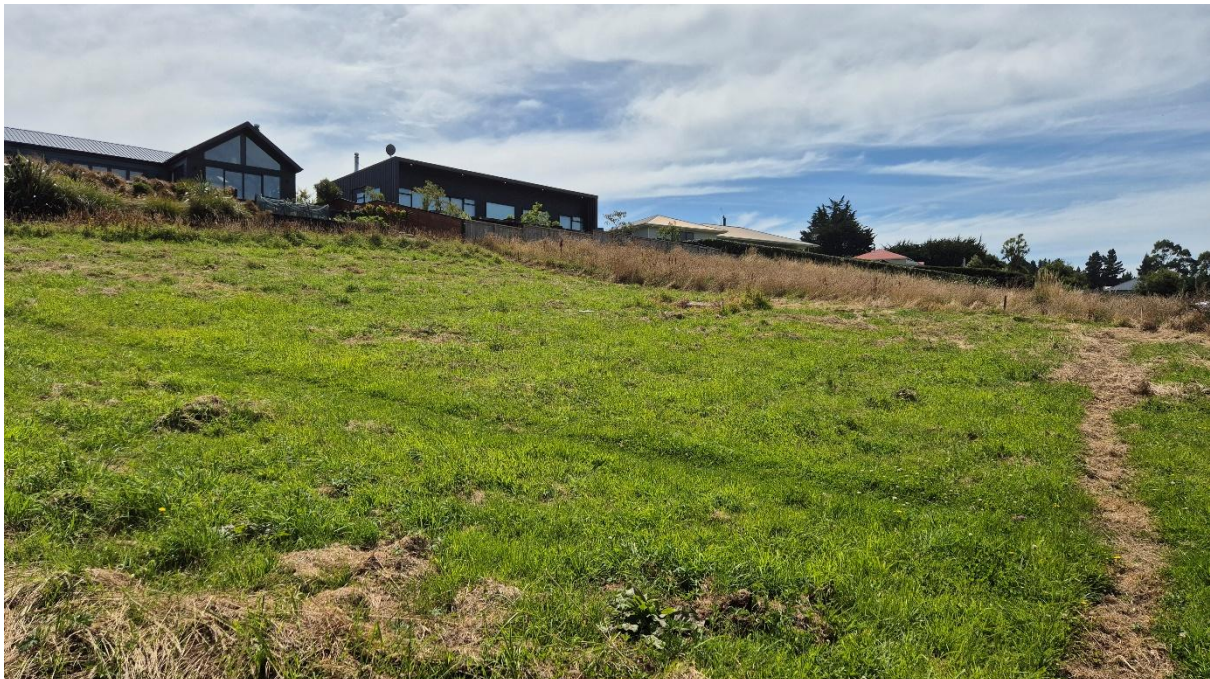
**Photograph 1: Proposed building site at 19b Esplanade, Warrington**

The site is located at 19b Esplanade, Warrington, and has an area of approximately 900 m<sup>2</sup>. The building site is currently undeveloped and occupies a south-facing slope with a relatively gentle gradient. Prior to subdivision, the wider site was most recently used for grazing. A large, partially embedded concrete fragment was noted in the centre of the site, however our investigations did not find evidence of any other waste on the property. The property is bounded by developed residential land to the north and south, and undeveloped residential land to the east and west.
