Information request – CLM/2016/026078 - 4 Woodbank Road, Hanmer Springs 7334

Claim: CLM/2016/026078

4 Woodbank Road, Hanmer has suffered damage from the Kaikoura Earthquake sequence late in 2016. This Scope Report has been completed for insurance assessment and estimating only.

APPENDIX A | Architectural Damage and Remedial Plans

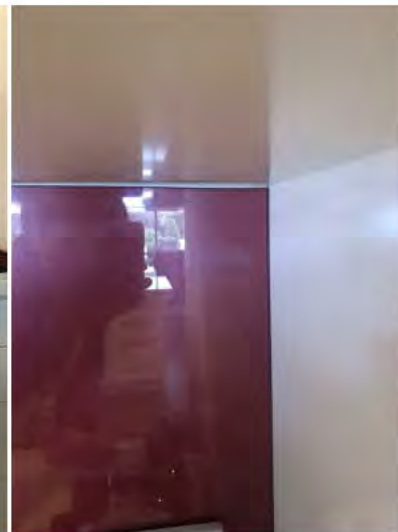
12. Kitchen (1.02) movement to splash back

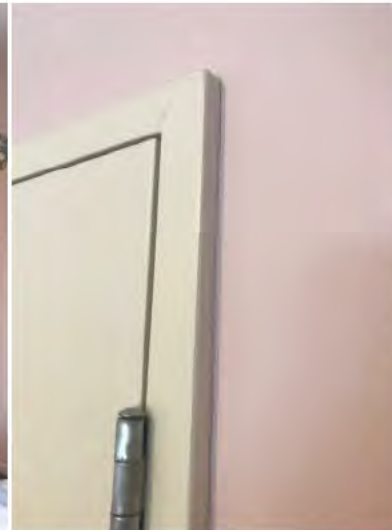
7. Bedroom 2 (1.10) movement to door

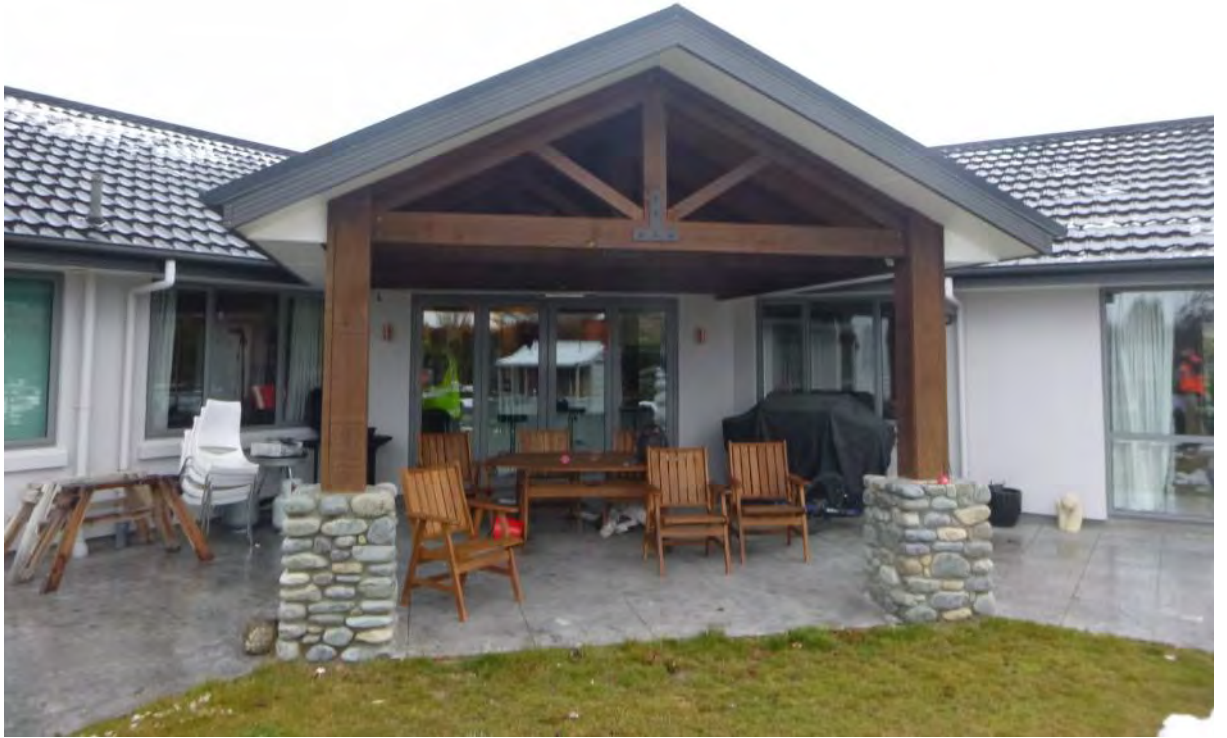
Figure 1 Manager's residence northeast elevation

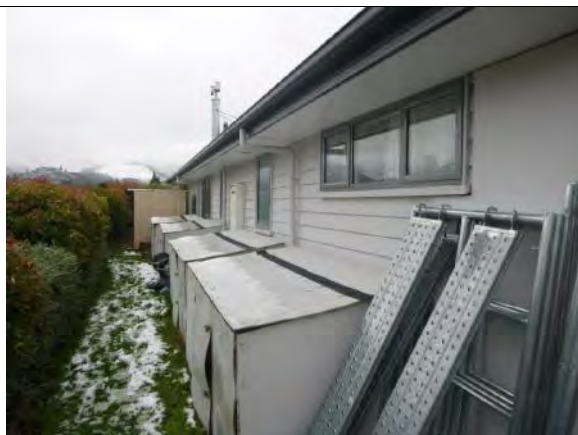
Photo 3: Managers' residence east elevation

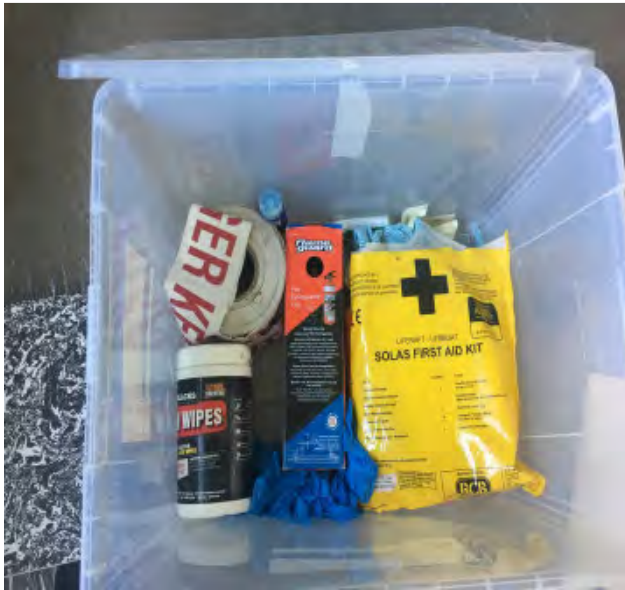
First aid kit, fire extinguisher

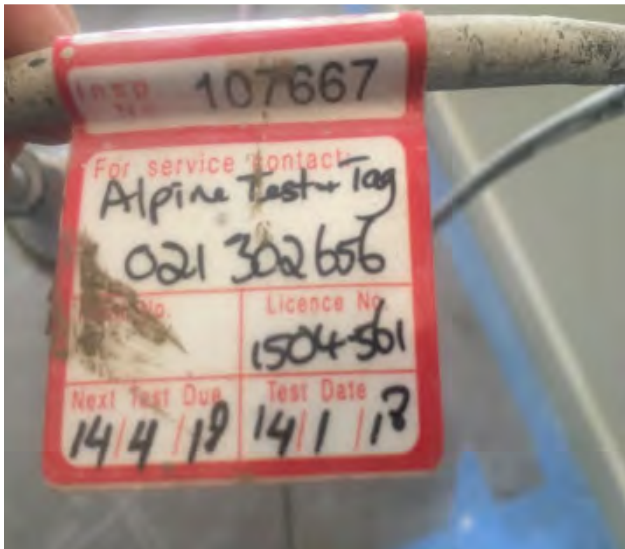
Expired test tag – painter's light
