KIWI INSPECTIONS LTD

RESIDENTIAL HOUSE INSPECTION

46 Murphys Rd
Christchurch, Canterbury 8025

Tallia
27/11/2024

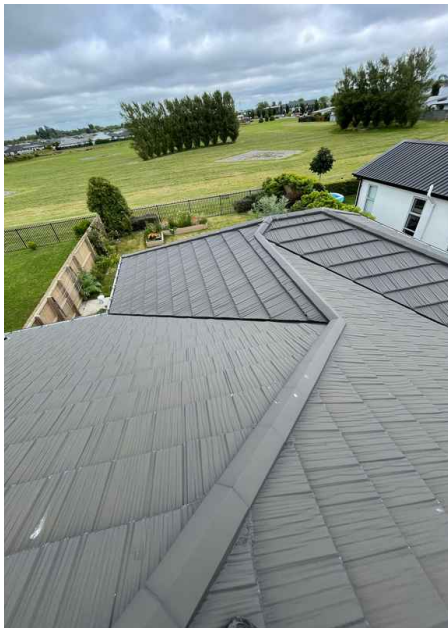
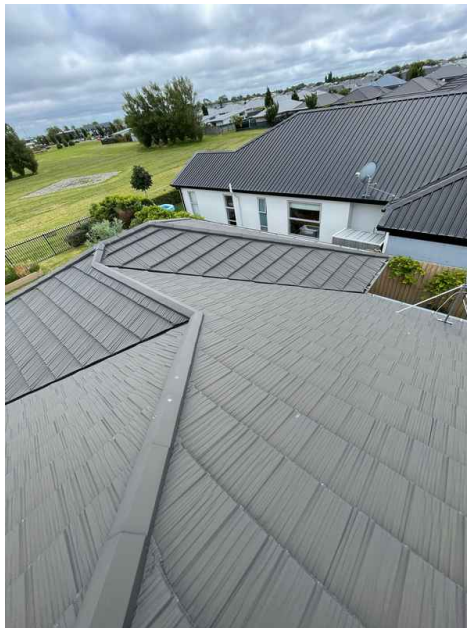
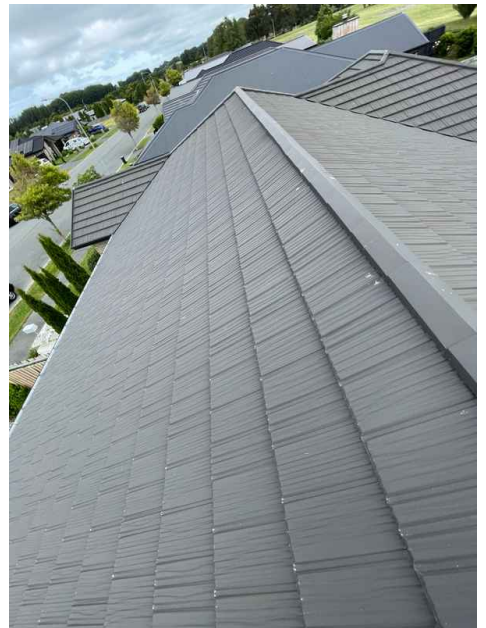
Roof System Images: Images Of The Roof System:

Good, With no visible issues at the time of inspection

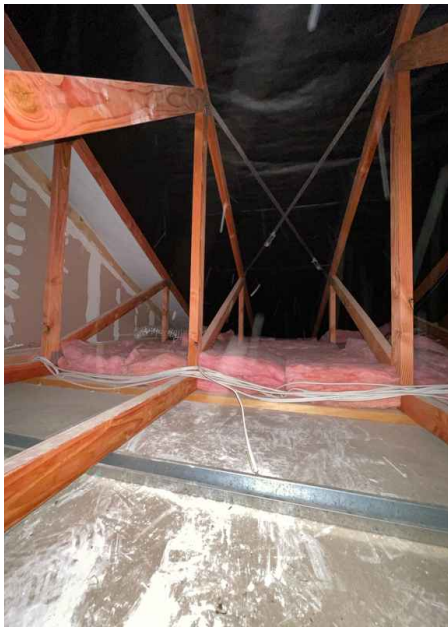
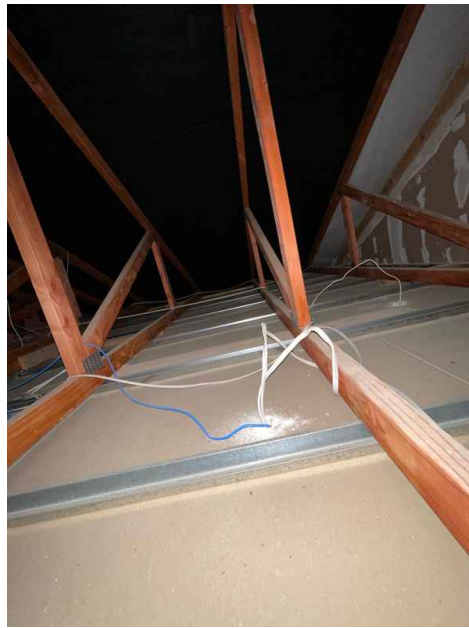
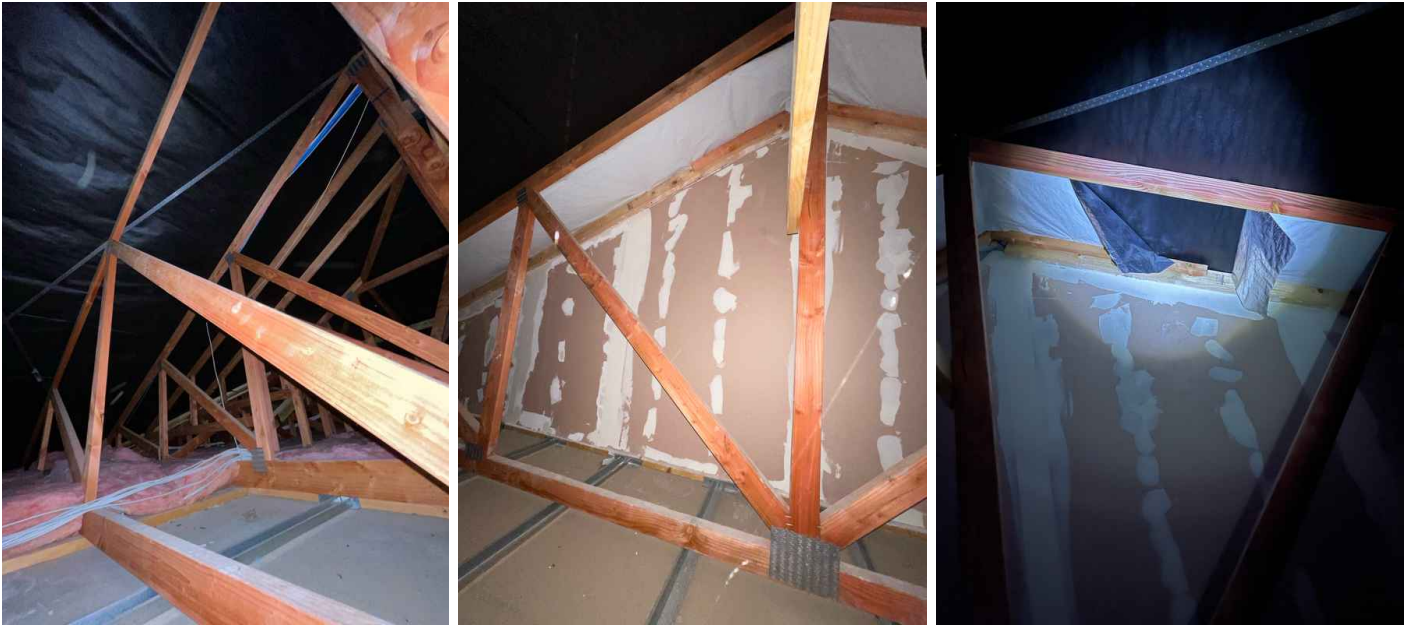
Roof Space Images:: Images

Good

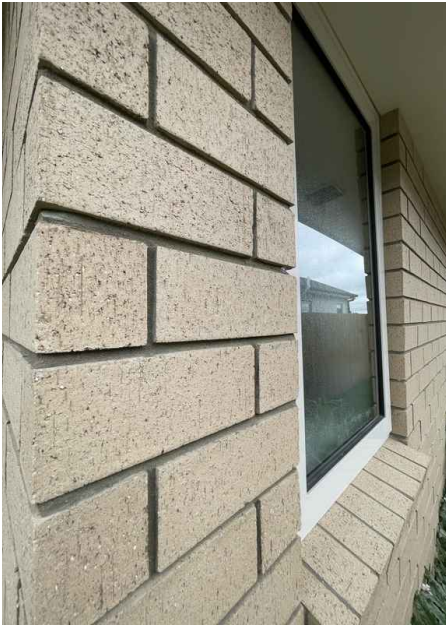
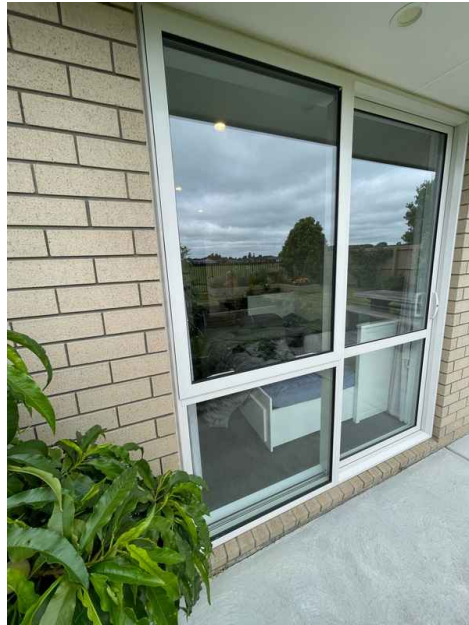
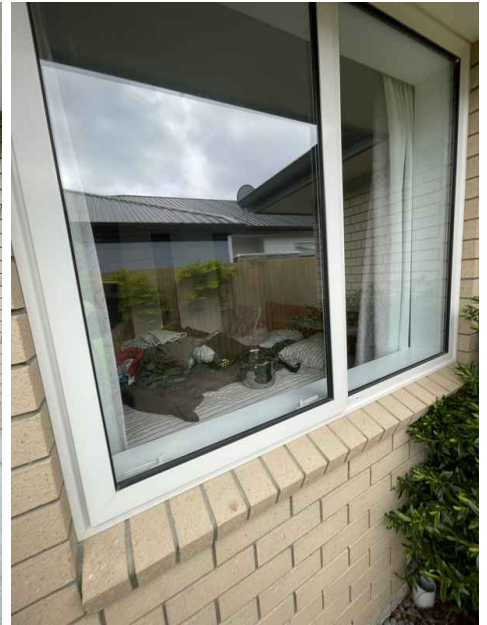
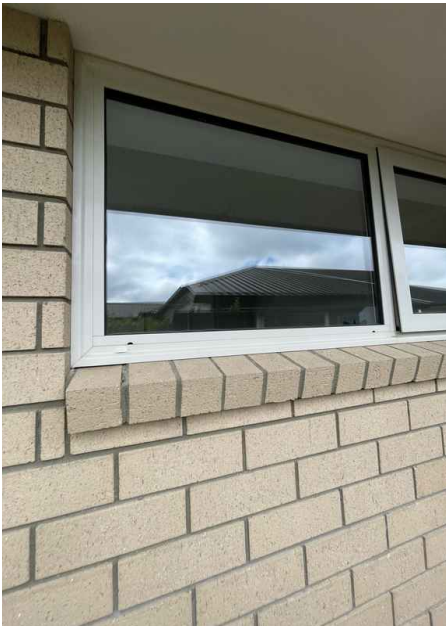
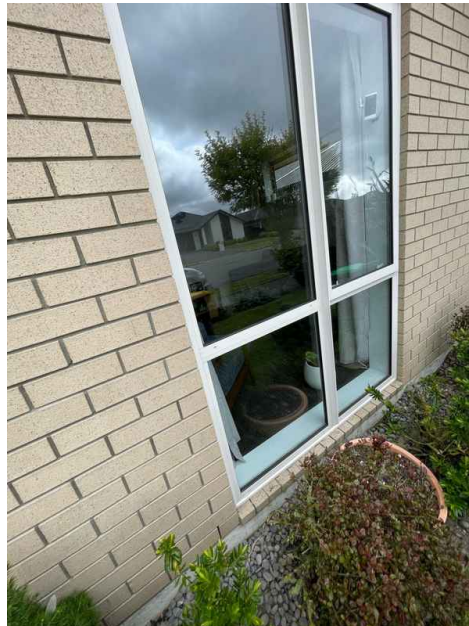
Exterior Joinery Images: Images

Good, With no visible issues
noted at the time of inspection.

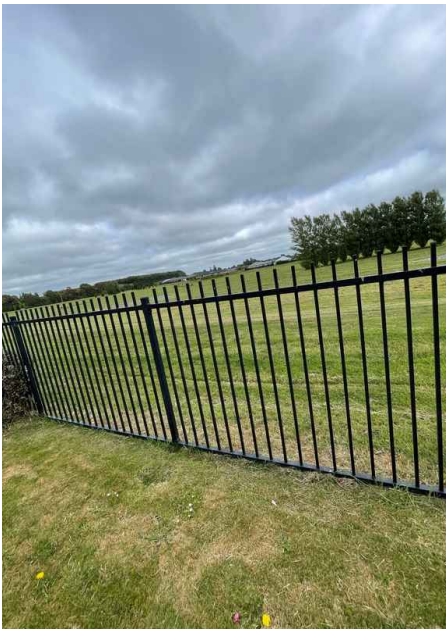
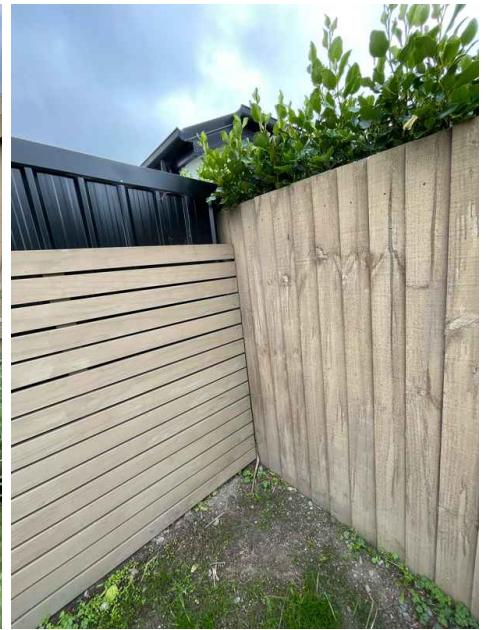
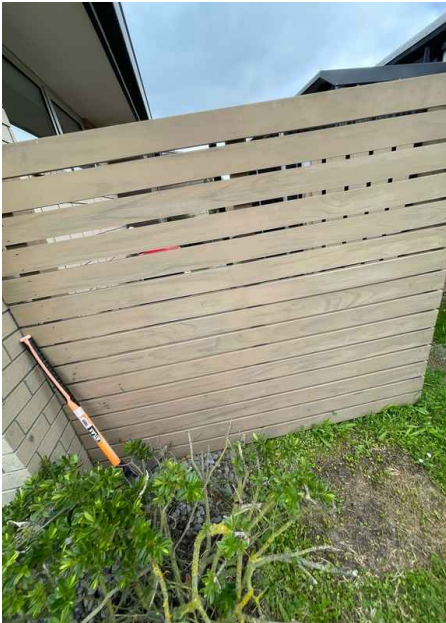
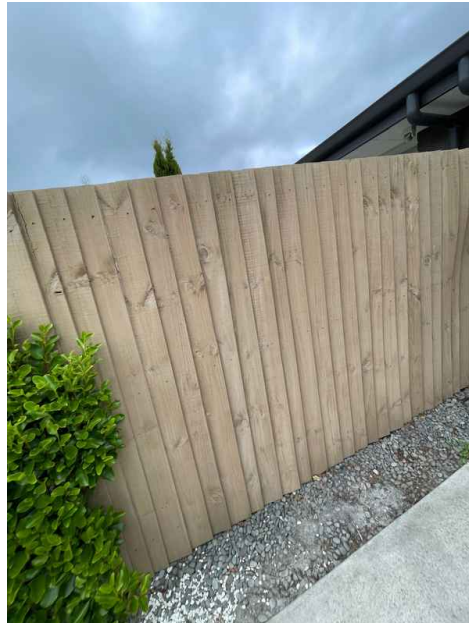
Fencing/Deck Images: Images

Fences: Condition
Good

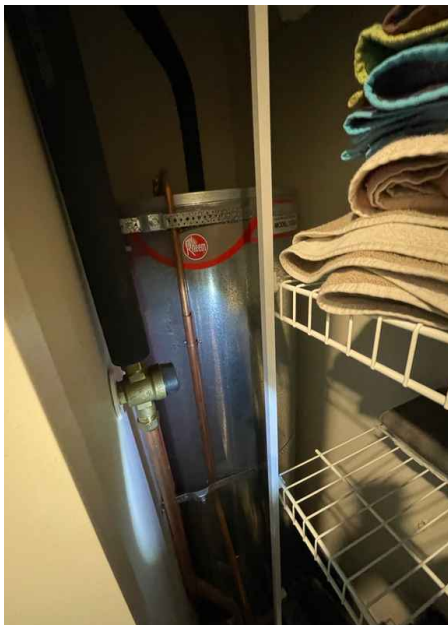
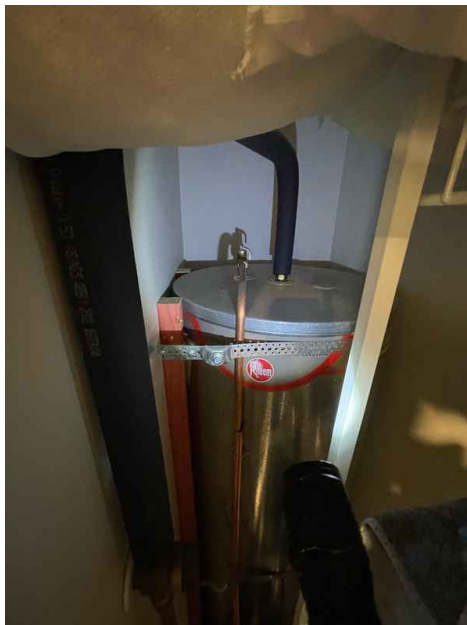
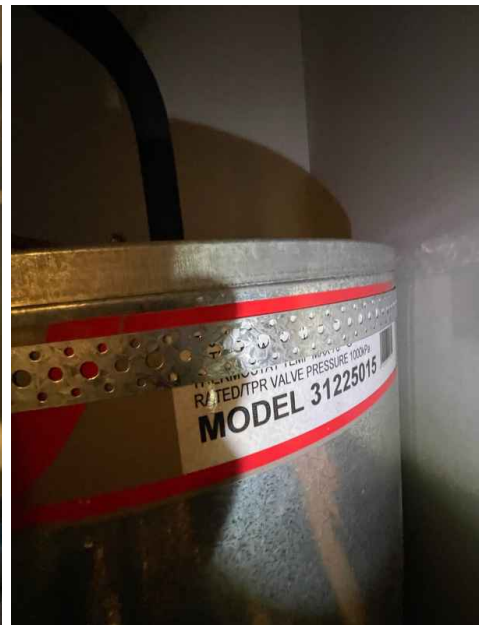
Water Heating Images: Water Heating Images

Hot Water Cylinder: Condition
Original, Good

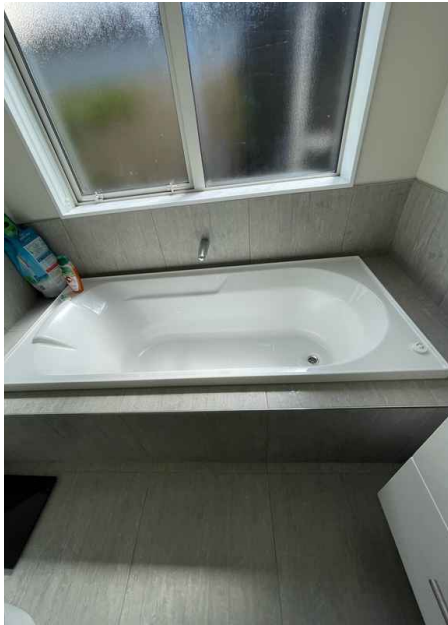
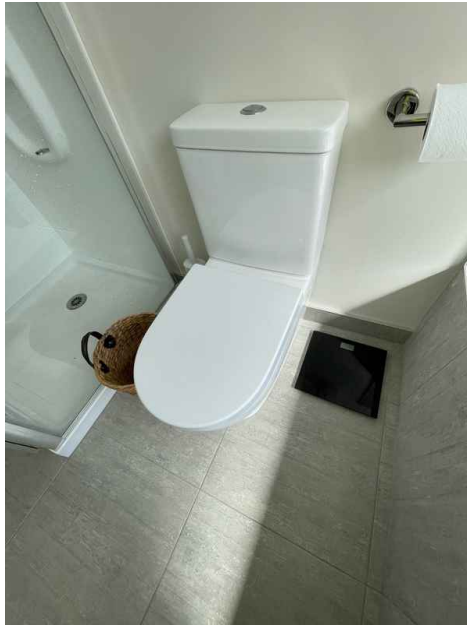
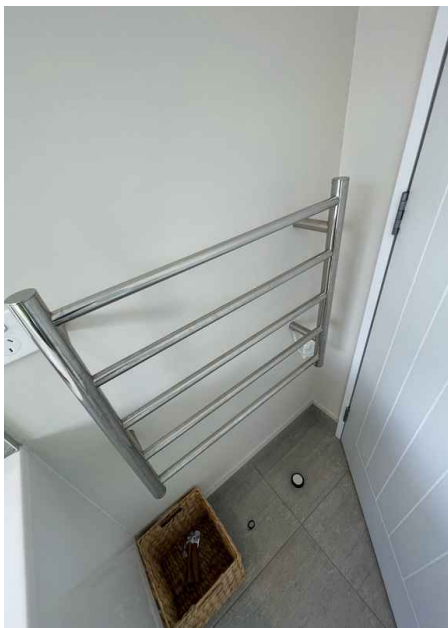
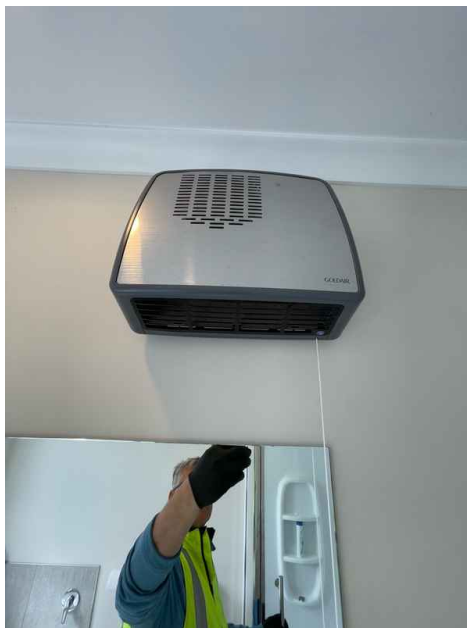
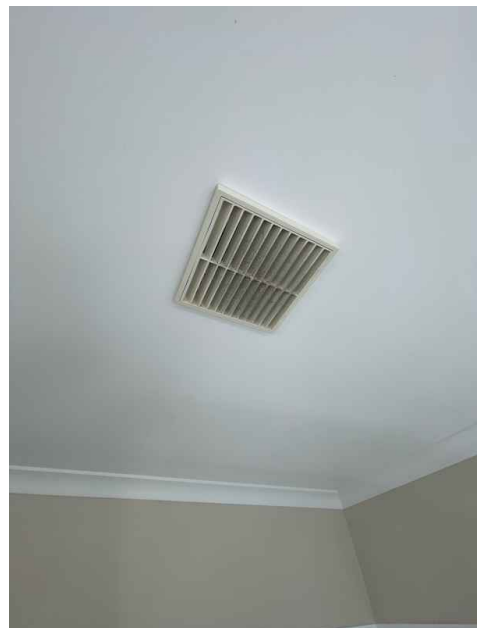
18.5.1 Fixtures

Recommendation

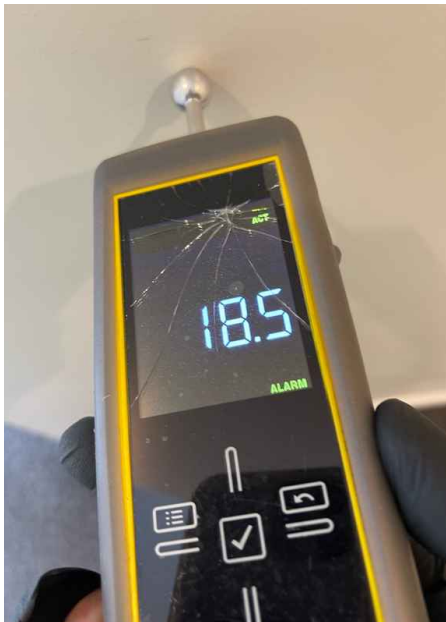
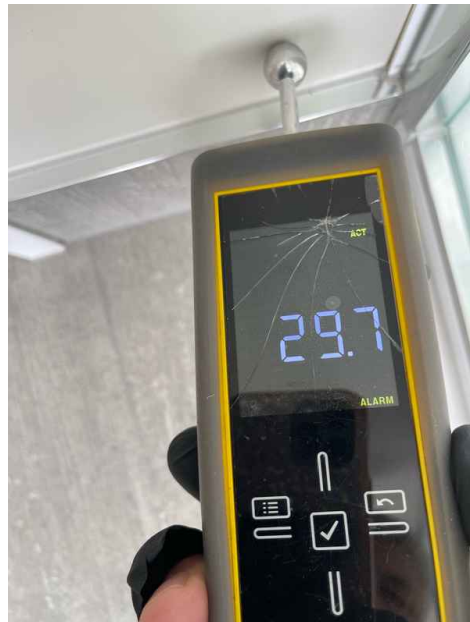
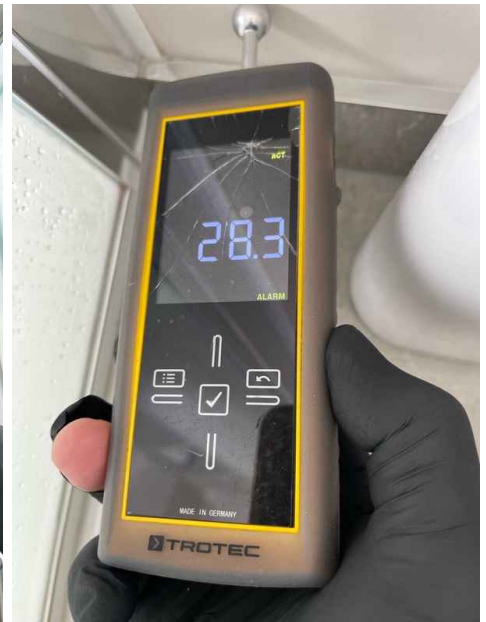
Sample Of Readings: Sample Images

Moisture : No elevated moisture levels were noted at the time of inspection.
