Brian Marsh Property Inspection

9 Weatherdeck Close
Whitby
Wellington

**CERTIFICATE OF INSPECTION
IN ACCORDANCE WITH NZS 4306:2005**

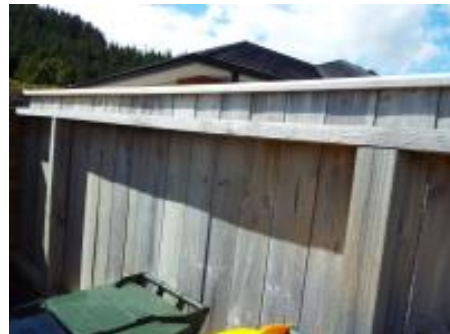
fences in good order

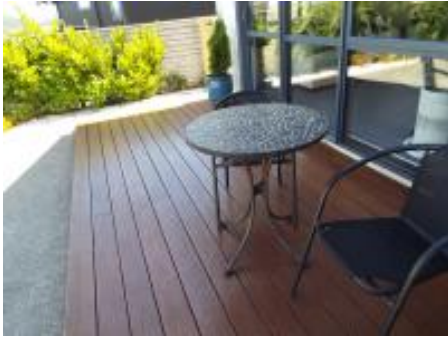
good order

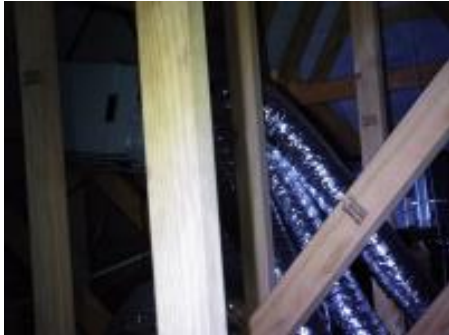
working at the time of inspection

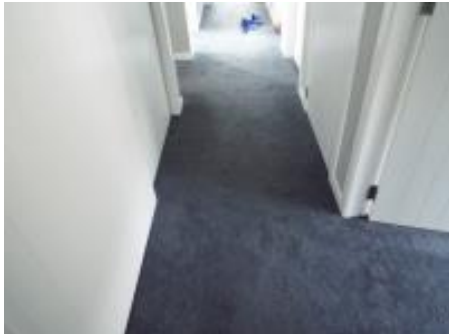
floor coverings in good order

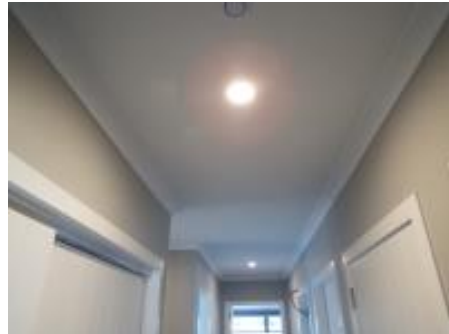
interior well painted

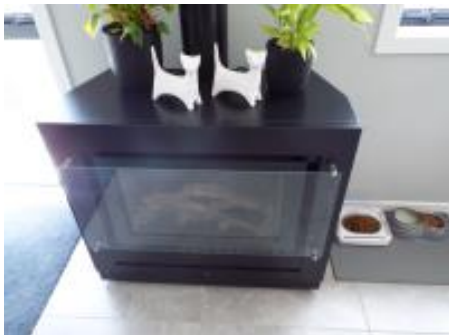
not tested

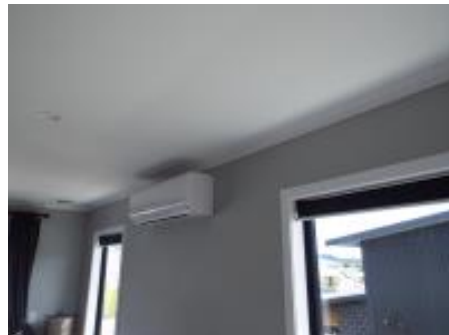
not tested

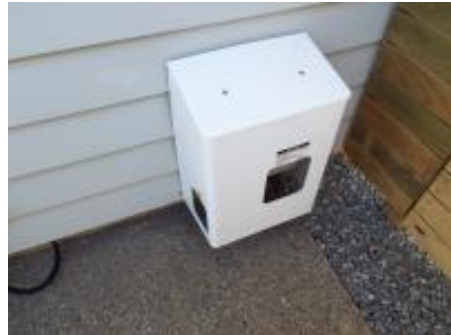
no issues

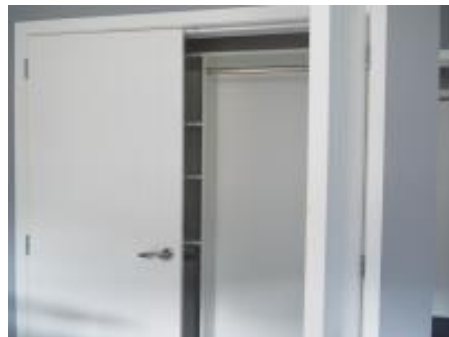
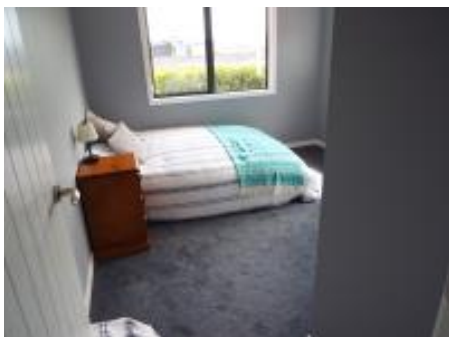
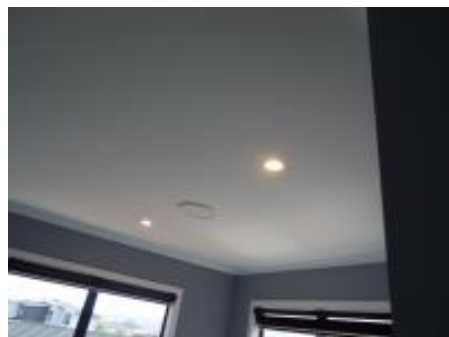
Bedrooms

Floor Carpet
Generally Good

Wall	Plasterboard Generally Good
Ceiling	Plasterboard Generally Good
Windows	Aluminium Generally Good
Doors	Hollow Core Generally Good

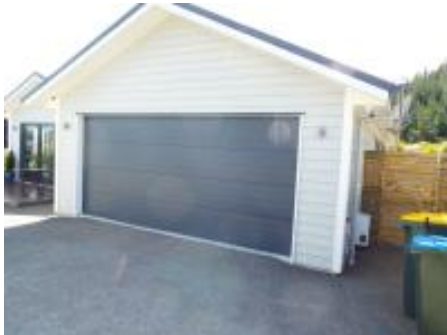
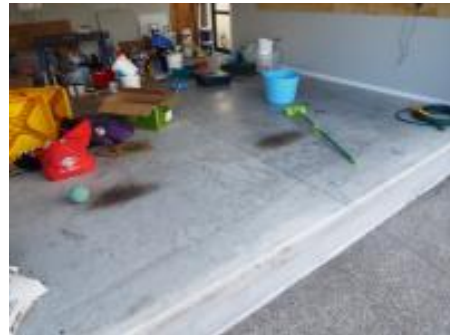
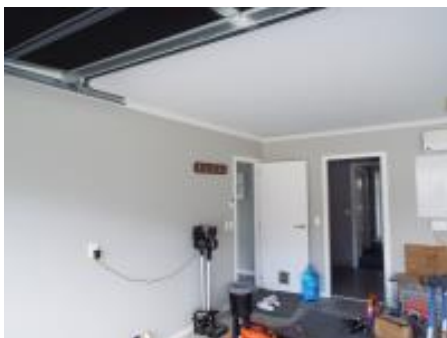
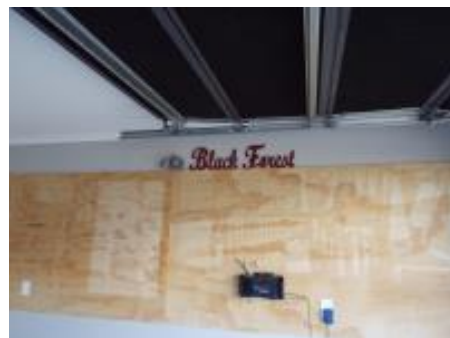
Garage Door	Sectional Door Generally Good
Size	Double Car Location ground floor
Location	Attached to house
Floor	Concrete Generally Good
Roof	Iron Generally Good
Subfloor	Concrete Slab Generally Good
Cladding	Same as the house Generally Good
Electrical	Connected
