RED LBP PRE-PURCHASE REPORT

Andy Vann

PRE-PURCHASE BUILDING REPORT

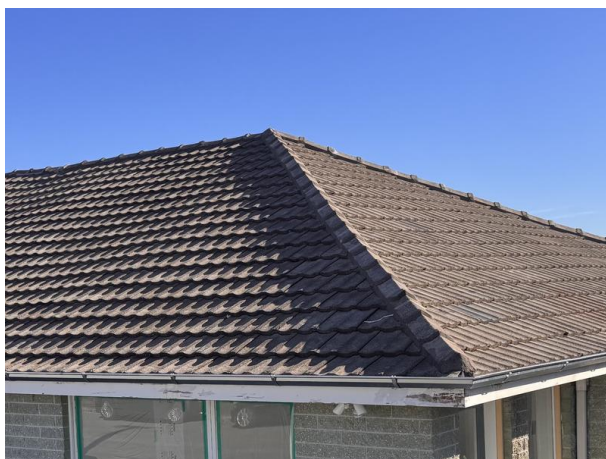
Photo 3

Original factory finished masonry tile hip roof.

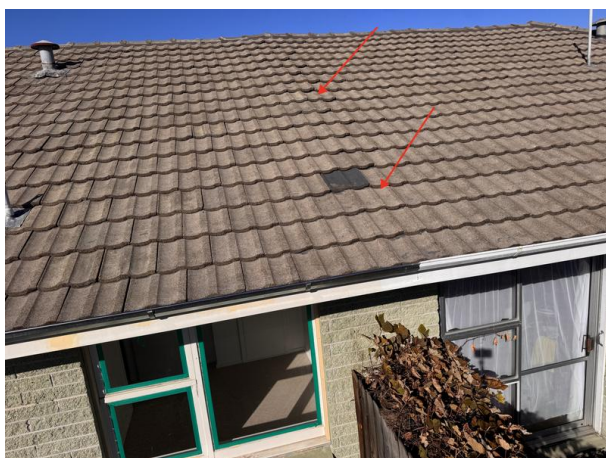
Photo 4

Slight bulge in the roof line visible over the intertenacy wall.

The masonry tile roofing exhibits surface deterioration and requires professional cleaning and recoating to restore its protective finish. To ensure the ongoing integrity and weathertightness of the roof system, it is recommended that a Licensed Building Practitioner (Roofing) be engaged to assess the full extent of deterioration and undertake the required recoating and maintenance works in accordance with the manufacturer's specifications and good trade practice.

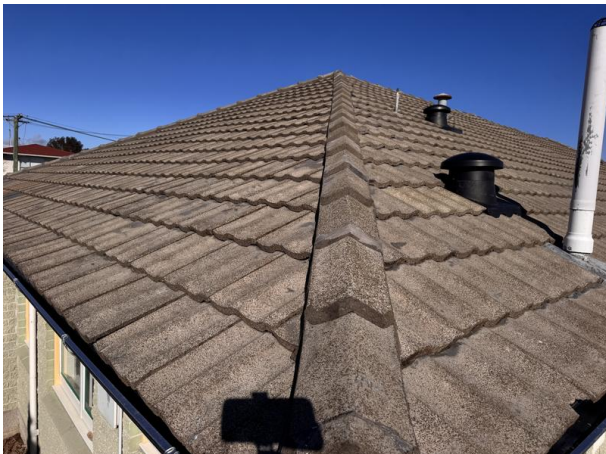
Photo 10
Masonry tile hip cap flashing secured in place with mortar.

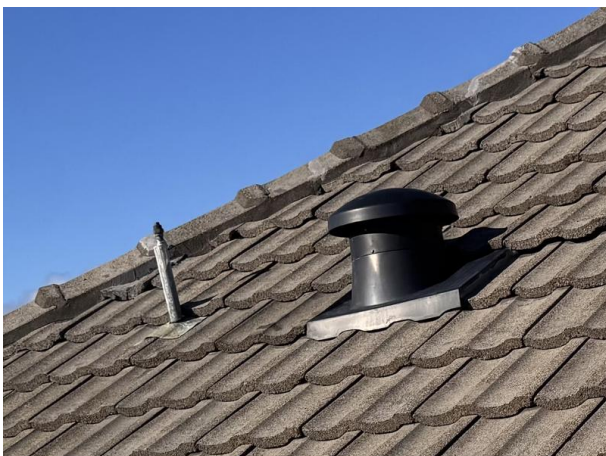
Photo 12
Hot water cylinder and extraction vent roof penetrations on the north elevation. With lead and a manufactured rubber base flashings.

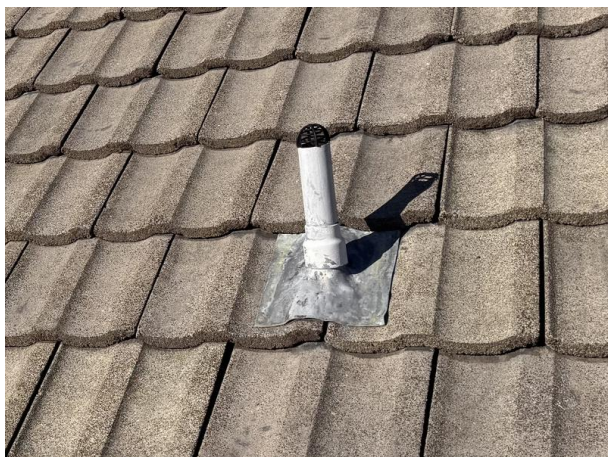
Photo 13
Terminal vent pipe roof penetration with a lead base flashing.

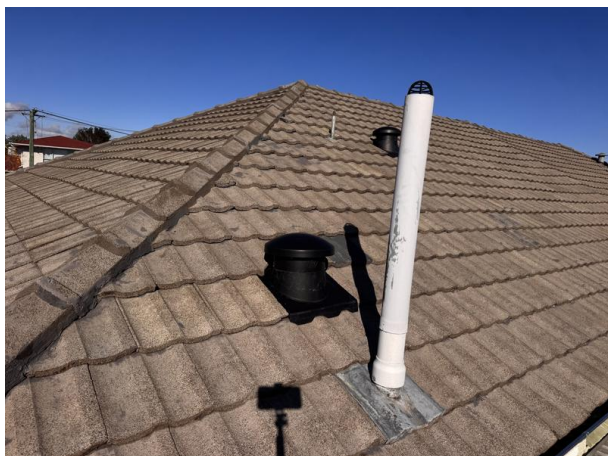
Photo 15
Extraction vent and terminal vent pipe roof penetration on the north elevation with a custom and lead base flashing.

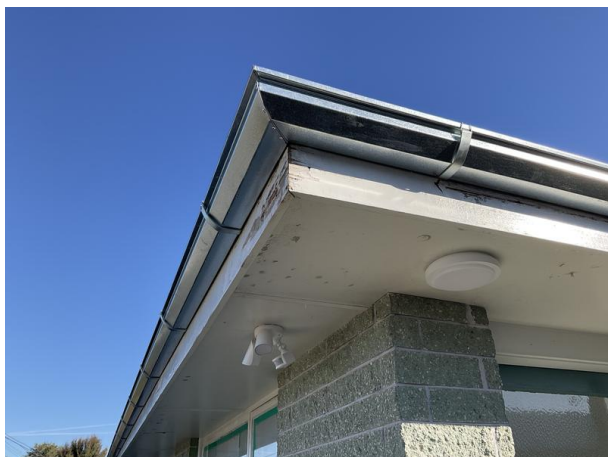
Photo 16
New profiled metal roof edge gutter attached to timber fascia boards with fibrous cement soffit linings.

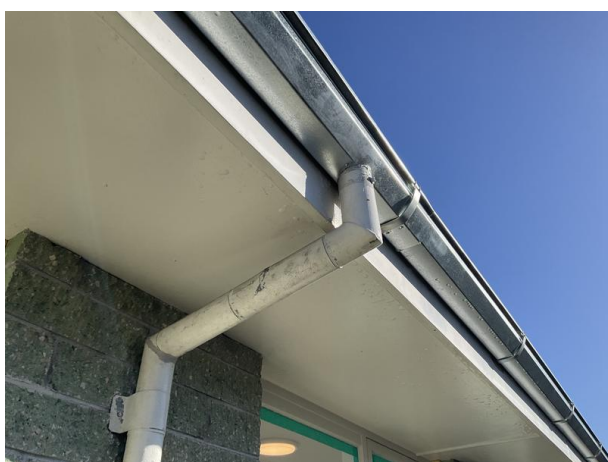
Photo 17
Profiled metal gutter and downpipes.

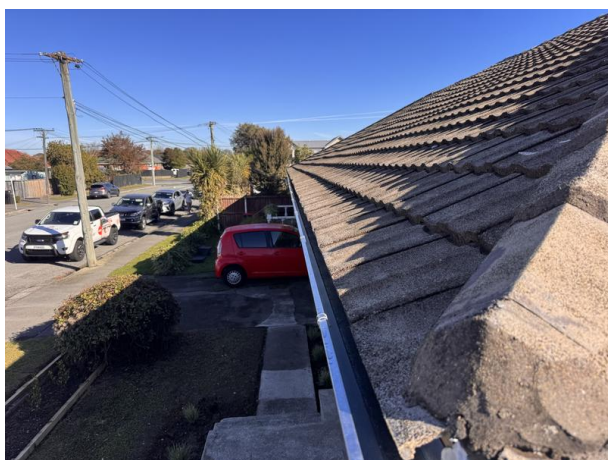
Photo 20
New profiled metal roof edge gutter on the south elevation, clear at the time of inspection.

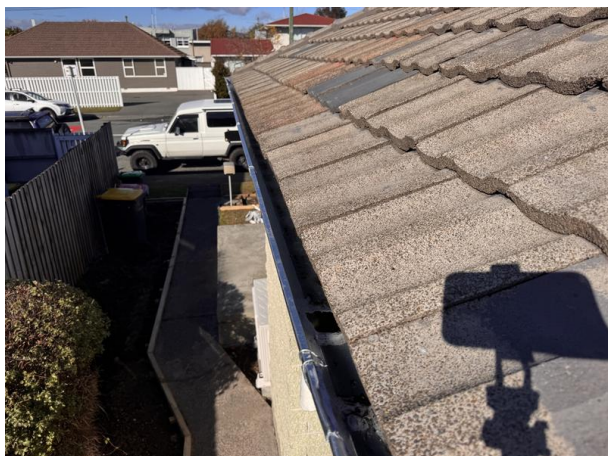
Photo 21
New profiled meta roof edge gutter on the east elevation, clear at the time of inspection.

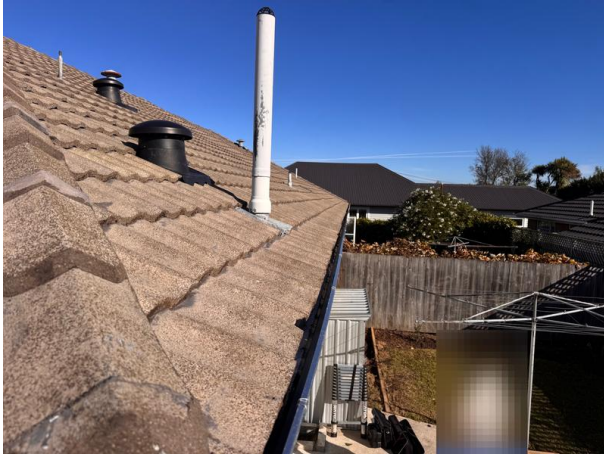
Photo 22
Profiled metal roof edge gutter on the north elevation, clear at the time of inspection.

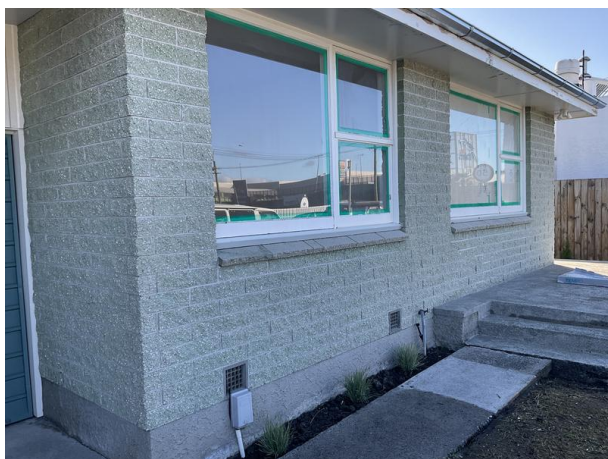
Photo 23
Summerhill stone veneer cladding. South elevation.

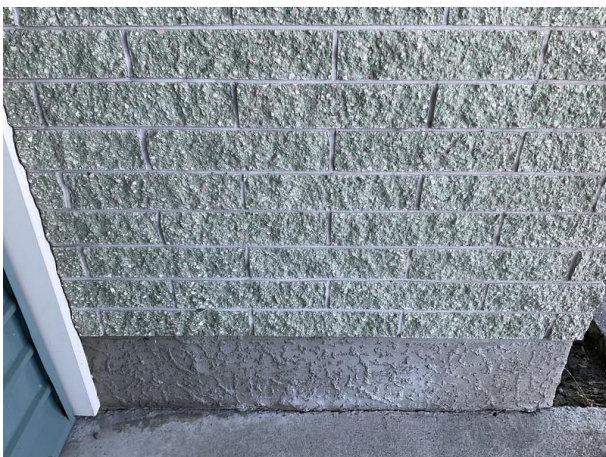
Early detail books from the 1970s showed suspended timber floors with brick veneer cavities left open to the subfloor. This allowed moist air to move up the cavity into the roof space, often causing significant moisture issues. During renovations, the cavity should be sealed from both the subfloor and roof space, as also required in SNZ HB 4236:2002, section 9.2.6(f).

Photo 24
No weep holes installed on the bottom course as the brick veneer is open to the subfloor.

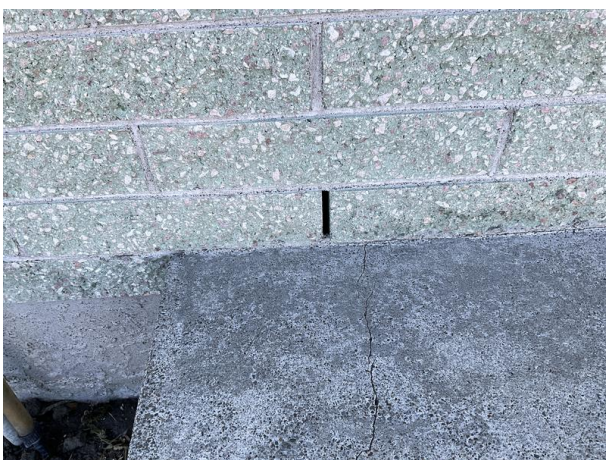
Photo 28
Weep holes visible over the concrete patio, on the south east corner.

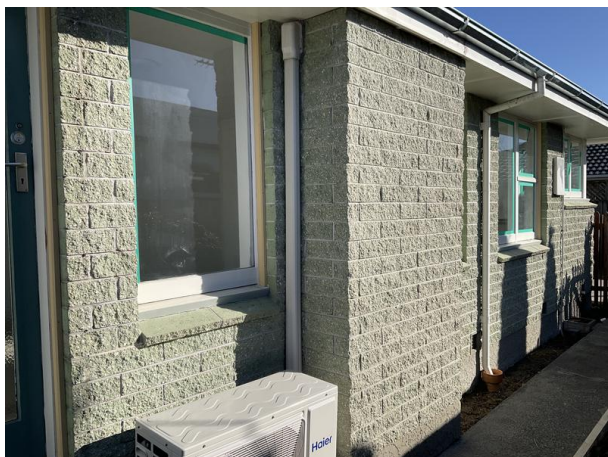
Photo 30
Summer hill stone cladding east elevation.

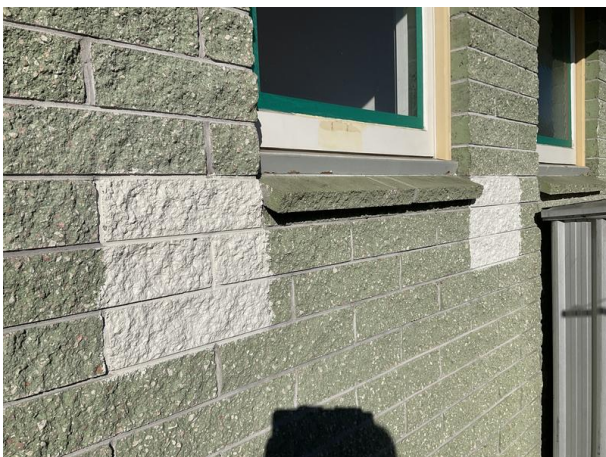
Photo 33
Cladding to be painted.

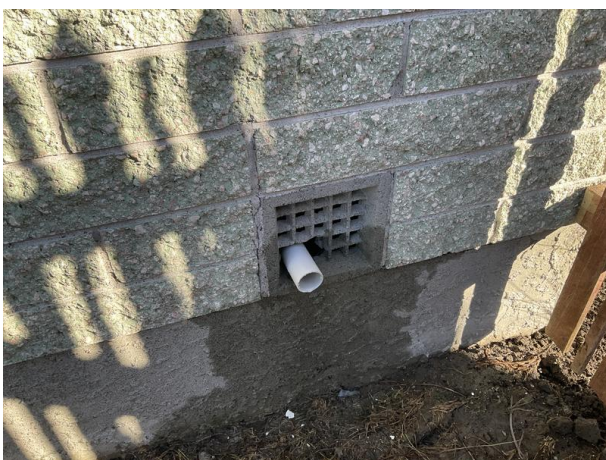
Photo 34
Dampness visible on the east elevation,
due to the hot water cylinder drain back
flowing.

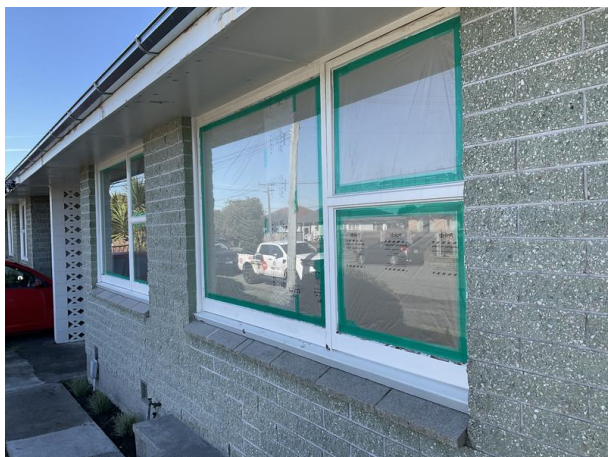
Photo 36

Single glazed timber joinery south elevation.

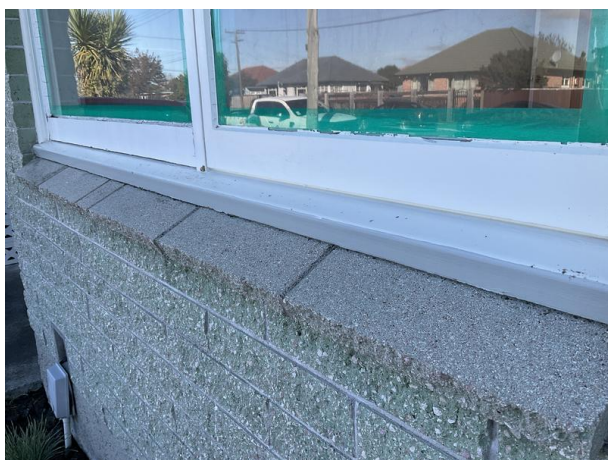
Photo 38
Timber and block sills installed with suitable run off angle.

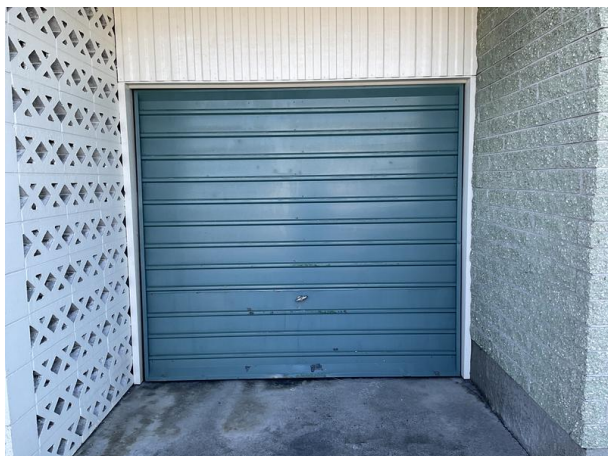
Photo 39
Aluminium tilt garage door.

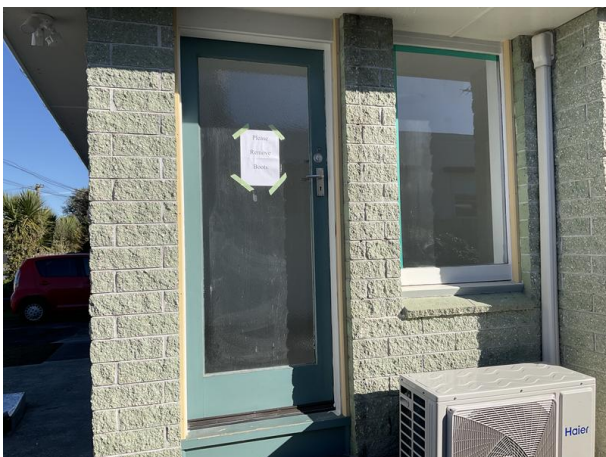
Photo 40
Single glazed timber joinery. East elevation.

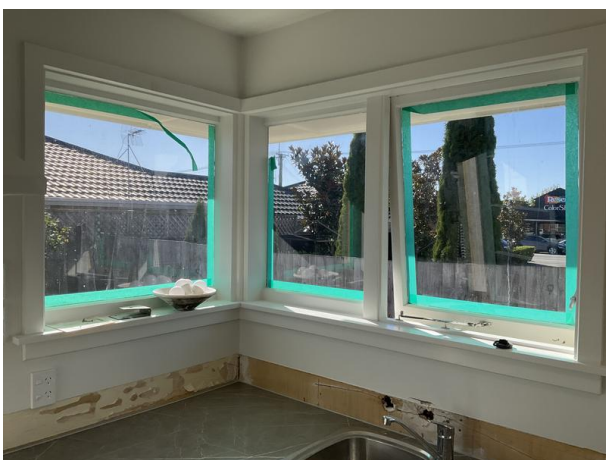
Photo 41
Painted timber joinery interior.

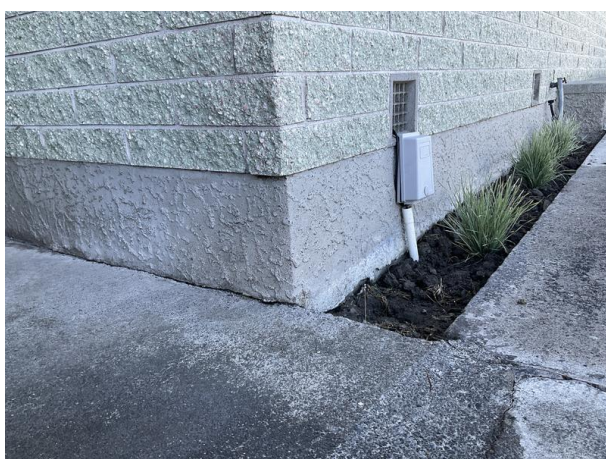
Photo 43

Concrete perimeter ring foundation.

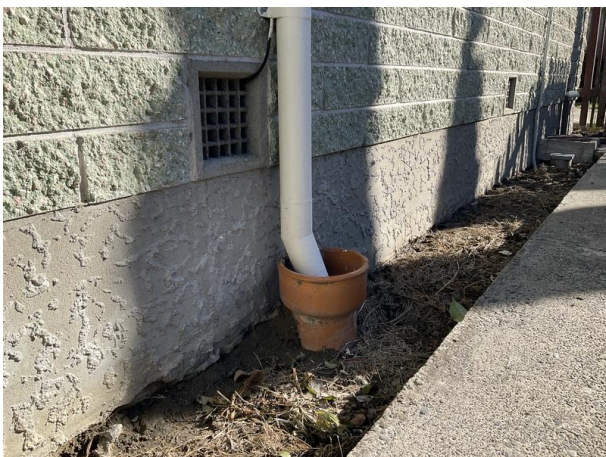
Photo 44
Concrete perimeter ring foundation east elevation with the slurry Plastered finish.

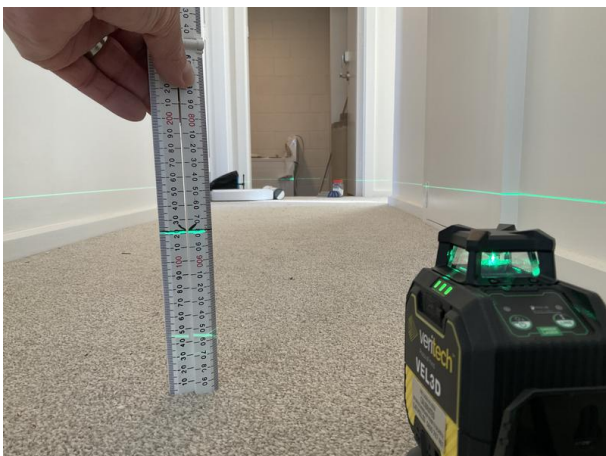
Photo 46
Floor levels chips using a self levelling laser

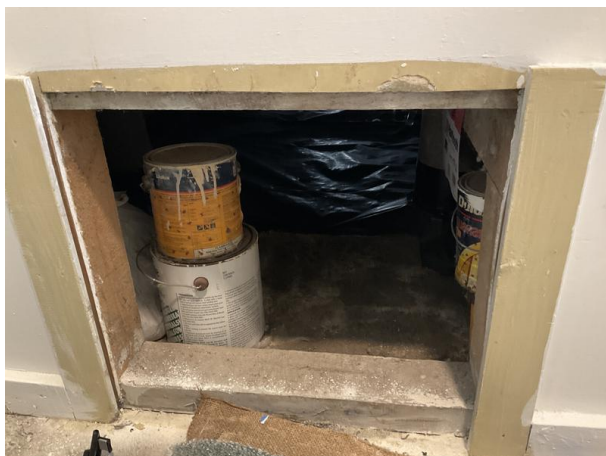
Photo 49
Subfloor access located in the garage.

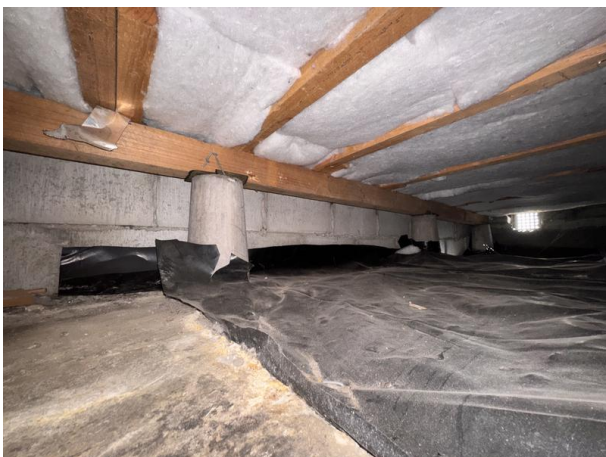
Photo 50
Concrete block intertenancy wall visible.

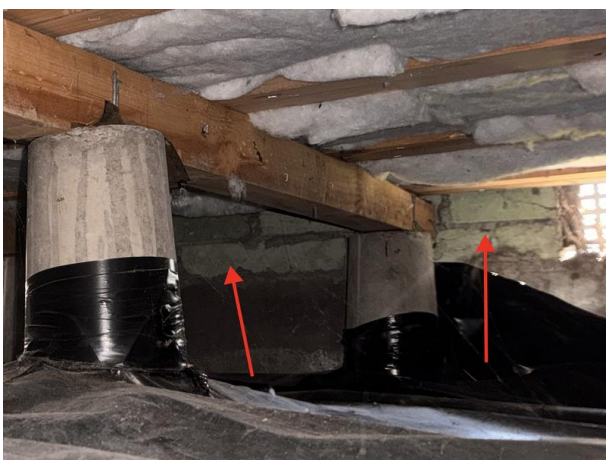
Photo 51
Summer hill stone cladding open to the subfloor.

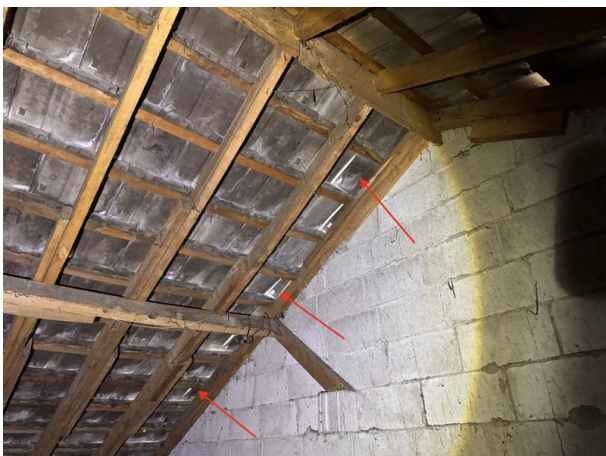
Photo 58
Some slightly lifting tile visible near the intertenancy wall.

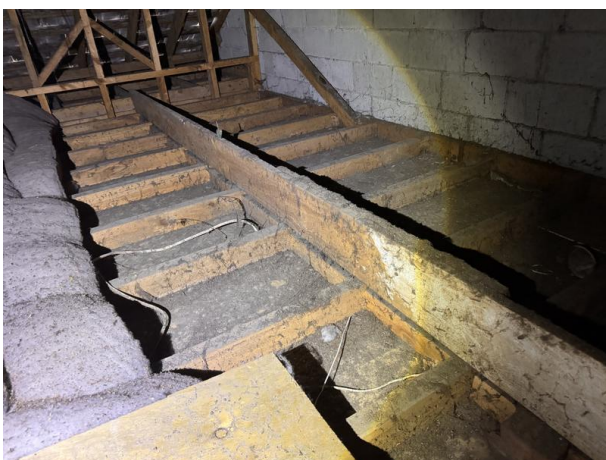
Photo 60
No insulation installed over the garage.

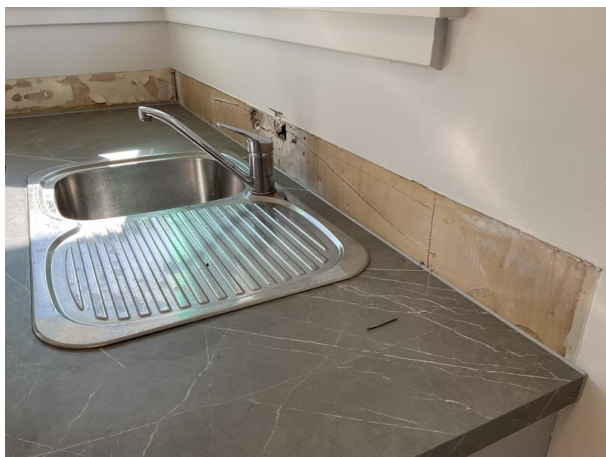
Splashback - None, painted plasterboard - Damaged.

Photo 83
Splash back yet to be installed.

It is recommended that a water-resistant splashback be installed behind the vanity to protect the painted wallboard from water damage.

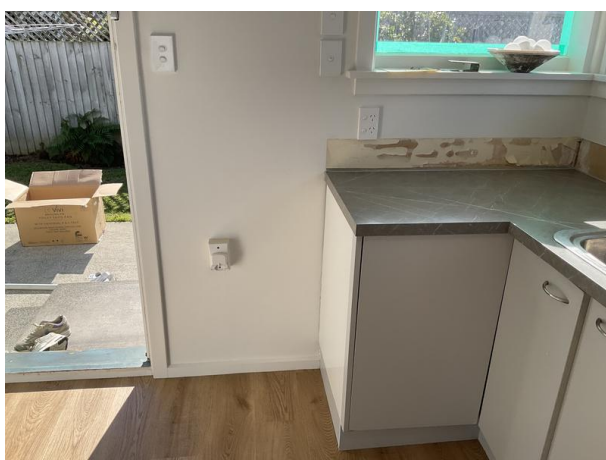
Photo 84
Oven not in place at the time of inspection.

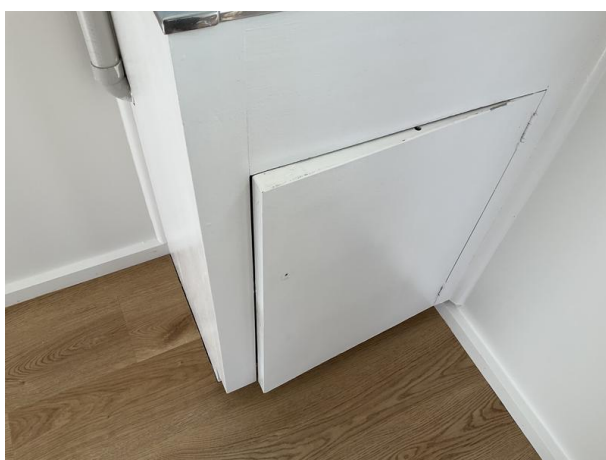
Photo 86
Laundry tub door handle not installed.

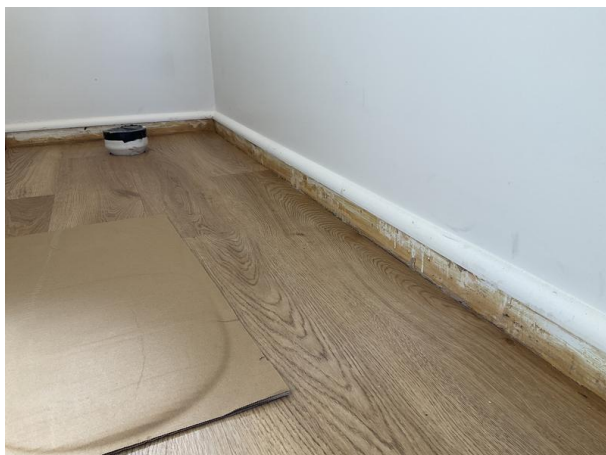
Photo 91
Flooring upstand skirting to be installed.

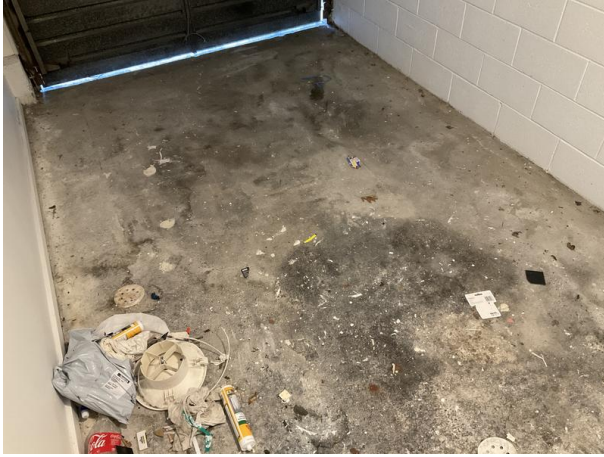
Photo 94
Concrete garage floor.

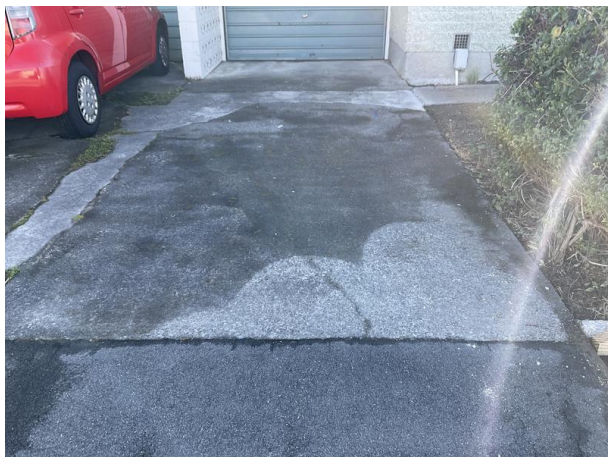
Plain concrete.
Saw cuts or construction joints - Yes.
Cracking - Areas of cracking visible.

Photo 95
Plain concrete driveway.

General upkeep and maintenance of the driveway is recommended, including cleaning it and keeping it free of debris.

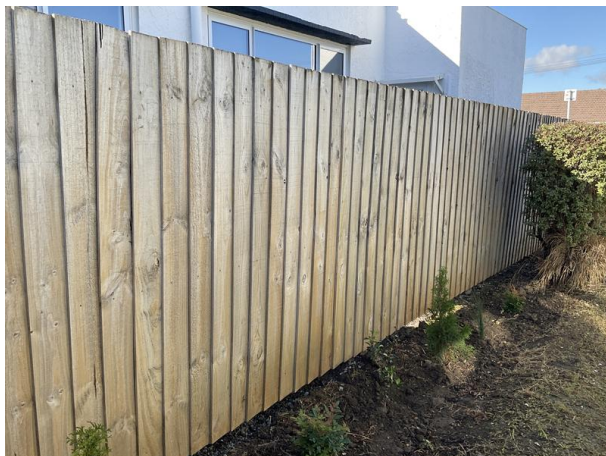
Photo 97

New timber paling east boundary fence.

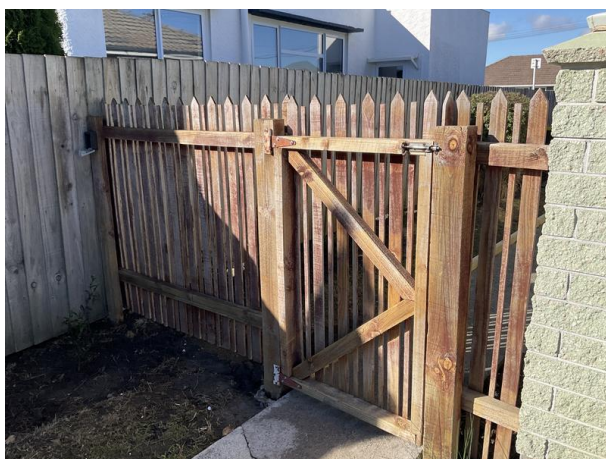
Photo 98

Stained timber picket dividing fence on the east elevation.

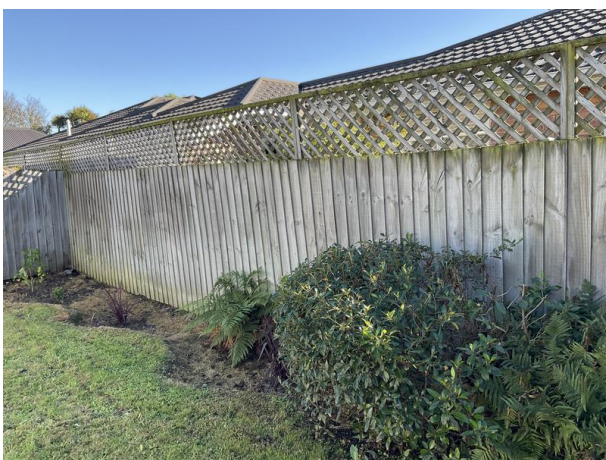
Photo 100
Timber Palisade north boundary fence with a timber trellis topper.

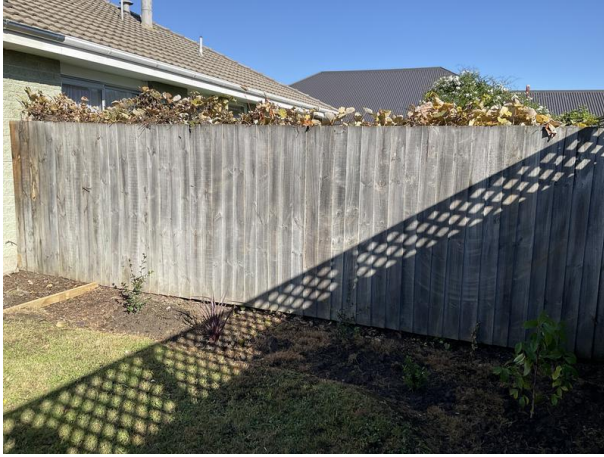
Photo 102
Timber paling west boundary fence.

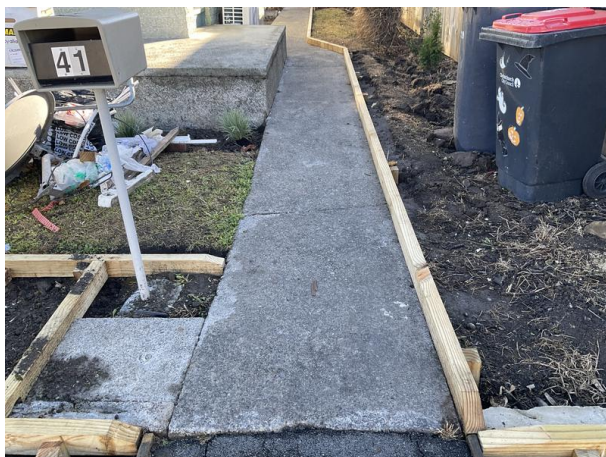
Photo 103
Plain concrete path on the east elevation.

General upkeep and maintenance. Clean down to remove moss and reduce slip hazard as part of regular maintenance.

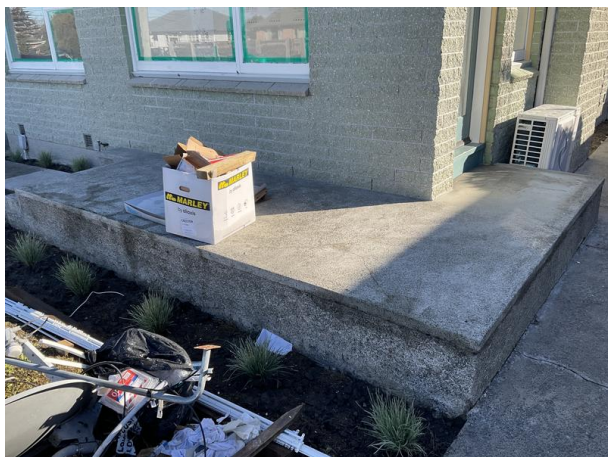
Photo 105
Plain concrete patio on the south east corner, access to the front entrance.

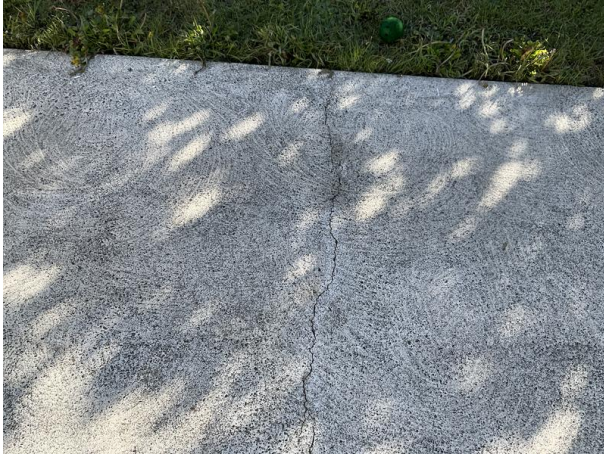
Photo 108
Cracking visible.

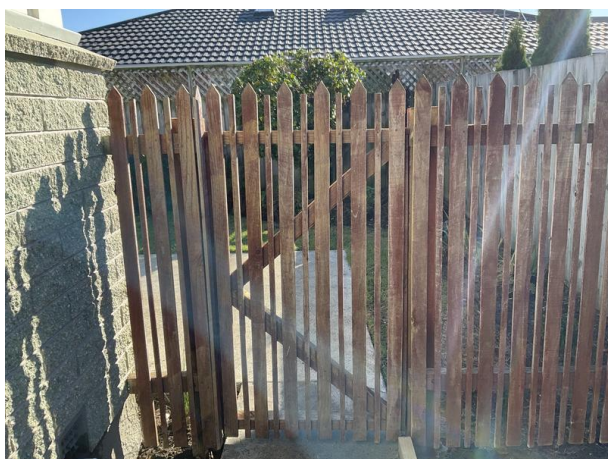
Photo 109
Timber side pedestrian gate on the east elevation.

It is recommended to apply regular maintenance to hinges and latches to maintain smooth operation.

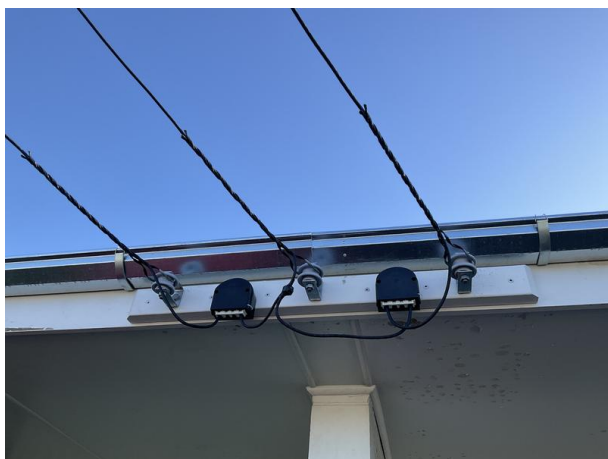
Photo 111
Over head power supply.

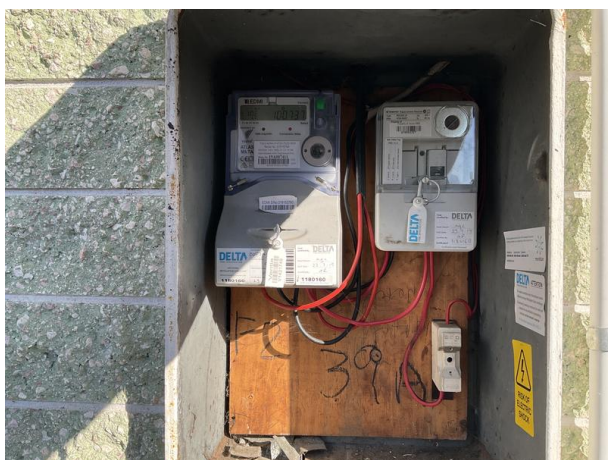
Photo 112
Power meter located on the east elevation.

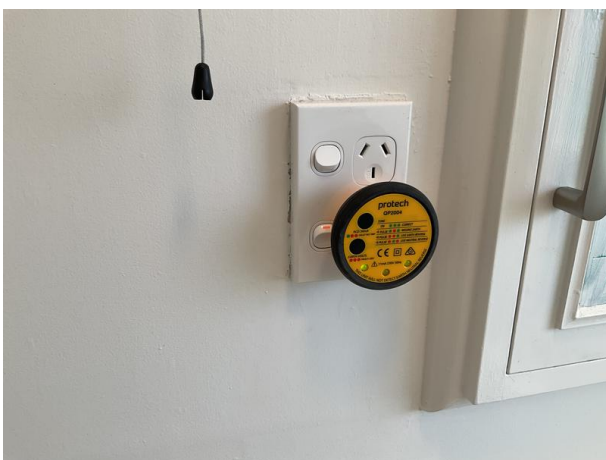
Photo 114
All accessible power sockets tested for faults, no faults detected at the time of inspection.

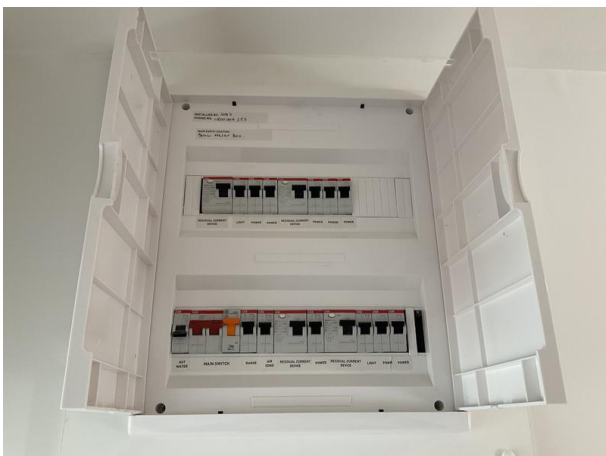
Photo 115
New power distribution board installed in the hallway.

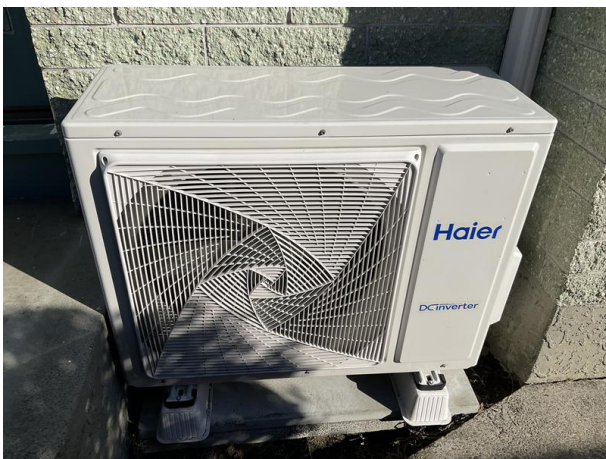
Photo 116

Haier heat pump inverter located on the east elevation.

Follow the manufacturer's recommended servicing schedule to ensure the equipment operates efficiently and maintains optimal performance. Adhering to these guidelines helps identify and address potential issues early, reducing the risk of costly repairs and ensuring compliance with warranty requirements.

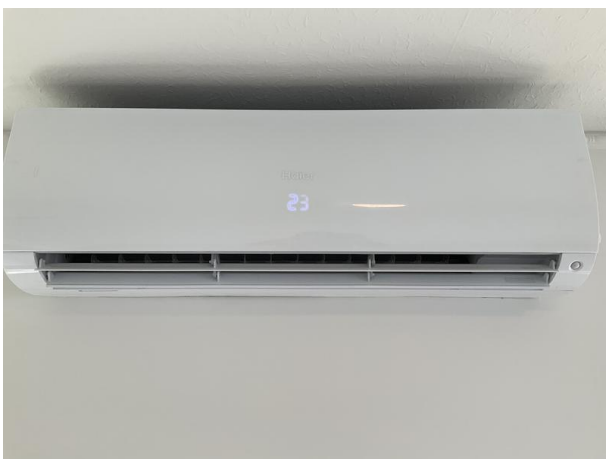
Photo 117

Haier high wall heat pump installed in the living room.

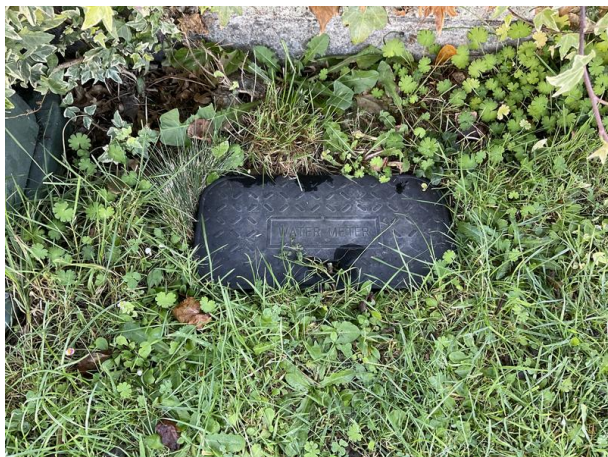
Photo 118

Water meter located in the front grass verge in front of the west unit.

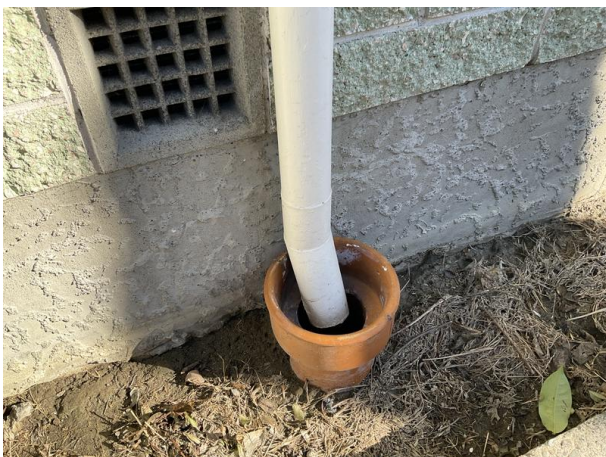
Photo 119
Earthenware stormwater risers.

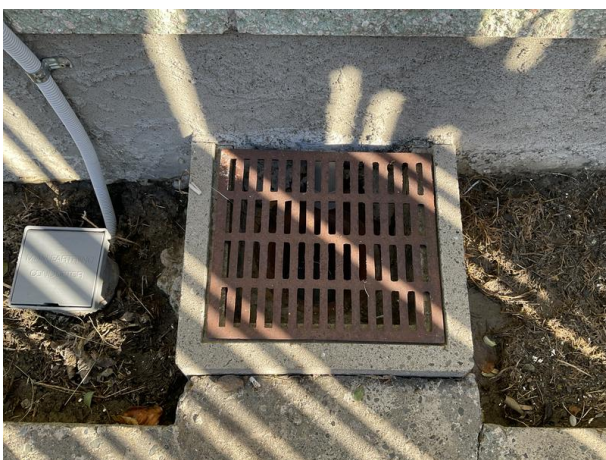
Photo 120
Earthenware gully traps.

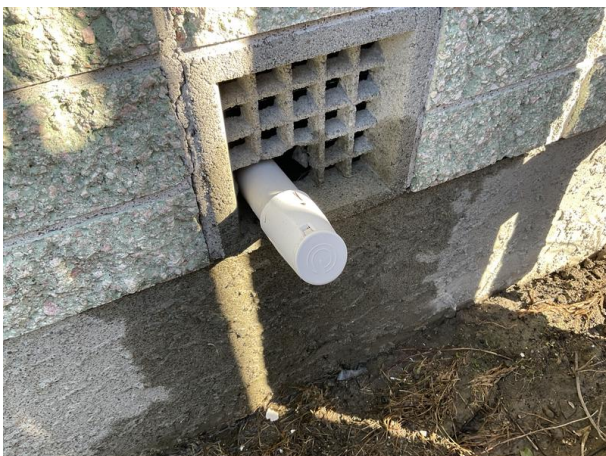
Photo 121
PVC hot water over flow drain pipe visible back flow on the to foundation. Recommend creating mor fall on installing a down turn to prevent back flow.

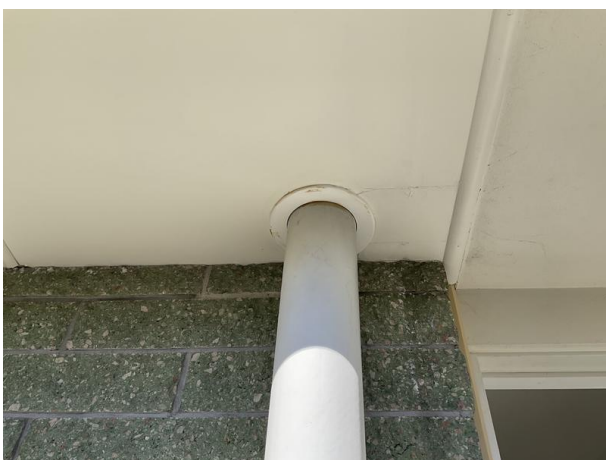
Photo 123
Terminal vent pipe soffit penetration.

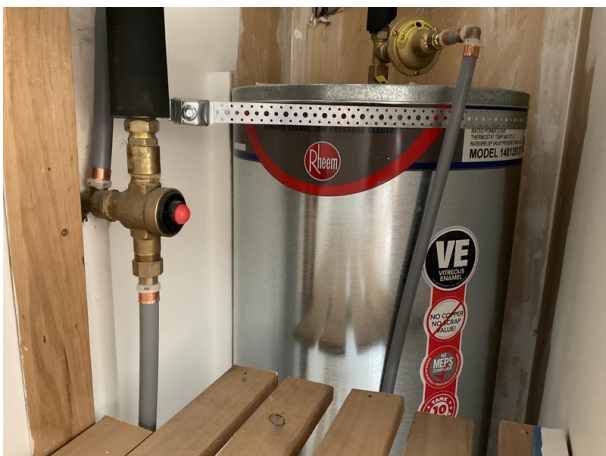
Photo 124
Modern low pressure hot water cylinder located in the hallway cupboard. Secured in place with seismic strapping.

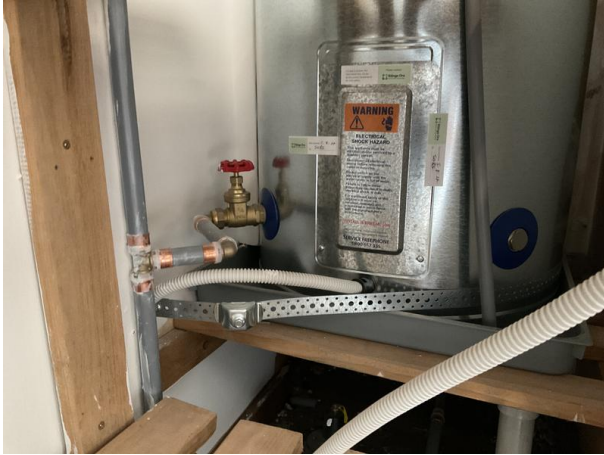
Photo 125
Water safety drip tray install installed
polybutylene Grey plumbing visible.

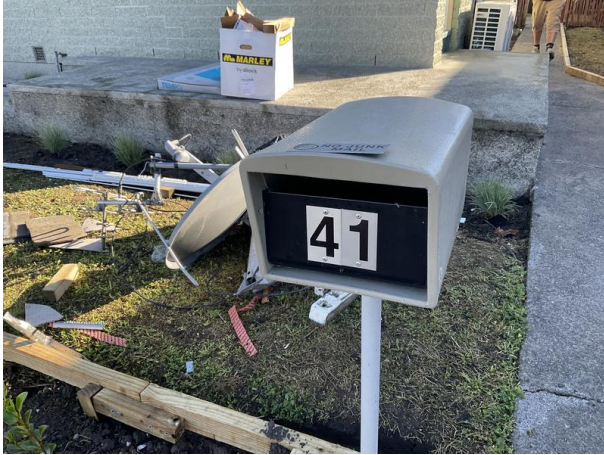
Photo 126
Letterbox.

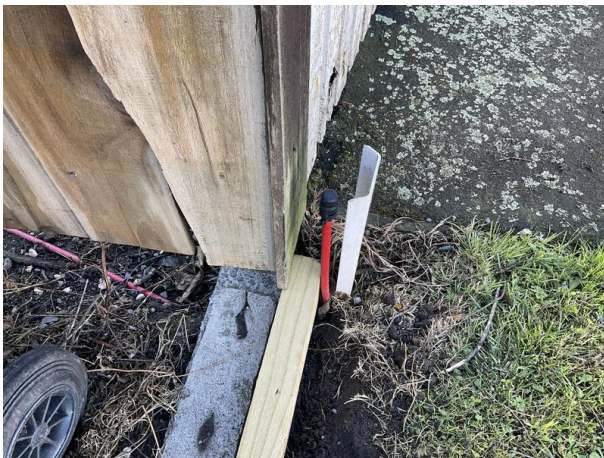
Photo 127
Fibre installed at the boundary.

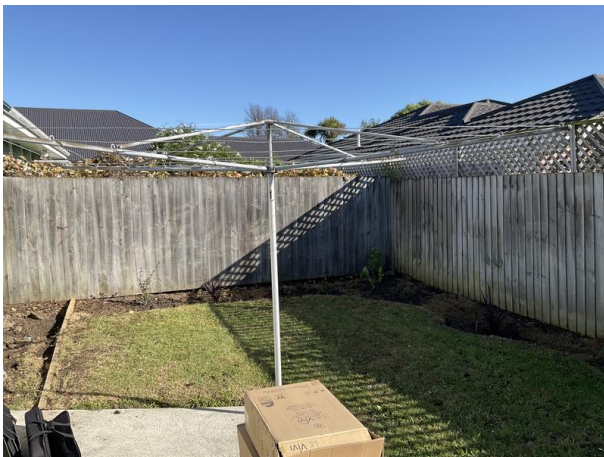
Photo 128
Clothesline.

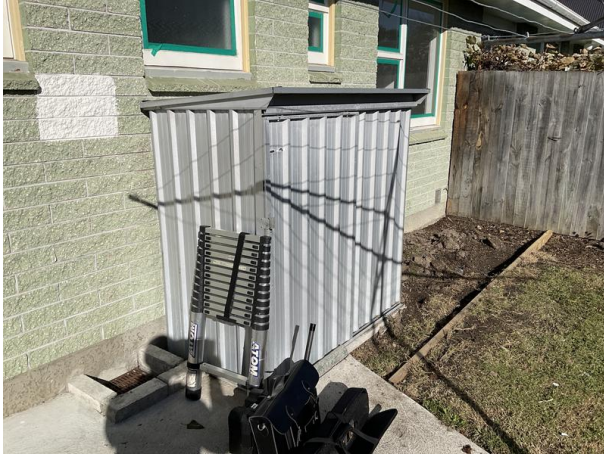
Photo 129
Garden shed.

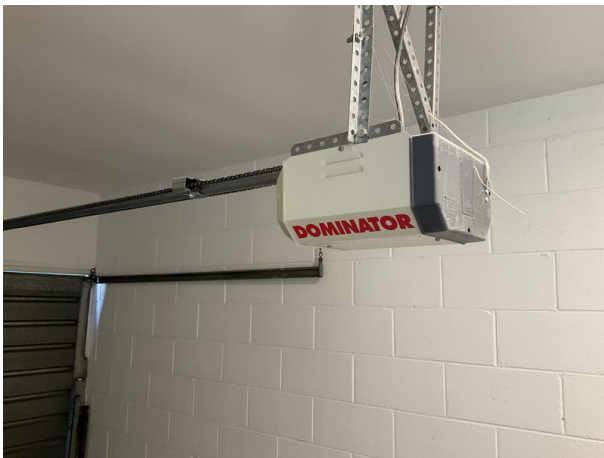
Photo 130
Garage door
